MINERALS PROGRAM INSPECTION REPORT
PHONE: (303) 866-3567

MINE NAME: Hale Pit aka Earl's Pit	MINE/PROSPECTING ID#: M-1981-121	MINERAL: Sand and gravel	COUNTY: El Paso
INSPECTION TYPE: Monitoring	INSPECTOR(S): Timothy A. Cazier	INSP. DATE: March 29, 2019	INSP. TIME: 13:40
OPERATOR: S & K No. 1, LLC	OPERATOR REPRESENTATIVE: Joe Kraig	TYPE OF OPERATION: 110c - Construction Limited Impact

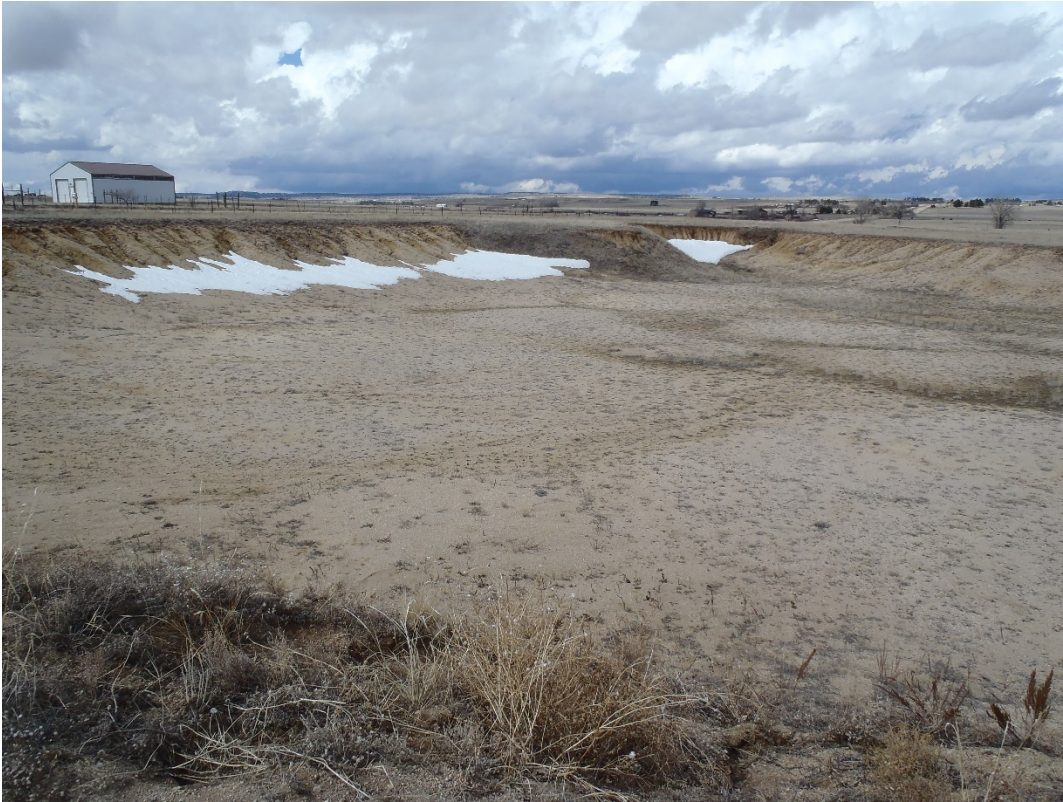
The observed disturbance was the same as that observed during the 2015 DRMS inspection (see **Photos 1, 2 and 3**).

Photo 1. Observed disturbance (same as 2015 inspection, looking NW from access road).

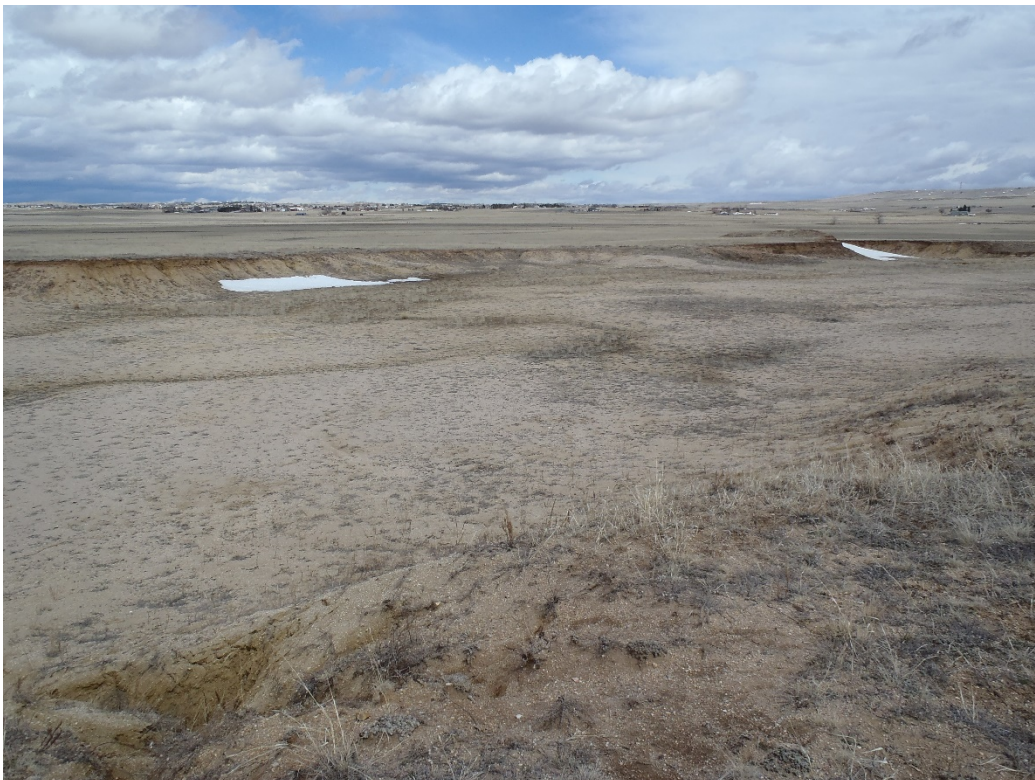
Photo 2. Observed disturbance (same as 2015 inspection, looking NE from access road).

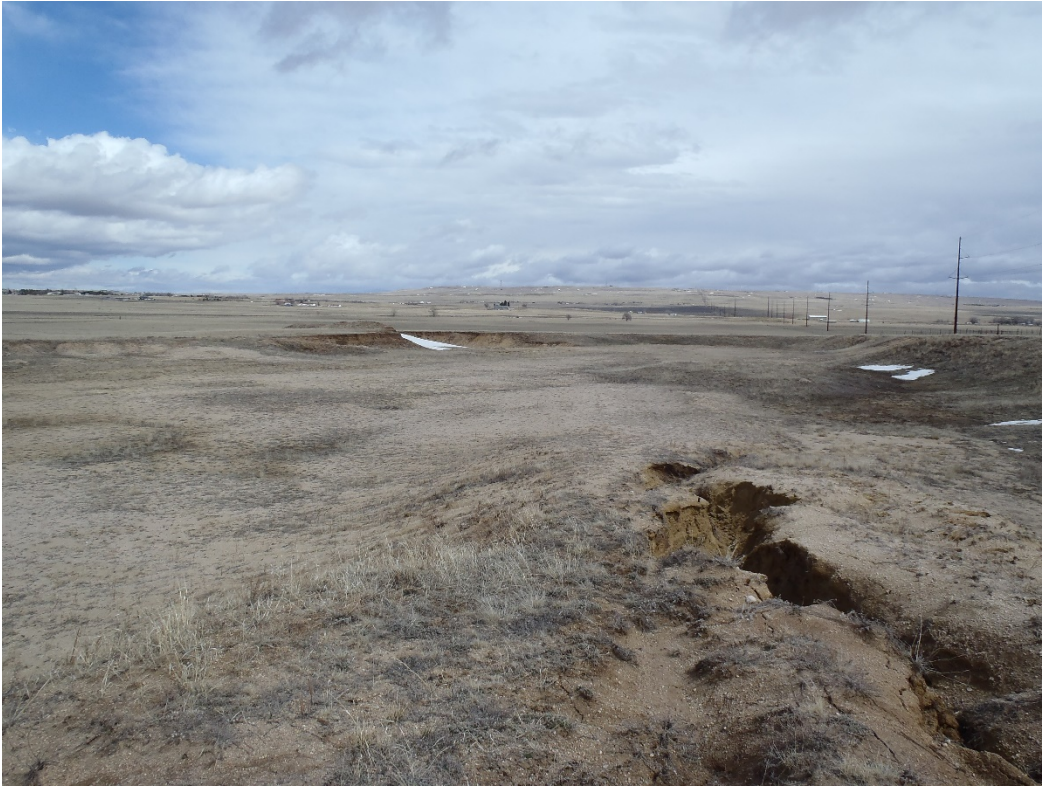
Photo 3. Observed disturbance (same as 2015 inspection, looking east from access road).

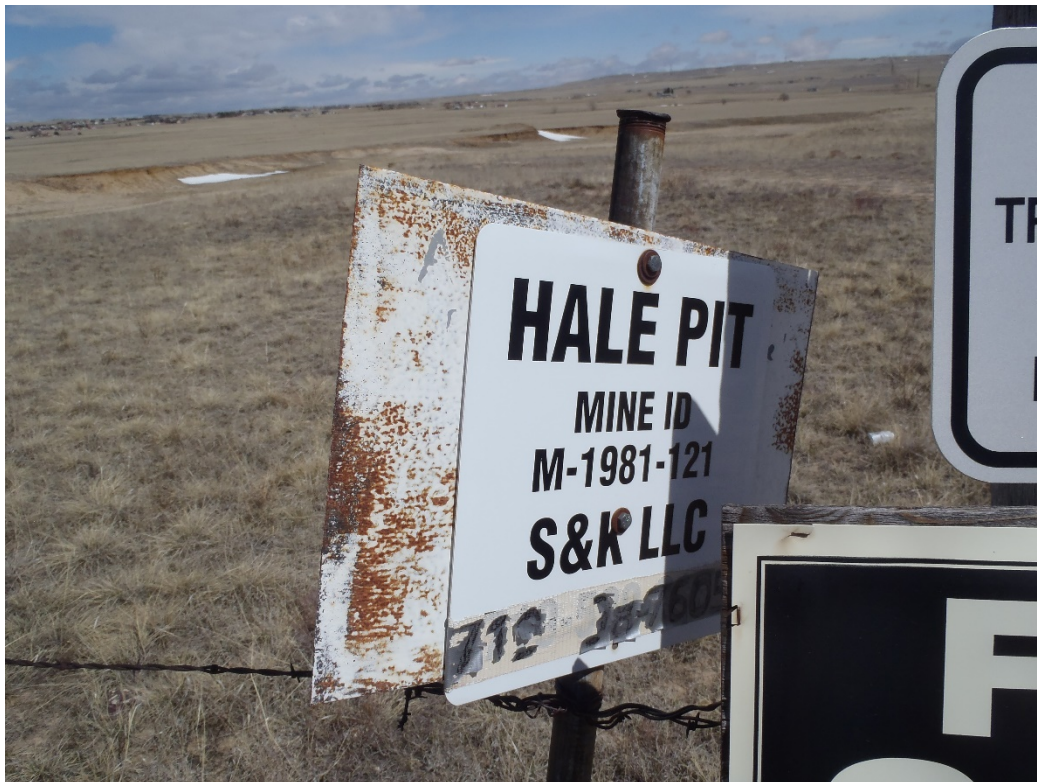
Signs and Markers: The permit sign was properly posted (see **Photo 4**). Prior to any additional mining activity, boundary markers for the four corners marking the current approved permit boundary must be placed.

Photo 4. Permit sign (at entrance).
