MINERALS PROGRAM INSPECTION REPORT
PHONE: (303) 866-3567

MINE NAME: Amity Gravel Pit	MINE/PROSPECTING ID#: File No. M-2019-014	MINERAL: Sand and Gravel	COUNTY: Bent
INSPECTION TYPE: Illegal (Unpermitted Operation)	INSPECTOR(S): Amy Eschberger	INSP. DATE: April 25, 2019	INSP. TIME: 14:00
OPERATOR: Amity Mutual Irrigation Company	PRESENT DURING INSPECTION: BNFF: Lillian Norman, Brad Semmens AMIC: Terry Howland, Glen Wilson	TYPE OF OPERATION: ILL - Illegal	
REASON FOR INSPECTION: Citizen Complaint	BOND CALCULATION TYPE: None	BOND AMOUNT: No Bond Held	
DATE OF COMPLAINT: March 28, 2019	POST INSP. CONTACTS: None	JOINT INSP. AGENCY: None	
WEATHER: Clear	INSPECTOR'S SIGNATURE:

DRMS File No. M-2019-014 / Amity Gravel Pit

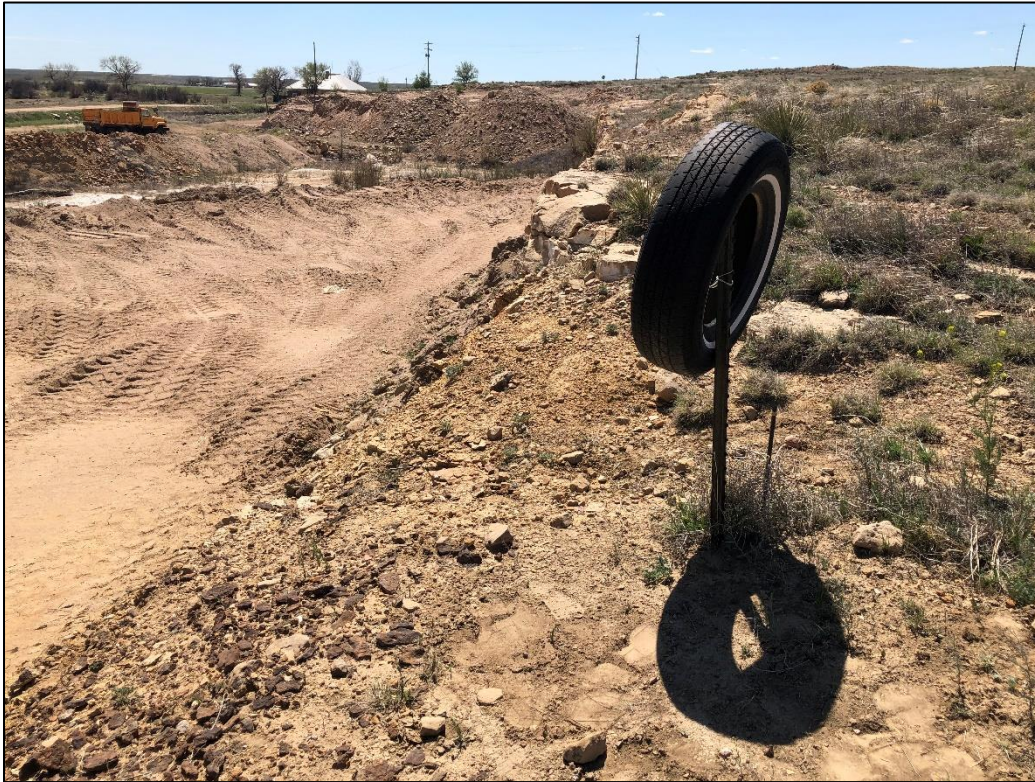
Photo 1. View looking southwest from top of highwall, standing on BNFF property. Note t-post which according to BNFF marks location of previous fence removed by AMIC.

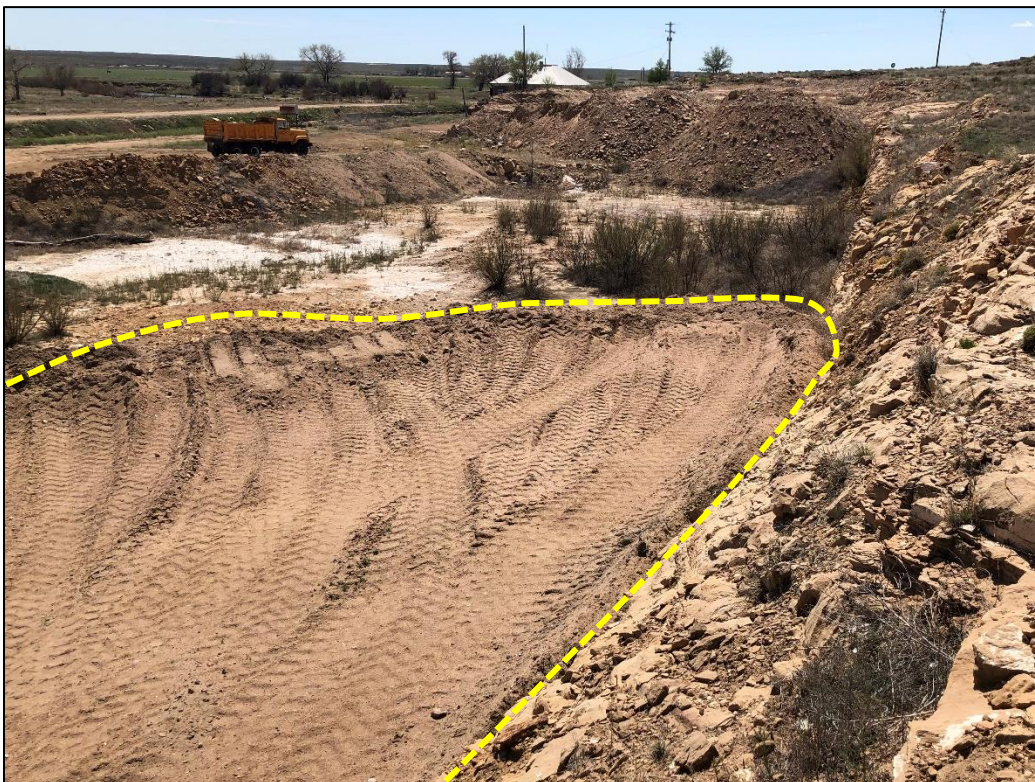
Photo 2. View looking southwest across AMIC's pit. Note backfilled portion of highwall indicated with yellow dashed line.

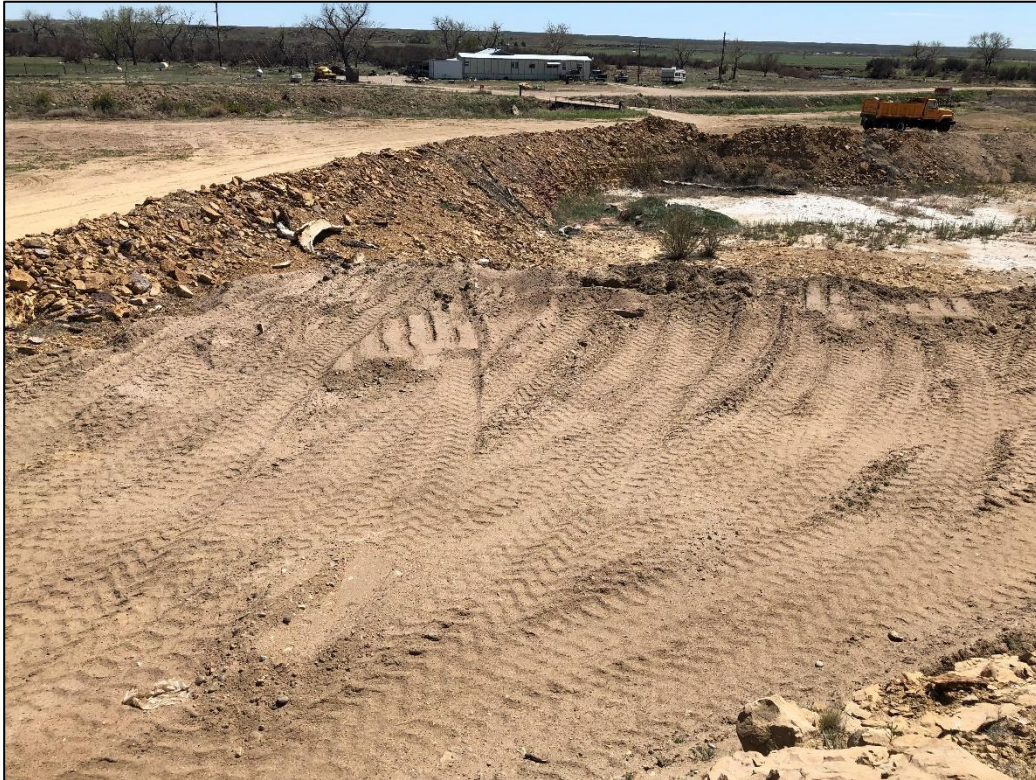
Photo 3. View looking south across backfilled portion of highwall in northeastern corner of pit. AMIC uses sand dredged from their canal as pit backfill material.

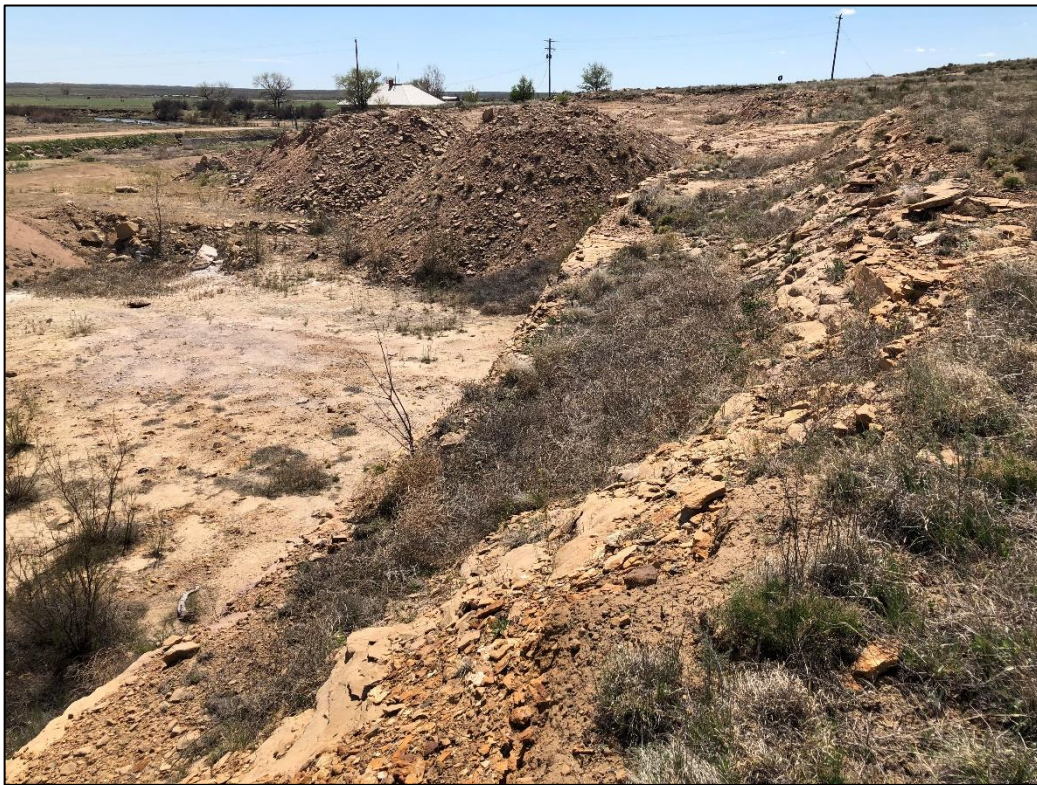
Photo 4. View looking southwest across pit from top of highwall. Note stockpiles of mined material stored in western portion of pit.

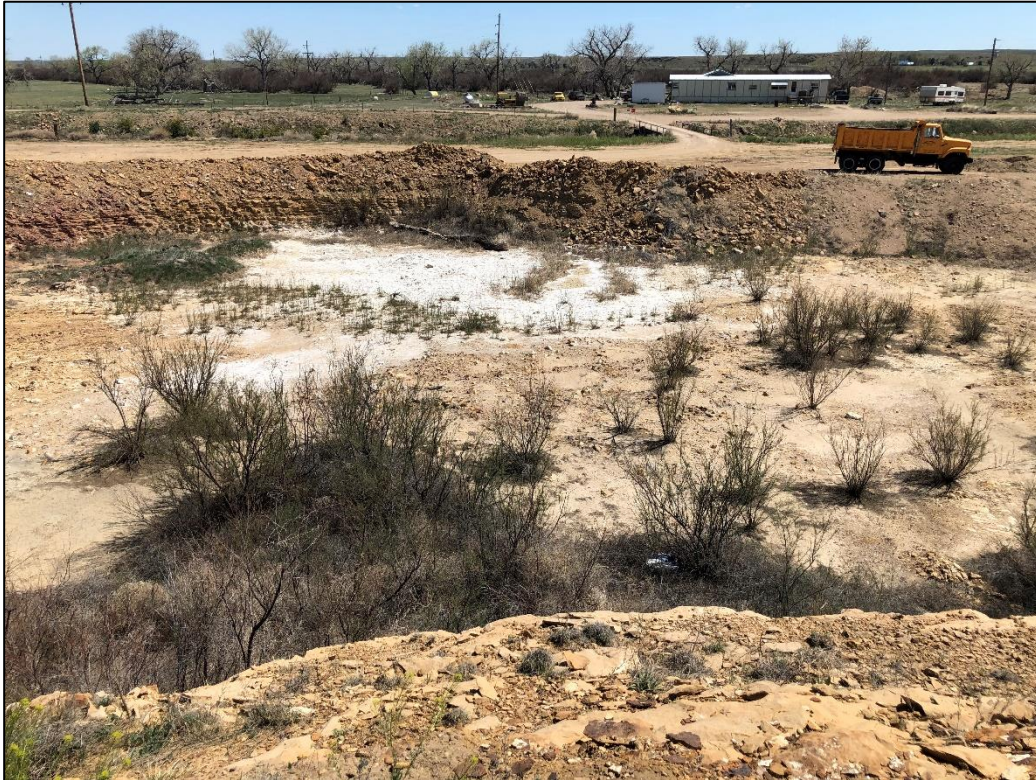
Photo 5. View looking south across pit from top of highwall. Note waste rock berm constructed along southern edge of pit, and pit floor dry with weedy vegetation.

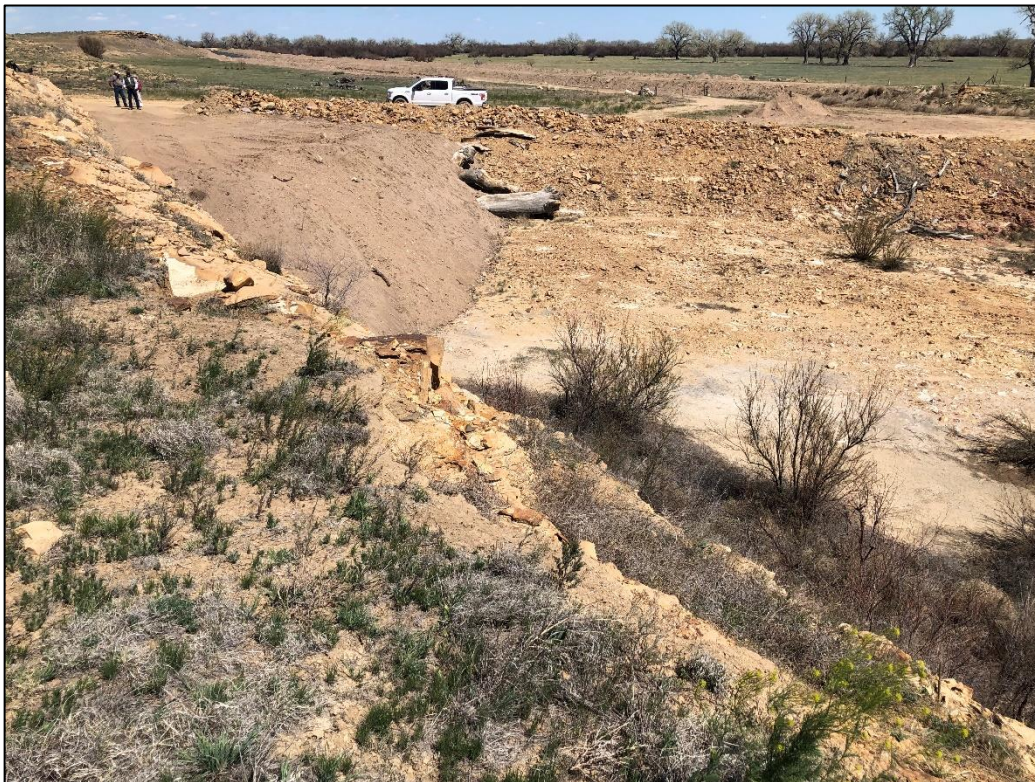
Photo 6. View looking east from top of highwall across northeastern portion of pit. Note backfilled portion of highwall at top left.

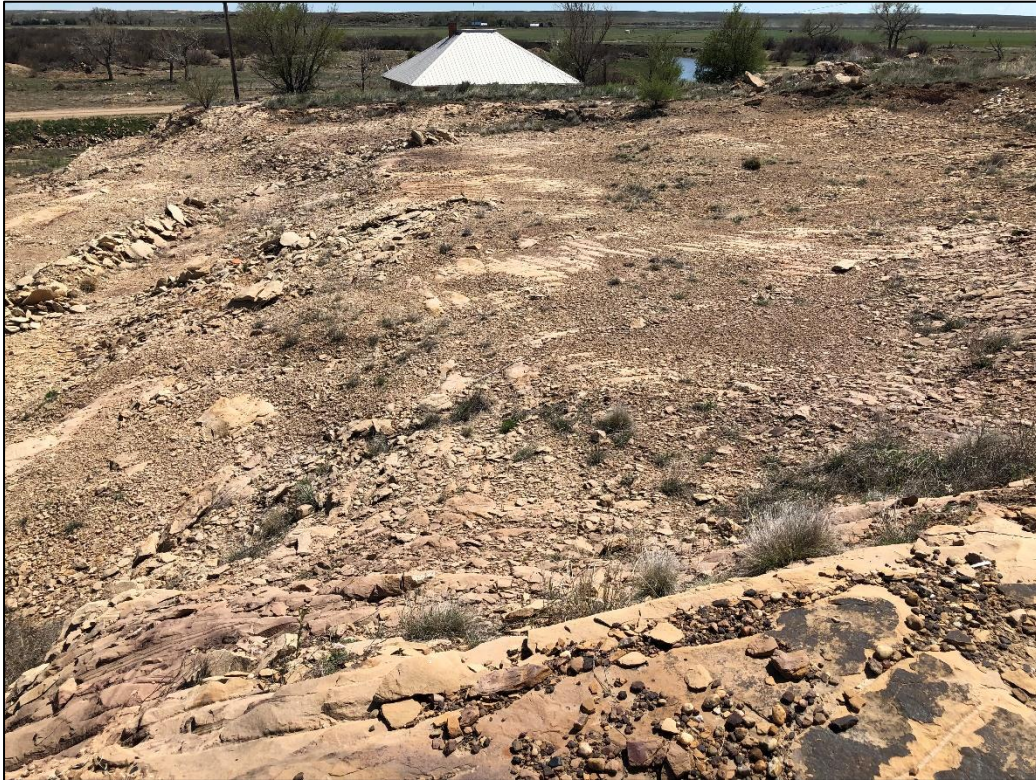
Photo 7. View looking south across small area west of pit where it appears topsoil has been stripped in preparation for expanding the pit westward (on AMIC property).

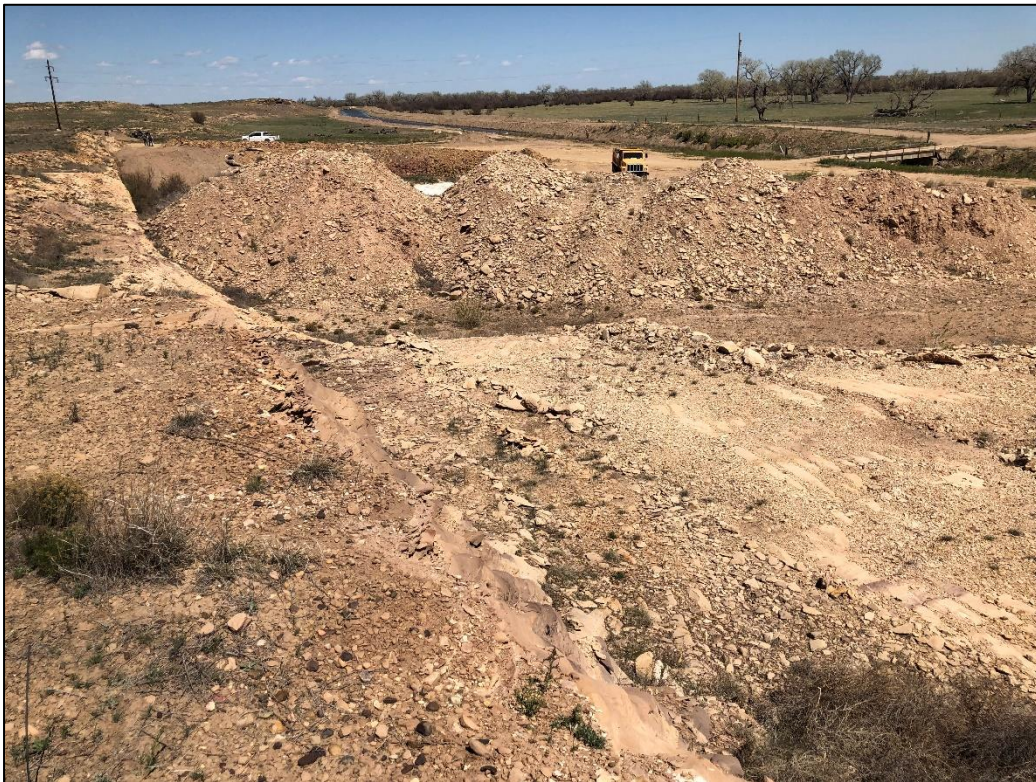
Photo 8. View looking east across western portion of pit, showing mined material stockpiled on pit floor.

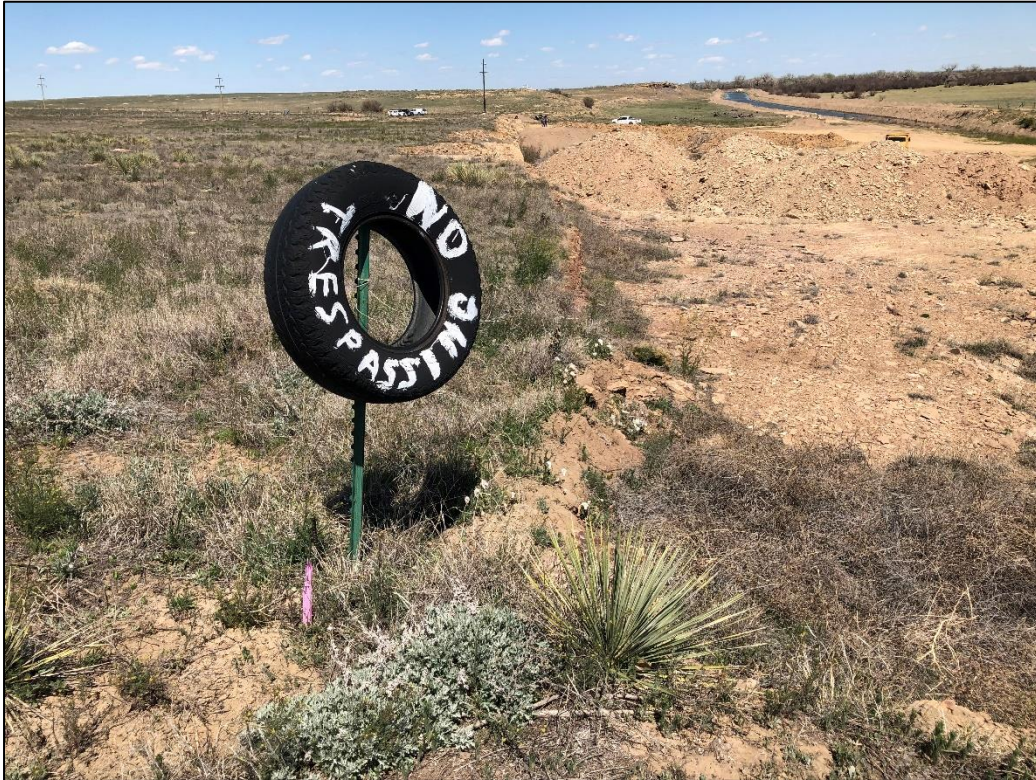
Photo 9. View looking northeast, standing on BNFF property. Note t-post which according to BNFF marks location of previous fence removed by AMIC.

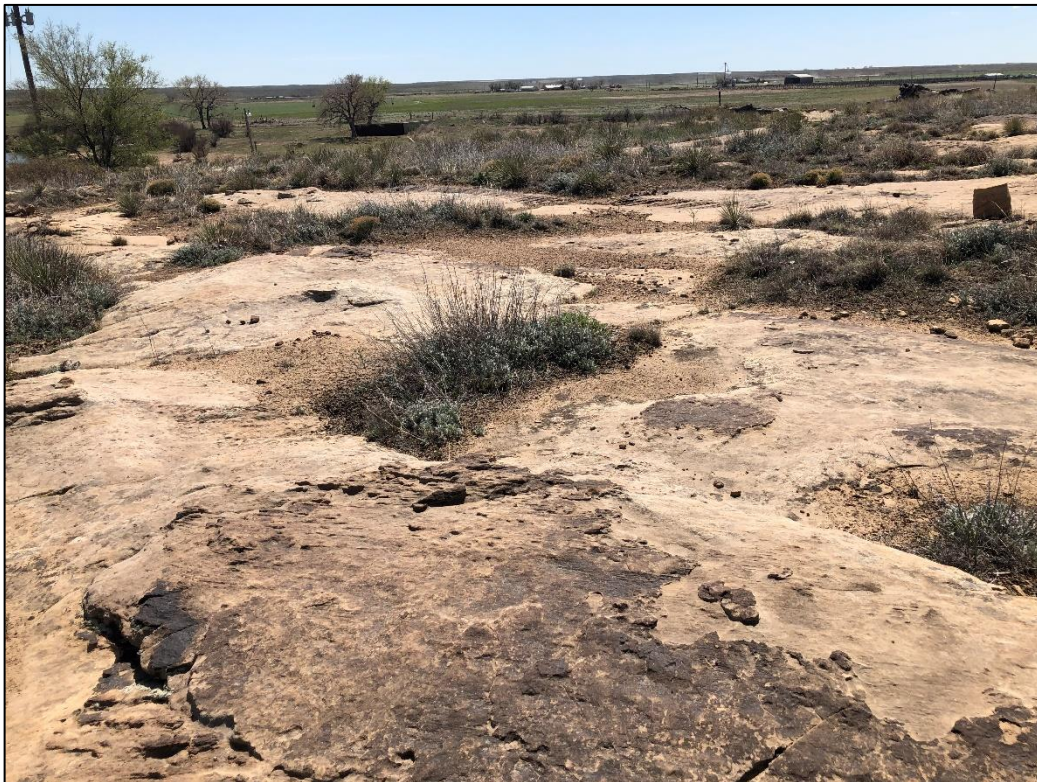
Photo 10. View looking southwest across undisturbed land west of pit, showing native conditions of rock outcropped at surface along edge of bluff.

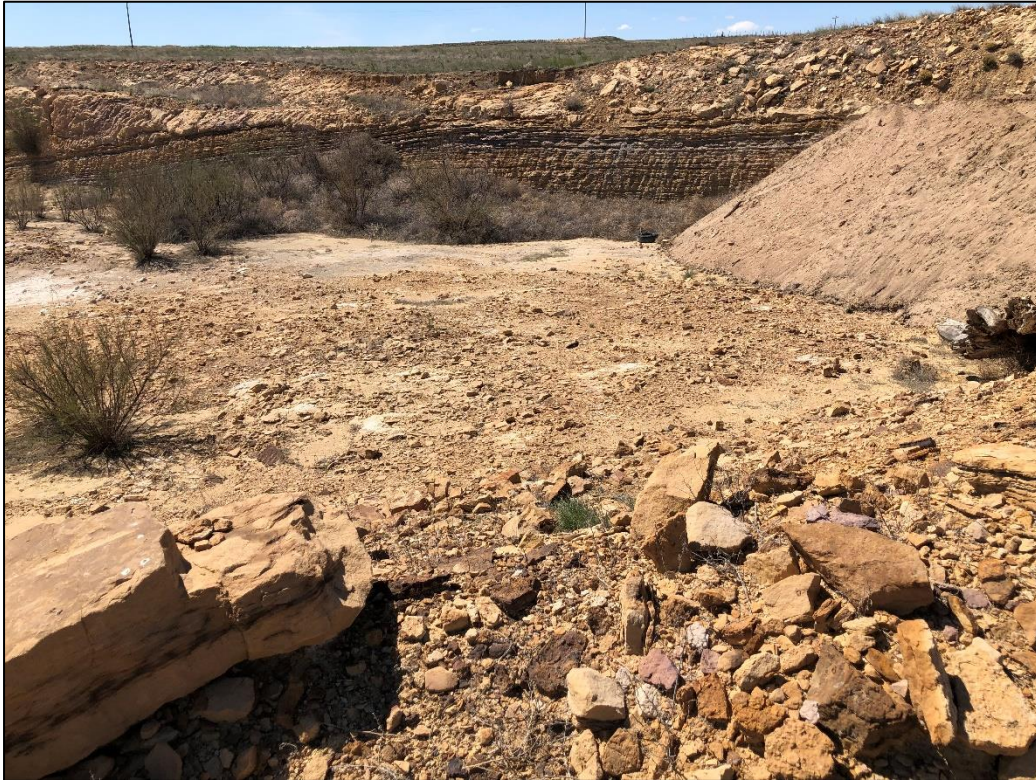
Photo 11. View looking north across eastern portion of pit from its southern edge. Note 10-15 foot tall highwall with near vertical slopes, and edge of backfill (at right).

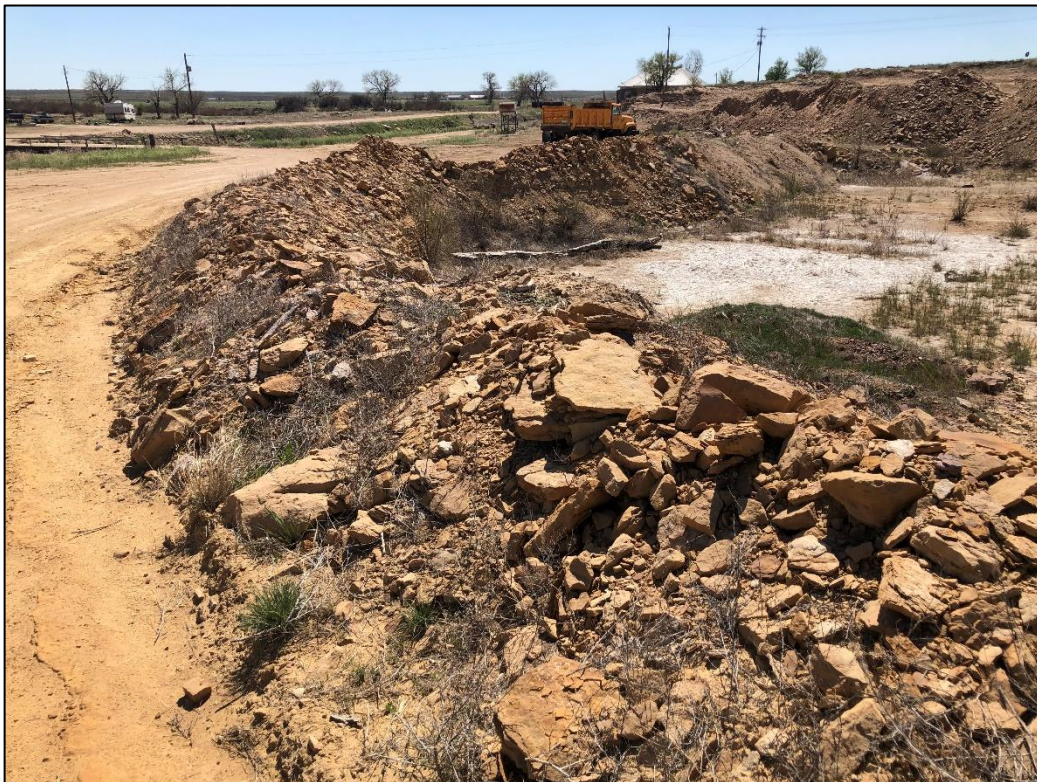
Photo 12. View looking southwest, showing waste rock berm constructed along southern edge of pit.

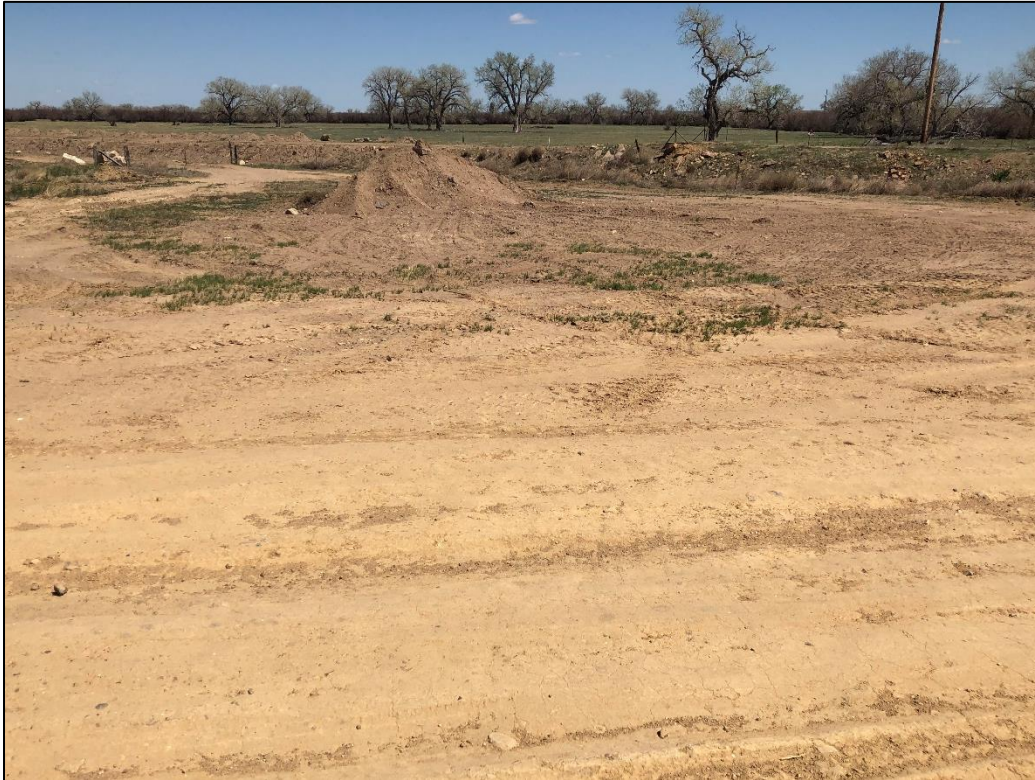
Photo 13. View looking east at stockpiling area located east of access road.

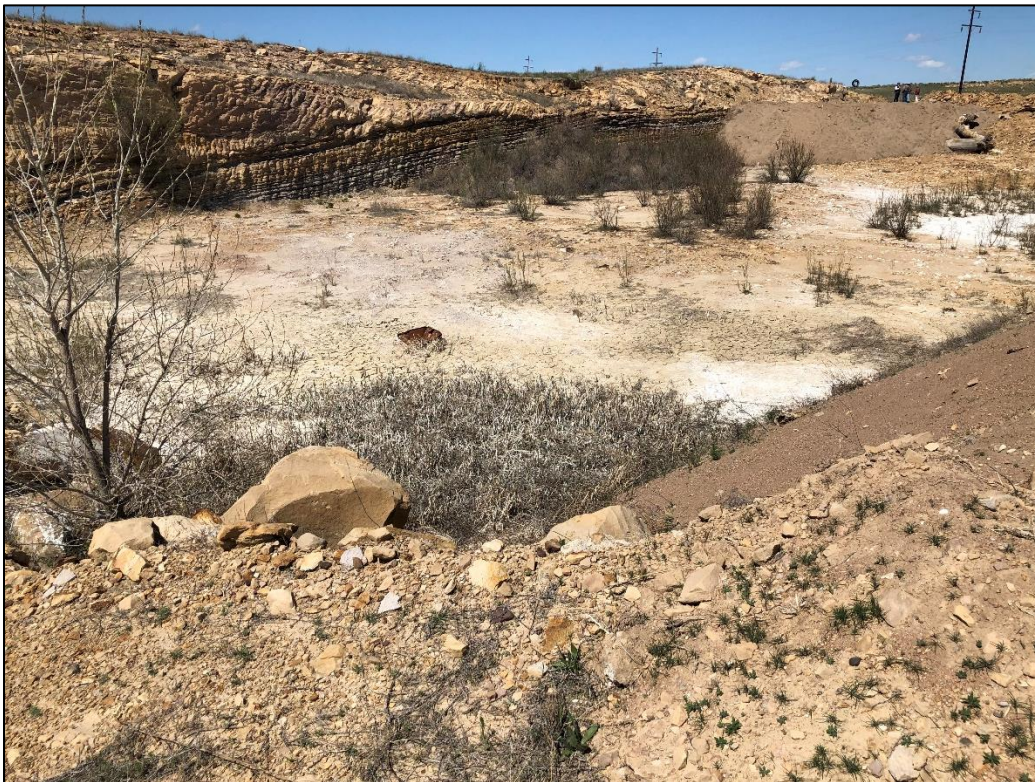
Photo 14. View looking northeast across pit from its southern edge.

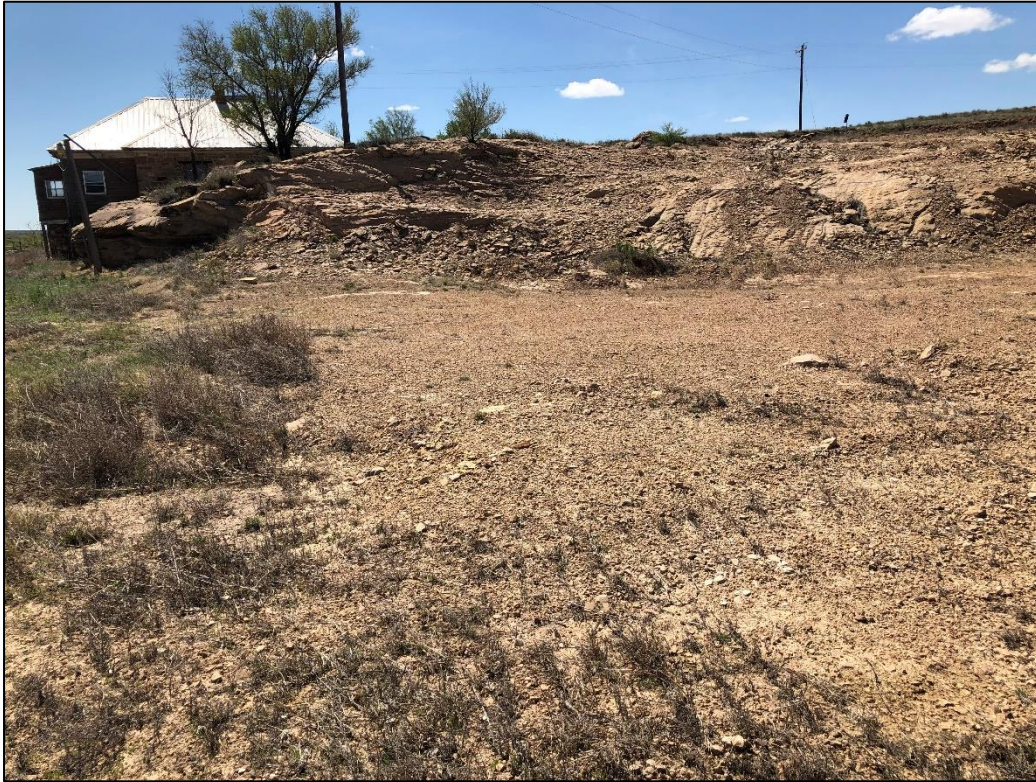
Photo 15. View looking west across western edge of pit. Note ~10 foot tall highwall daylights to the east in this area.

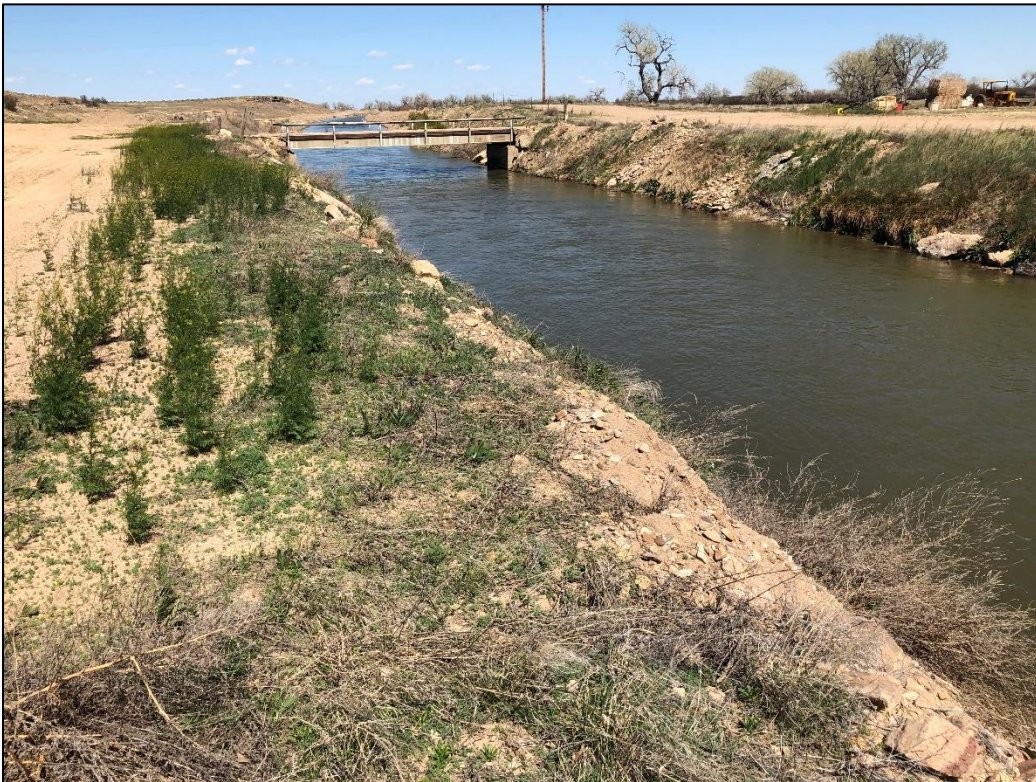
Photo 16. View looking northeast across Amity Canal (adjacent to pit) for which AMIC uses material mined from their property to stabilize the slopes.

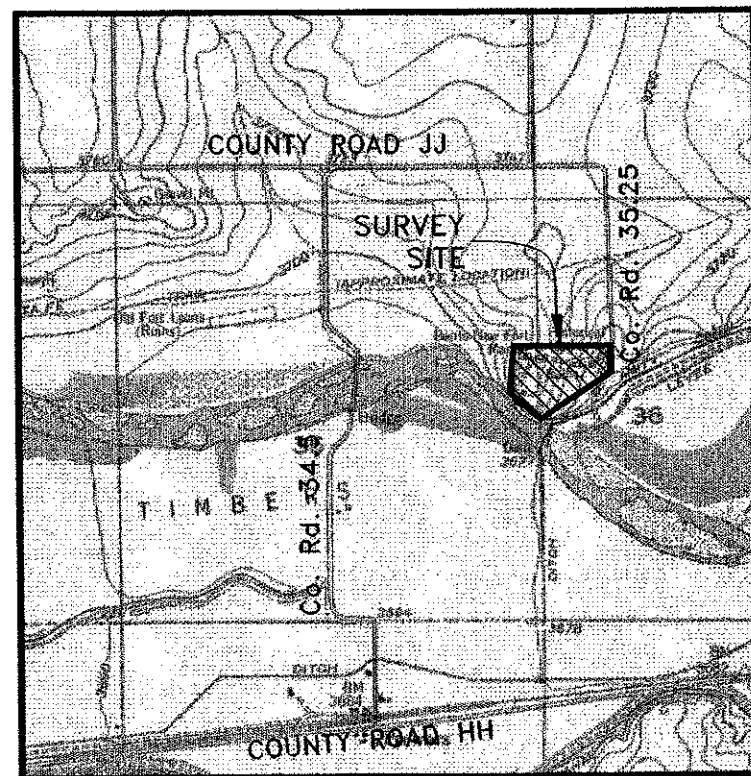
**LAND SURVEY
PLAT**

THE LOCATION OF NEW BENT'S FORT BOUNDARY IS BEST FACILITATED BY THE EVIDENCE OF OLD FENCE CORNERS IN THE LOCATION OF THE NW AND SE CORNERS OF SAID SITE AND FENCE REMNANTS ALONG THE NORTH SIDE THEREOF.

QUARTER CORNER COMMON TO SEC. 35 AND 36; SET 3/4" X 30" REBAR AND 2-1/2" ALUM. CAP, BRUNDAGE, PLS 30087; THIS POSITION ESTABLISHED BY BLM METHOD OF SINGLE PROPORTION. NO EVIDENCE OF ORIGINAL STONE MONUMENT OR EVIDENCE BASED UPON VARIOUS DEED CALLS IN THE AREA TO THIS POSITION COULD BE FOUND ON THE GROUND.

The Division observed metal T-posts at the northeastern and southwestern edges of the pit, which BNFF indicated mark the location of the previous fence that was removed by AMIC in 2009. According to the Land Survey Plat provided with the complaint, a portion of the pit highwall does appear to be located on BNFF's property, estimated to consist of approximately 0.13 acre.

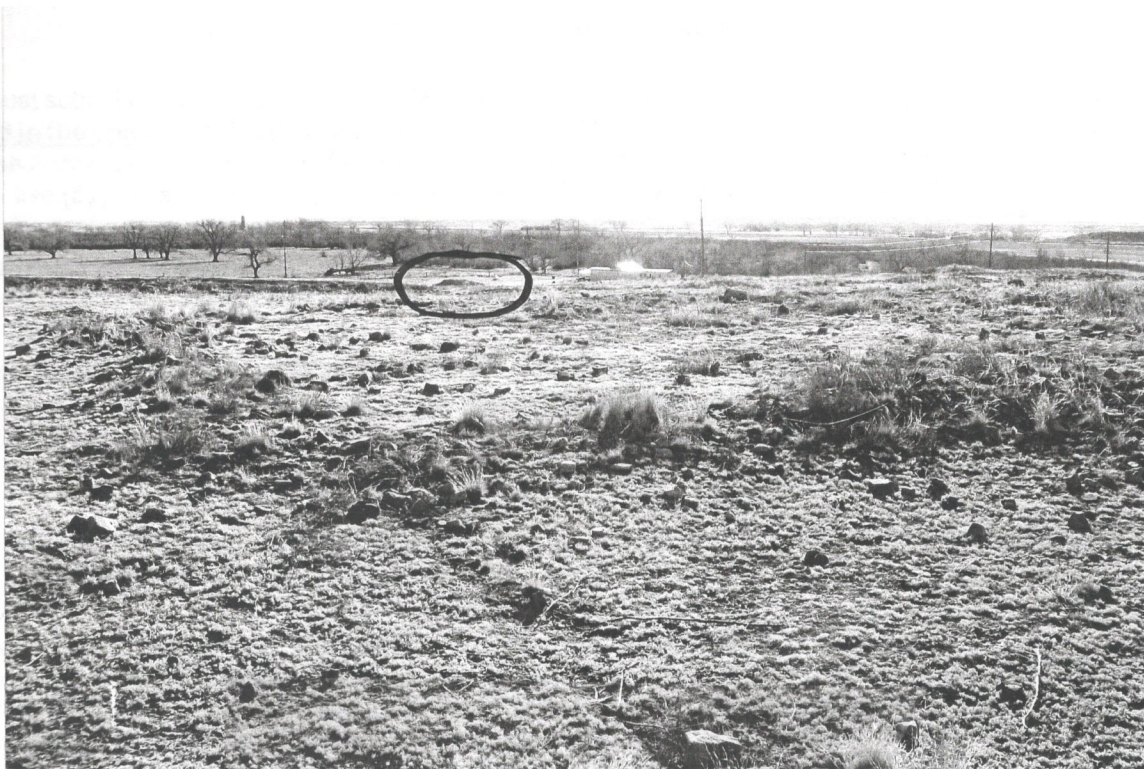
**FOUNDATIONS OF FORT WALLS LOOKING SOUTHEAST (NOTE:
CIRCLED AREA SHOWS TOP OF DIRT MOUND PICTURED BELOW)**

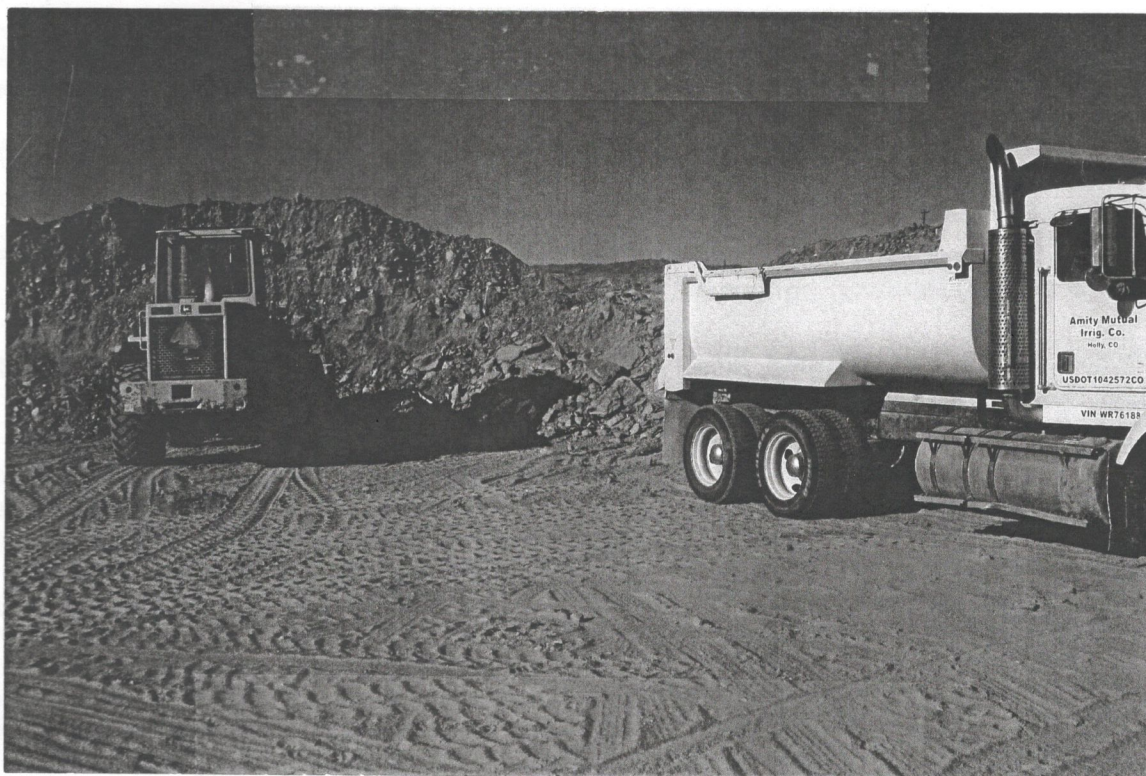
**ELECTRIC POWER GENERATION COMPANY'S EXCAVATIONS
ENCROACHING ON SOUTHEAST BOUNDARY OF BENT'S NEW FORT**

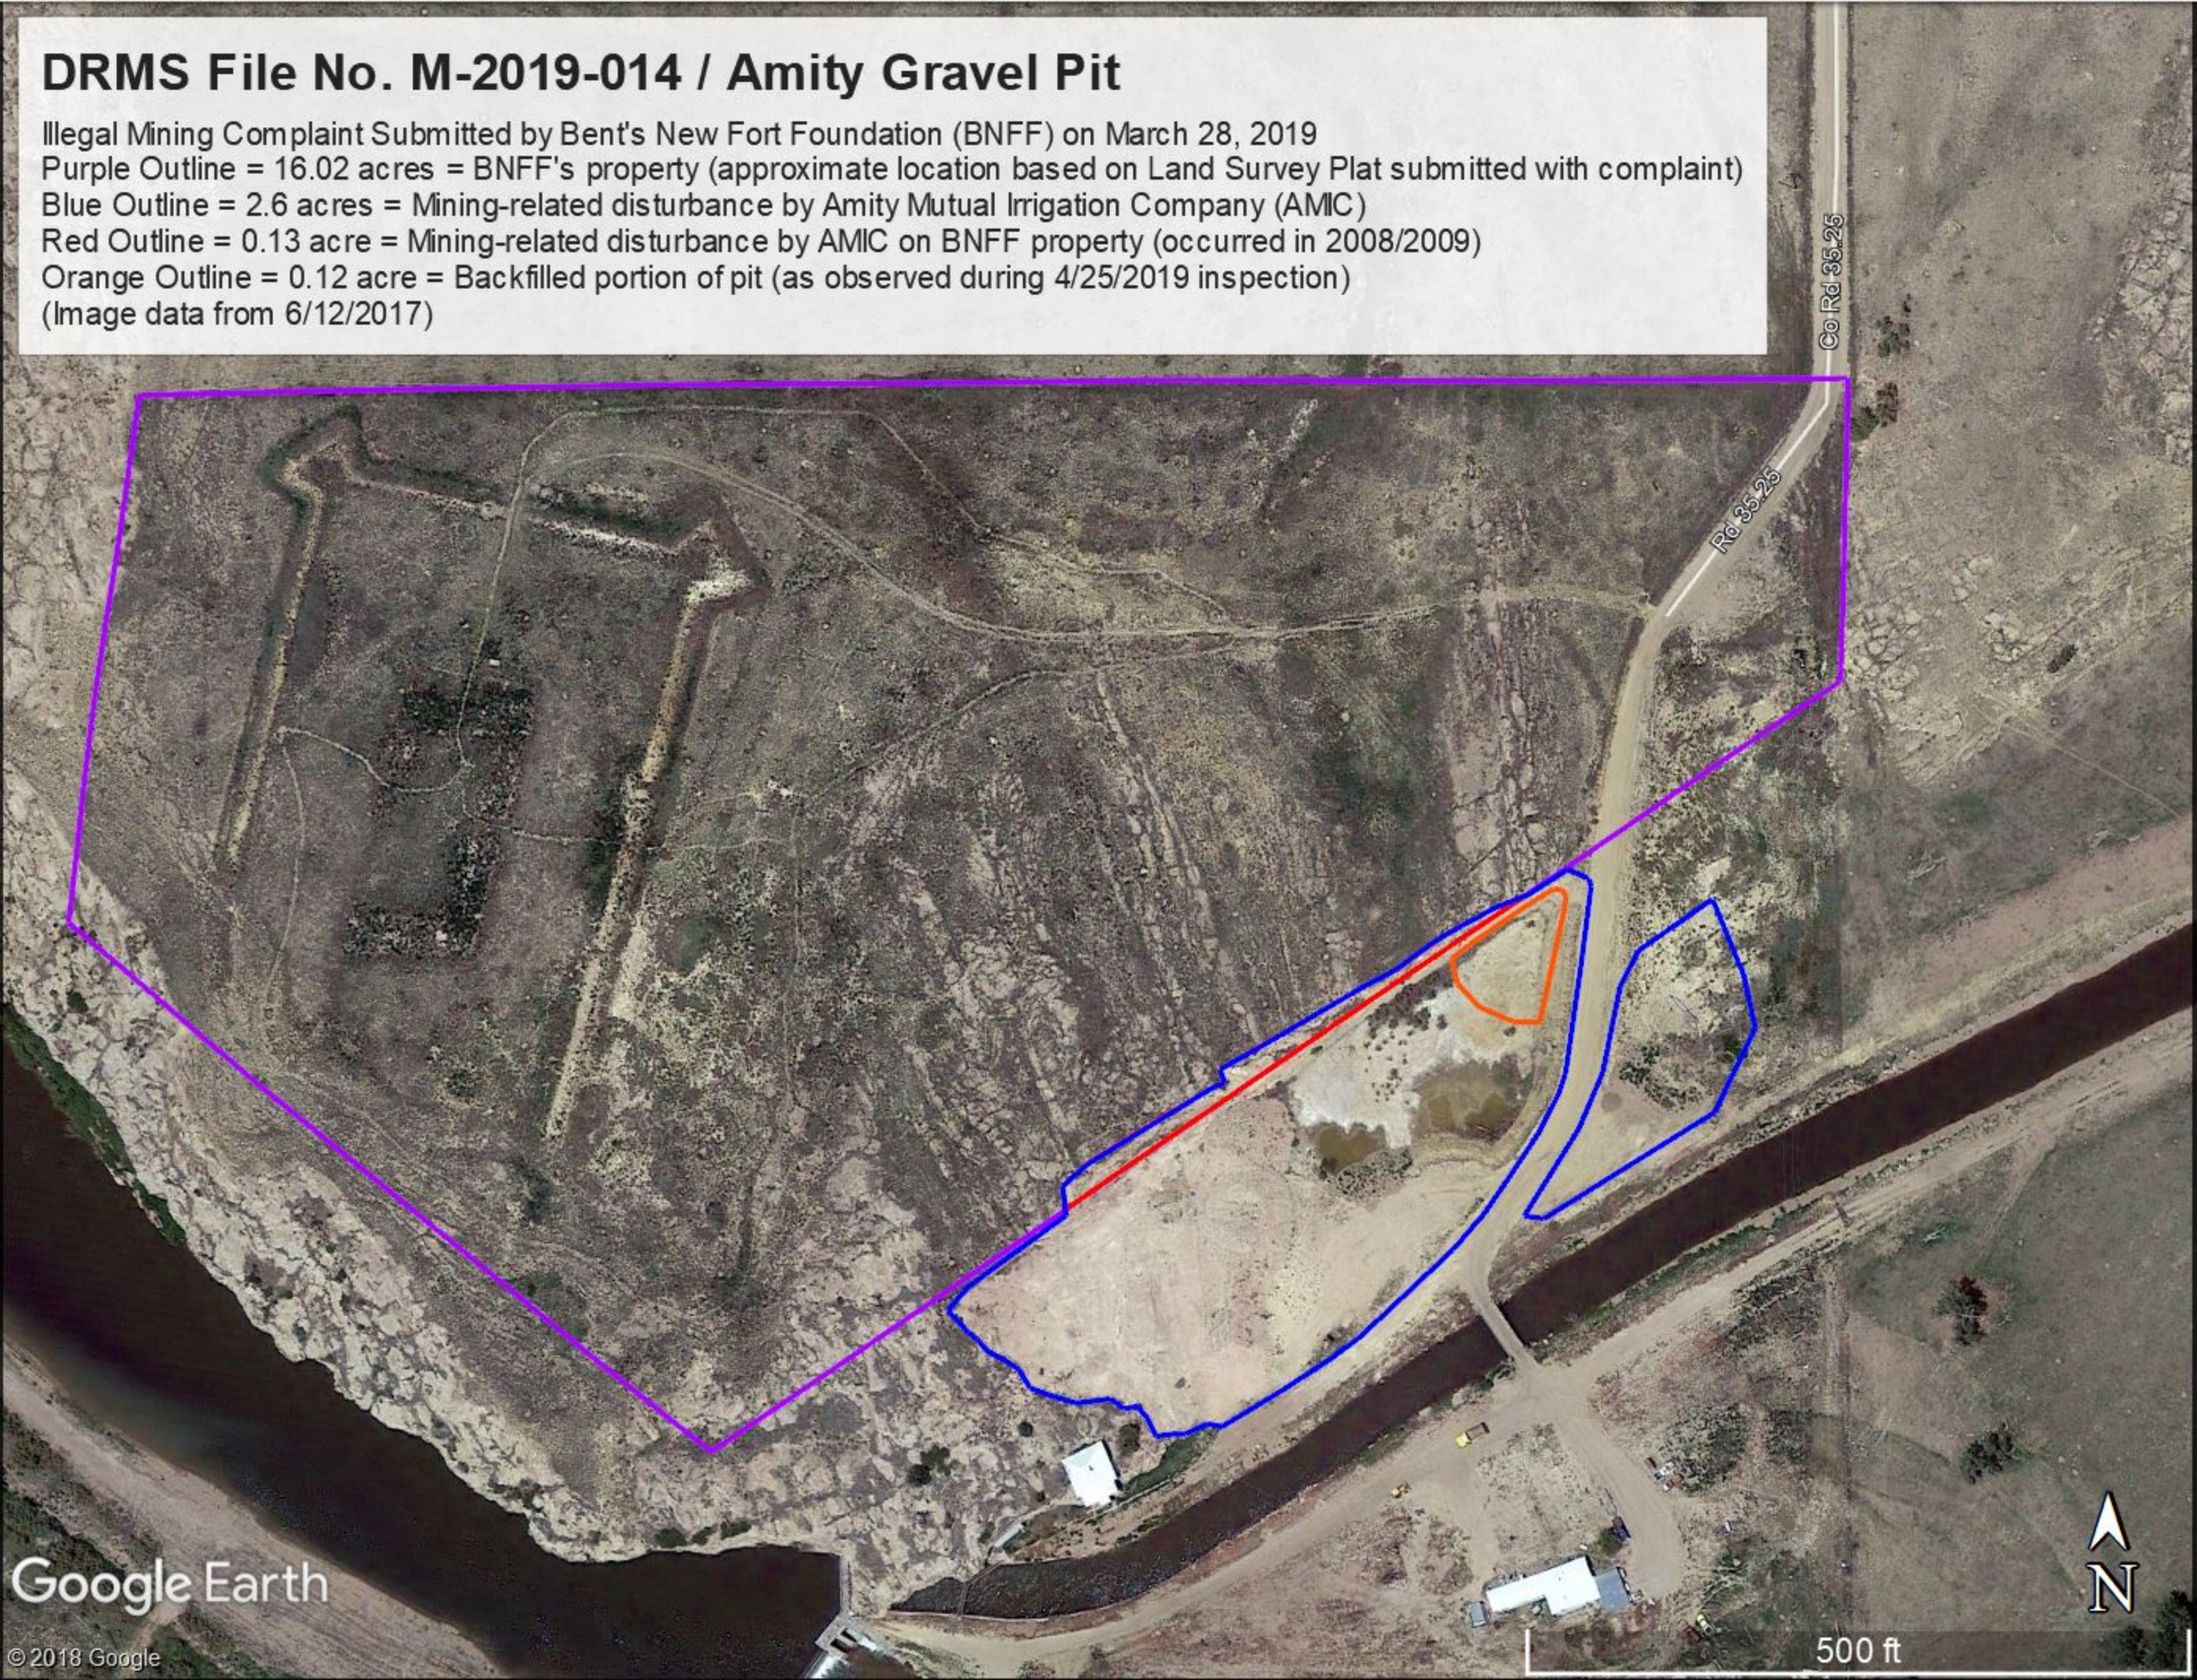
Purple Outline = 16.02 acres = BNFF's property (approximate location based on Land Survey Plat submitted with complaint)

Blue Outline = 2.6 acres = Mining-related disturbance by Amity Mutual Irrigation Company (AMIC)

Red Outline = 0.13 acre = Mining-related disturbance by AMIC on BNFF property (occurred in 2008/2009)

Orange Outline = 0.12 acre = Backfilled portion of pit (as observed during 4/25/2019 inspection)
