**COLORADO DIVISION OF RECLAMATION, MINING AND SAFETY**  
**MINERALS PROGRAM INSPECTION REPORT**  
**PHONE: (303) 866-3567**

<b>MINE NAME:</b> Cecil 11-34-49	<b>MINE/PROSPECTING ID#:</b> M-1983-001	<b>MINERAL:</b> Sand and gravel	<b>COUNTY:</b> Washington
<b>INSPECTION TYPE:</b> Monitoring	<b>INSPECTOR(S):</b> Brock Bowles	<b>INSP. DATE:</b> June 16, 2019	<b>INSP. TIME:</b> 1130
<b>OPERATOR:</b> Washington County	<b>OPERATOR REPRESENTATIVE:</b> Steve Williams	<b>TYPE OF OPERATION:</b> 110c - Construction Limited Impact	
<b>REASON FOR INSPECTION:</b> Normal I&E Program	<b>BOND CALCULATION TYPE:</b> None	<b>BOND AMOUNT:</b> \$0.00	
<b>DATE OF COMPLAINT:</b> NA	<b>POST INSP. CONTACTS:</b> None	<b>JOINT INSP. AGENCY:</b> None	
<b>WEATHER:</b> Clear	<b>INSPECTOR'S SIGNATURE:</b>

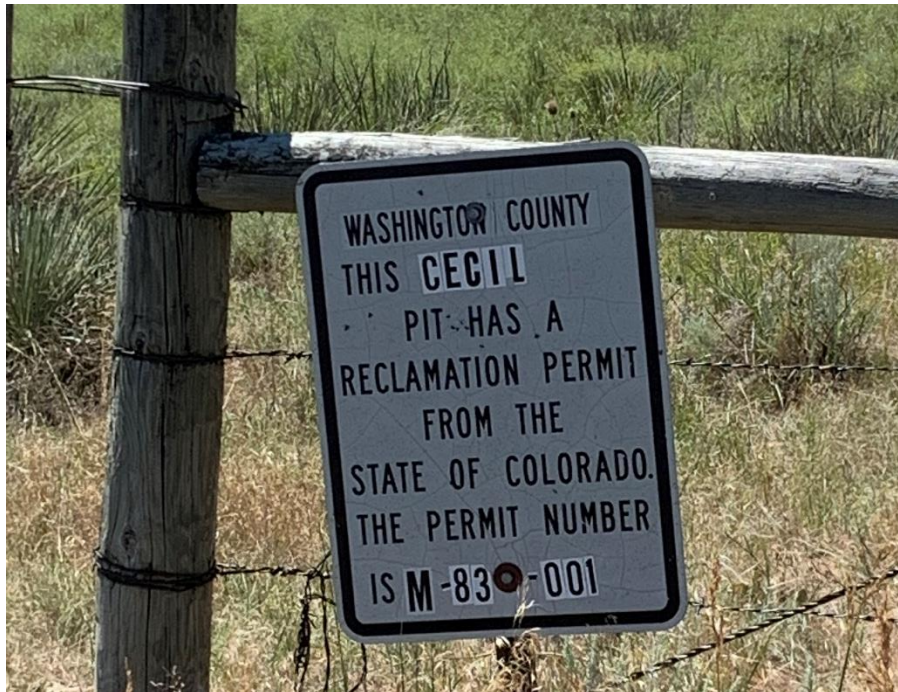
The permit identification sign was in place at the mine entrance and legible. The permit boundary corner posts were in place. Most of the slopes in the pit area have been graded to 3H:1V. Some slopes on the west side of the pit still need to be sloped to their final configuration. Three topsoil stockpiles were in place on the east and north sides of the pit area. The stockpiles were well vegetated and appeared to be stable. Many musk thistle plants were noted in and around the pit area. These plants have recently been treated.

Permit identification sign; looking south.

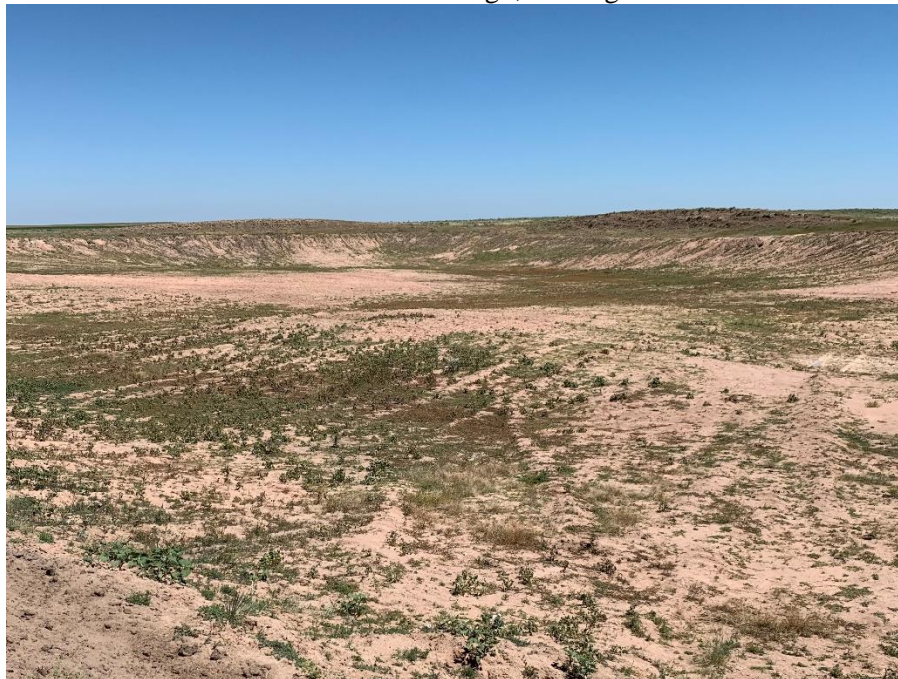
No mining activities were occurring during the time of the inspection and no equipment was on site. There was no evidence of recent mining or reclamation activities observed. The pit appears to have not been active for a long time due to the abundance of volunteer vegetation growing on the pit slopes and floor. The June 2019 annual report notes that the last excavation was June 2010. As per Rule 3.1.3, all reclamation shall be carried to completion within 5 years from the date the operator has ceased mining. Please see the corrective action section of this report for more information. The Division requires the Operator to submit a Reclamation Schedule within 30 days of this report.

Pit area and topsoil stockpiles, looking northeast

**CORRECTIVE ACTIONS:** The Operator shall submit a Reclamation Schedule within 30 days of this report, with all reclamation to be completed by December 31, 2020. Please see the inspection narrative for specific requirements of this Reclamation Schedule.
