**COLORADO DIVISION OF RECLAMATION, MINING AND SAFETY**  
**MINERALS PROGRAM INSPECTION REPORT**  
**PHONE: (303) 866-3567**

<b>MINE NAME:</b> 7Y Ranch Pit #1	<b>MINE/PROSPECTING ID#:</b> M-2010-075	<b>MINERAL:</b> Sand and gravel	<b>COUNTY:</b> Washington
<b>INSPECTION TYPE:</b> Monitoring	<b>INSPECTOR(S):</b> Brock Bowles	<b>INSP. DATE:</b> June 16, 2019	<b>INSP. TIME:</b> 1200
<b>OPERATOR:</b> Washington County	<b>OPERATOR REPRESENTATIVE:</b> Steve Williams	<b>TYPE OF OPERATION:</b> 110c - Construction Limited Impact	
<b>REASON FOR INSPECTION:</b> Normal I&E Program	<b>BOND CALCULATION TYPE:</b> None	<b>BOND AMOUNT:</b> \$0.00	
<b>DATE OF COMPLAINT:</b> NA	<b>POST INSP. CONTACTS:</b> None	<b>JOINT INSP. AGENCY:</b> None	
<b>WEATHER:</b> Clear	<b>INSPECTOR'S SIGNATURE:</b>

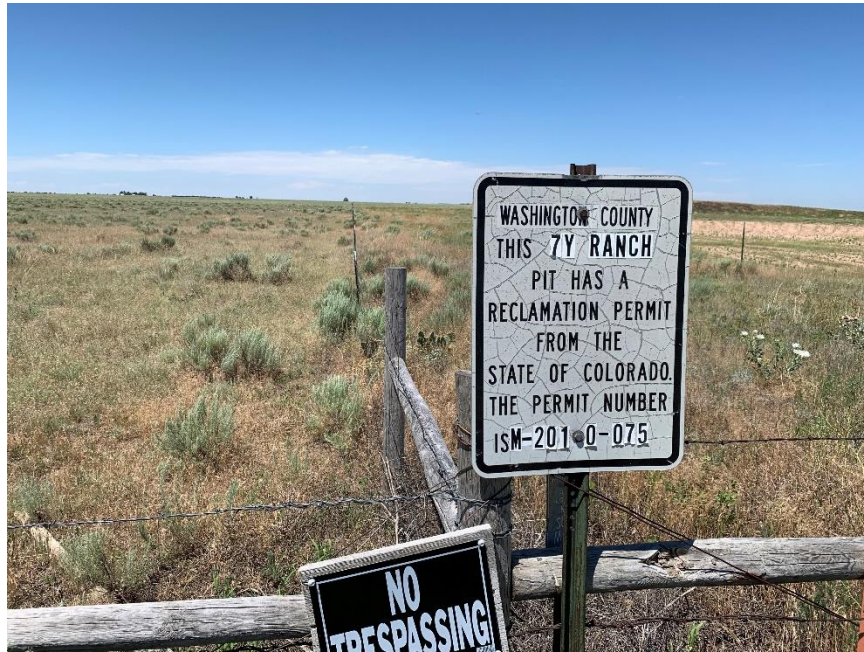
The permit identification sign was in place at the mine entrance and legible. The permit boundary was clearly delineated by a fence which was in good repair. The slopes in the pit area have been graded to 3H:1V. The topsoil is stockpiled on the west side of the pit, it is well vegetated and appears to be stable.

Permit identification sign; looking west.

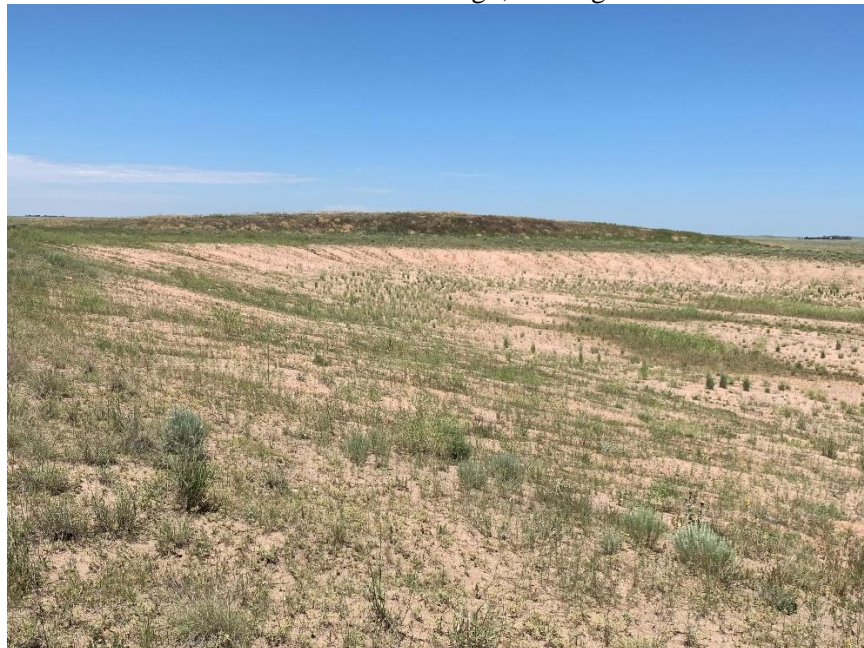
No mining activities were occurring during the time of the inspection and no equipment was on site. There was no evidence of recent mining or reclamation activities observed. The pit appears to have not been active for a long time due to the abundance of volunteer vegetation growing on the pit slopes and floor. The January 2019 annual report notes that the last excavation was May 2012. As per Rule 3.1.3, all reclamation shall be carried to completion within 5 years from the date the operator has ceased mining. Please see the corrective action section of this report for more information. The Division requires the Operator to submit a Reclamation Schedule within 30 days of this report.

Pit area and topsoil stockpile, looking west

**CORRECTIVE ACTIONS:** The Operator shall submit a Reclamation Schedule within 30 days of this report, with all reclamation to be completed by December 31, 2020. Please see the inspection narrative for specific requirements of this Reclamation Schedule.
