MINERALS PROGRAM INSPECTION REPORT
PHONE: (303) 866-3567

MINE NAME: Little Snake Pit #26	MINE/PROSPECTING ID#: M-1999-048	MINERAL: Sand and gravel	COUNTY: Moffat
INSPECTION TYPE: Monitoring	INSPECTOR(S): Amy C. Yeldell	INSP. DATE: July 16, 2019	INSP. TIME: 11:00
OPERATOR: Moffat County	OPERATOR REPRESENTATIVE: None	TYPE OF OPERATION: 112c - Construction Regular Operation	
REASON FOR INSPECTION: Normal I&E Program	BOND CALCULATION TYPE: Partial Bond	BOND AMOUNT: \$0.00	
DATE OF COMPLAINT: NA	POST INSP. CONTACTS: None	JOINT INSP. AGENCY: None	
WEATHER: Clear	INSPECTOR'S SIGNATURE:

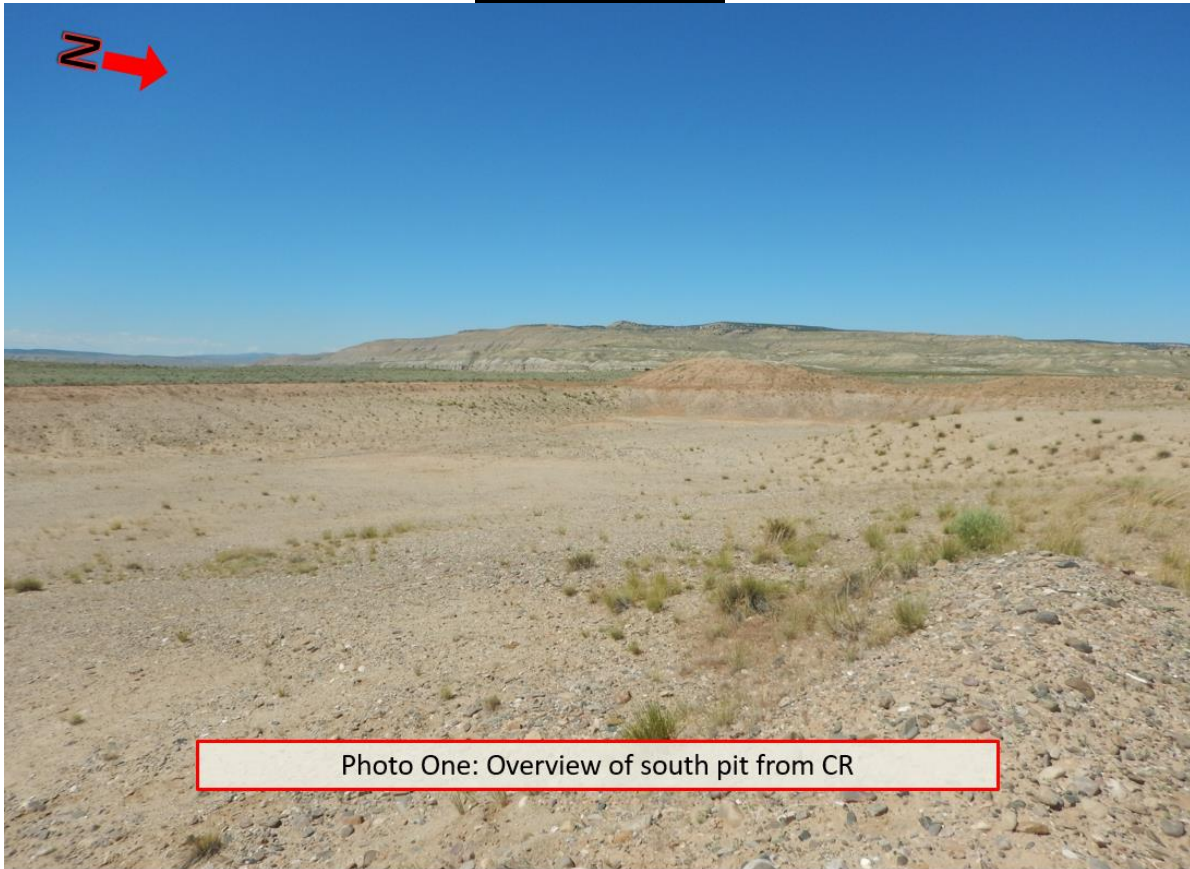
To the south of the road is a long pit with slopes mostly regarded to a 3H: 1V or less. The pit to the north of the road is significantly smaller with slopes slightly steeper, but no more than a 2H: 1V. There is some erosion within the northern pit that needs to be addressed next time equipment is in the area. The sediment drains into the pit so there is no risk for off-site damage. Overall the pit is stable.

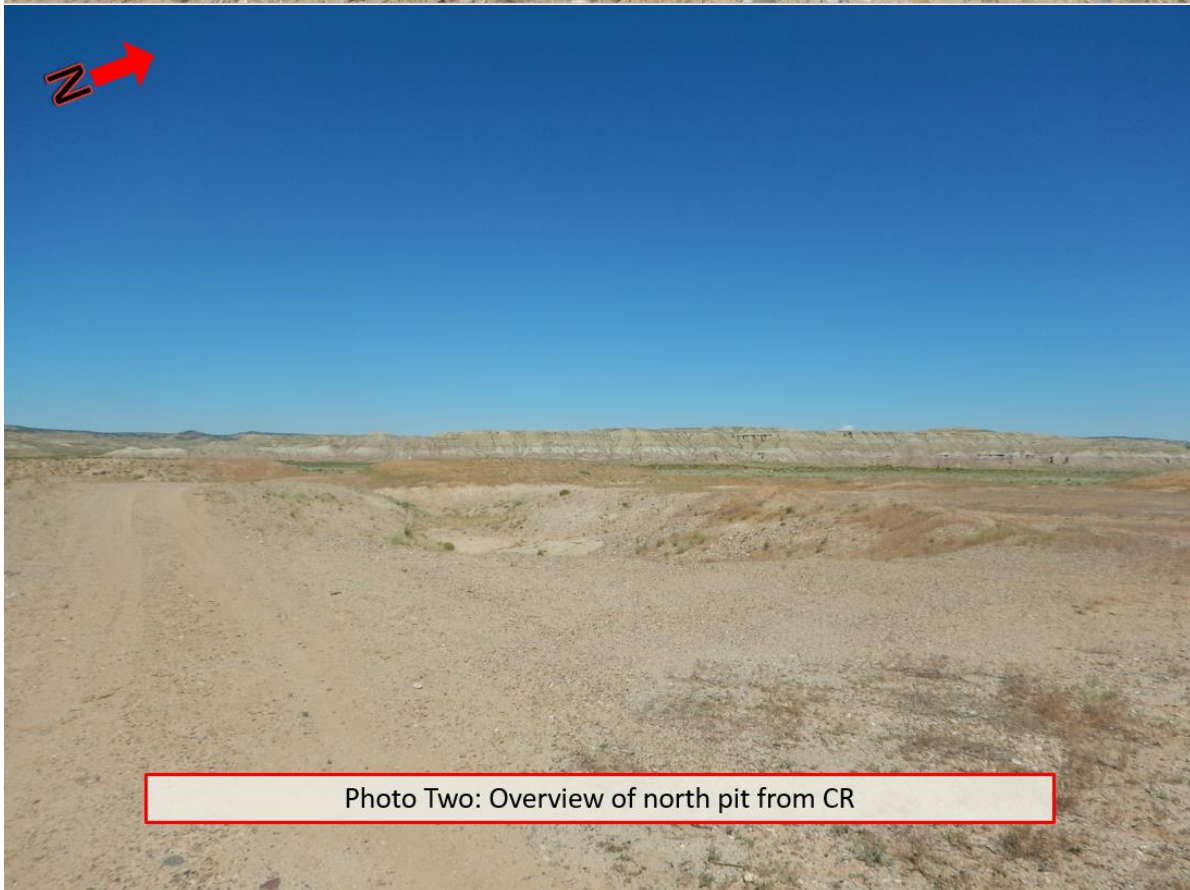
Noxious weeds such as Halogeton and Cheatgrass were observed. The pit floor could benefit from a bare ground treatment to prevent the establishment of weeds during times of idol. Topsoil is mostly stored in a long scraper pile along the west side of the pit, with one smaller pile near the east side entrance as well.

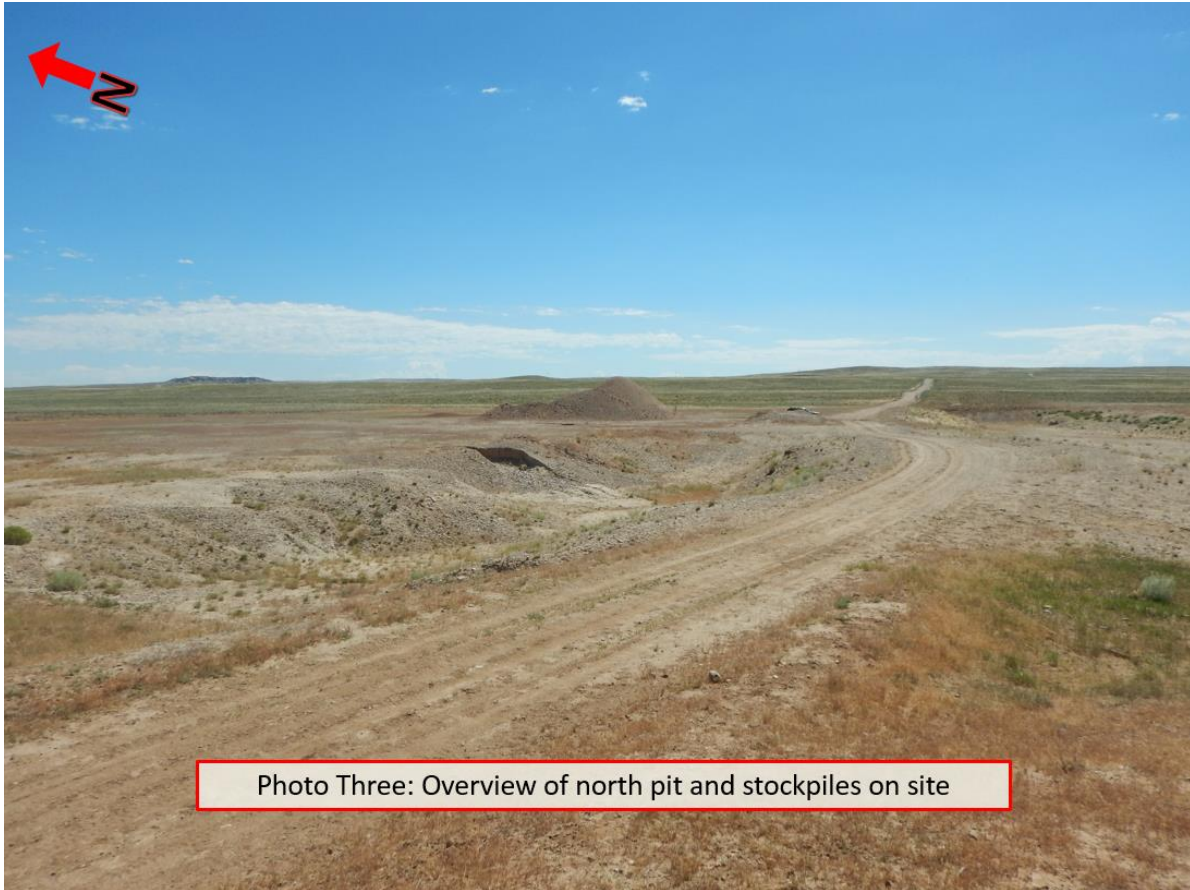
Photo Three: Overview of north pit and stockpiles on site

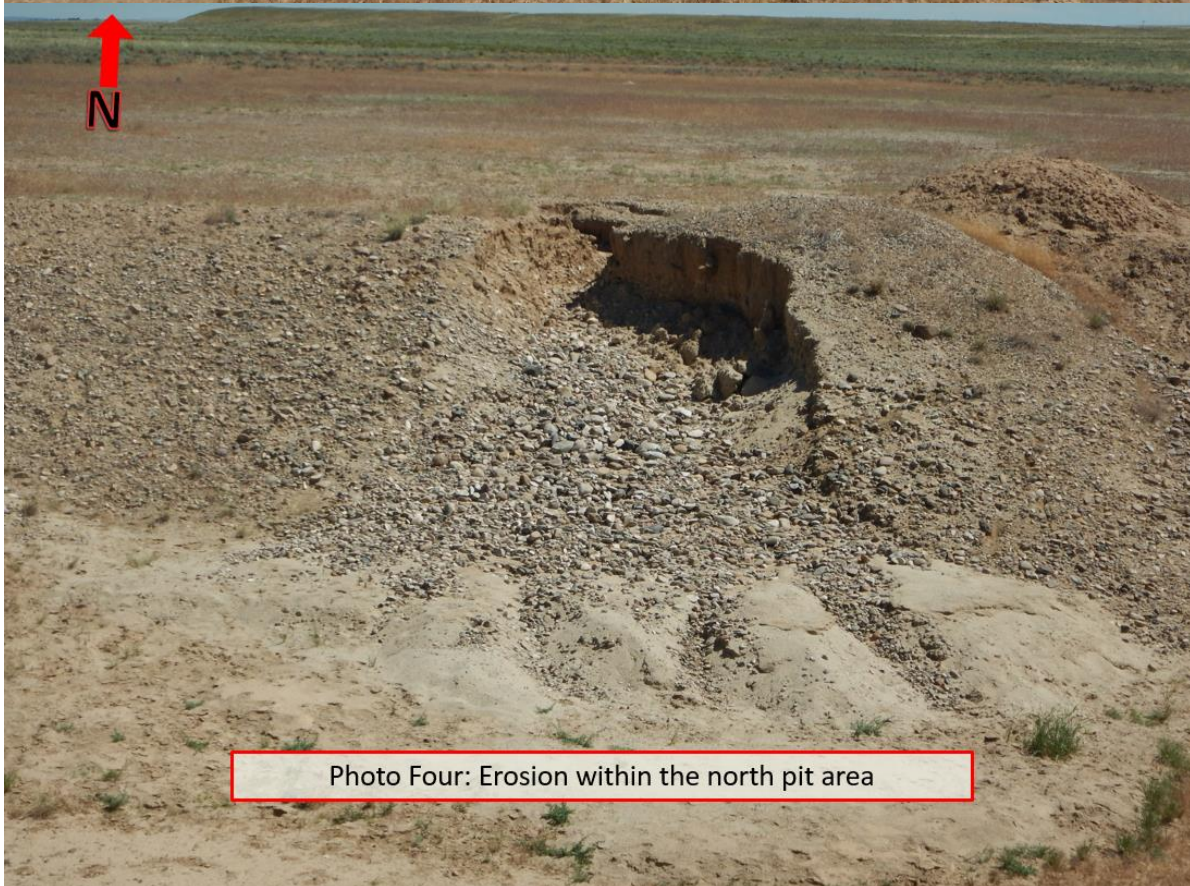
Photo Four: Erosion within the north pit area
