MINERALS PROGRAM INSPECTION REPORT**PHONE: (303) 866-3567**

MINE NAME: West of Maybell Pit	MINE/PROSPECTING ID#: M-1979-142	MINERAL: Sand and gravel	COUNTY: Moffat
INSPECTION TYPE: Monitoring	INSPECTOR(S): Amy C. Yeldell	INSP. DATE: July 17, 2019	INSP. TIME: 13:50
OPERATOR: Colorado Department of Transportation	OPERATOR REPRESENTATIVE: Randy McIntosh	TYPE OF OPERATION: 112c - Construction Regular Operation	
REASON FOR INSPECTION: Normal I&E Program	BOND CALCULATION TYPE: None	BOND AMOUNT: No Bond Held	
DATE OF COMPLAINT: NA	POST INSP. CONTACTS: None	JOINT INSP. AGENCY: None	
WEATHER: Clear	INSPECTOR'S SIGNATURE:

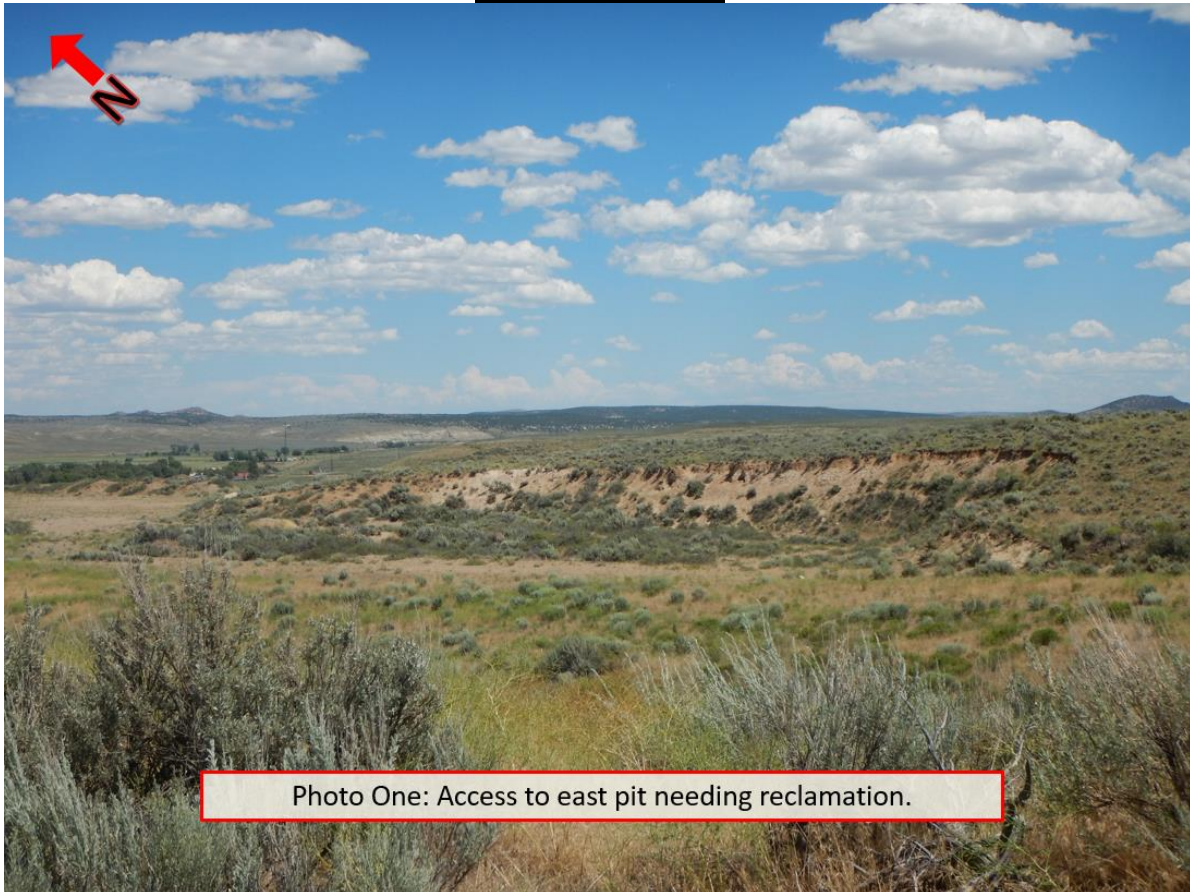
Photo One: Access to east pit needing reclamation.

This site has been inactive for several years and will be going into final reclamation. Native vegetation has volunteered throughout most of site and in some areas appears to have self-reclaimed. The Division encourages limiting disturbances to only what is necessary to complete reclamation. There are a few stockpiles need to be removed. The fences will need to be removed unless otherwise approved by BLM.

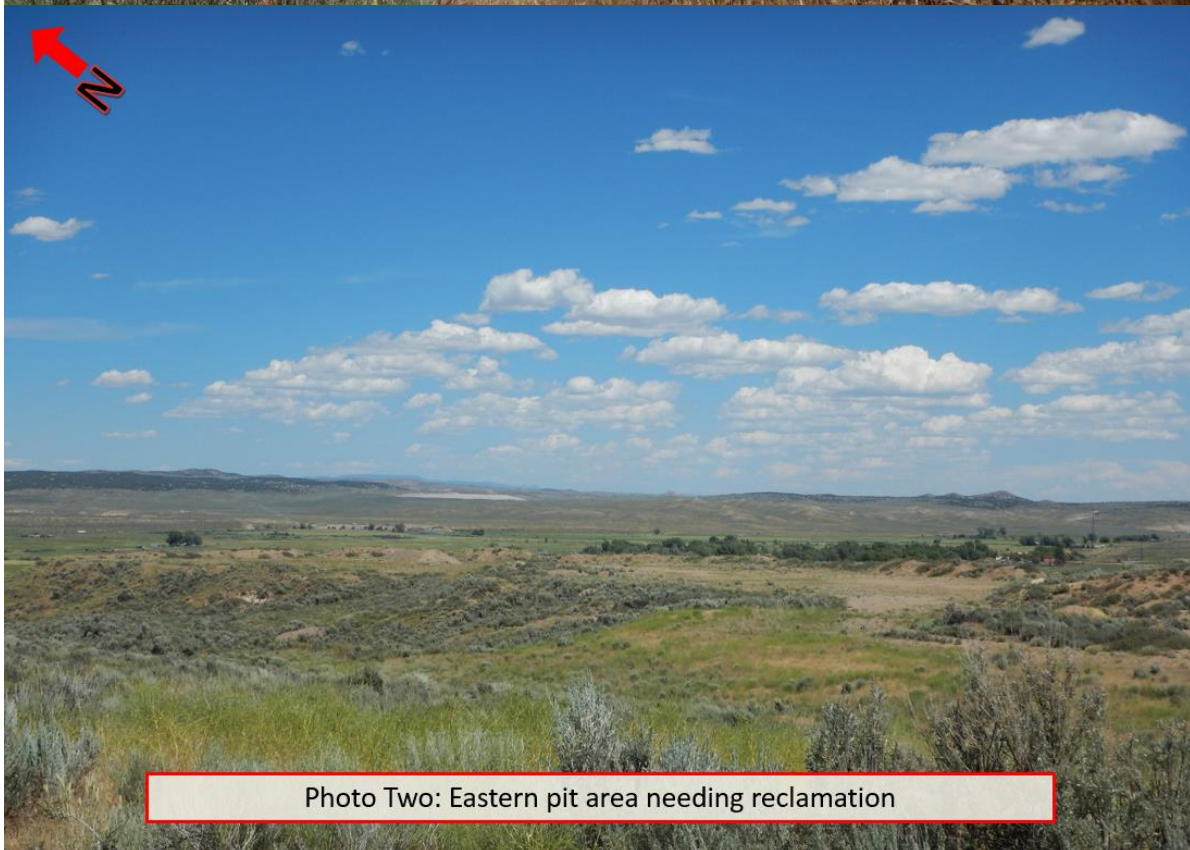
Photo Two: Eastern pit area needing reclamation
