**MINERALS PROGRAM INSPECTION REPORT**  
**PHONE: (303) 866-3567**

<b>MINE NAME:</b> Pit No 6	<b>MINE/PROSPECTING ID#:</b> M-1978-192	<b>MINERAL:</b> Sand and gravel	<b>COUNTY:</b> Chaffee
<b>INSPECTION TYPE:</b> Monitoring	<b>INSPECTOR(S):</b> Dustin M. Czaplá	<b>INSP. DATE:</b> August 20, 2019	<b>INSP. TIME:</b> 11:45
<b>OPERATOR:</b> Chaffee County	<b>OPERATOR REPRESENTATIVE:</b> None	<b>TYPE OF OPERATION:</b> 110c - Construction Limited Impact	
<b>REASON FOR INSPECTION:</b> Normal I&E Program	<b>BOND CALCULATION TYPE:</b> None	<b>BOND AMOUNT:</b> \$0.00	
<b>DATE OF COMPLAINT:</b> NA	<b>POST INSP. CONTACTS:</b> None	<b>JOINT INSP. AGENCY:</b> None	
<b>WEATHER:</b> Clear	<b>INSPECTOR'S SIGNATURE:</b>

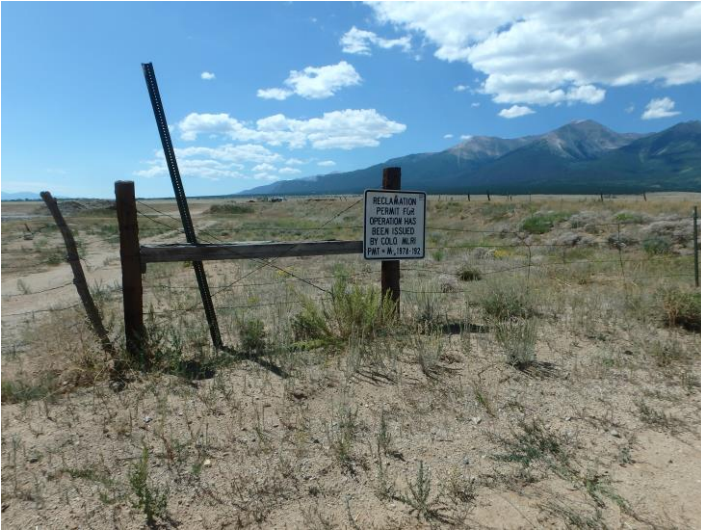
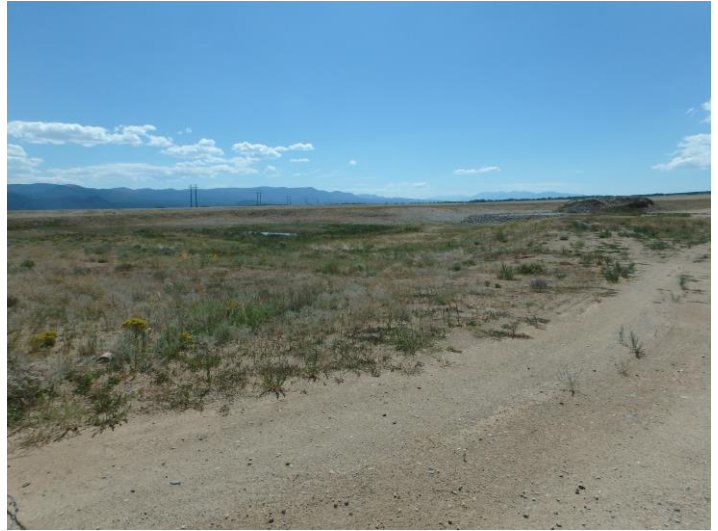
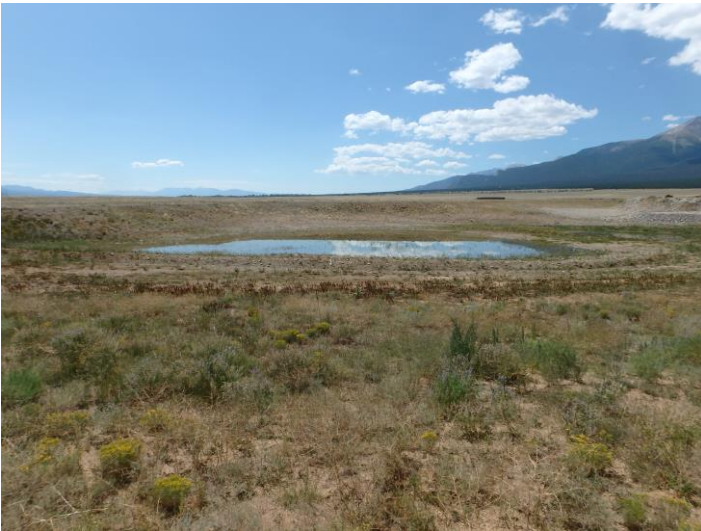
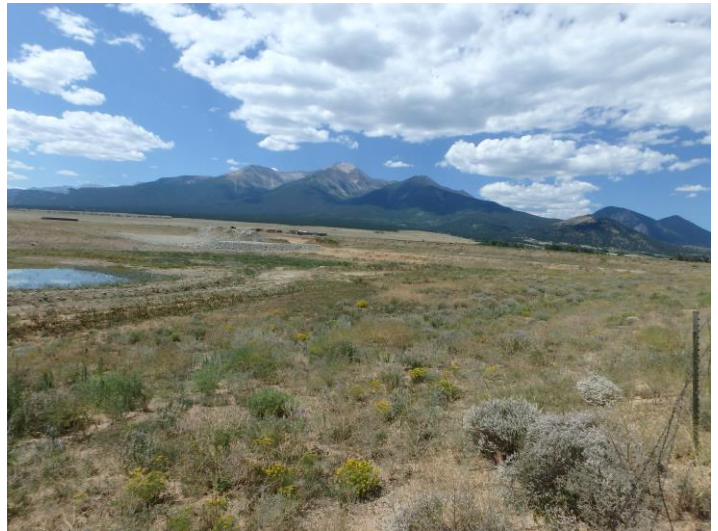
## **PHOTOGRAPHS**

Adequate mine identification signage was noted at the entrance to the site.

The affected area was marked by fencing on the north and west sides. The boundary is not clearly marked on the south and east sides, but the operator's disturbance at the site appears to be contained within the footprint of the pre-permit disturbance area.

The slope along the west pit boundary has been graded to an approximate 1.5H:1V slope. Some slope reduction of this slope will be necessary during final reclamation. The remainder of the slopes around the pit appeared to be 3H:1V or less. Materials stockpiles are located in the west part of the pit.
