**MINERALS PROGRAM INSPECTION REPORT**  
**PHONE: (303) 866-3567**

<b>MINE NAME:</b> Weimer No. 2	<b>MINE/PROSPECTING ID#:</b> M-1996-031	<b>MINERAL:</b> Gravel	<b>COUNTY:</b> Montrose
<b>INSPECTION TYPE:</b> Monitoring	<b>INSPECTOR(S):</b> Dustin M. Czaplá	<b>INSP. DATE:</b> August 13, 2019	<b>INSP. TIME:</b> 12:00
<b>OPERATOR:</b> Sutherland Brothers, Inc.	<b>OPERATOR REPRESENTATIVE:</b>	<b>TYPE OF OPERATION:</b> 110c - Construction Limited Impact	
<b>REASON FOR INSPECTION:</b> Normal I&E Program	<b>BOND CALCULATION TYPE:</b> Complete Bond	<b>BOND AMOUNT:</b> \$17,857.00	
<b>DATE OF COMPLAINT:</b> NA	<b>POST INSP. CONTACTS:</b> None	<b>JOINT INSP. AGENCY:</b> None	
<b>WEATHER:</b> Clear	<b>INSPECTOR'S SIGNATURE:</b>

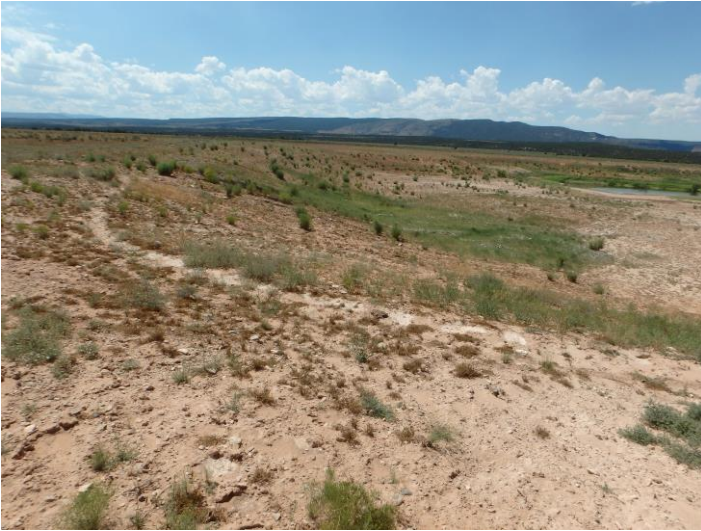
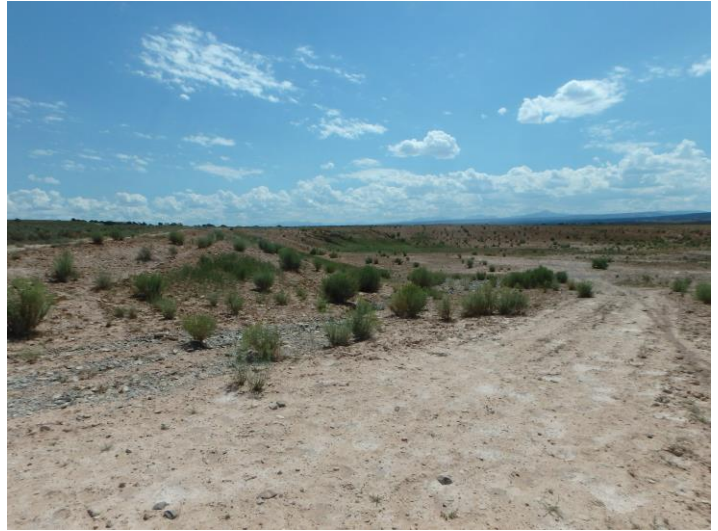
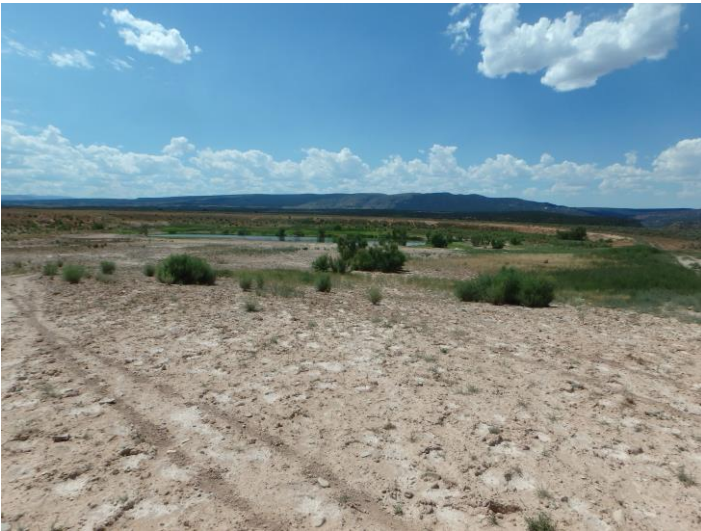
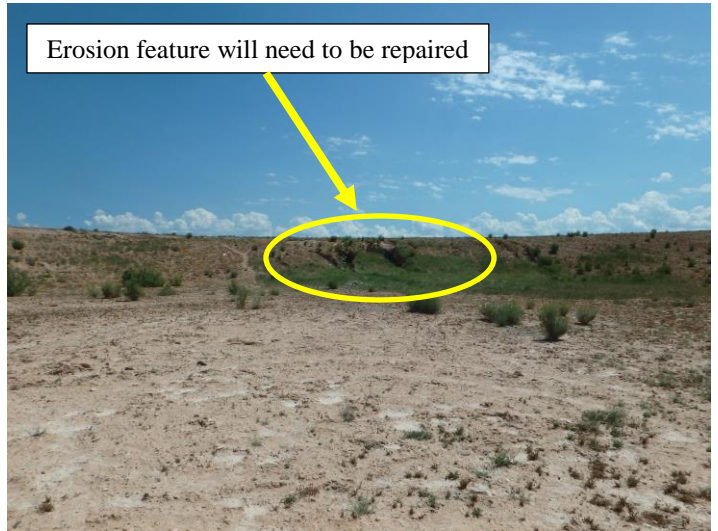
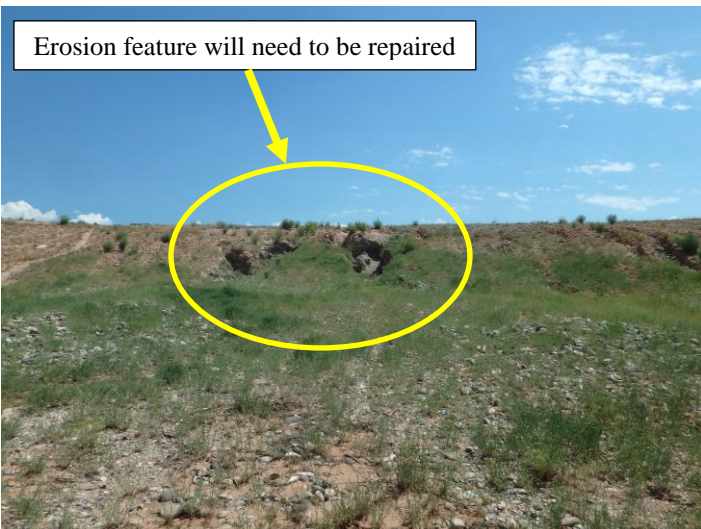
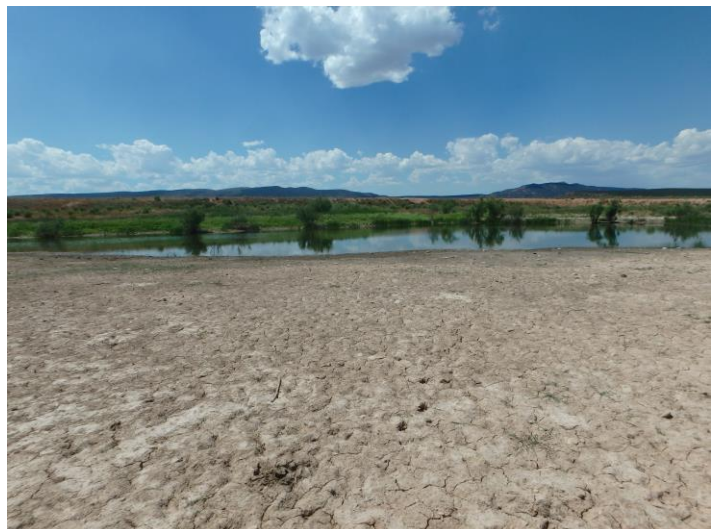
## PHOTOGRAPHS

The site is in final reclamation. Final grading has been completed, however, there is a large rill developed on the east pit slope that will need to be repaired before permit release can be considered. Vegetation is becoming well established and cover appears equal in extent to that of the surrounding area.
