MINERALS PROGRAM INSPECTION REPORT

MINE NAME: Prince Albert Mine	MINE/PROSPECTING ID#: M-2011-040	MINERAL: Uranium and vanadium	COUNTY: Montrose
INSPECTION TYPE: Monitoring	INSPECTOR(S): Dustin M. Czapla	INSP. DATE: August 13, 2019	INSP. TIME: 13:30
OPERATOR: Rimrock Exploration & Development, Inc.	OPERATOR REPRESENTATIVE:	TYPE OF OPERATION: 110d - Designated Limited Impact

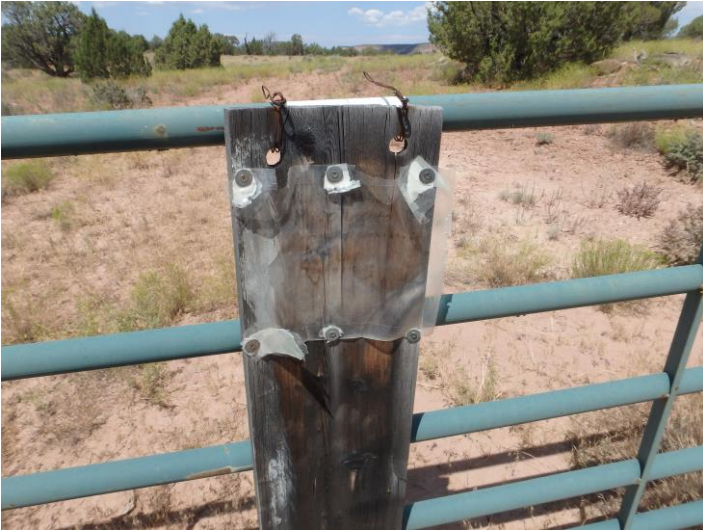
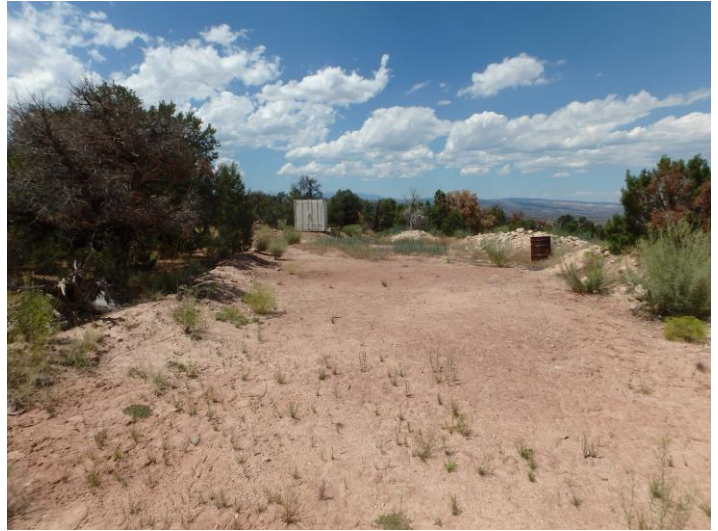
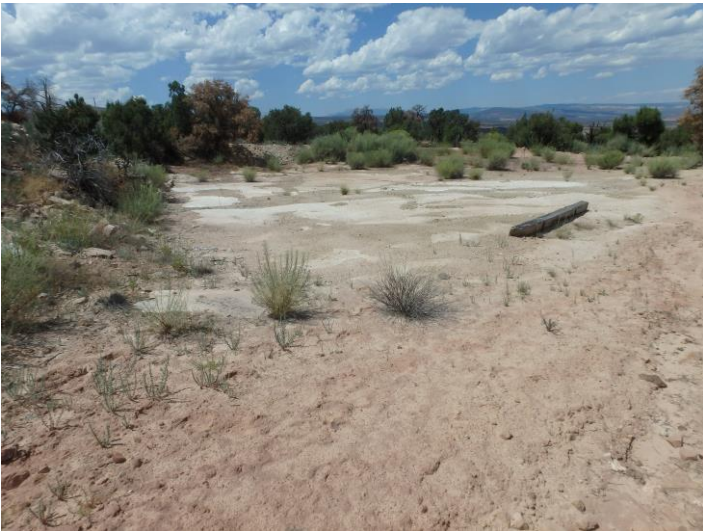
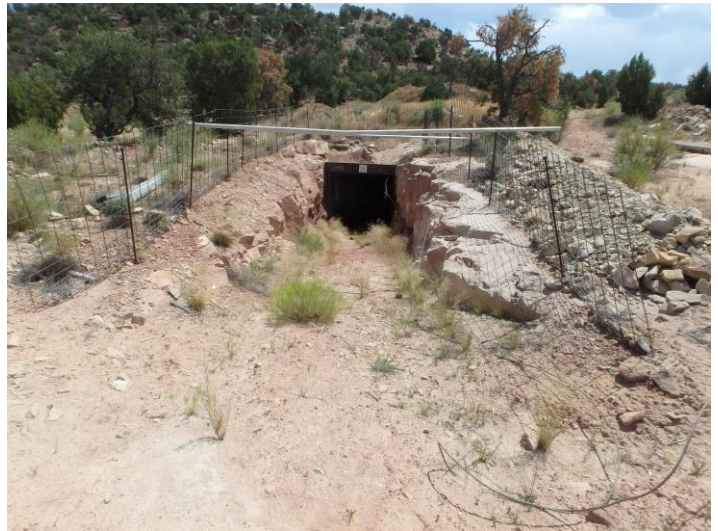
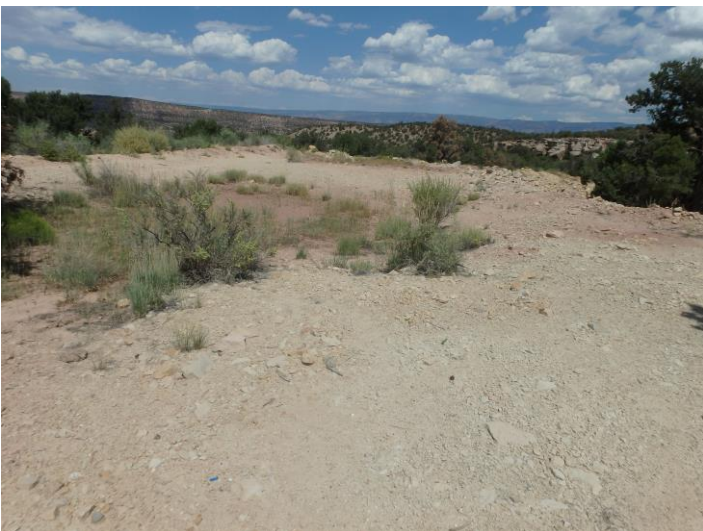
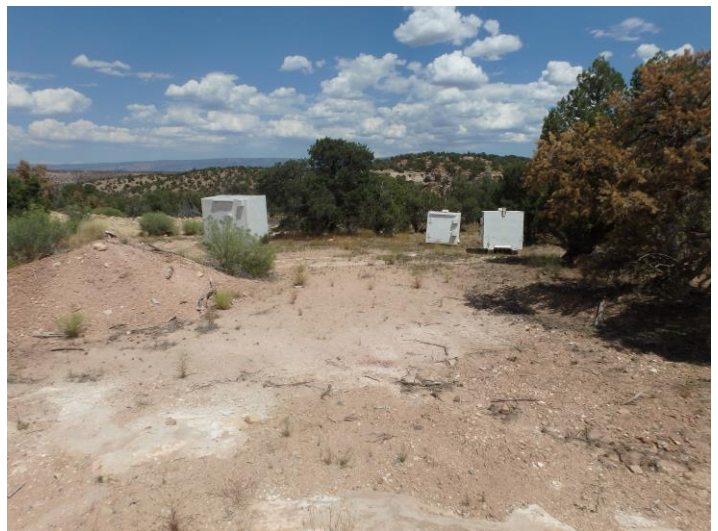
PHOTOGRAPHS

This inspection was conducted as part of the Division of Reclamation, Mining and Safety's (Division) normal monitoring program. A representative for the operator was not present. Photographs are included with this report in order to illustrate some of the conditions observed.

Adequate mine identification signage was not noted at the entrance to the site. This is noted as a problem in this report.

The affected area was marked by t-posts that were adequate to delineate the affected area boundary.

There is no ore stored on the ore pad. Stormwater controls appear effective. No sedimentation or erosion issues were observed. The catchment pond was dry during this inspection. Noxious weed infestations were not noted.

CORRECTIVE ACTIONS: The operator shall, at the entrance of the mine site, post a sign which shall be clearly visible from the access road with the following: the name of the operator, a statement that a reclamation permit for the operation has been issued by the Colorado Mined Land Reclamation Board; and the permit number. The operator shall submit photo documentation that a proper sign has been posted by the corrective action date.
