**MINERALS PROGRAM INSPECTION REPORT****PHONE: (303) 866-3567**

<b>MINE NAME:</b> County Line Pit	<b>MINE/PROSPECTING ID#:</b> M-1987-016	<b>MINERAL:</b> Sand and gravel	<b>COUNTY:</b> Lincoln
<b>INSPECTION TYPE:</b> Monitoring	<b>INSPECTOR(S):</b> Patrick Lennberg	<b>INSP. DATE:</b> August 21, 2019	<b>INSP. TIME:</b> 13:00
<b>OPERATOR:</b> Lincoln County	<b>OPERATOR REPRESENTATIVE:</b> Fred Lundy	<b>TYPE OF OPERATION:</b> 110c - Construction Limited Impact

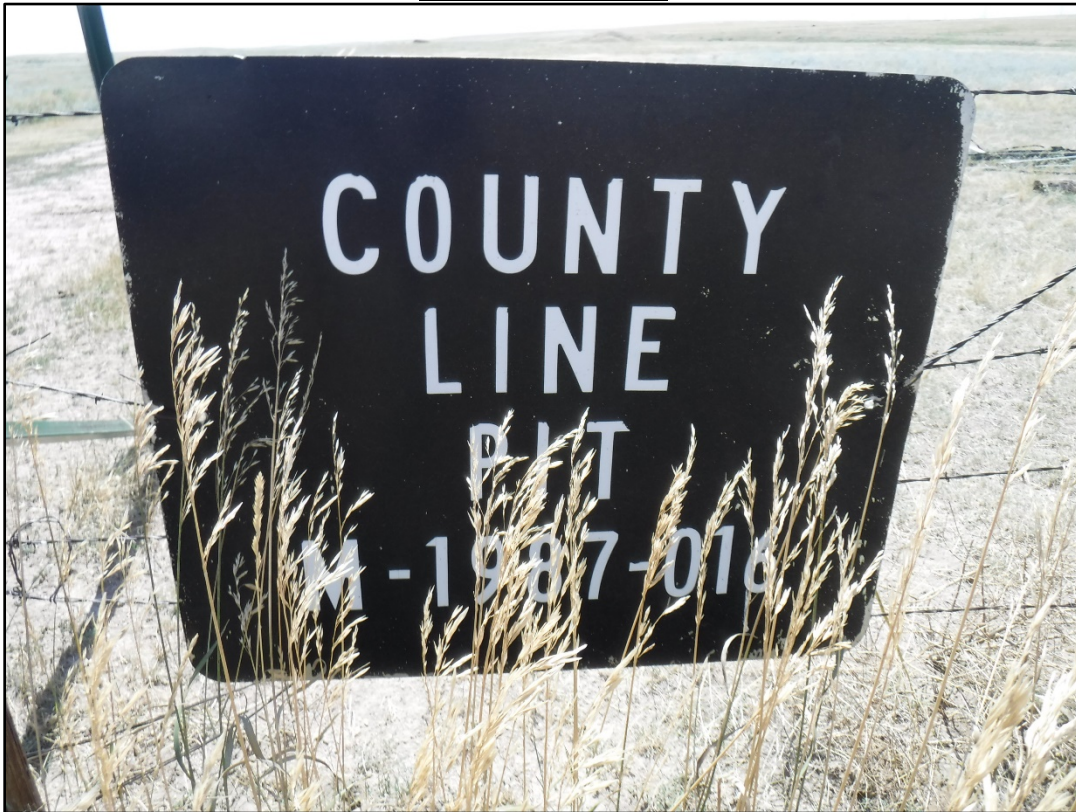
The County Line Pit is located approximately 25 miles north of Limon, Colorado just south of the Lincoln County line. Access to the site is off of Co Rd 4D. The site is situated on the ephemeral streambed of the Vega Creek, which only flows during heavy storm events. When carrying water, the river flows northward. The affected land is owned by Charles and Elaine Covington. The pit is a 110c operation permitted for 9.9 acres for the removal of sand and gravel for county road maintenance and repair. The site is surrounded by rangeland and the post-mining land use is rangeland. A mine sign was observed as required by Rule 3.1.12.

**Photo 1:** Mine sign at entrance off of County Road 4D

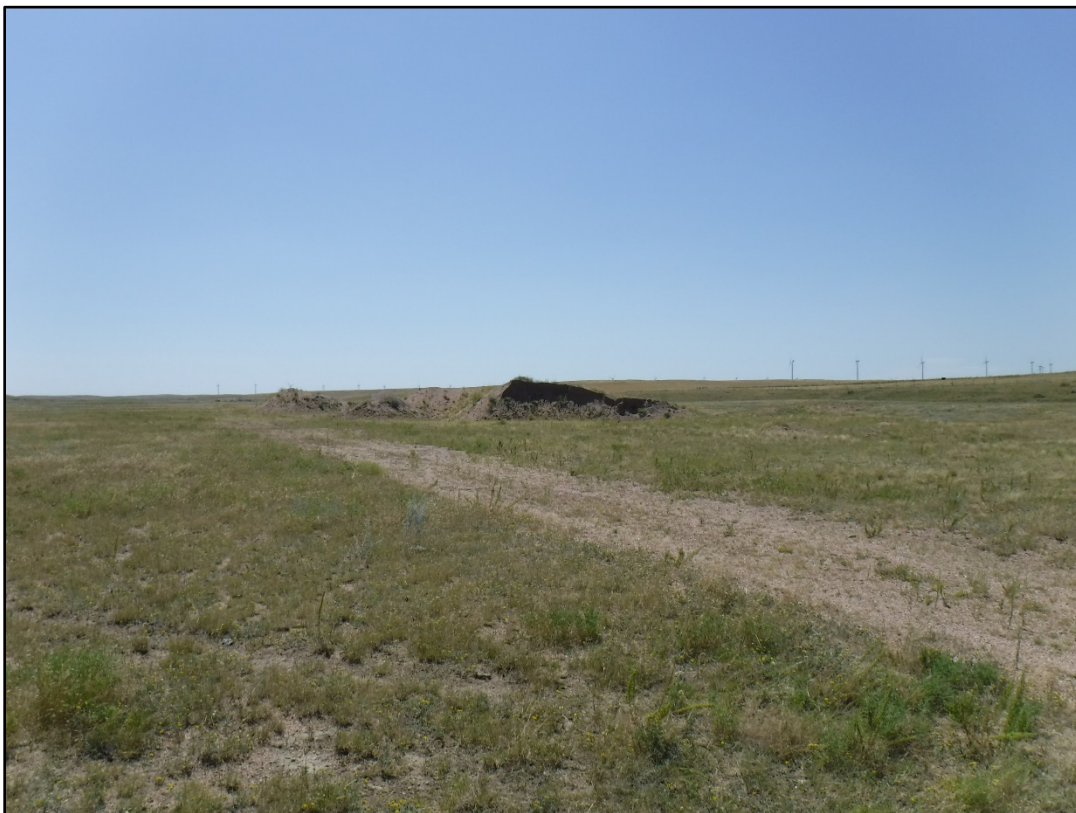
The site was not active at the time of inspection and it did not appear that the site has seen any recent mining activity, the mine is listed as an intermittent operation. Mined material is stockpiled on the east bank of the creek. The only areas to be disturbed besides the creek bed are the stockpile area and the areas cut into the creek bank for equipment access. The approved Reclamation Plan includes grading all disturbed areas to a gradient of 3H:1V or flatter, and revegetating all but the creek bed, which will be graded smooth. In the streambed there were a few depressions where material was removed and pushed up on the east bank and stockpiled. During the inspection it was found that most of the permit boundary markers were knocked down (cattle) or were missing completely. The lack of permit boundary markers is being cited as a problem in this report. Some native grasses, forbs and annual weeds have volunteered into the disturbed area. All current mining is within the permit boundaries.

**Photo 2:** Existing product stockpiles

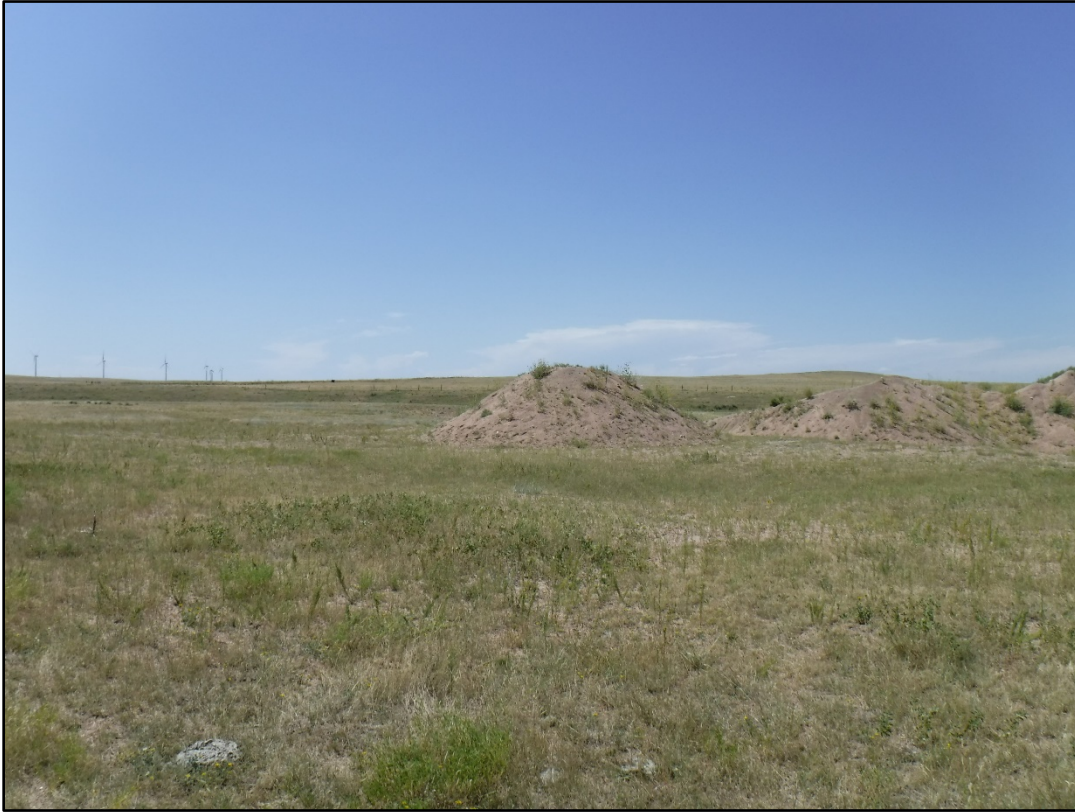
It should be noted here that two small screening stockpiles were left just north of the permit area by previous CDOT operations. According to the Acreage Reduction request (AR-01) that was approved by the Division on 05/21/2001, this northern portion (approximately 4.2 acres) which was undisturbed by the permitted operation was released from the permit area, and the stockpiles were left at the request of the landowner.

**Photo 3:** Stockpiles remaining at the site from CDOT operation to the north of permit area

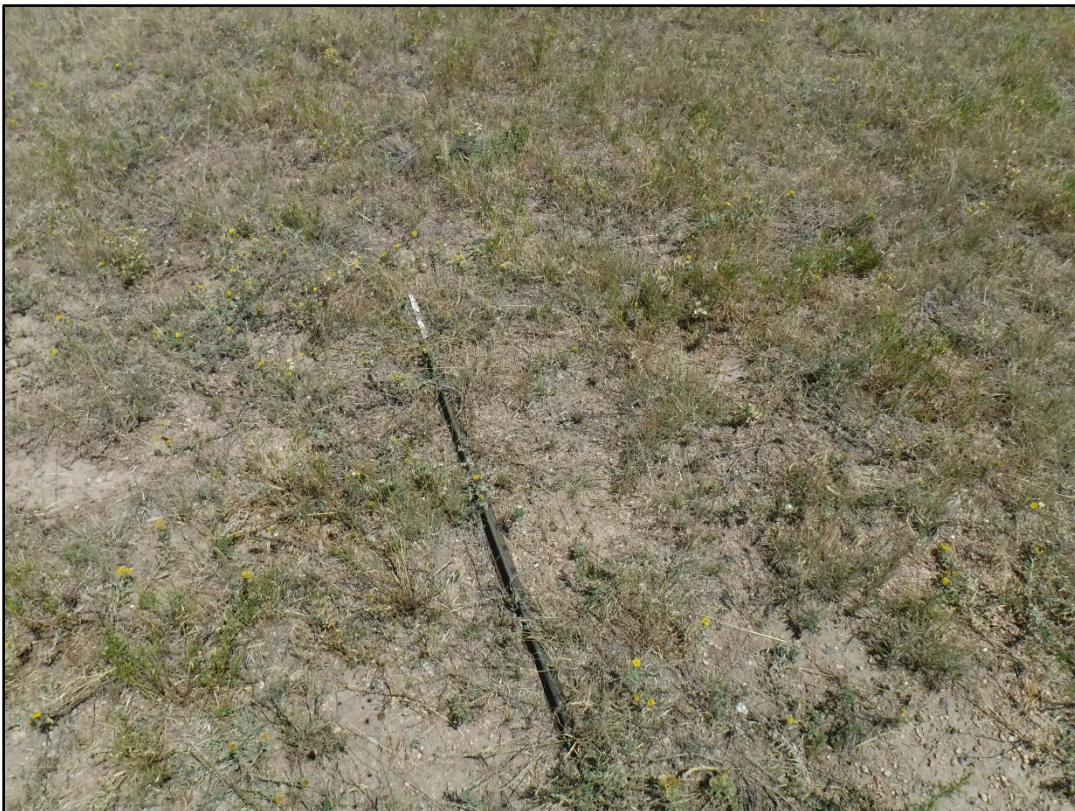
**PROBLEM:** The affected area boundary markers are missing or incorrectly placed. This is a problem for failure to maintain boundary markers around the affected area as required by Section 3.1.12(2) of the rule.

**Photo 4:** Boundary marker that was probably knocked down by cattle grazing

**CORRECTIVE ACTIONS:** The operator shall conduct a survey and replace the boundary markers in the correct location(s). The operator shall provide proof to the Division, through photographic documentation, that this has been done by the corrective action date.

**CORRECTIVE ACTION DUE DATE:** 10/01/19

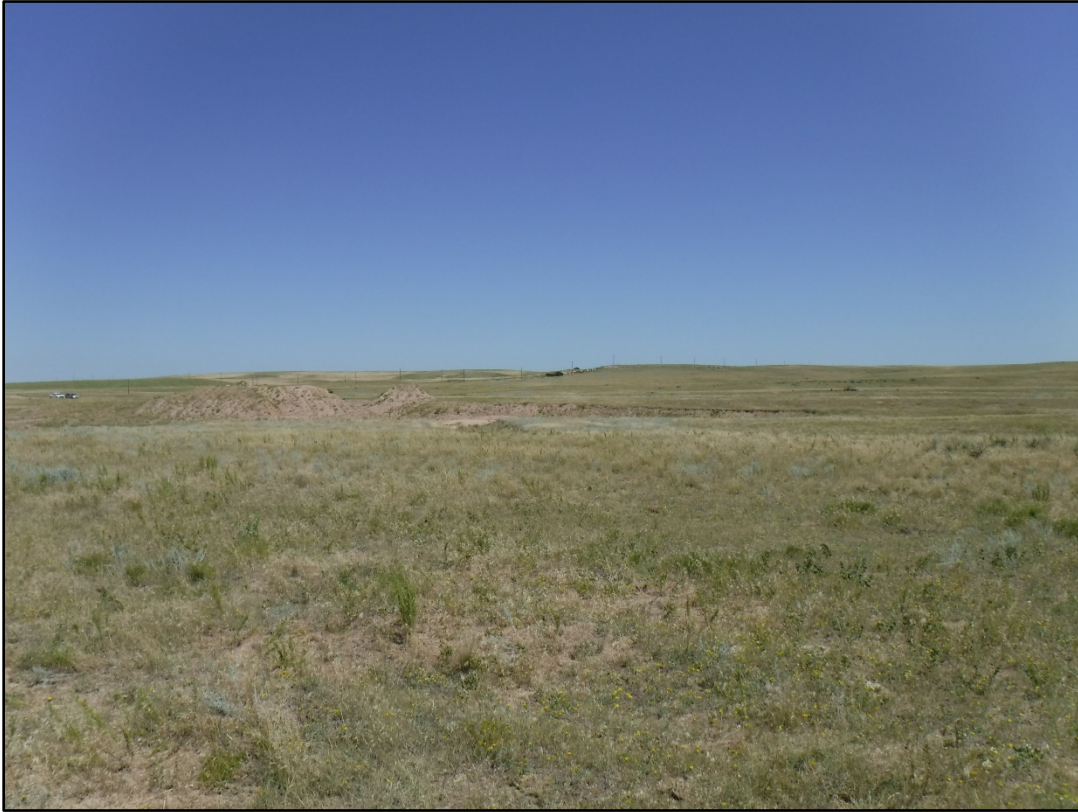
**Photo 5:** Looking east across permit area from west side of permit

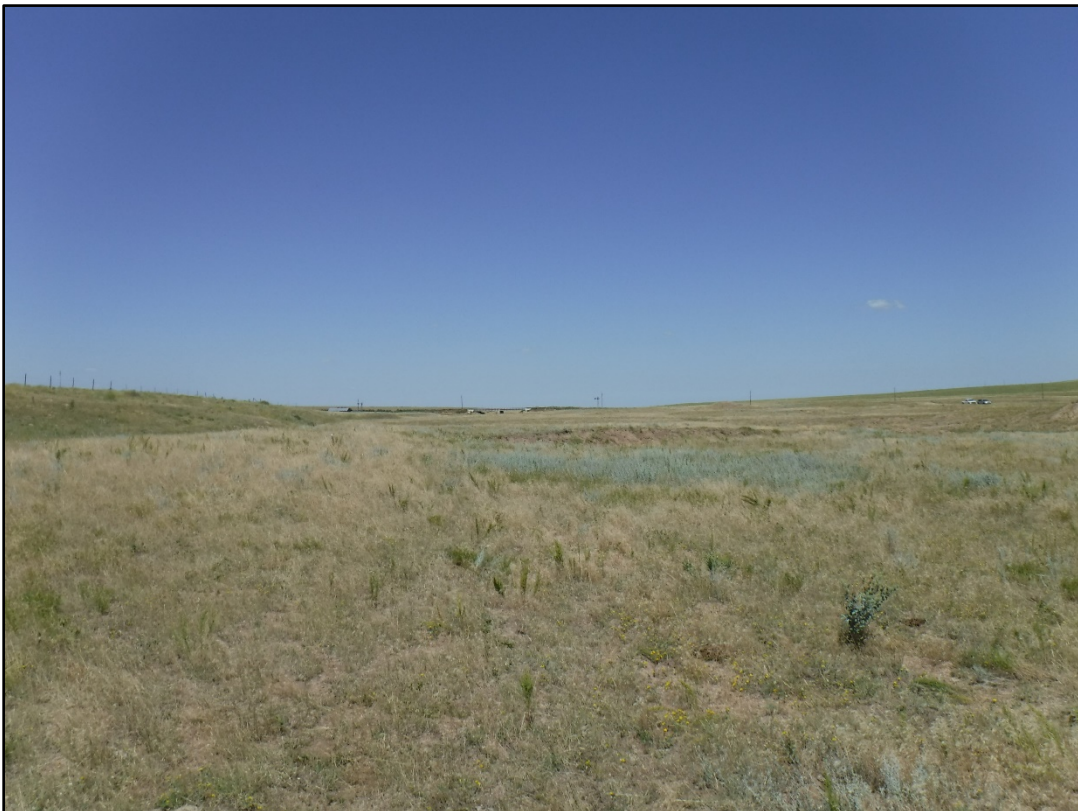
**Photo 6:** Looking north across westernmost disturbed area, note state of revegetation
