**MINERALS PROGRAM INSPECTION REPORT****PHONE: (303) 866-3567**

<b>MINE NAME:</b> State Land-Jensen Pit	<b>MINE/PROSPECTING ID#:</b> M-1983-050	<b>MINERAL:</b> Sand and gravel	<b>COUNTY:</b> Sedgwick
<b>INSPECTION TYPE:</b> Monitoring	<b>INSPECTOR(S):</b> Brock F. Bowles	<b>INSP. DATE:</b> August 12, 2019	<b>INSP. TIME:</b> 11:30
<b>OPERATOR:</b> Phillips County	<b>OPERATOR REPRESENTATIVE:</b> Mike Salyards	<b>TYPE OF OPERATION:</b> 110c - Construction Limited Impact

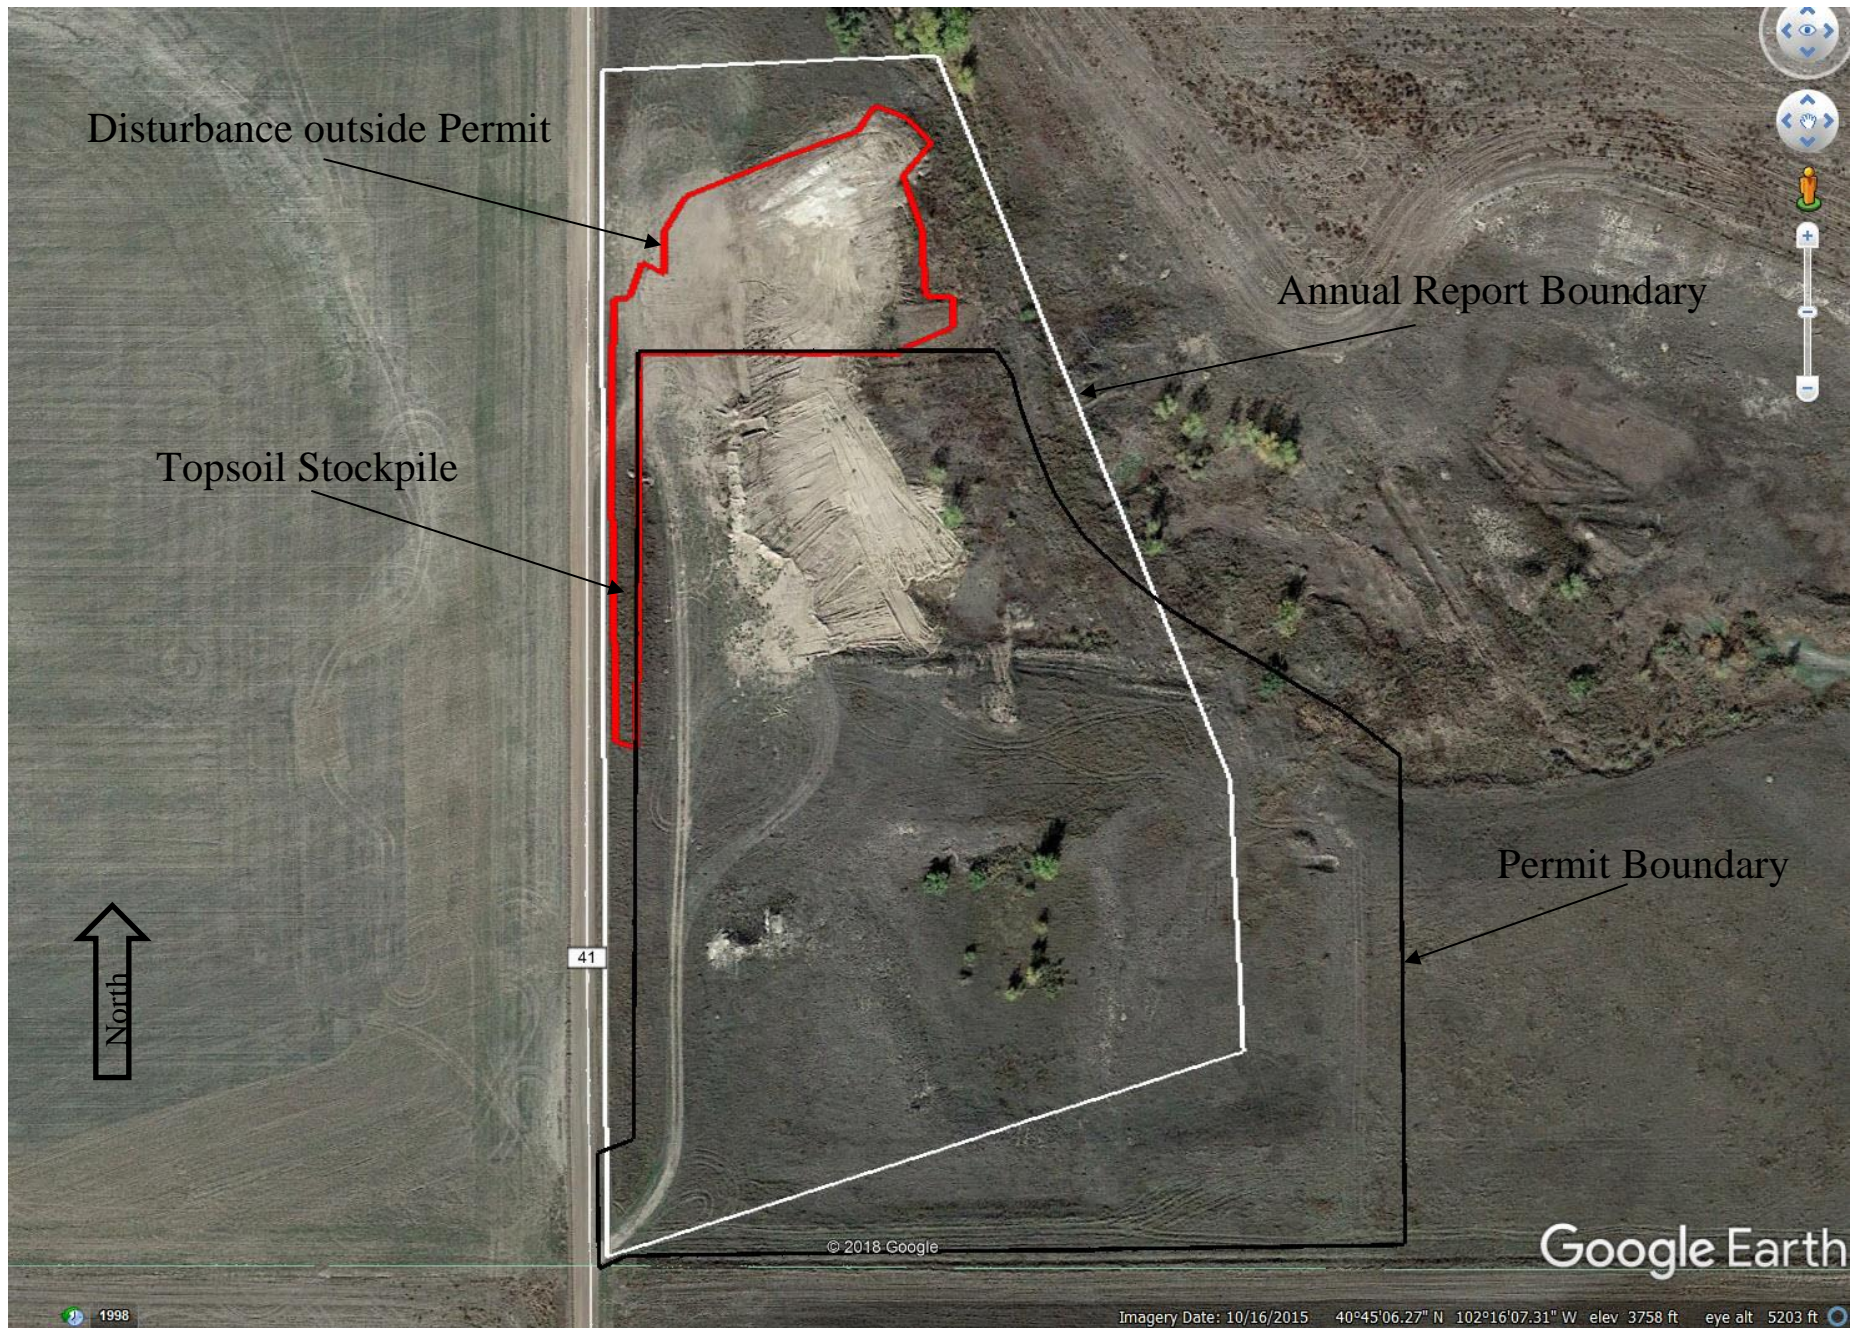
After the inspection, the permit map was imported into Google Earth to verify the exact location of the missing boundary markers. This is when it was noticed that the permit boundary map and the Annual Report Map are not the same causing confusion of the permit boundary location. It appears that mining operations have been conducted according to the Annual Report Map which includes areas outside the approved permitted area. No revisions or amendments have been submitted for this permit, therefore the original permit boundary is still the approved boundary. Mining operations were conducted beyond the northern permit boundary and the topsoil stockpile was placed outside the permit boundary along County Road 41. The mining related disturbance beyond the approved permit boundary is noted in the red polygon on the attached map and consists of 1.1 acre. This matter has been cited as a possible violation; please see the first page of the report for additional details.

**INSPECTION TOPIC:** Off-site Damage**PROBLEM/POSSIBLE VIOLATION:** Possible Violation: Land has been affected outside of the approved permit boundary. This is a possible violation at this time pursuant to C.R.S. 34-32.5-116(4)(i) for failure to protect areas outside of the affected land from slides or damages occurring during the mining operation.**CORRECTIVE ACTIONS:** This possible violation will require a hearing before the Mined Land Reclamation Board. The schedule and other details for the MLRB hearing will be provided under a separate document to be sent via certified mail to the operator.**CORRECTIVE ACTION DUE DATE:** 10/23/19**INSPECTION TOPIC:** Signs & Markers**PROBLEM/POSSIBLE VIOLATION:** Problem: The affected area boundary markers are missing or incorrectly placed. This is a problem for failure to maintain boundary markers around the affected area as required by Section 3.1.12(2) of the rule.**CORRECTIVE ACTIONS:** The operator shall conduct a survey and replace the boundary markers in the correct location(s). The operator shall provide proof to the Division that this has been done by the corrective action date.**CORRECTIVE ACTION DUE DATE:** 10/03/19

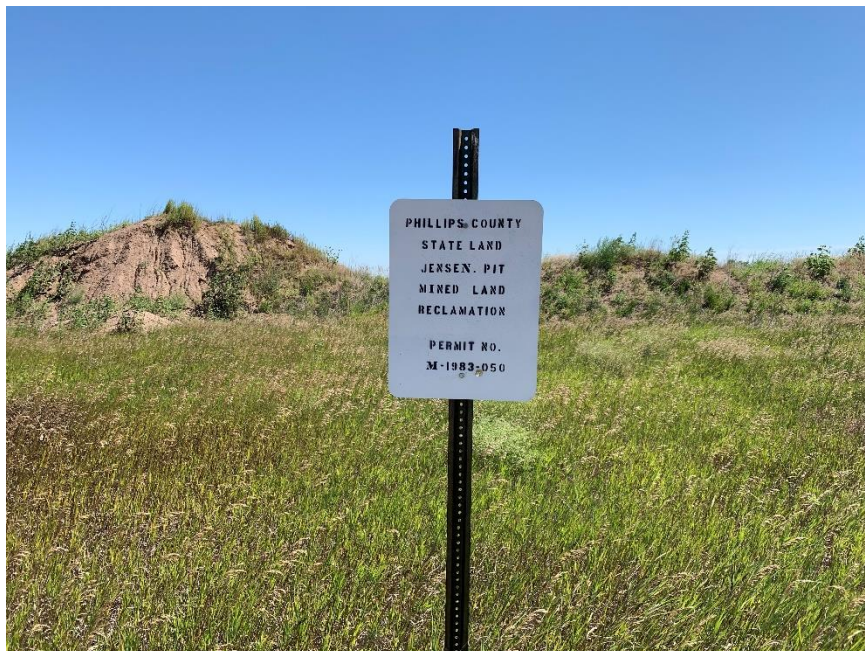
The permit identification sign was in place at the mine entrance and legible. No mining activity was being conducted and no equipment was on site. A pile of gravel was pushed up on the west side of the pit. There was some standing water on the east side of the permit area in the bottom of Dry Creek. This water is most likely a result of the recent heavy rains. There was standing water in other low areas outside the permit area including along the gravel roads.

Mine entrance sign facing County Road 41

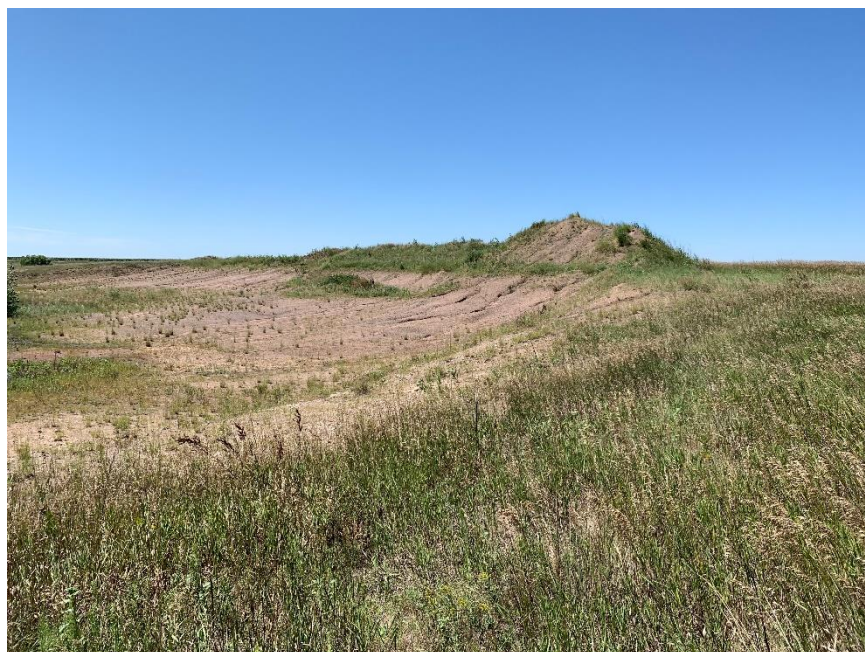
Gravel pile pushed to west side of pit area.

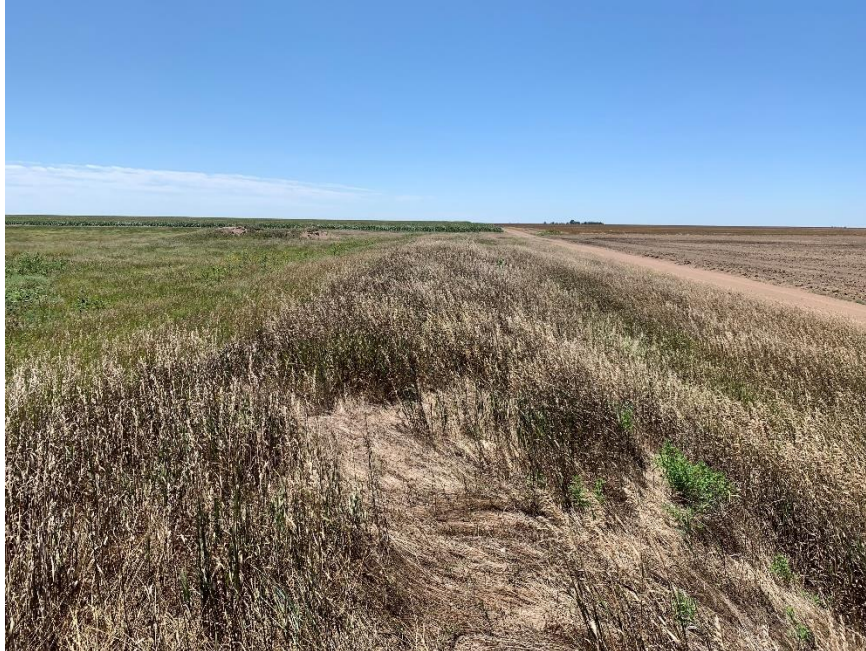
The topsoil stock pile was well vegetated and appeared to be stable.

Topsoil stockpile along County Road 41. Picture facing south

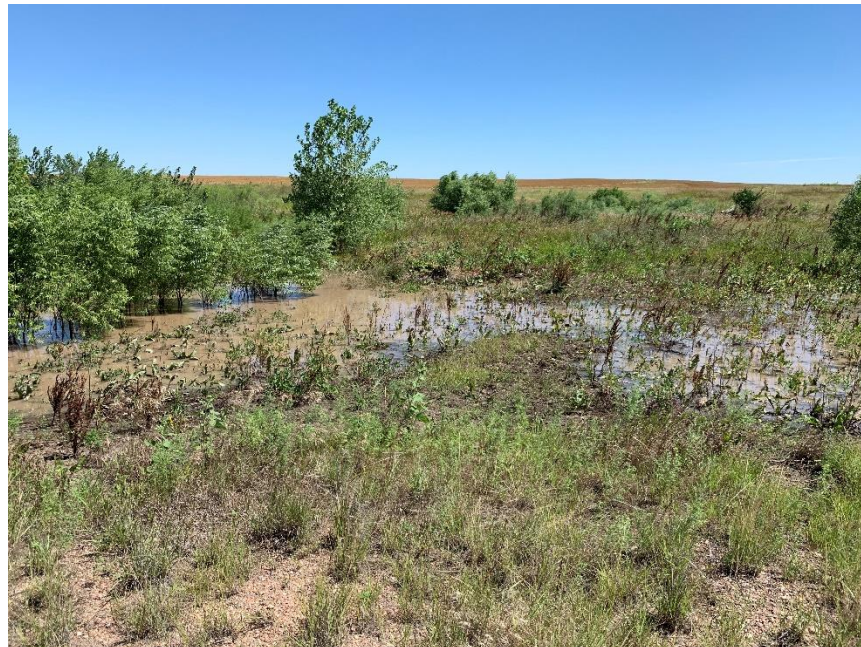
Standing water in the bottom of Dry Creek. Picture facing east.
