Report of Undesirable Event

| 1. Operator: Natural Soda LLC | | Field Name: N/A | |
| 9. Well or Facility ID: 15H well | | | |
| 10. Type of Event (see instructions): Brine (Water) Spill | | | |

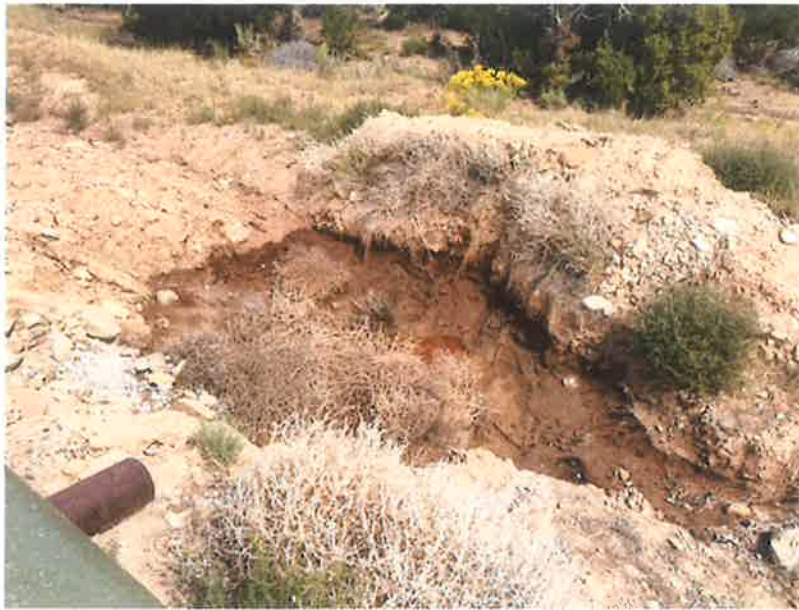
| 11. Cause of, and Extent of Event: Surface piping modification for 15H-R well. When flange was broken open, fluid had unexpectedly leaked past a closed valve resulting in a spill on the edge of the pad which flowed into a storm water catchment area just off the pad. | | | |
| 15. Description of Potential/Resultant Damage and Cause/Extents of Personal Injuries: There were no injuries in this event. All brine was contained in the storm water catchment basin approximaely 15 feet from the edge of the pad. | | | |

Leak Event on September 5, 2019. Spill contained in storm water catchment. Roughly 200 GPM was pumped out and recovered.

| 16. Clean up Procedures and Dates: A portable sump pump was used to pump out the catchment into a 250 gallon spill tote. This fluid was disposed of in Natural Soda's waste pond. Work was completed on September 6, 2019. | | | |
| 17. Action Taken to Prevent Recurrence/Initiate or Update Contingency Planning Procedure will be modified to anticipate fluid and establish proper drainage directly into the tote prior to opening a flange in this area. | | | |

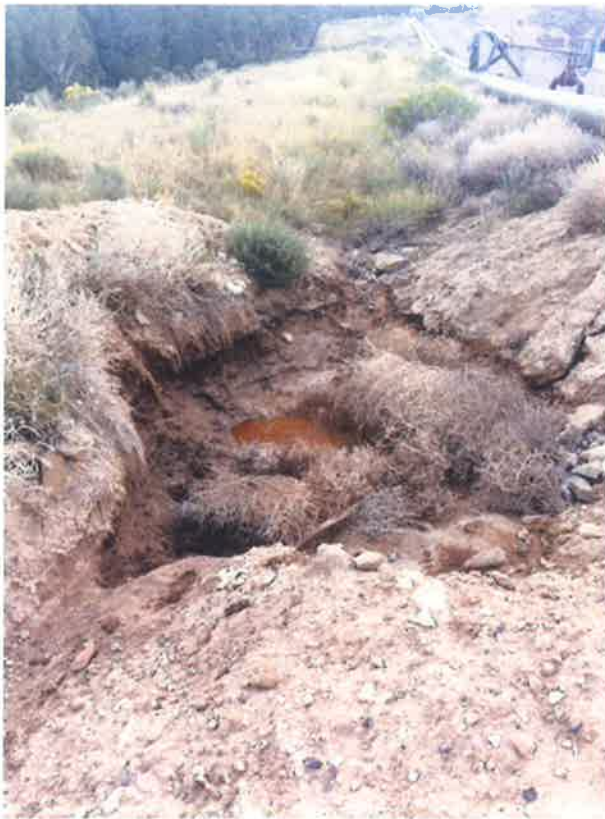
This picture shows that the spill did not “over-top” the catchment area.
