## MINERALS PROGRAM INSPECTION REPORT

| <b>MINE NAME:</b><br>Blue Grass Gravel Pit | <b>MINE/PROSPECTING ID#:</b><br>M-2008-001 | <b>MINERAL:</b><br>Sand, gravel, borrow | <b>COUNTY:</b><br>Pueblo |
| <b>INSPECTION TYPE:</b><br>Monitoring | <b>INSPECTOR(S):</b><br>Elliott R. Russell | <b>INSP. DATE:</b><br>May 23, 2018<br>June 1, 2018 | <b>INSP. TIME:</b><br>10:00 |

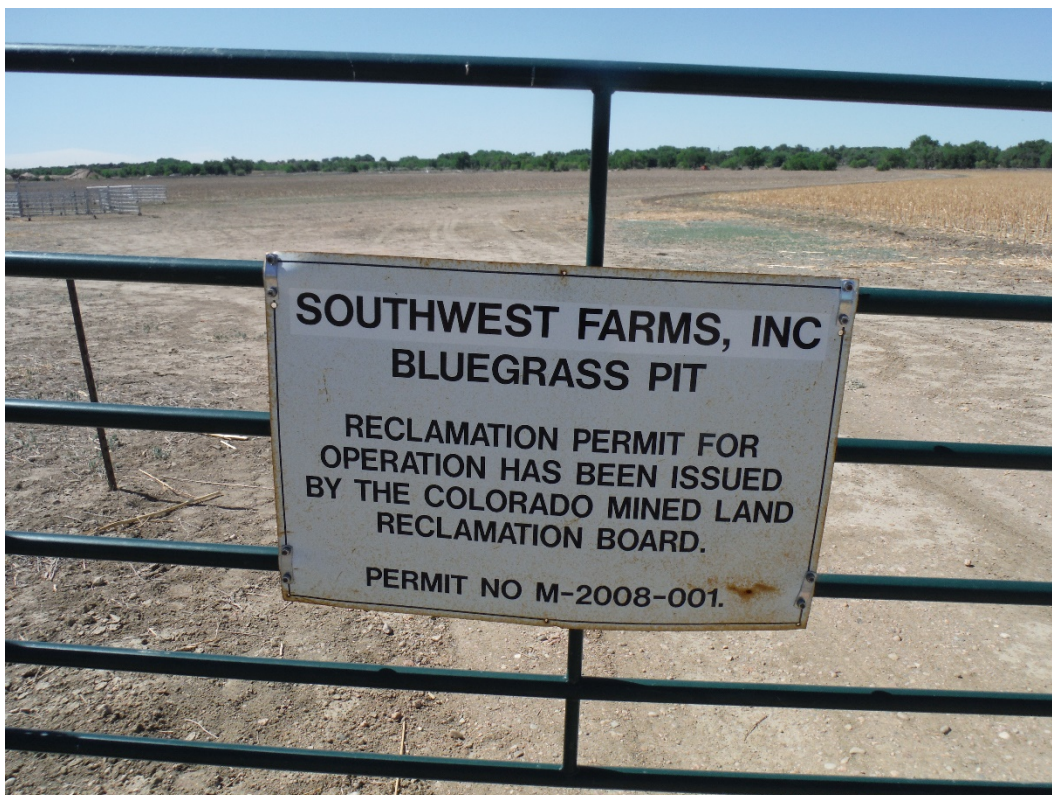
**COMPLIANCE PROBLEM:** The mine identification sign was not properly posted at the entrance of the mine site. This is a problem for failure to post a mine identification sign as required by Rule 3.1.12(1).

Signs and Markers: The permit sign was posted at the northern access point to the eastern permit area, however, the sign still identifies the previous Operator. This has been cited as a compliance problem requiring corrective action. Boundary markers were observed to delineate the permit boundary.

**Photo 1.** Mine identification sign, new Operator name needed; looking south.

**CORRECTIVE ACTIONS:** The operator shall, at the entrance of the mine site, post a sign which shall be clearly visible from the access road with the following: the name of the operator, a statement that a reclamation permit for the operation has been issued by the Colorado Mined Land Reclamation Board; and the permit number. The operator shall submit photo documentation that a proper sign has been posted by the corrective action date.

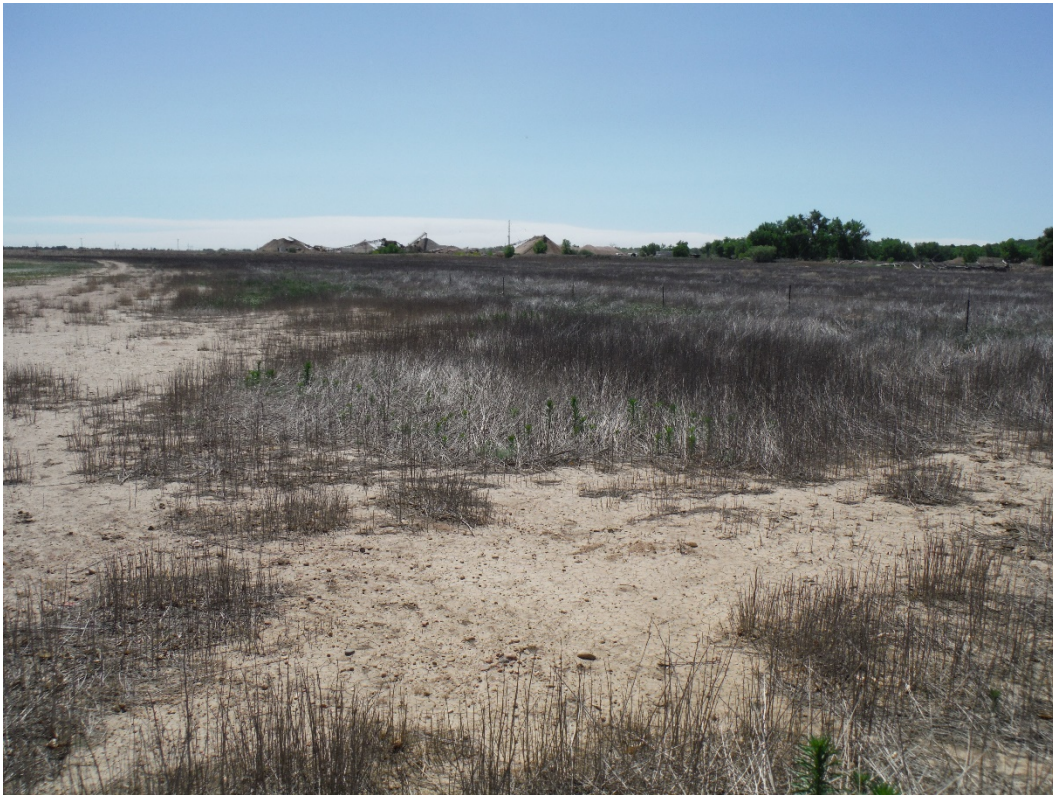
Revegetation: The 18-acre disturbance mainly consists of annual weeds. This area will likely need to be mowed, tilled, and planted with the enclosed approved seed mixture if reclamation is initiated after TC-01 ends. The Division observed Tamarisk (also known as Salt Cedar) establishing on the site in two low areas along the west side of the eastern permit area. Tamarisk is a noxious weed List B species, and therefore has been cited as a compliance problem requiring corrective action. The Division has enclosed a noxious weed factsheet on tamarisk for the Operator's reference regarding treatment.

**Photo 2.** Disturbed area in the southeast portion of the permit; looking southeast.

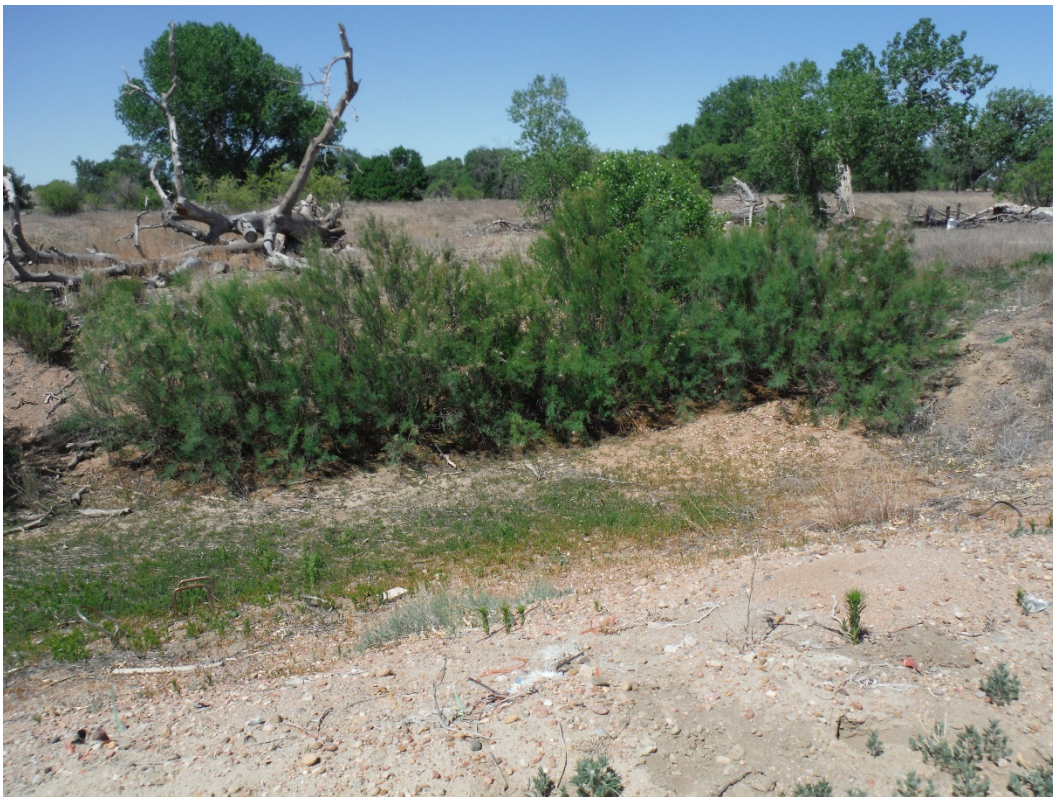
**COMPLIANCE PROBLEM:** Tamarisk (salt cedar) trees are present within or have volunteered into the permit area and are becoming established. This is a problem for failure to employ weed control methods for a state listed noxious weed species within the permitted area, and to reduce the spread of weeds to nearby areas as required by Rule 3.1.10 (6).

**Photo 3.** Tamarisk observed along the western portion of the eastern mining area; looking southwest.

**CORRECTIVE ACTIONS:** The operator shall employ weed control methods for the tamarisk trees. The operator shall submit photo documentation of the tamarisk by the corrective action date.

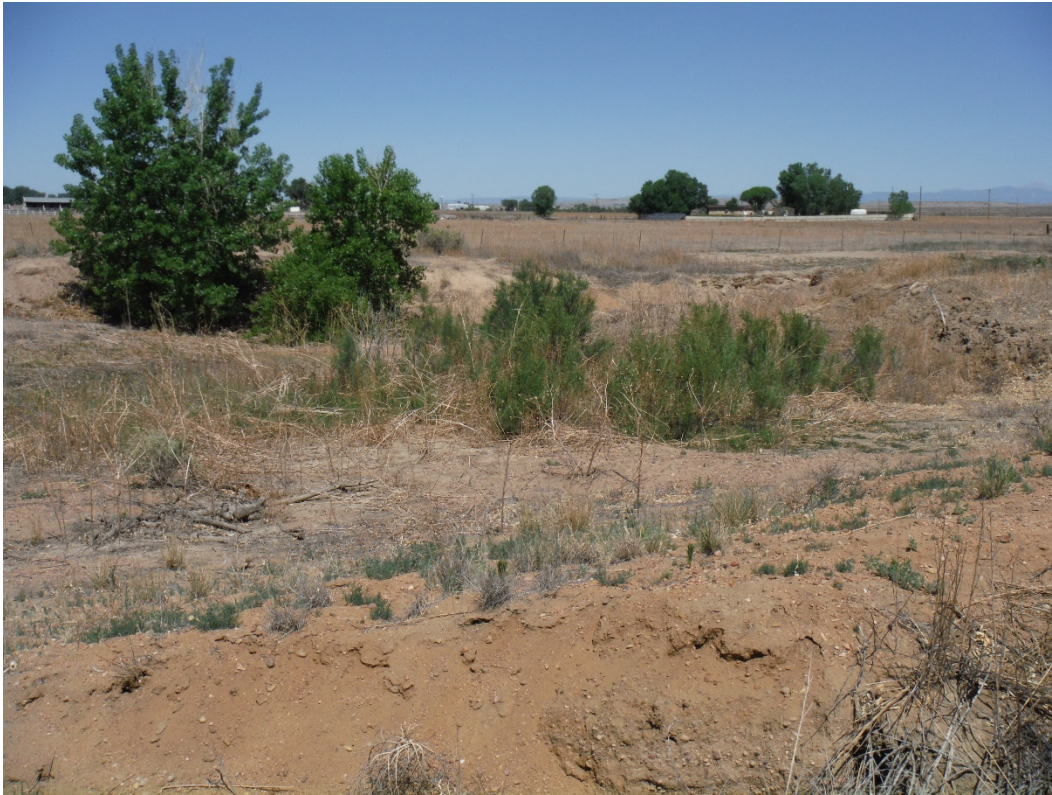
**Photo 4.** Additional tamarisk observed along the western portion of the eastern mining area; looking northwest.

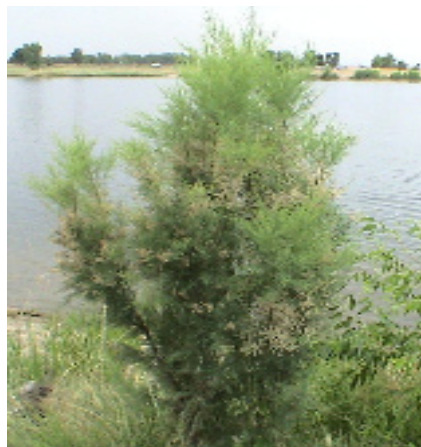
## Saltcedar Identification and Management

1. Saltcedar is a tall shrub or small tree that has white to pink flowers in clusters called racemes.
2. Leaves are small and scaly.

Saltcedar, or tamarisk (*Tamarix spp.*), is a non-native deciduous evergreen shrub or small tree that grows from 5 to 20 feet tall. The bark on saplings and stems is reddish-brown. The leaves are small, scale-like and bluish-green in color. Tiny pink to white flowers have five petals and grow on slender racemes. Saltcedar reproduces by seeds as well as vegetatively. A mature plant can produce up to 600,000 seeds per year. Seeds are viable for up to 45 days under ideal conditions. Saltcedar buds break dormancy in February or March. Flowering occurs anytime between April and August. Ideal conditions for saltcedar seedling survival are saturated soil during the first few weeks of life, a high water table, and open sunny ground with little competition from other plants.
