MINERALS PROGRAM INSPECTION REPORT
PHONE: (303) 866-3567

MINE NAME: Midwestern Farms	MINE/PROSPECTING ID#: M-1993-059	MINERAL: Sand and gravel	COUNTY: Prowers
INSPECTION TYPE: Monitoring	INSPECTOR(S): Amy Eschberger	INSP. DATE: September 11, 2019	INSP. TIME: 15:15
OPERATOR: Midwestern Farms	OPERATOR REPRESENTATIVE: Mel DePra	TYPE OF OPERATION: 112c - Construction Regular Operation

OBSERVATIONS

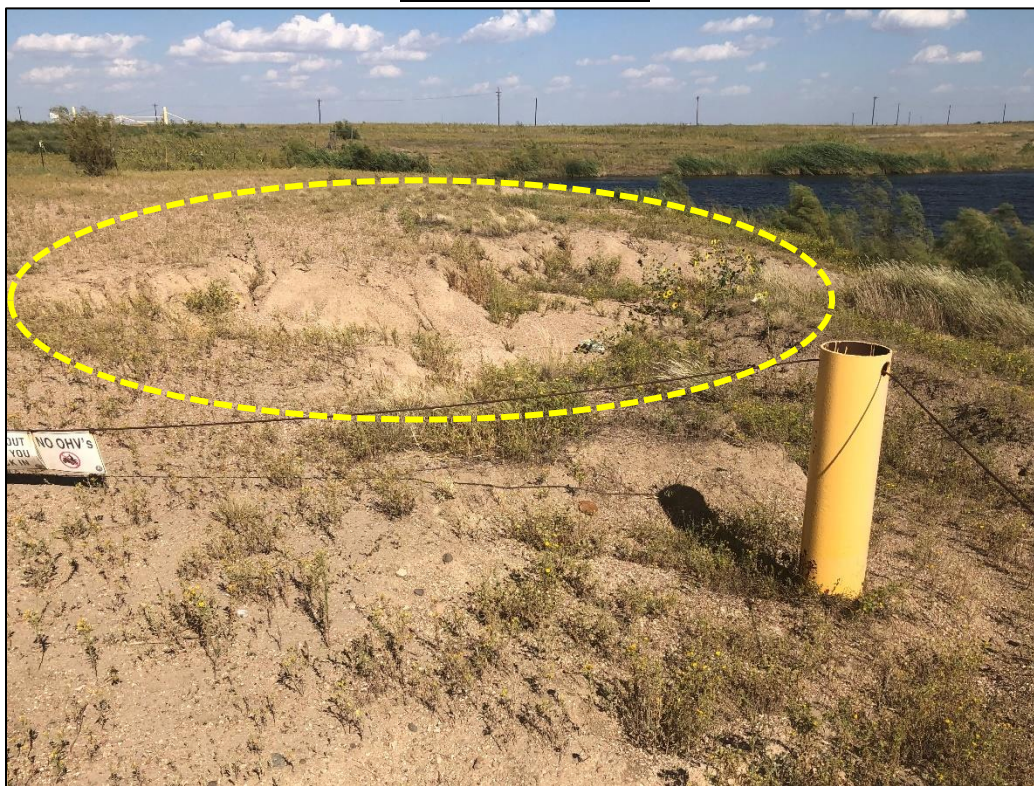
During the current inspection, the Division observed several locations along the pond shorelines where erosion gullies have formed (see enclosed Google Earth image of site showing approximate locations of erosion features observed). The Division also observed the section of the eastern pond shoreline on which the riprap blanket was installed per TR-6. The riprap appeared to be effectively controlling erosion along the majority of this shoreline. However, at one location, where the pond bank is closest to the adjacent farm road, the pond water was overflowing the bank onto the adjacent road. At this location, it appeared the pond bank had been graded too flat prior to placing the riprap, which did not properly account for seasonal fluctuations of the pond water level. According to Mr. Kaczmarek, pond water levels are currently about 16-18 inches higher than they are in winter months (when the shoreline was regraded for riprap placement). Additionally, the eastern pond shoreline receives a significant amount of wave action. Therefore, this low-lying portion of the eastern pond shoreline will require additional stabilization measures to keep the shoreline from eroding further, and migrating into the adjacent farm road and ditch. The Division is citing a problem in this report pursuant to C.R.S. 34-32.5-116(4)(j) and Construction Materials Rule 3.1.6(3) for failure to protect all surface areas of the affected land from erosion. The operator will need to repair the erosion damage present along pond shorelines and provide photo documentation to the Division that this has been done. If the operator proposes an alternative method for stabilizing the eastern pond shoreline (besides riprap placement), this proposal must be submitted in the form of a Technical Revision (see enclosed form).

Photo 1. View looking east across erosion feature (circled) observed at northwestern edge of pond, near CPW-designated parking area.

CORRECTIVE ACTIONS: By the corrective action date, the operator shall provide the Division with photo documentation verifying the erosion damage on pond shorelines has been repaired, and the site has been reconstructed and stabilized to prevent further erosion damage. If the operator proposes an alternative method for

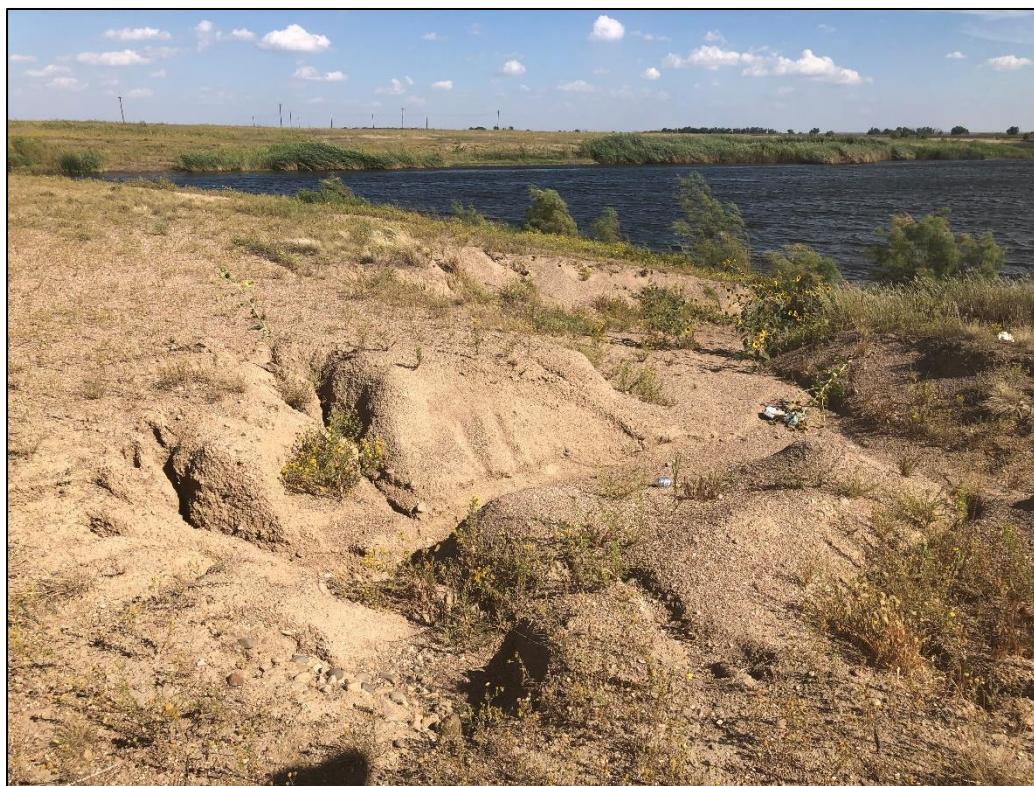
Photo 2. Closer view of erosion feature identified in Photo 1 (located at northwestern edge of pond).

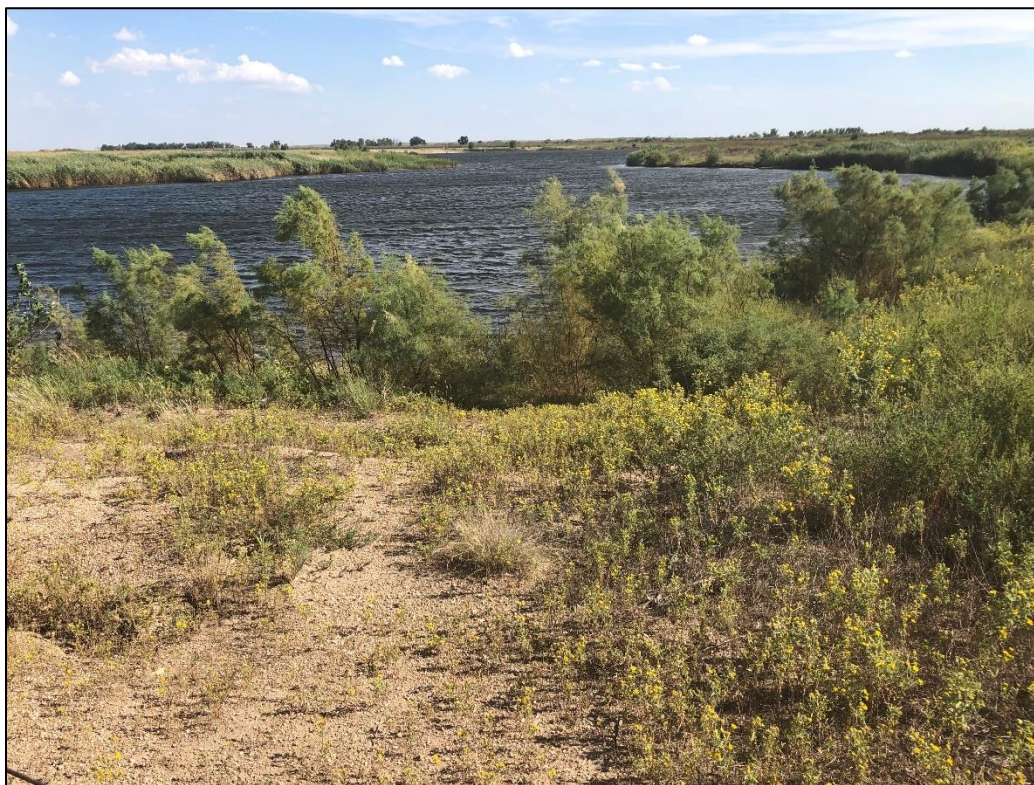
During the inspection, the Division observed numerous Tamarisk trees present on site, particularly along the western and southern pond shorelines, but also in disturbed areas north of the pond. The Division observed Field bindweed growing in several areas around the pond, especially in the disturbed areas southeast and northeast of the pond. The operator is clearly not implementing the approved weed control plan for the site.

Photo 3. View looking south, showing numerous Tamarisk trees present along northwestern pond shoreline.

CORRECTIVE ACTIONS: By the corrective action date, the operator shall implement the approved weed control plan for all state-listed noxious weed species on the affected lands, and provide proof to the Division that this was done. If the operator wishes to revise the approved weed control plan, the proposed plan must be submitted in the form of a Technical Revision with the appropriate fee of \$216.00 by the corrective action date. The Division recommends the operator consult with the county extension agency or weed control district office in developing a plan that includes specific control measures to be applied, a schedule for when control measures will be applied, and a post-treatment monitoring plan.

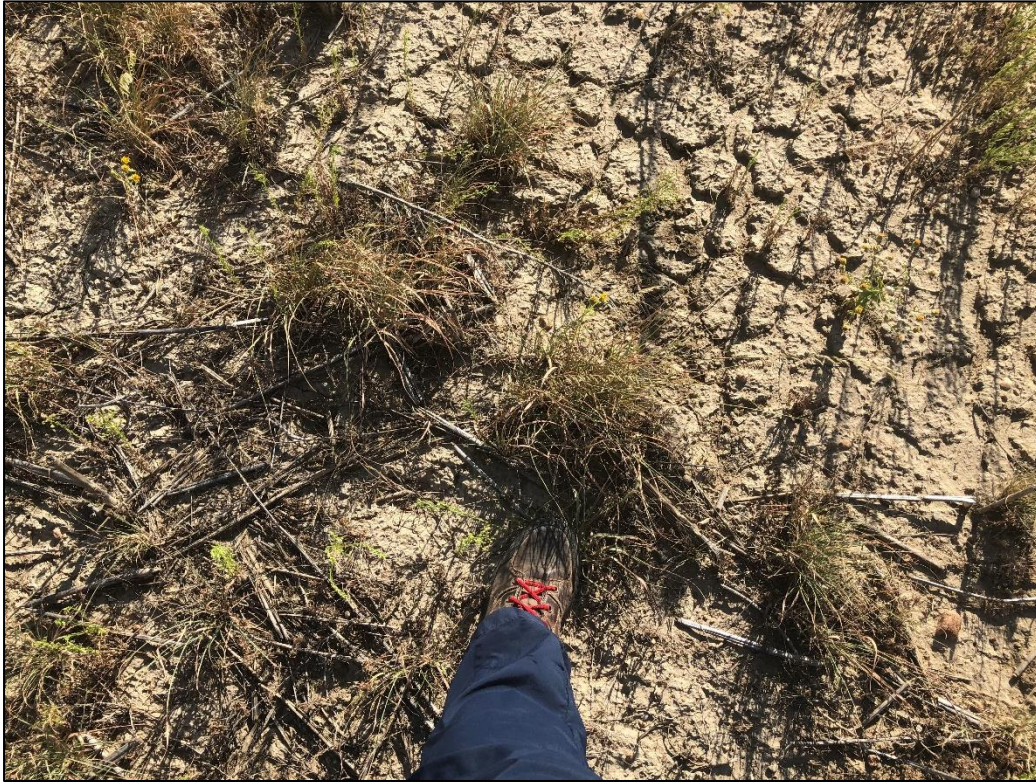
Photo 25. Ground view of area shown in Photo 24 located north of pond, showing some grasses present in this area.

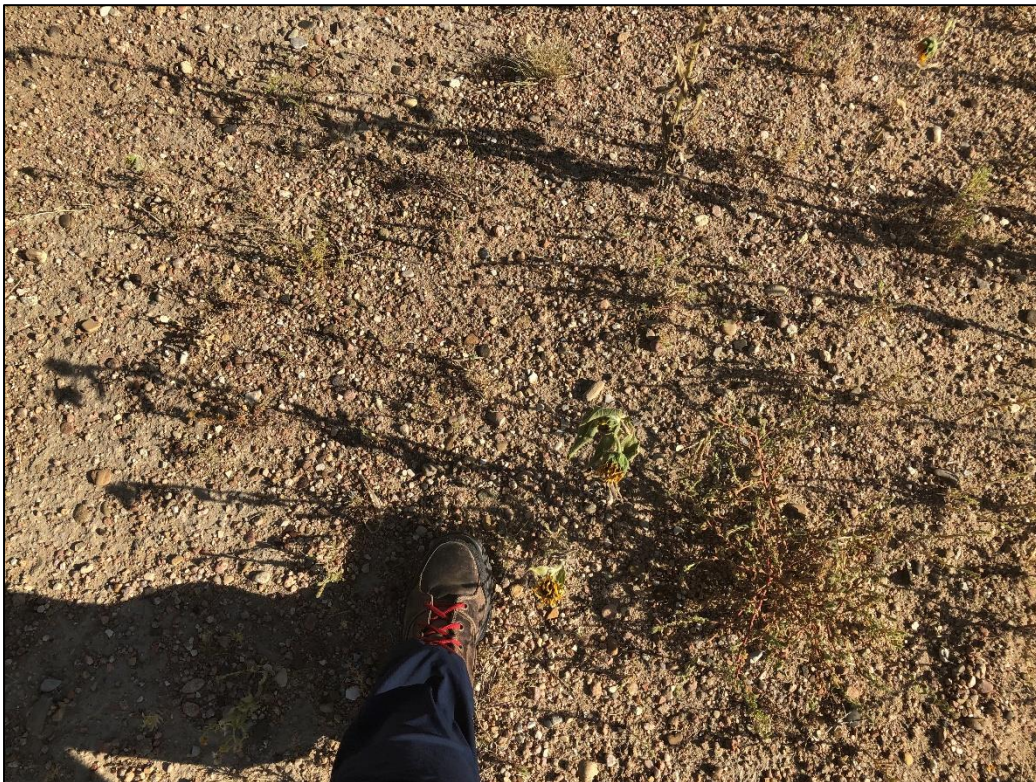
The Division observed the portions of the site undergoing revegetation, and could find very little if any evidence that the initial (2017) seeding event was successful. The vegetative cover present in these areas consisted primarily of weeds (e.g., kochia, wild sunflower, curlycup gumweed, marehail, field bindweed). According to Mr. Kaczmarek, CPW drill-seeded the areas located south and southeast of the pond in 2017, 2018, and 2019. CPW has also aerial sprayed the site for broadleaves a few times, the last of which occurred in April of 2019. This was done in hopes of giving the grass seed a chance to grow and establish. The Division observed established grasses, including yellow indian grass, big bluestem, sand dropseed, sideoats grama, and switchgrass, in the areas south and southeast of the pond. The Division also observed Illinois bundleflower growing in these areas (planted by CPW), which is a warm season legume that provides good wildlife food and cover. The vegetative cover present in the areas south and southeast of the pond (seeded by CPW) differs significantly from the areas north of the pond which have very little to no grass growth and abundant weeds. The Division recommends the operator plant a new cover crop and reseed the areas to be revegetated for final reclamation in accordance with the revegetation plan approved in TR-5. Ideally, the cover crop should be planted this September/early October, and the site reseeded this Spring.

Photo 26. Ground view of area shown in Photo 24 located north of pond, showing sparse vegetative cover present in much of this area.

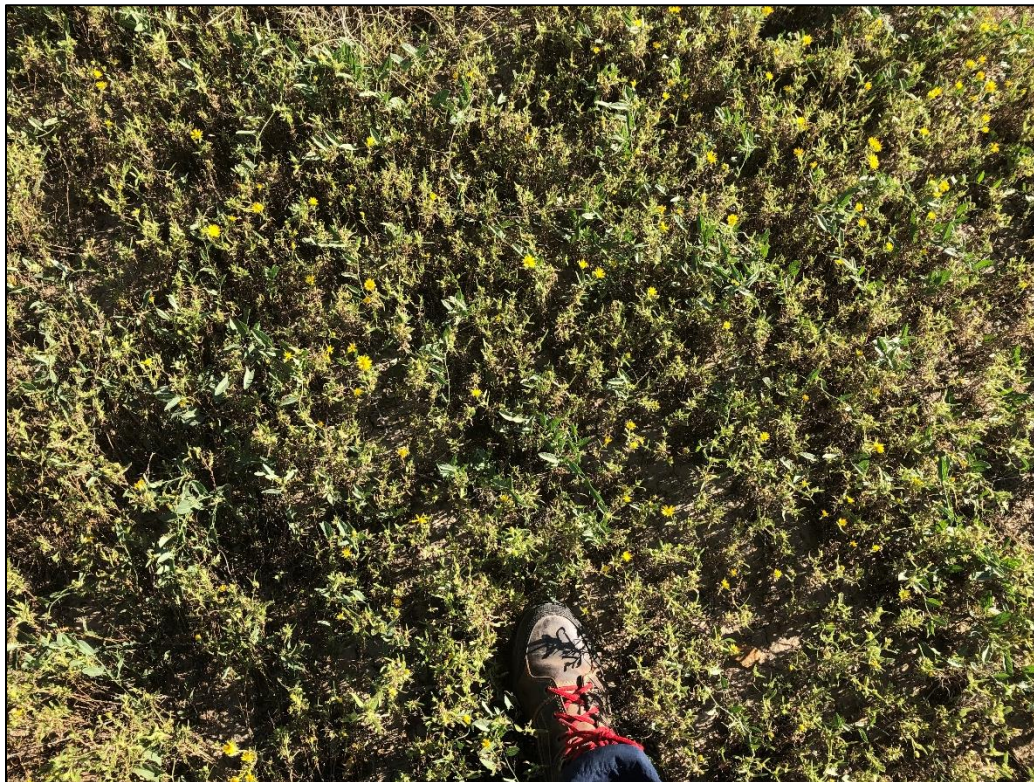
Photo 29. Ground view of area shown in Photo 28 located northwest of pond, showing field bindweed present in this area.
