MINERALS PROGRAM INSPECTION REPORT
PHONE: (303) 866-3567

MINE NAME: Yocam Borrow Pit	MINE/PROSPECTING ID#: M-2018-020	MINERAL: Borrow material for	COUNTY: Morgan
INSPECTION TYPE: Surety Release Inspection	INSPECTOR(S): Brock F. Bowles	INSP. DATE: September 10, 2019	INSP. TIME: 10:00
OPERATOR: Castle Rock Construction Company of Colorado	OPERATOR REPRESENTATIVE: Darren Janssen	TYPE OF OPERATION: 111 - Construction by Government Agency	
REASON FOR INSPECTION: Surety Release Requested	BOND CALCULATION TYPE: Partial Bond	BOND AMOUNT: \$42,500.00	
DATE OF COMPLAINT: NA	POST INSP. CONTACTS: None	JOINT INSP. AGENCY: None	
WEATHER: Clear	INSPECTOR'S SIGNATURE:

**Re: Yocam Borrow Pit, Permit No. M-2018-020, Financial Warranty Release Denial,
Revision No. SL-01**

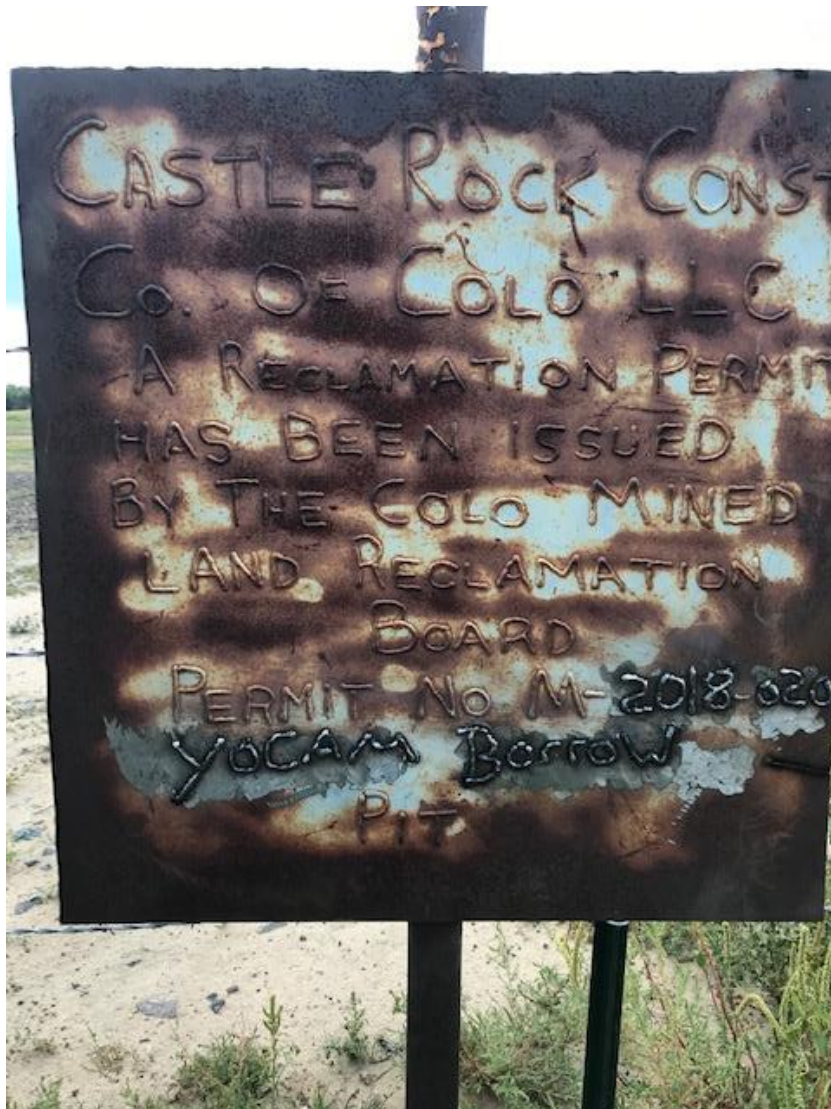
The permit entrance sign was not in place at the time of the inspection as required by Rule 3.1.12. On September 16, 2019, the operator send pictures showing that a permit entrance sign was installed at the entrance gate of the permit area. The permit boundary around the pit area was marked with an electric fence.

Mine entrance sign along CR 1/144. Picture courtesy of Darren Janssen.

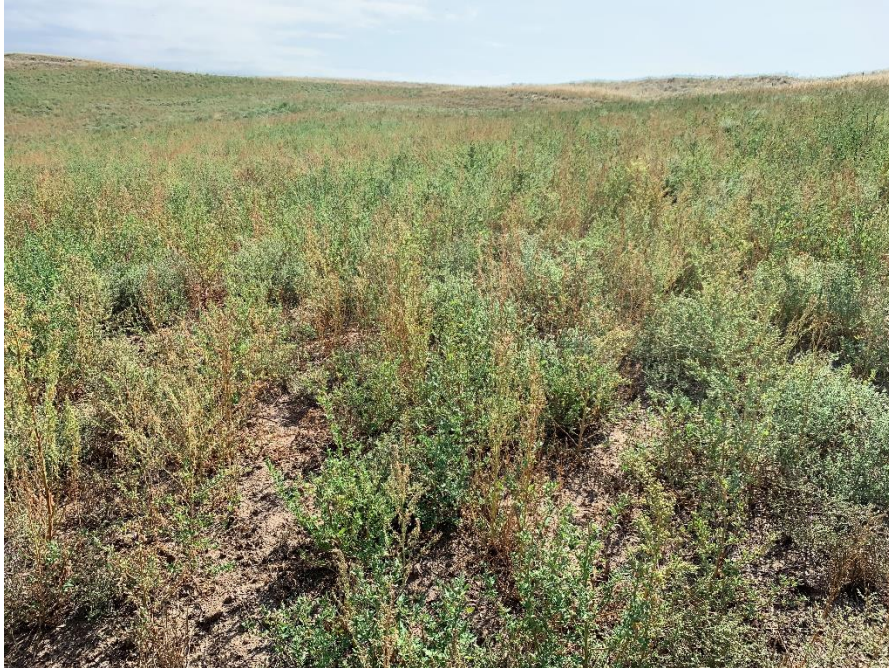
The vegetation in the reclaimed area mostly consisted of kochia and Russian thistle, both non-desirable annuals but not Colorado Dept. of Agriculture listed noxious weeds. It appears the oats cover crop has sprouted and completed its life cycle (died) which is appropriate for oats in September. No other native grasses or desirable species were seen. The last excavation date was November 2018 and the pit area was seeded sometime after that date. Mr. Janssen was not sure of the exact date of planting.

The vegetation reclamation standard (Rule 3.1.10(1)) is to establish a diverse, effective and long-lasting vegetative cover that is capable of self-regeneration and is at least equal in extent of cover to the natural vegetation of the surrounding fields. The vegetation did not meet this standard for the reasons stated above and the Division will deny the final performance and financial warranties release request based on the observations from this inspection. It usually takes 2-4 years for vegetation to achieve the reclamation standard (weather dependent). The Division suggests to keep monitoring the site and spot treat noxious weeds as they appear.

Vegetation mostly consisting of kochia and Russian thistle.

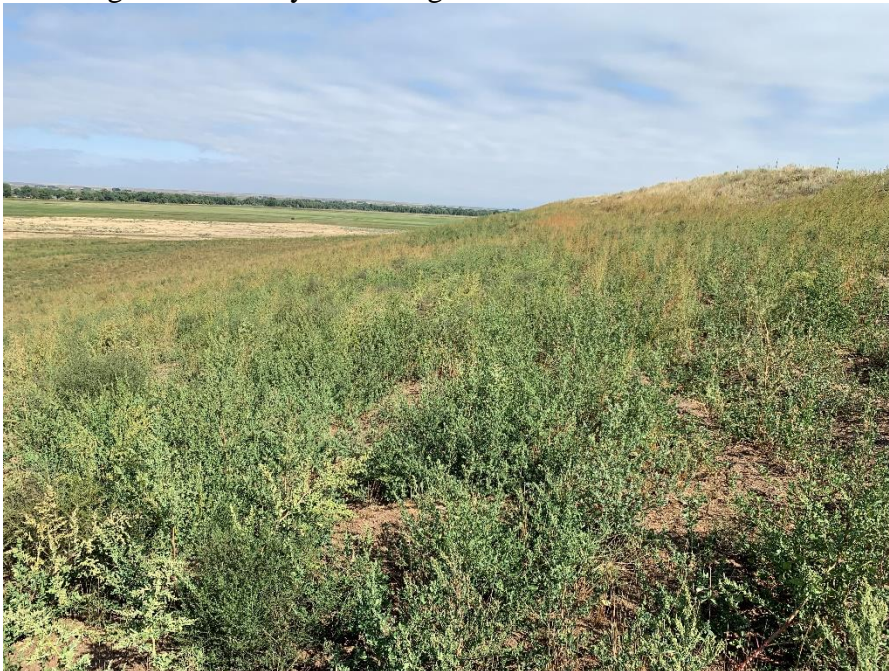
The slopes of the pit area were graded to approximately 4h:1v as required by the permit. The soil appears to be stable and there were no signs of erosion. The access road appeared to be stable and in passable condition.

Slopes graded to approximately 4h:1v.

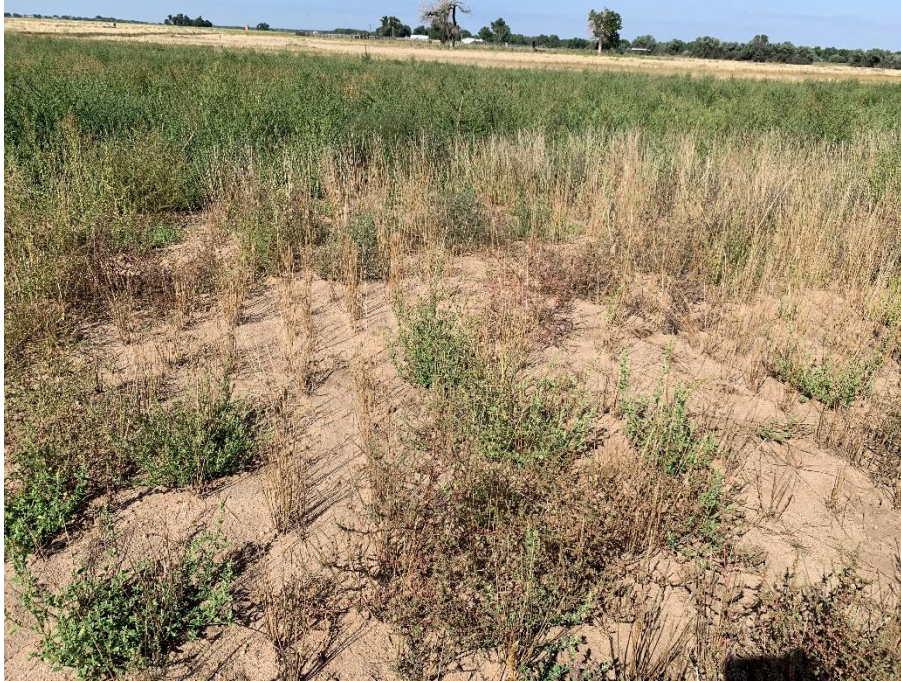
Oats plants planted in rows, have died at end of season.
