MINERALS PROGRAM INSPECTION REPORT

MINE NAME: City of Las Animas Sand Excavation Area	MINE/PROSPECTING ID#: M-2012-008	MINERAL: Sand	COUNTY: Bent
INSPECTION TYPE: Monitoring	INSPECTOR(S): Amy Eschberger	INSP. DATE: September 11, 2019	INSP. TIME: 11:00
OPERATOR: City of Las Animas	OPERATOR REPRESENTATIVE: Ken Wagner	TYPE OF OPERATION: 111 - Construction by Government Agency	
REASON FOR INSPECTION: Normal I&E Program	BOND CALCULATION TYPE: None	BOND AMOUNT: NA	
DATE OF COMPLAINT: NA	POST INSP. CONTACTS: None	JOINT INSP. AGENCY: None	
WEATHER: Clear	INSPECTOR'S SIGNATURE:

M-2012-008 / City of Las Animas Sand Excavation Area / City of Las Animas (111c)

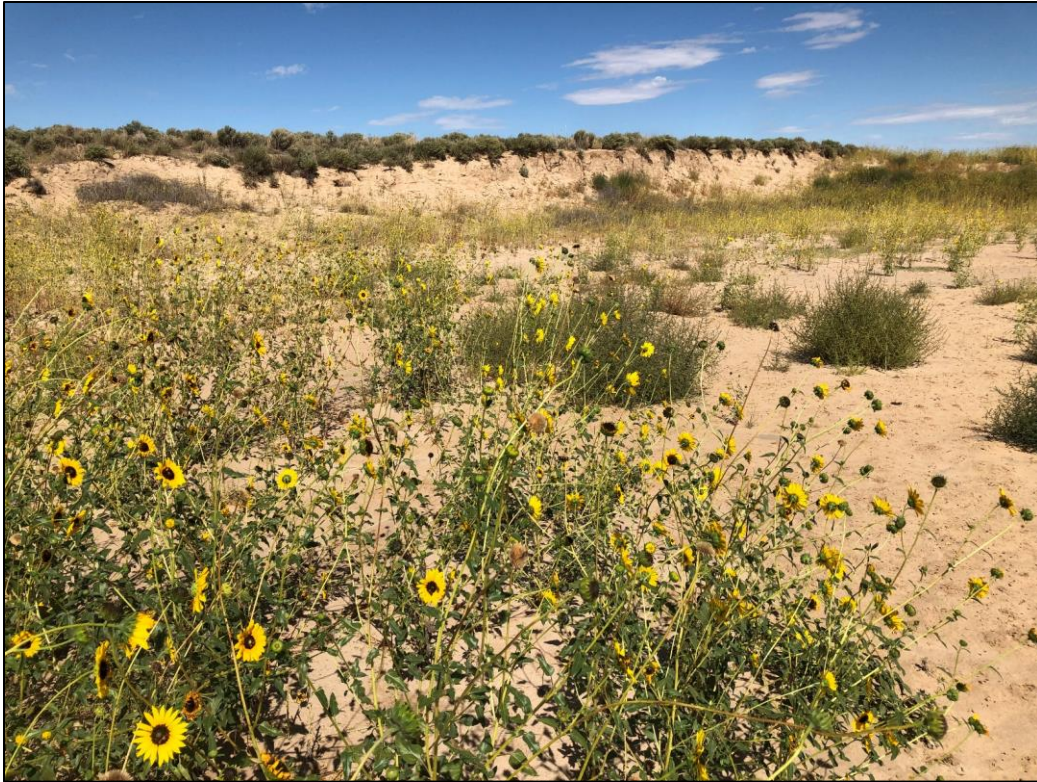
Photo 1. View looking northwest across pit from its southern edge. Note western pit wall (background, left) and vegetative cover of disturbed area consisting primarily of weeds (e.g., wild sunflowers, kochia).

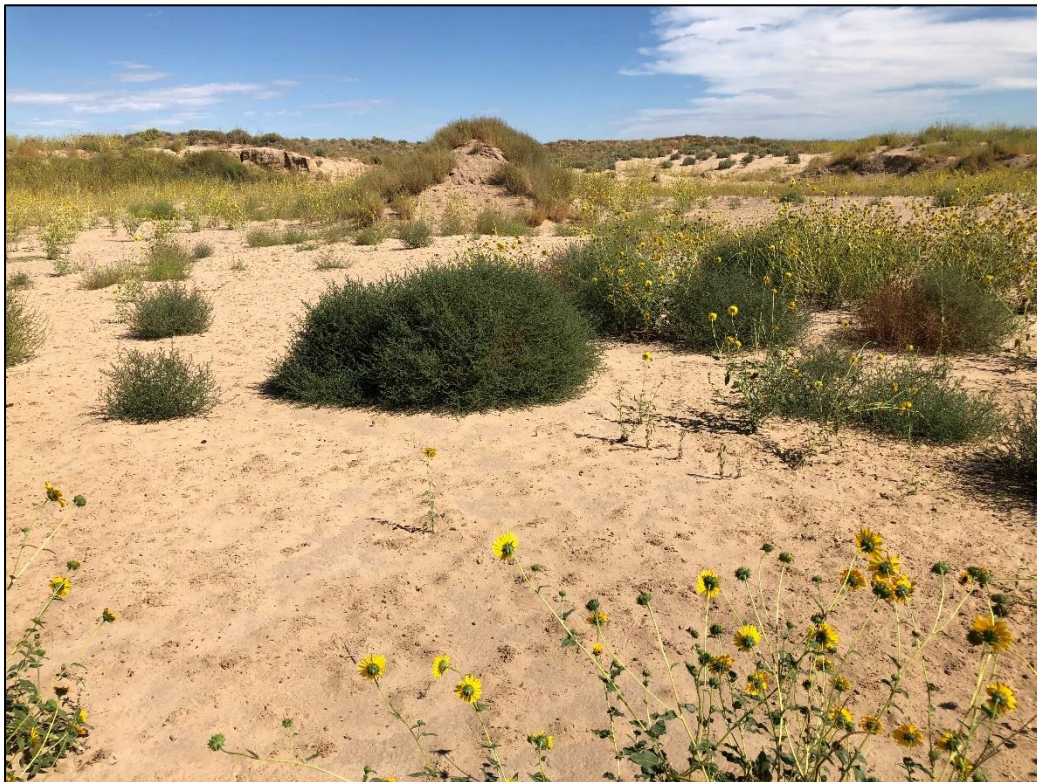
Photo 2. View looking north across pit from its southern edge. Note material stockpile stored on pit floor (top, center) and vegetative cover of disturbed area consisting primarily of weeds (e.g., wild sunflowers, kochia).

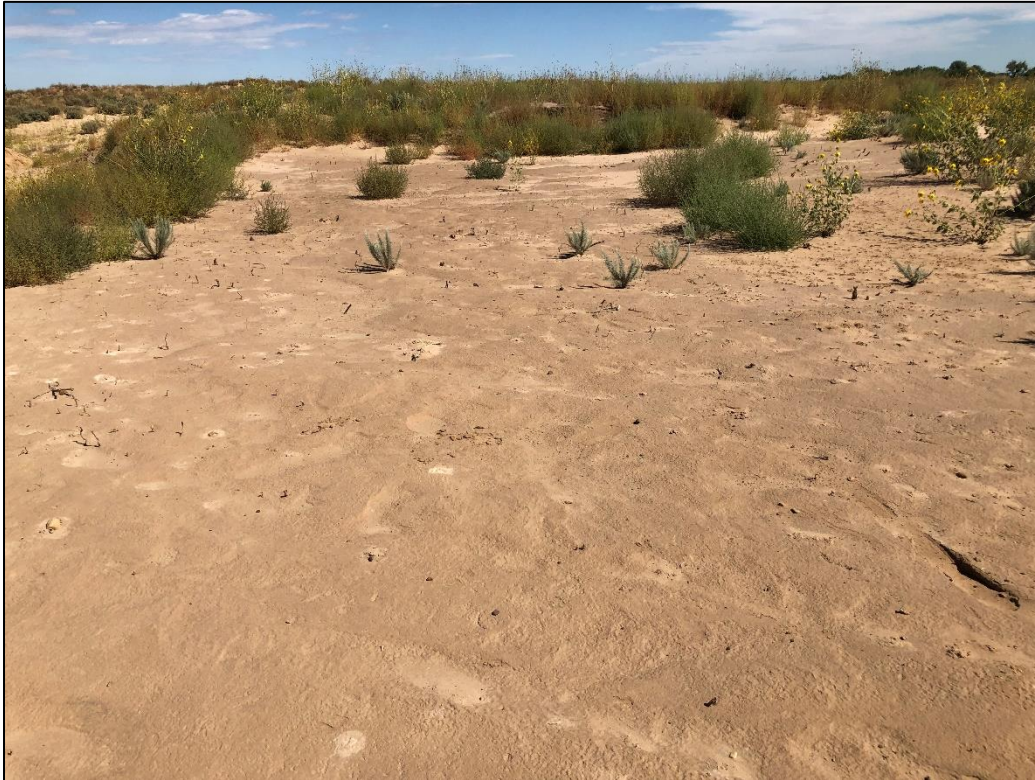
Photo 3. View looking north across area recently stripped northeast of pit in preparation for mining. Note annual weeds (e.g., wild sunflowers, kochia) and sand sagebrush volunteering into this area.

No problems were observed. However, given the operator's commitment to limit pit disturbance to no more than two acres at a time, prior to disturbing additional land, the operator should either complete reclamation of existing disturbance, or submit a Technical Revision to increase the maximum disturbance at any time to more than two acres.

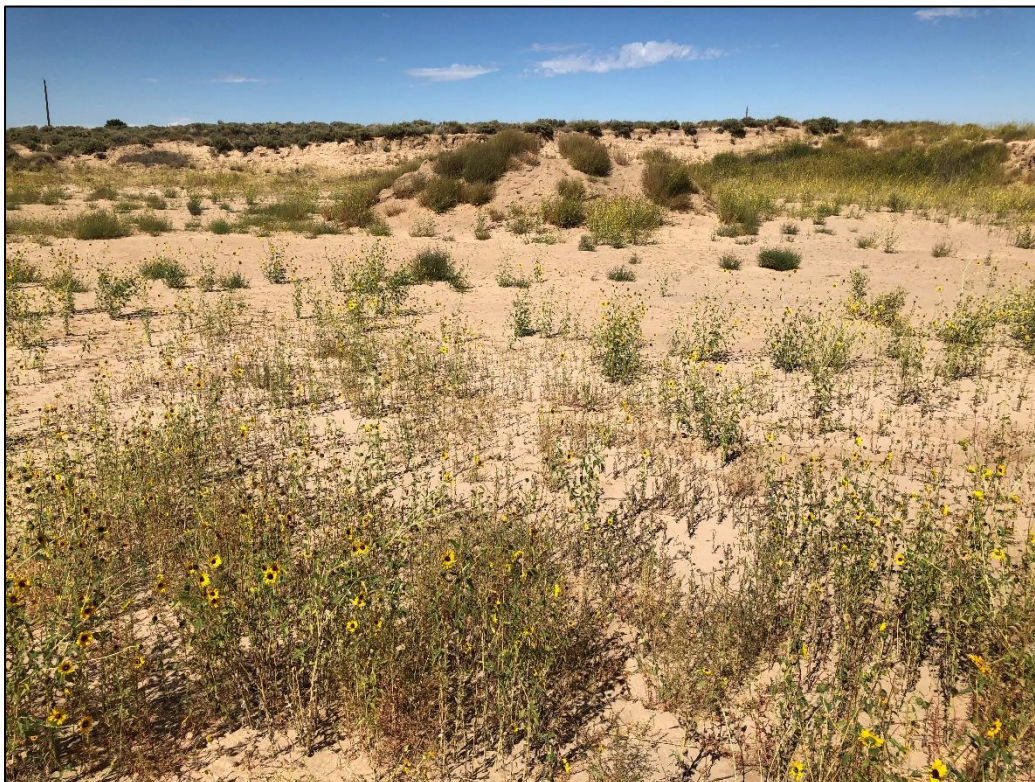
Photo 4. View looking west across pit from its eastern edge. Note material stockpile stored on pit floor (top, center) and vegetative cover of disturbed area consisting primarily of weeds (e.g., wild sunflowers, kochia).

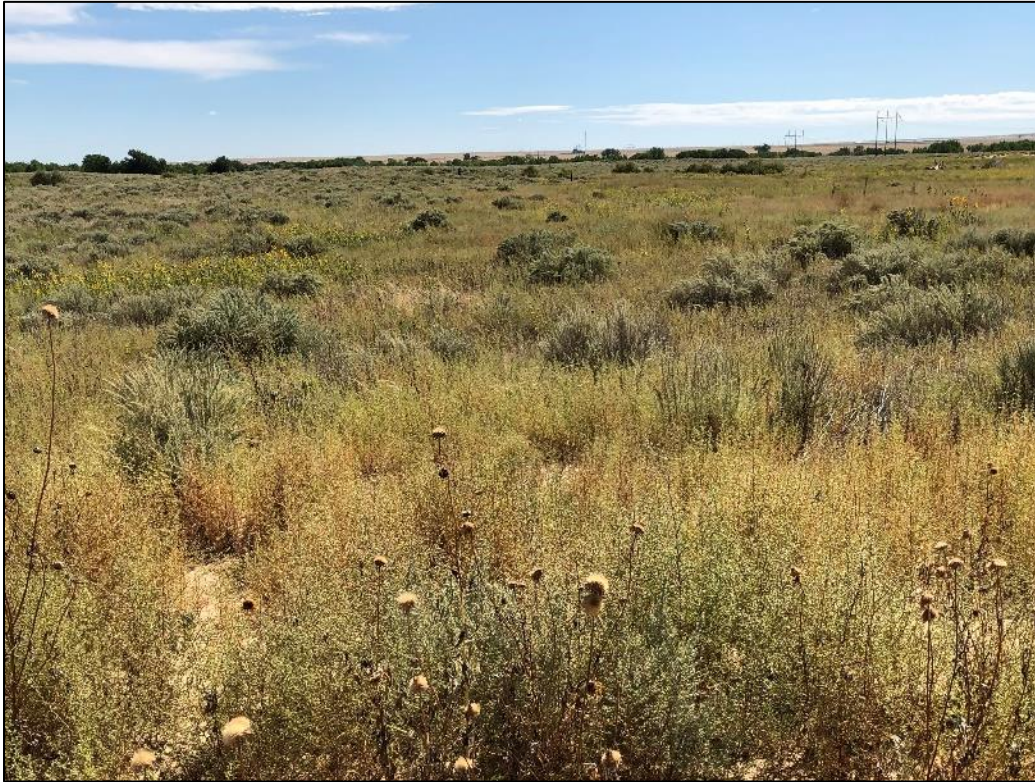
Photo 5. View looking east from eastern edge of pit disturbance, showing undisturbed portion of permit area.

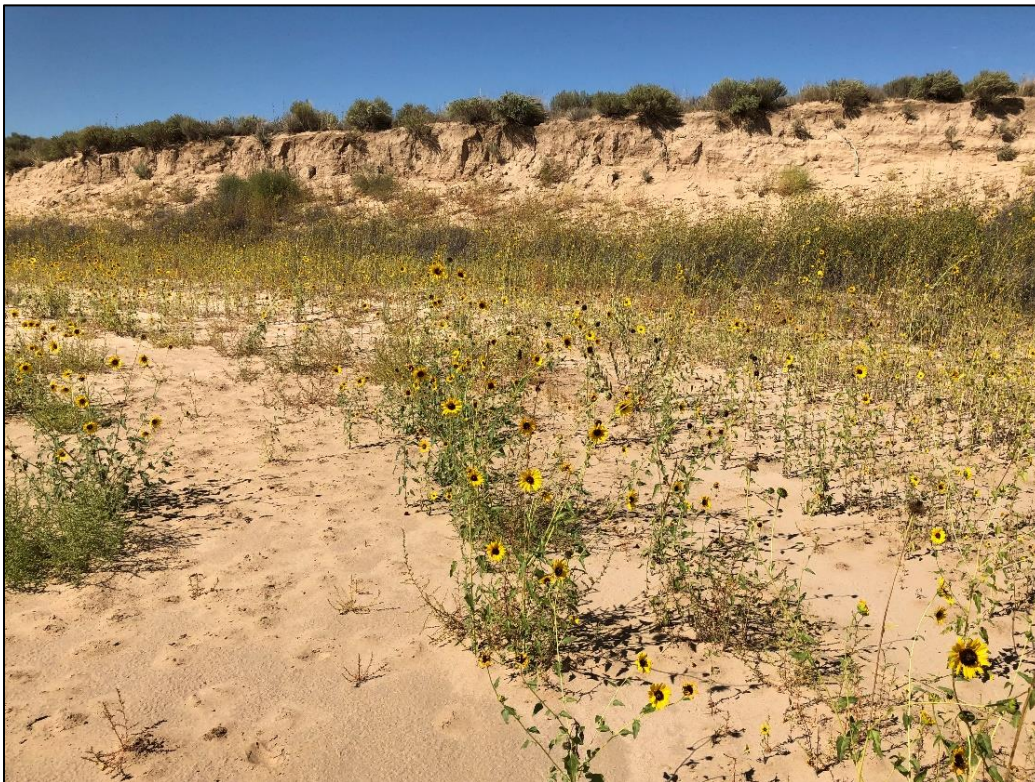
Photo 6. View looking west at western pit wall, which is approximately 6-8 feet in height with near vertical to 1H:1V slopes.

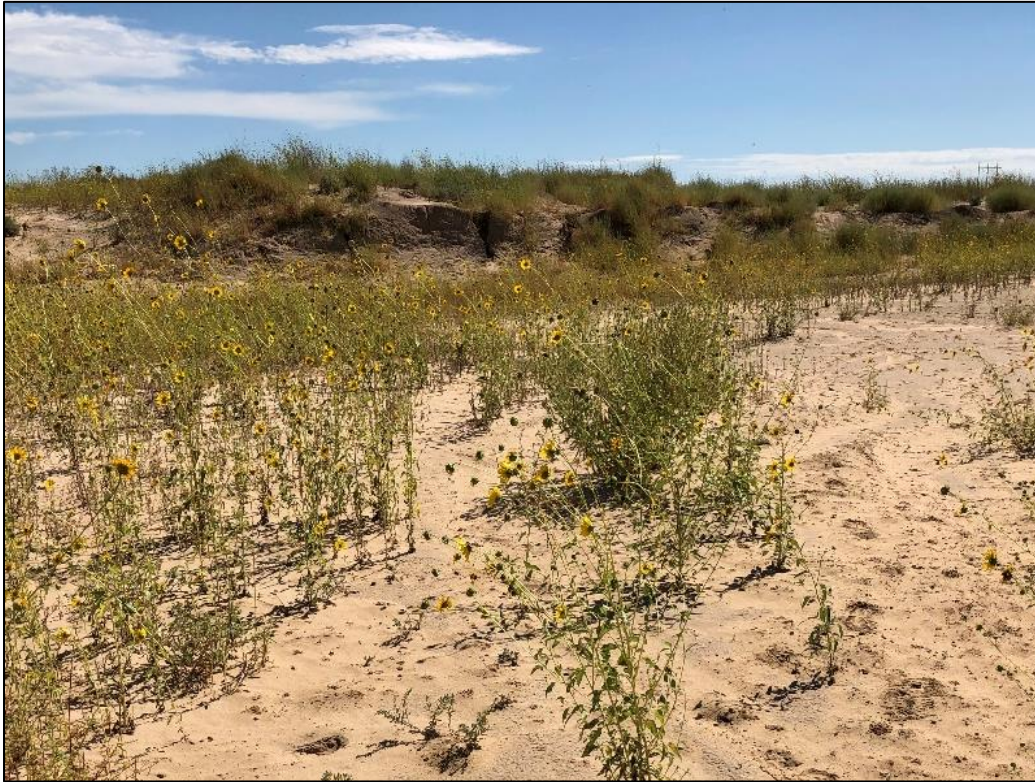
Photo 7. View looking north at northern pit wall, which is approximately 4-6 feet in height with near vertical to 1H:1V slopes.

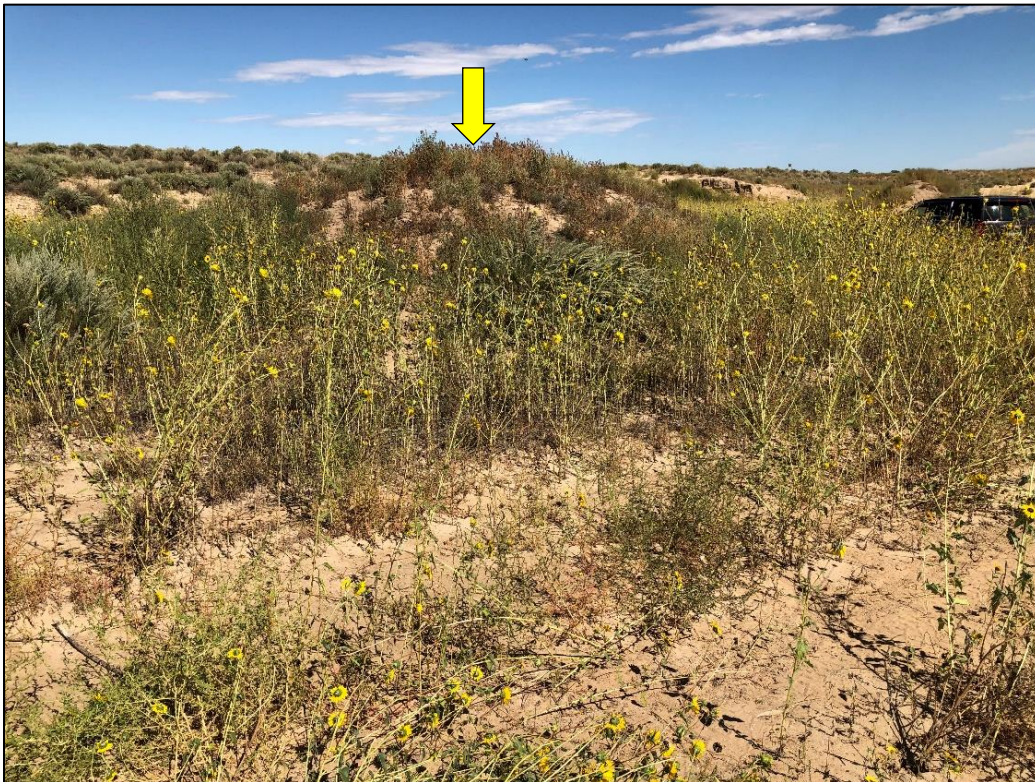
Photo 8. View looking north, showing topsoil stockpile (indicated) stored at southwestern corner of pit disturbance. Note this stockpile is stable with vegetative cover.

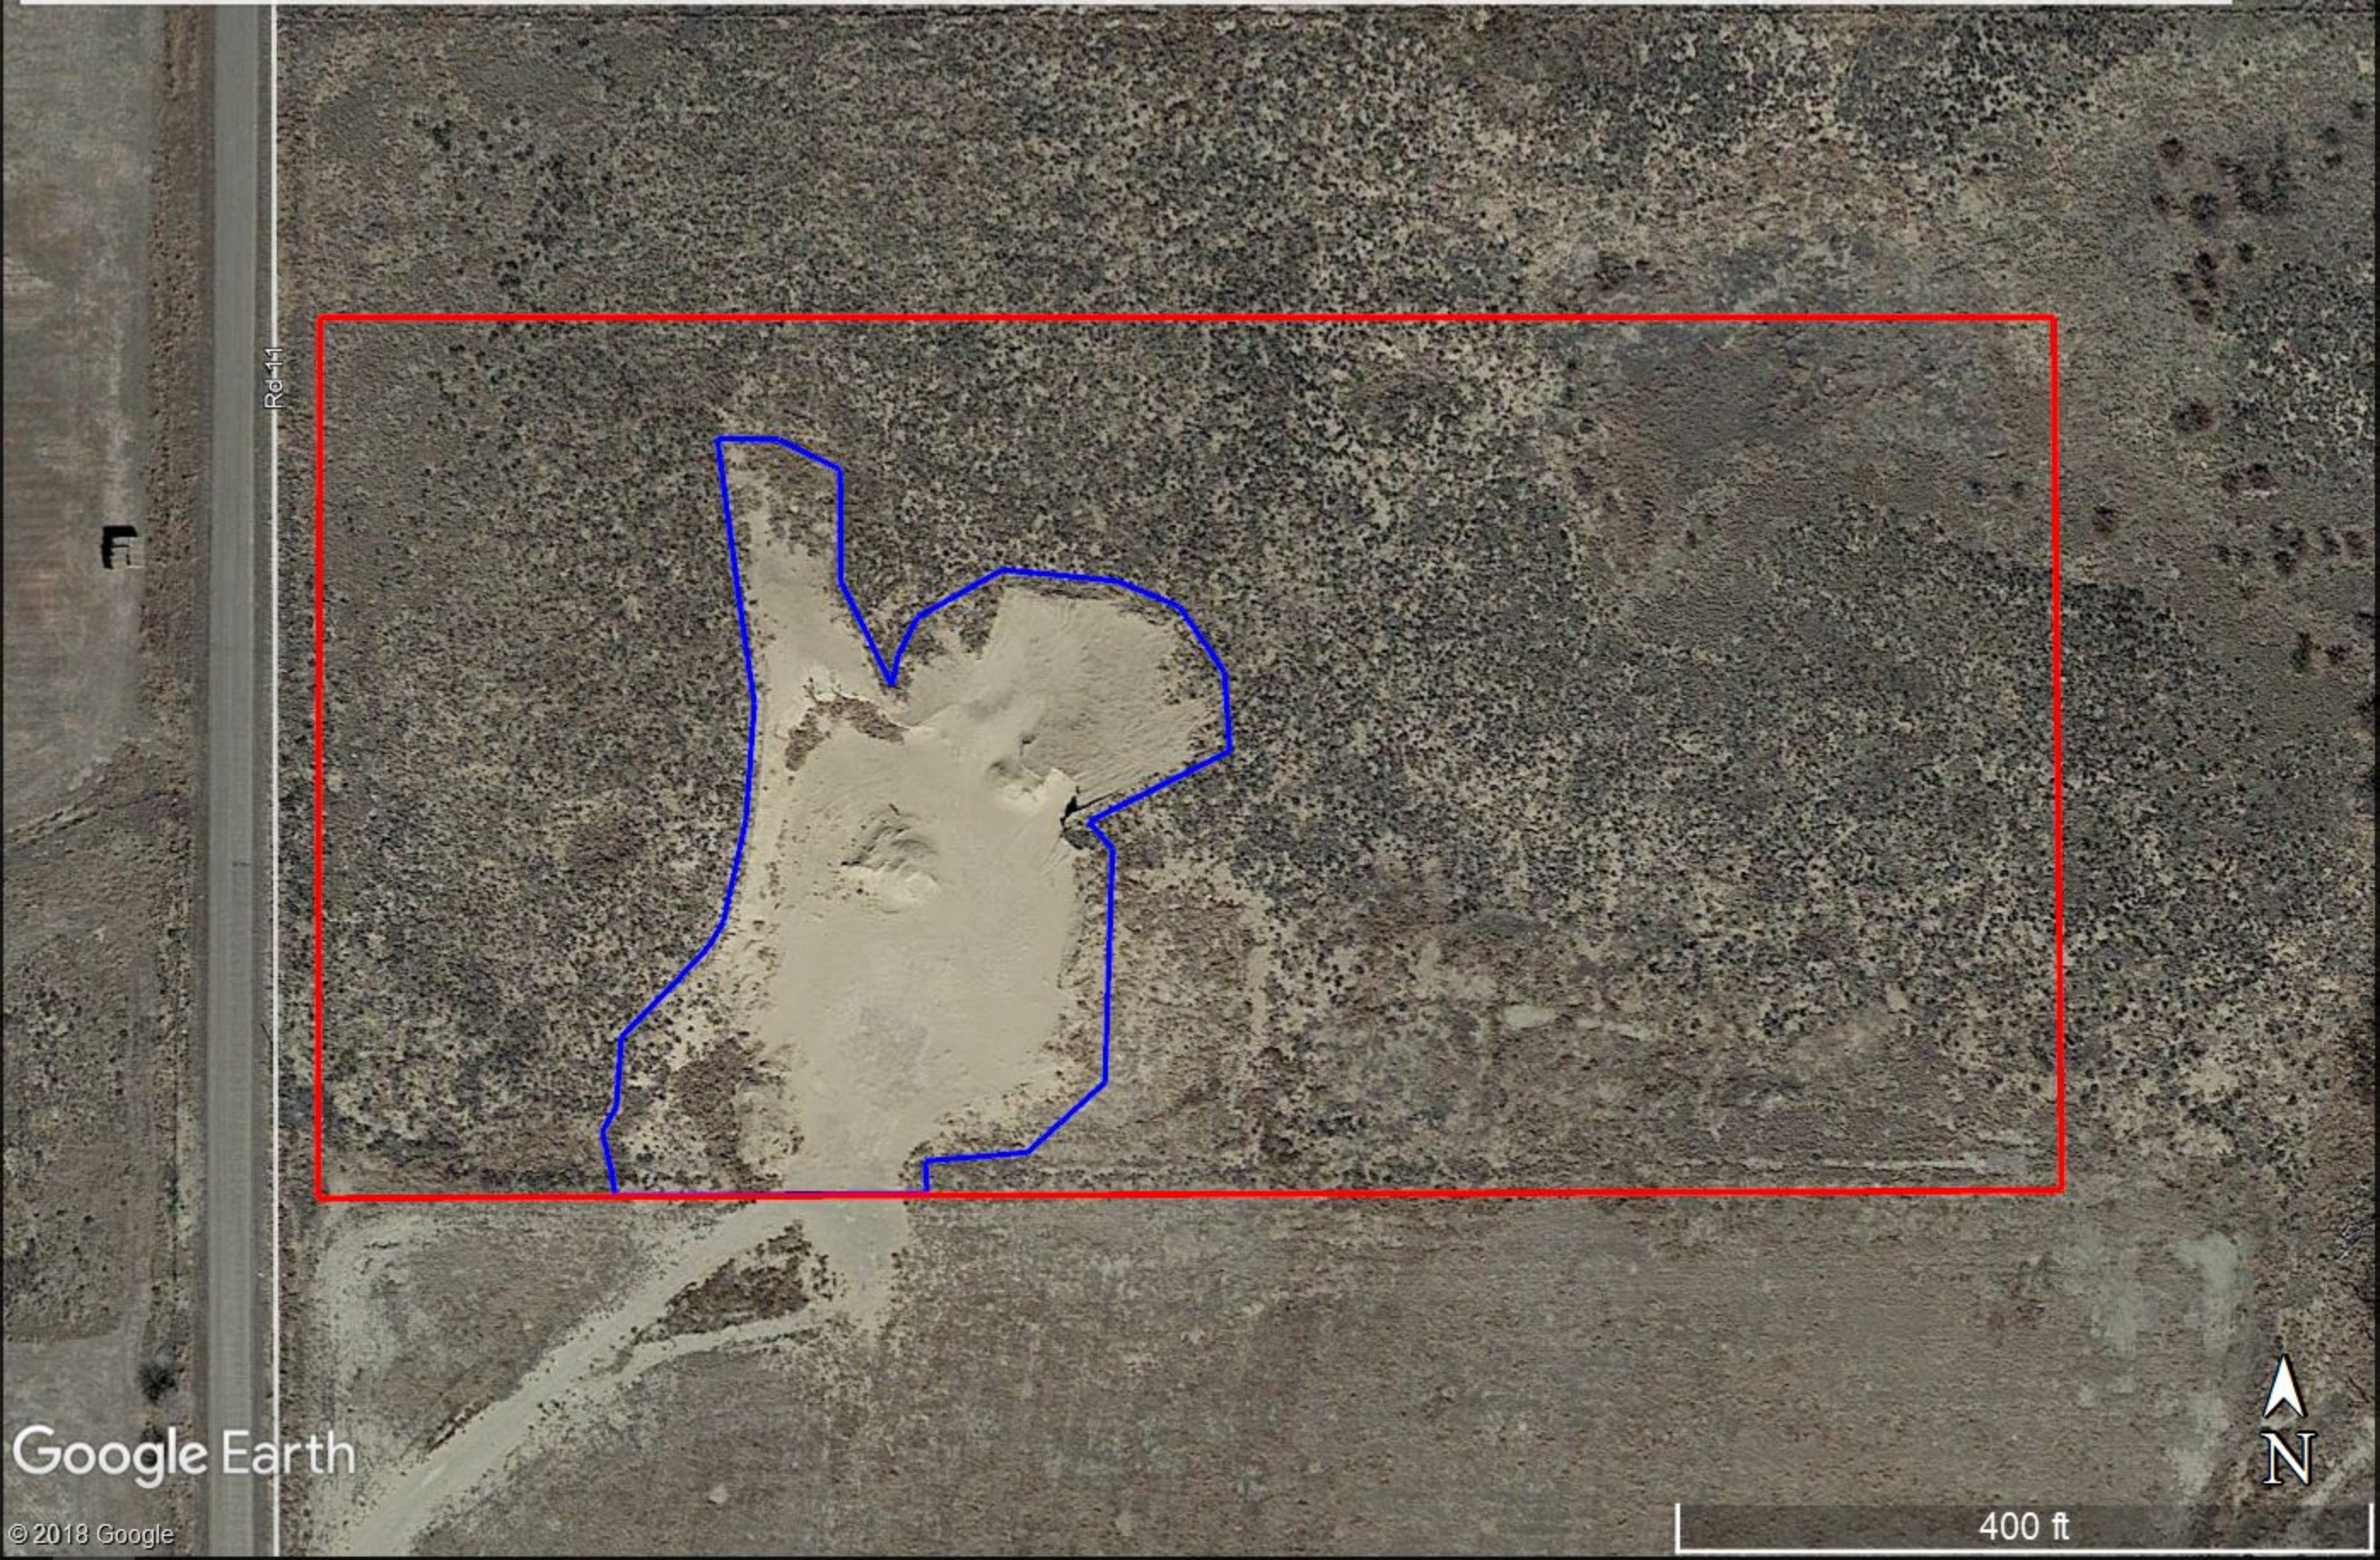
Red Outline = 11.47 acres = Approved Permit Area
Blue Outline = 2.0 acres = Approximate Disturbed Area
(Image data from 3/19/2016)
