Denver Field Branch Bond Release Evaluation Report

| Mine: | Keenesburg Mine |
| Permit No: | C-1981-028 |
| Inspection Type: | Partial Phase II bond release |

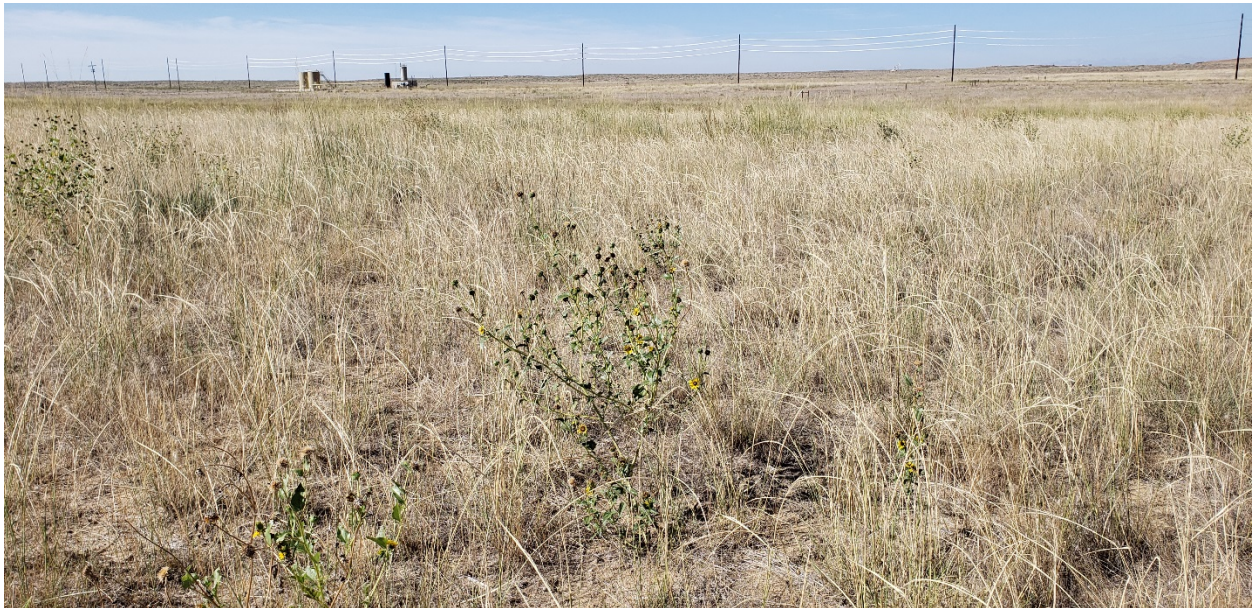
Beginning with the 12.39 acre Area 33 parcel, followed by the 5.54 acre Area 32 parcel, and finishing with the 11.89 acre Area 31 parcel, the inspection Team walked each reclamation unit to visually confirm vegetative cover and species composition data presented in the SL-10 application and physically verify topsand depths averaging two feet. Due to similar aspect, elevation, seed mix and reclamation timing, the three parcels were nearly indistinguishable in appearance. See Figures 1-3. The vegetation was dense, diverse, and chest high in some areas.

Figure 1. Overview of Area 31.

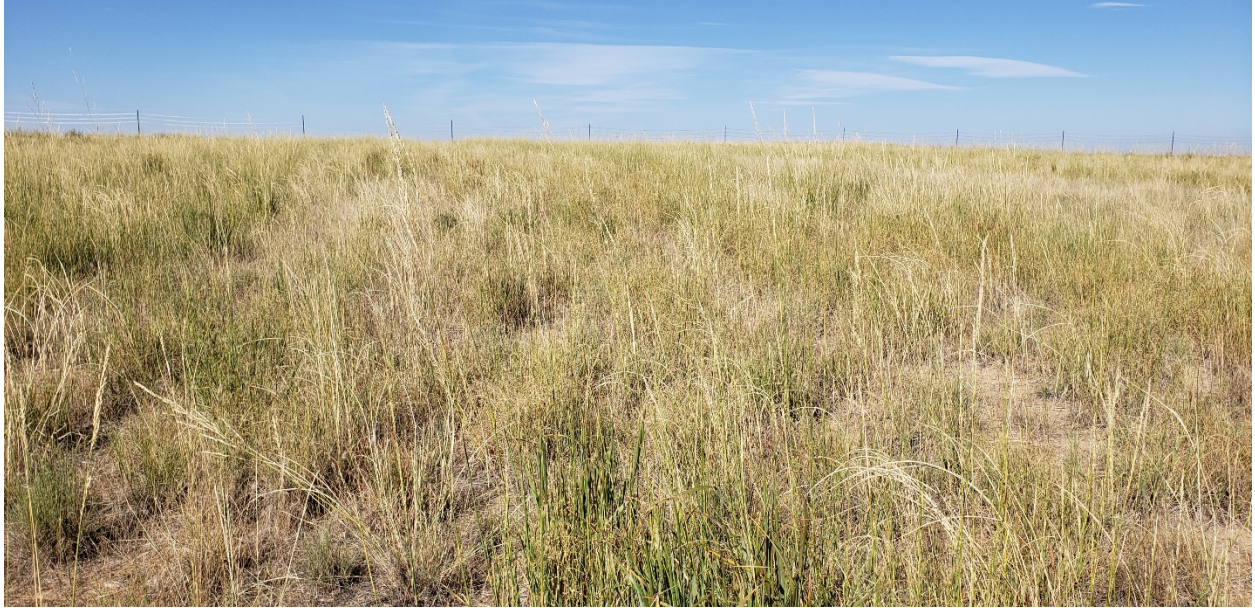
Figure 2. Overview of Area 32.

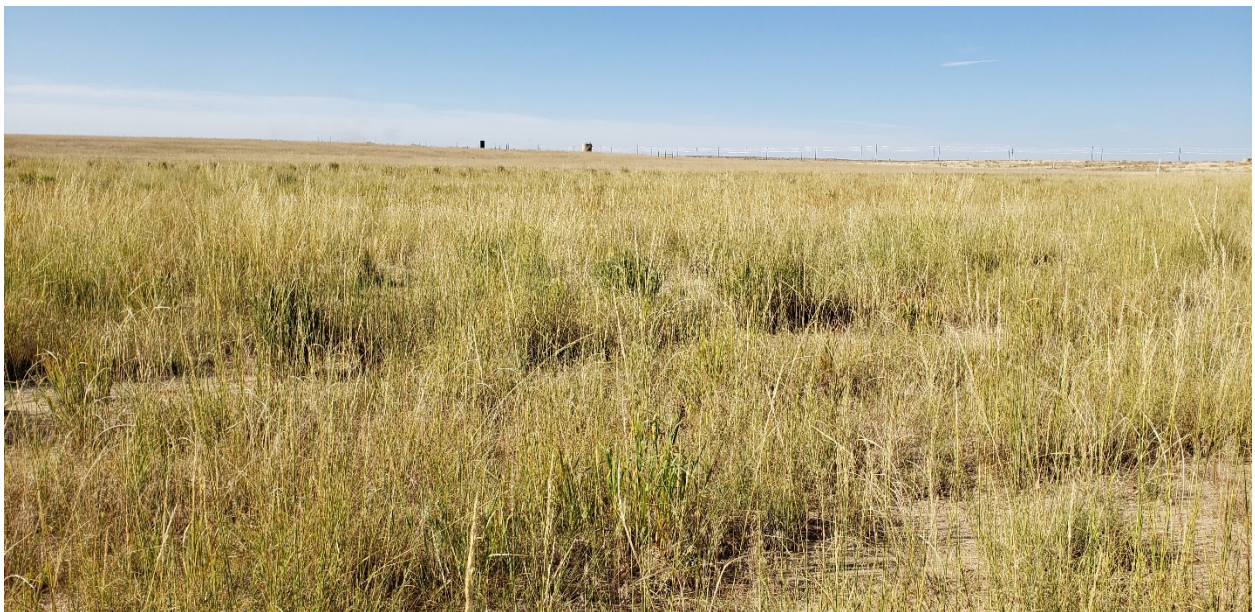
Figure 3. Overview of Area 33.

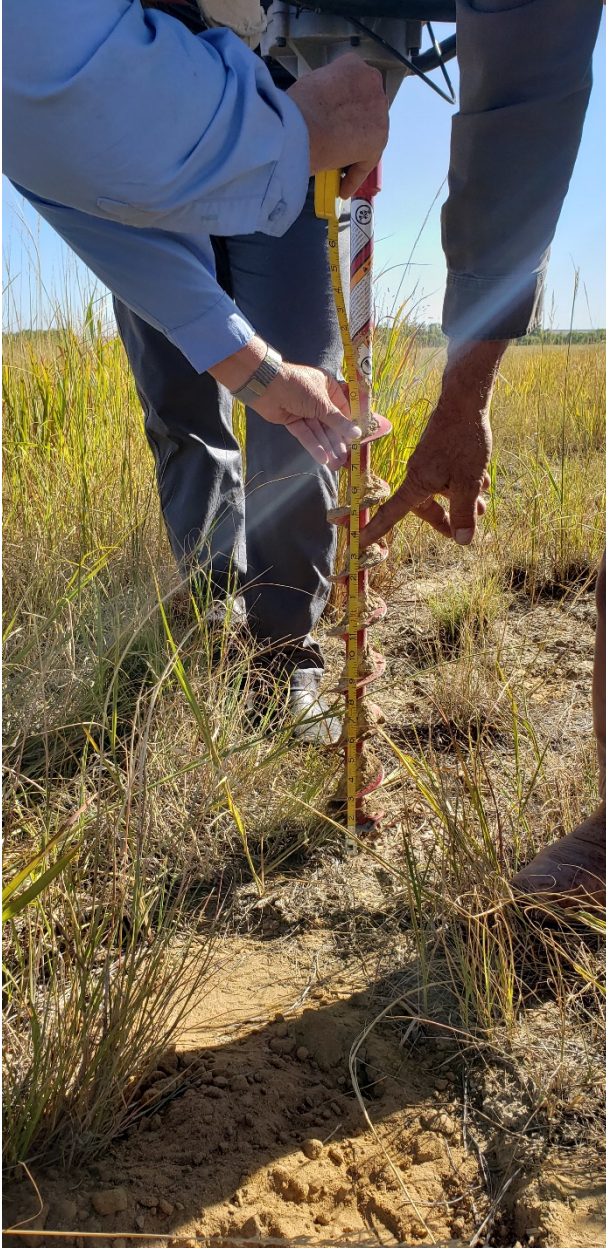
Species of note included Indian ricegrass, blue gramma, prairie sandreed, and sand dropseed, in addition to volunteer fringed sagebrush, sunflower, prickly pear cactus, and yucca. Impressively, cheatgrass was nearly absent from each parcel. No evidence of erosion or sedimentation was observed. Randomly selected topsand verification holes measured 1 foot 7 inches at Area 33, 2+ feet at Area 32, and 2+ feet at Area 31. See Figure 4.

Figure 4. Topsand depth verification.
