**MINERALS PROGRAM INSPECTION REPORT**  
**PHONE: (303) 866-3567**

<b>MINE NAME:</b> Jenkins Site	<b>MINE/PROSPECTING ID#:</b> M-1977-393	<b>MINERAL:</b> Sand and gravel	<b>COUNTY:</b> Boulder
<b>INSPECTION TYPE:</b> Monitoring	<b>INSPECTOR(S):</b> Amy Eschberger	<b>INSP. DATE:</b> November 5, 2019	<b>INSP. TIME:</b> 08:30
<b>OPERATOR:</b> City of Boulder	<b>OPERATOR REPRESENTATIVE:</b> Chris Lawlor and Matt Ashley	<b>TYPE OF OPERATION:</b> 112c - Construction Regular Operation	
<b>REASON FOR INSPECTION:</b> Normal I&E Program	<b>BOND CALCULATION TYPE:</b> None	<b>BOND AMOUNT:</b> \$0.00	
<b>DATE OF COMPLAINT:</b> NA	<b>POST INSP. CONTACTS:</b> None	<b>JOINT INSP. AGENCY:</b> None	
<b>WEATHER:</b> Clear	<b>INSPECTOR'S SIGNATURE:</b>

# M-1977-393 / Jenkins Site / City of Boulder (112c Permit)

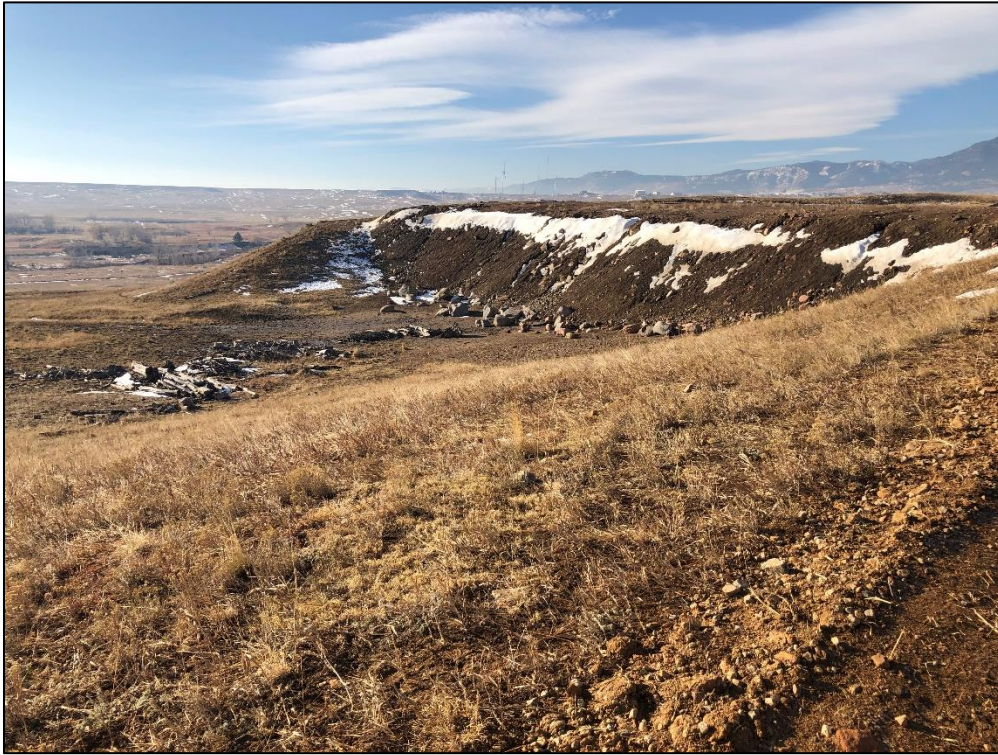
**Photo 1.** View looking southwest from access road across eastern portion of pit located in north mining area, which the operator is backfilling. Note eastern side of lower lift shown at right.

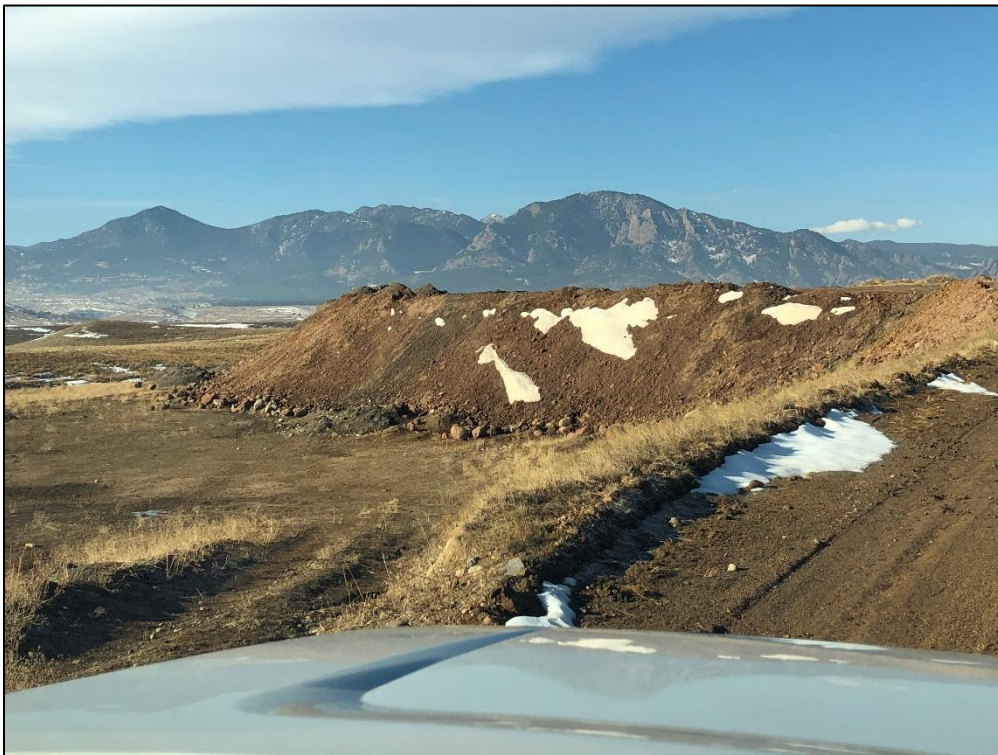
**Photo 2.** View looking southwest from access road across top of backfilled portion of pit in north mining area, showing eastern side of upper lift.

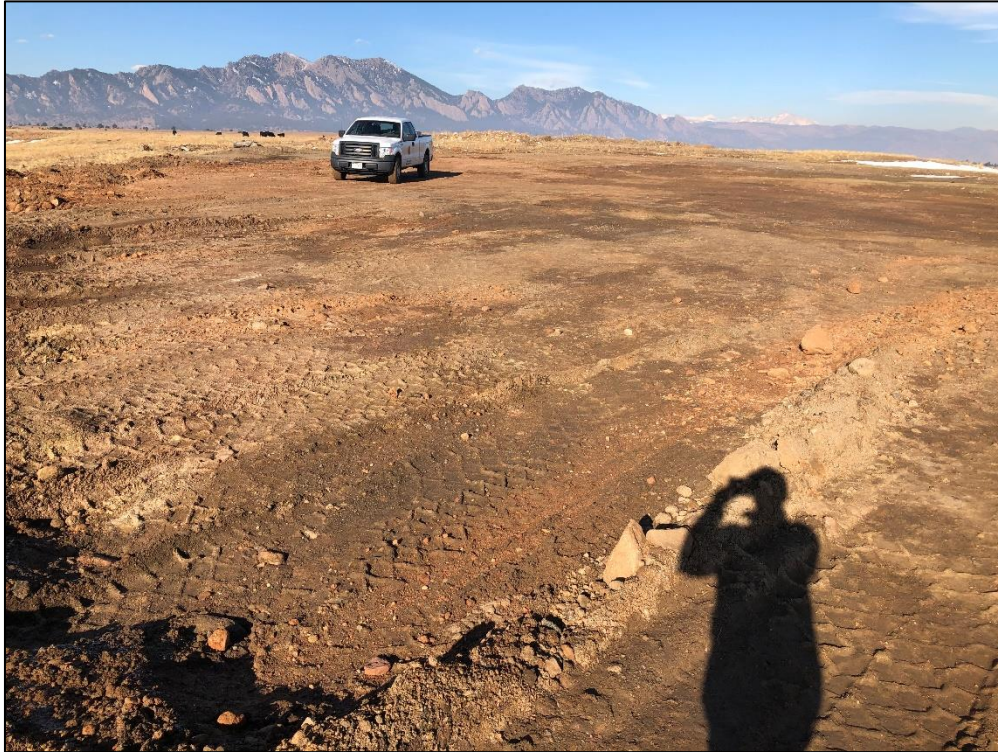
**Photo 3.** View looking west across top of backfilled portion of pit (upper lift) in north mining area.

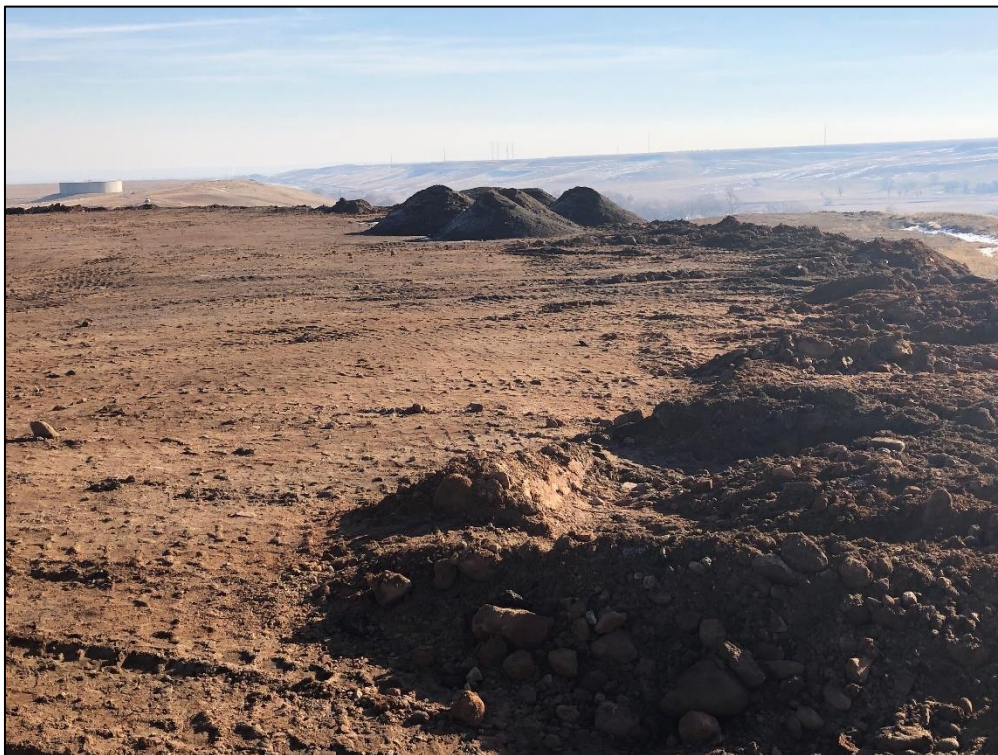
**Photo 4.** View looking east across top of backfilled portion of pit (upper lift) in north mining area. Note small stockpiles of imported material stored on top of lift.

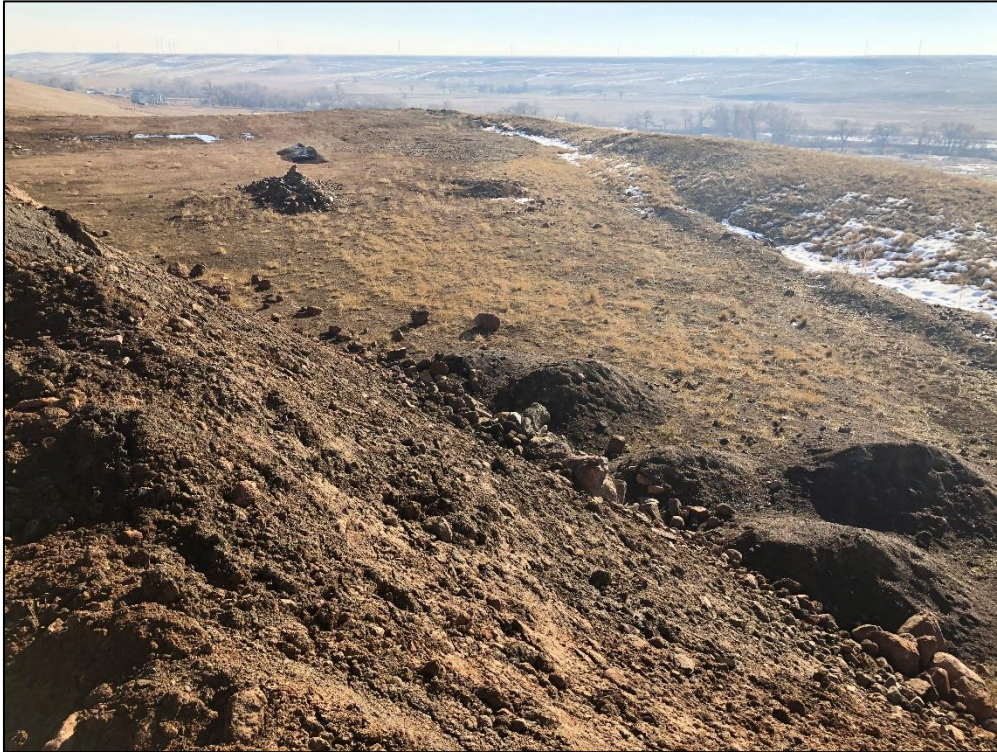
The Division observed the pit located at the top of the mesa in the north mining area, which the operator is continuing to backfill from west to east, in two primary lifts. The lower lift is approximately 25 feet in height with slope gradients of 1.5H:1V to 2H:1V. The upper lift is approximately 15 feet in height with slopes gradients of 1H:1V to 1.5H:1V. The eastern edge of the upper lift is currently approximately 450 feet from the eastern edge of the lower lift. According to the operator, active dumping occurs on site almost daily during the annual 3-month active period. A few small stockpiles of imported material were stored on top of the upper lift. Besides the active backfilling portion of the pit, all other disturbed lands in the north mining area have been reclaimed with slopes graded to 3H:1V or flatter and a good vegetative cover consisting of grasses and some shrubs. The reclaimed areas appeared to be stable with no erosion issues observed. The Division estimates approximately 8 acres of disturbance requiring reclamation exists in the north mining area.

**Photo 5.** View looking east across top of lower lift of backfilled pit in north mining area. Note side slope of upper lift (in foreground) at an approximate 1.5H:1V gradient.

Since the approved reclamation plan for the site does not require the operator to completely backfill the pit, but to grade all disturbed slopes to 3H:1V or flatter, the Division believes the operator could expedite reclamation of the site by discontinuing the backfilling activities and working to grade all disturbed slopes to the approved final configuration. Currently, this would consist of grading the southern and eastern slopes of the upper lift and the eastern slope of the lower lift to 3H:1V or flatter. This could potentially be done via the cut and fill method, which would not require additional material to be imported to the site. The Division strongly encourages the operator to utilize the next construction period (August 1<sup>st</sup> - October 31<sup>st</sup> of 2020) to complete all reclamation earthwork and seeding (if possible), and to request a site inspection toward the end of this period so the Division can assess any reclamation work completed.

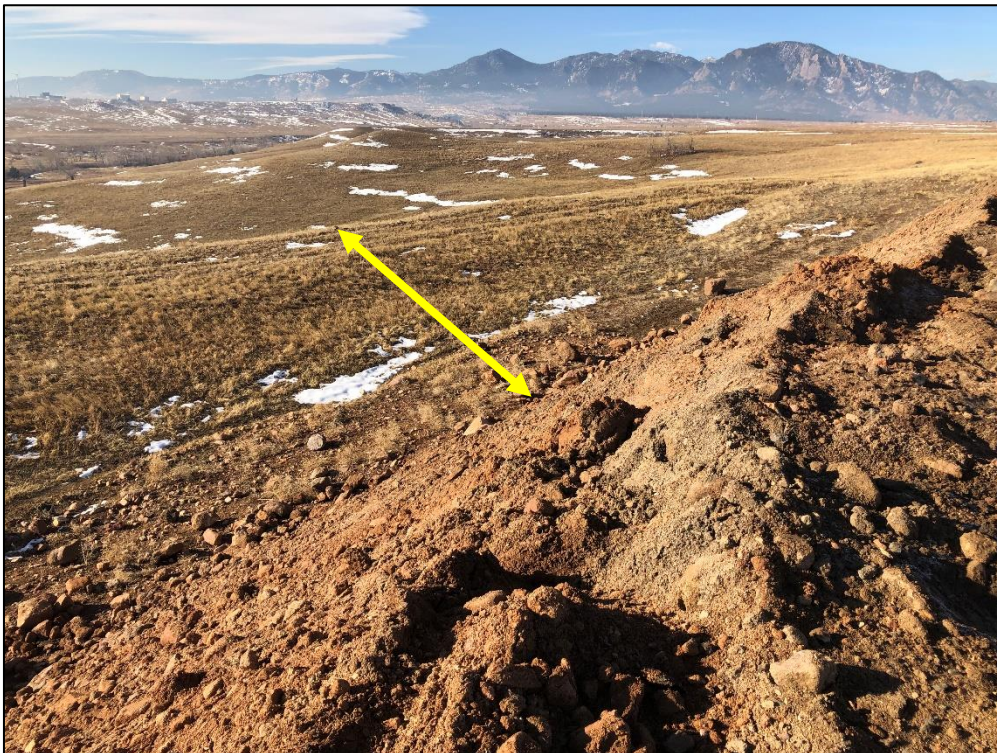
**Photo 6.** View looking west from top of upper lift of backfilled pit in north mining area, showing southern section of pit (indicated) which operator intends to continue backfilling, although not required by the approved reclamation plan.

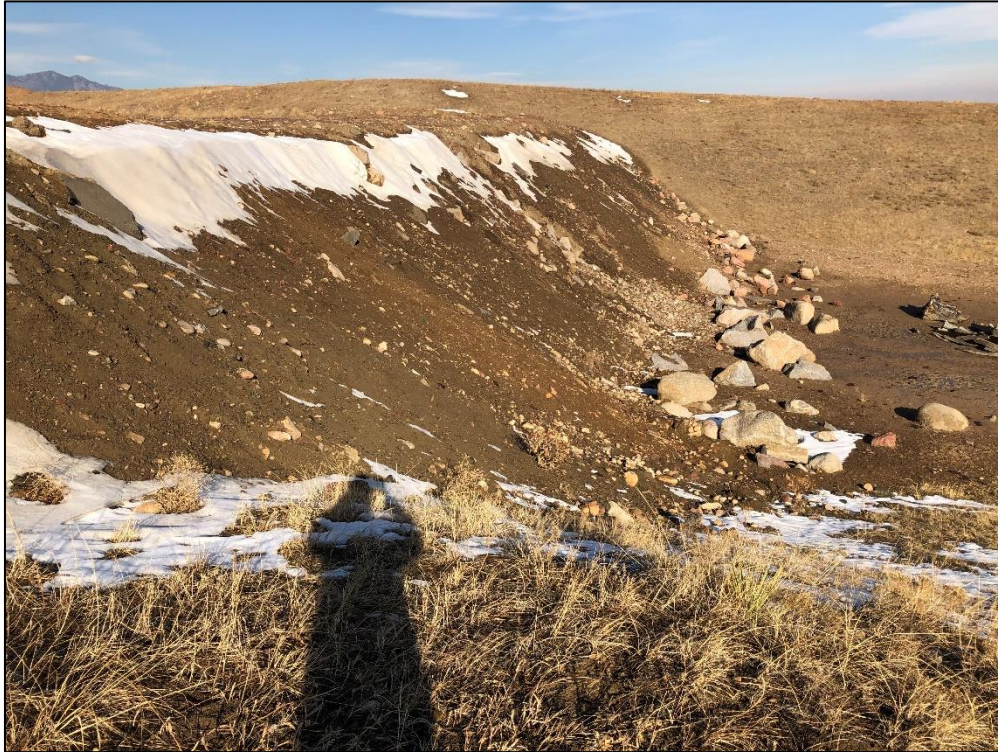
**Photo 7.** View looking north across eastern side slope of lower lift at approximate 1.5H:1V to 2H:1V gradient.

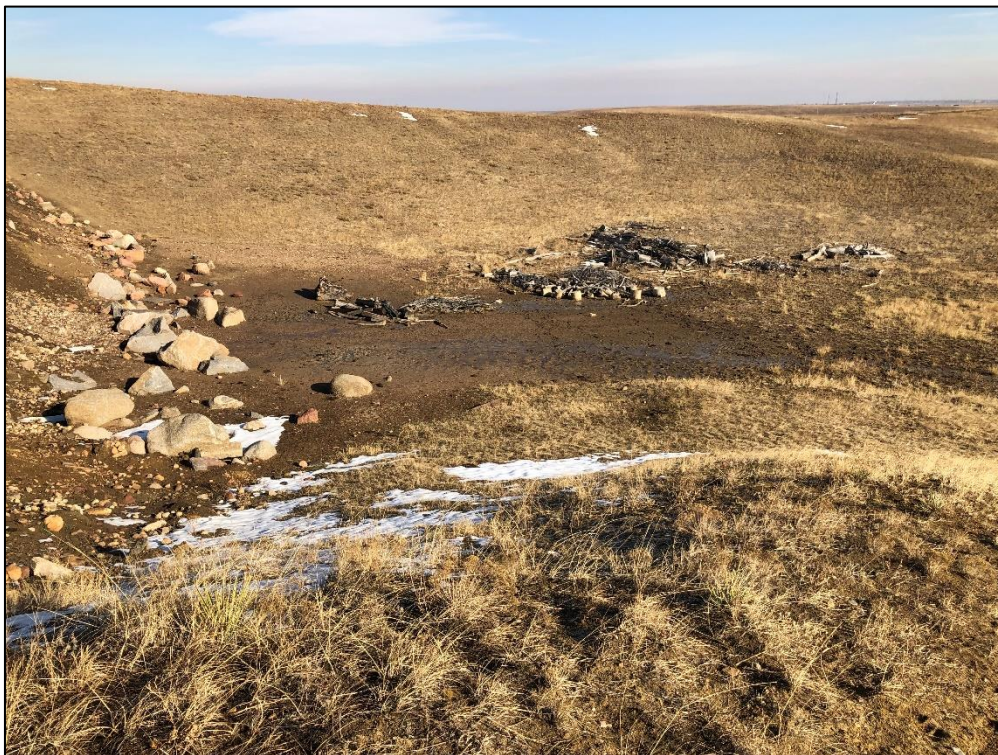
**Photo 8.** View looking northeast across eastern portion of pit in north mining area which operator intends to continue backfilling, although not required by the approved reclamation plan.

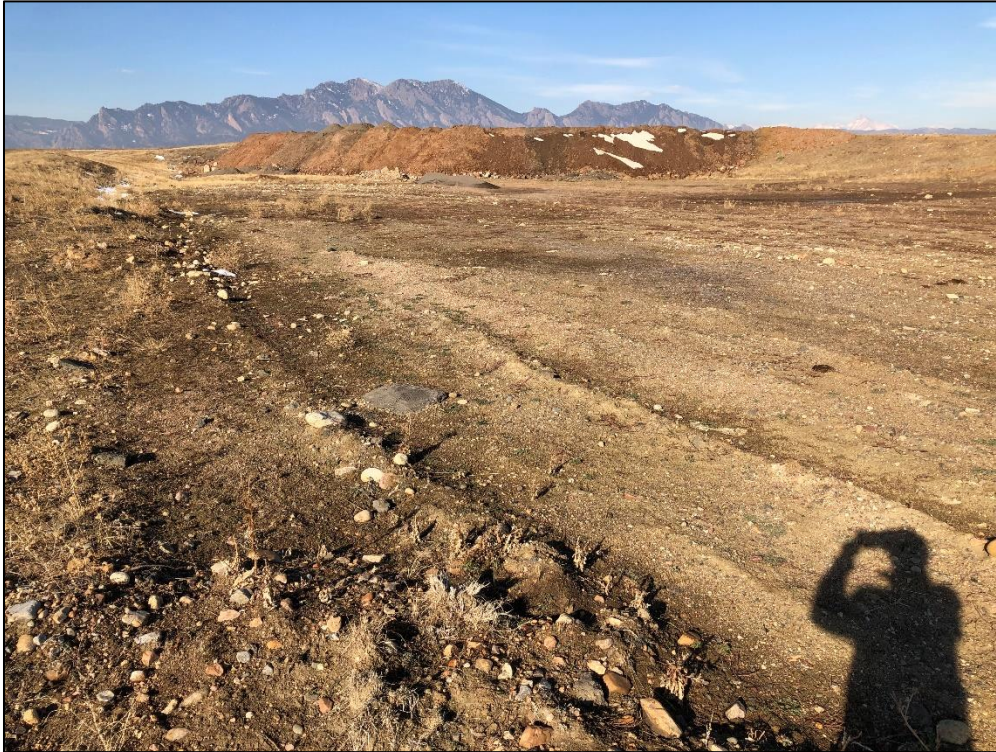
**Photo 9.** View looking west across top of backfilled portion of pit (lower lift) in north mining area. Note upper lift in far background.

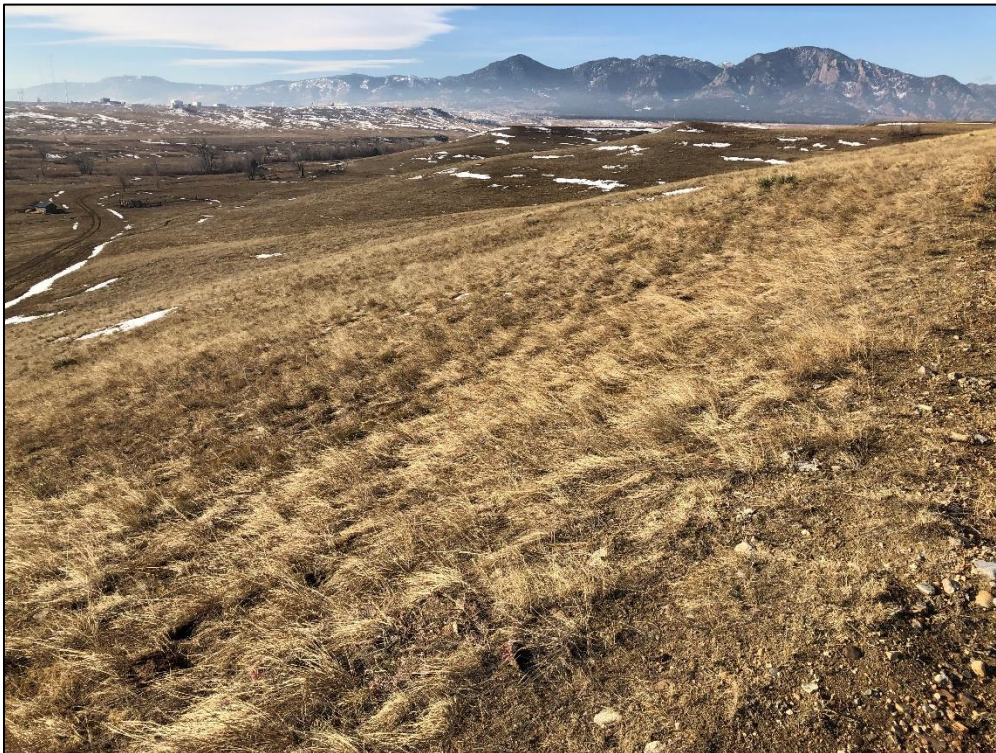
**Photo 10.** View looking southwest across reclaimed southern slope of backfilled pit in north mining area.

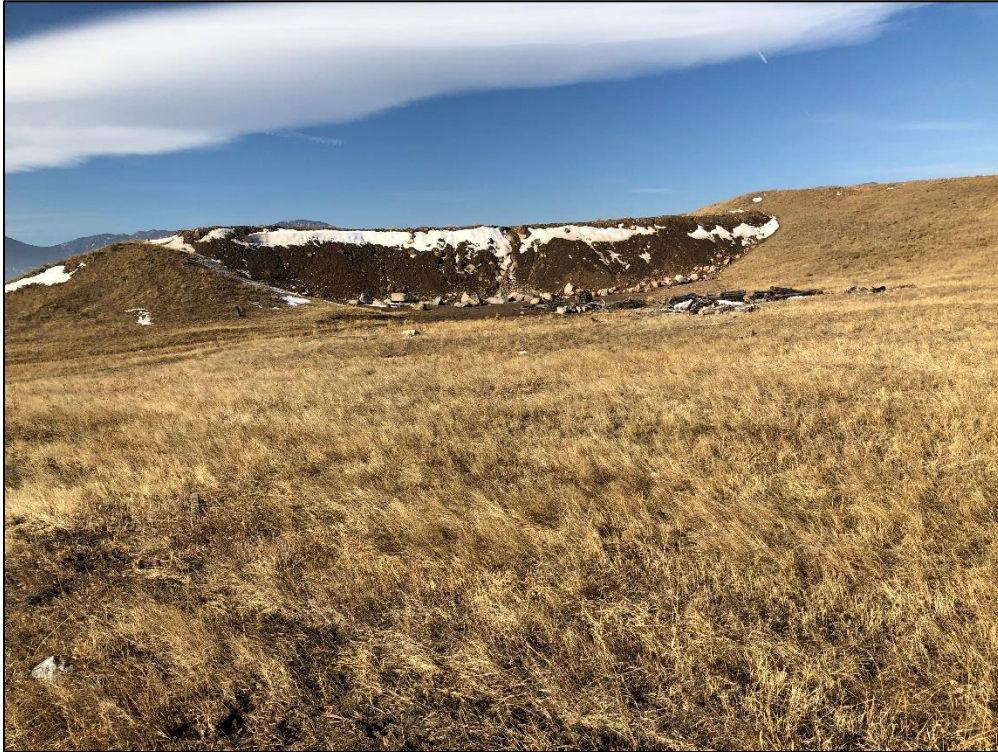
**Photo 11.** View looking west across reclaimed eastern portion of disturbance in north mining area. Note backfilled portion of pit in background (lower left).

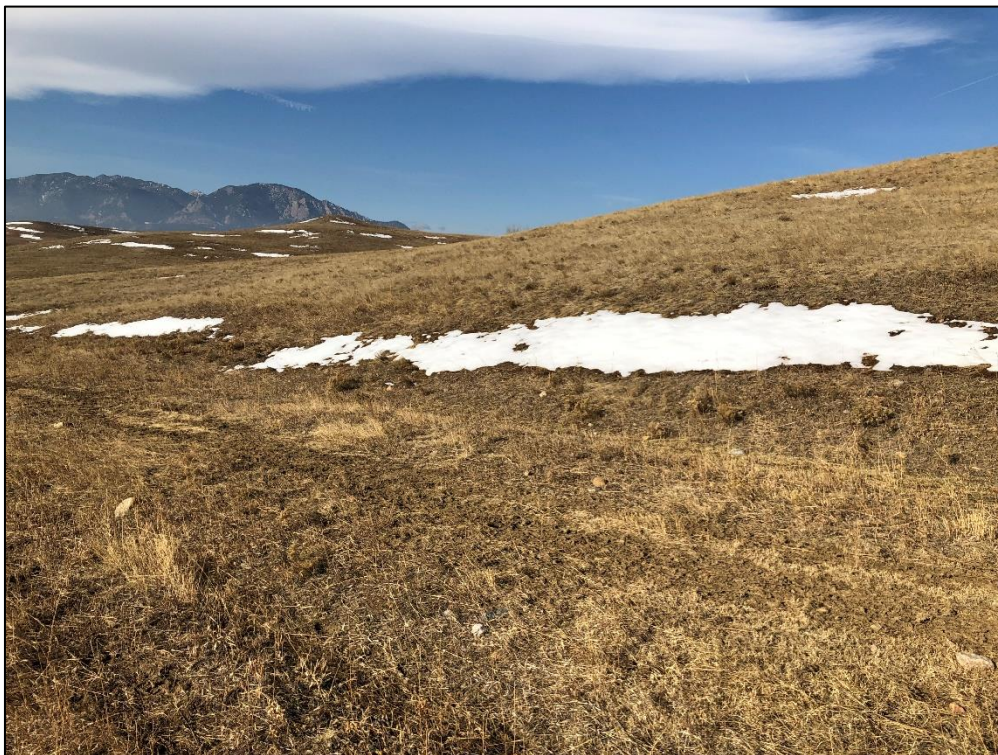
**Photo 12.** View looking west across reclaimed southern portion of disturbance in north mining area.

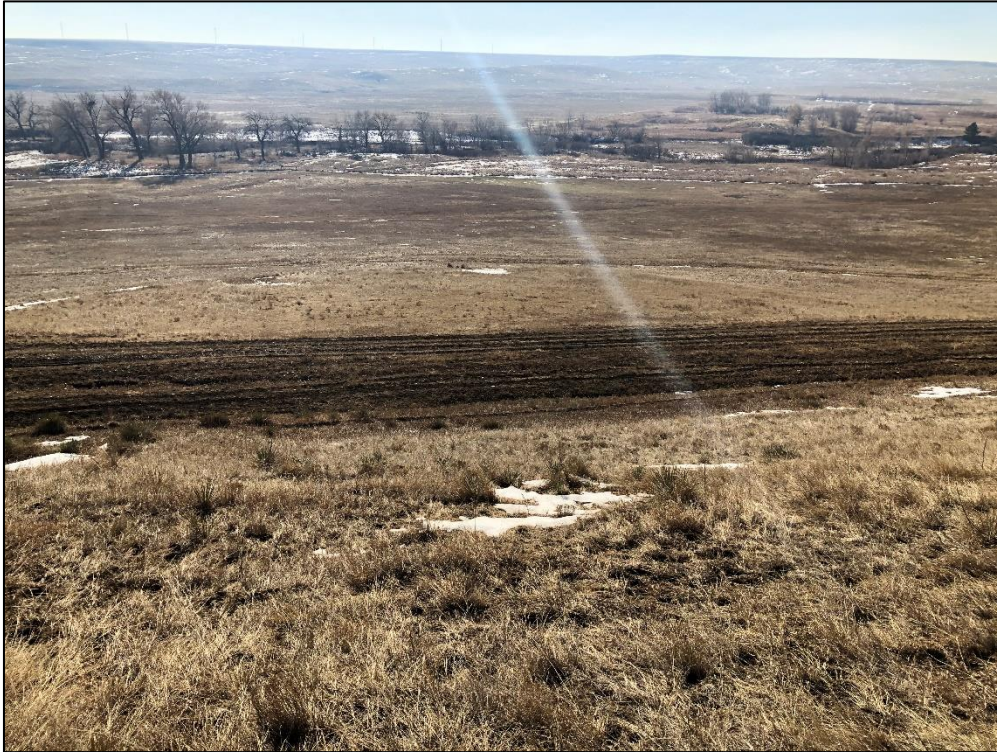
**Photo 13.** View looking south across permit area from top of backfilled portion of pit in north mining area. Note trees in background lining edges of Coal Creek, which separates north mining area from south mining area (reclaimed).

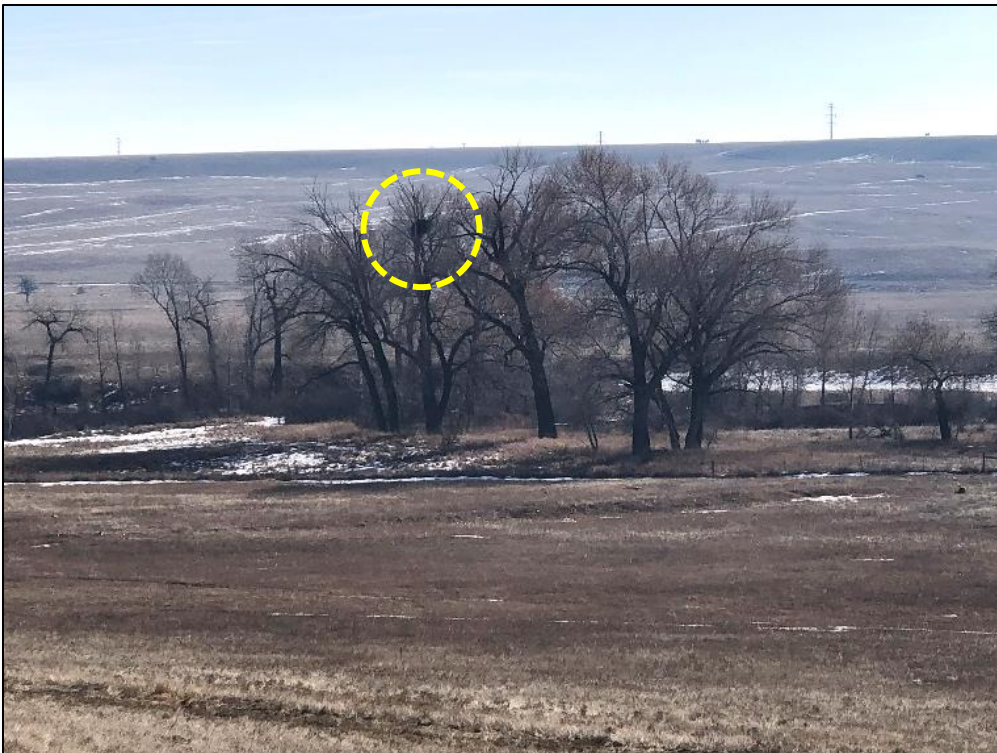
**Photo 14.** View looking south at tree with eagle's nest (circled), located along north edge of Coal Creek. The nest was not occupied during the inspection.

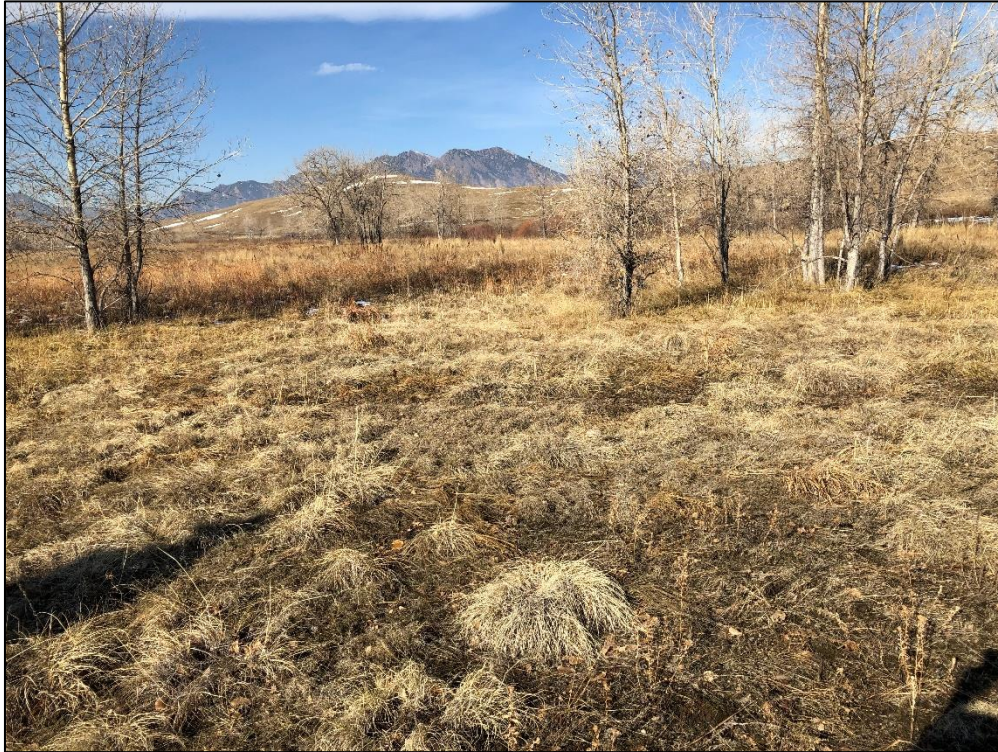
**Photo 15.** View looking northwest across northern portion of reclaimed south mining area. Note all slopes graded 3H:1V or flatter and established vegetation consisting of grasses and some trees.

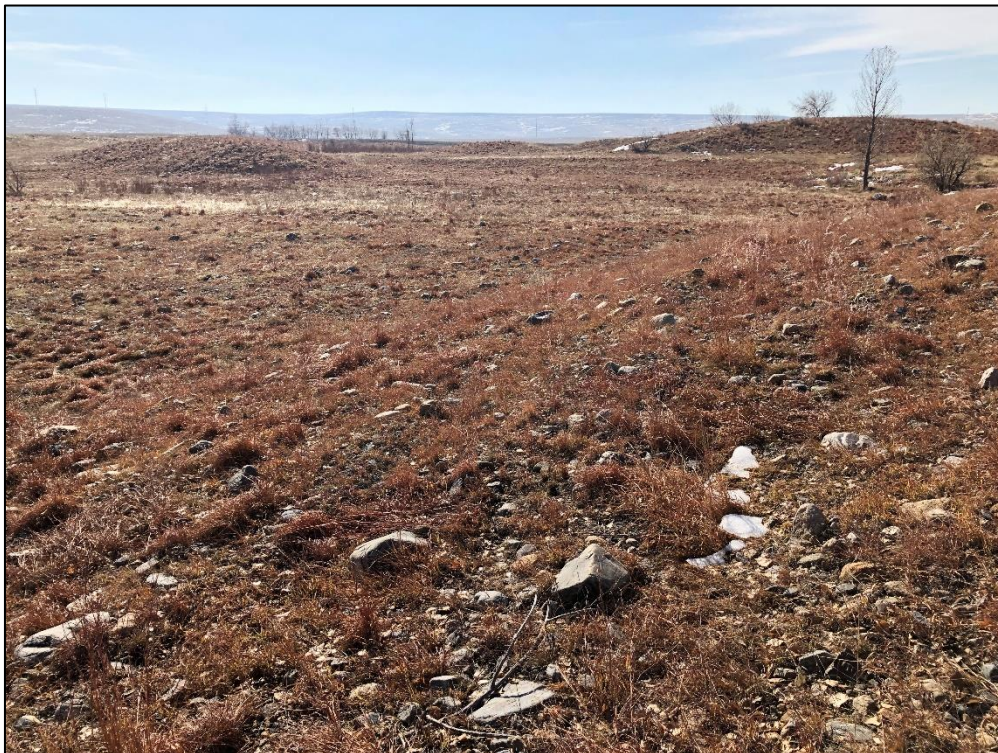
**Photo 16.** View looking southwest across reclaimed south mining area. Note all slopes graded 3H:1V or flatter and established vegetation consisting of grasses and some trees.

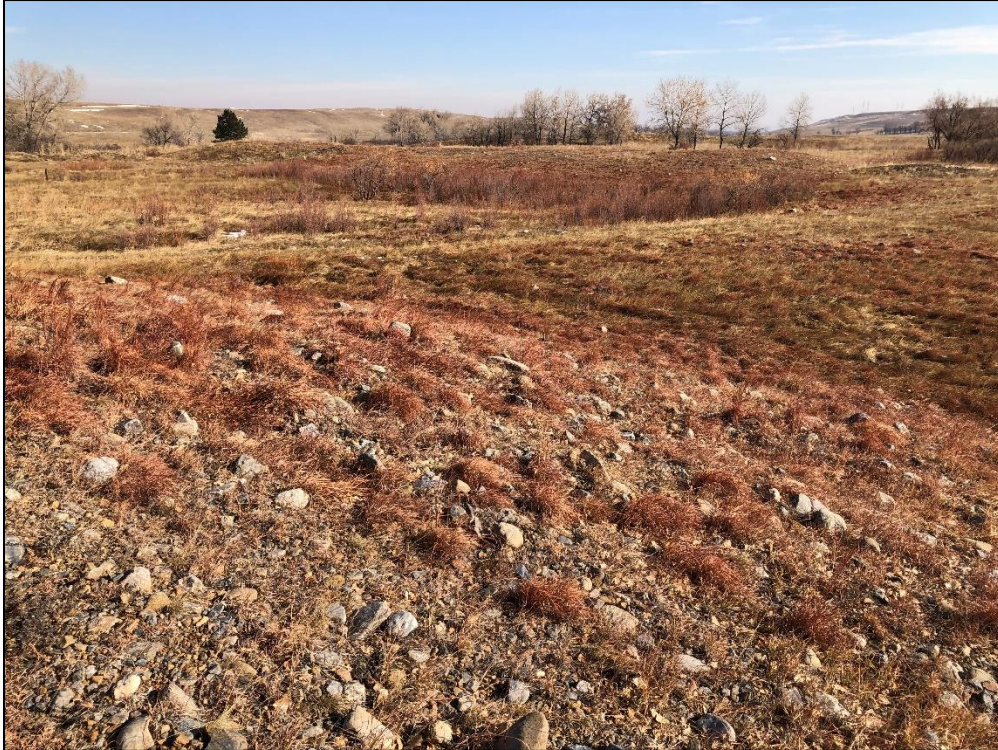
**Photo 17.** View looking southeast across reclaimed south mining area. Note all slopes graded 3H:1V or flatter and established vegetation consisting of grasses and some trees.

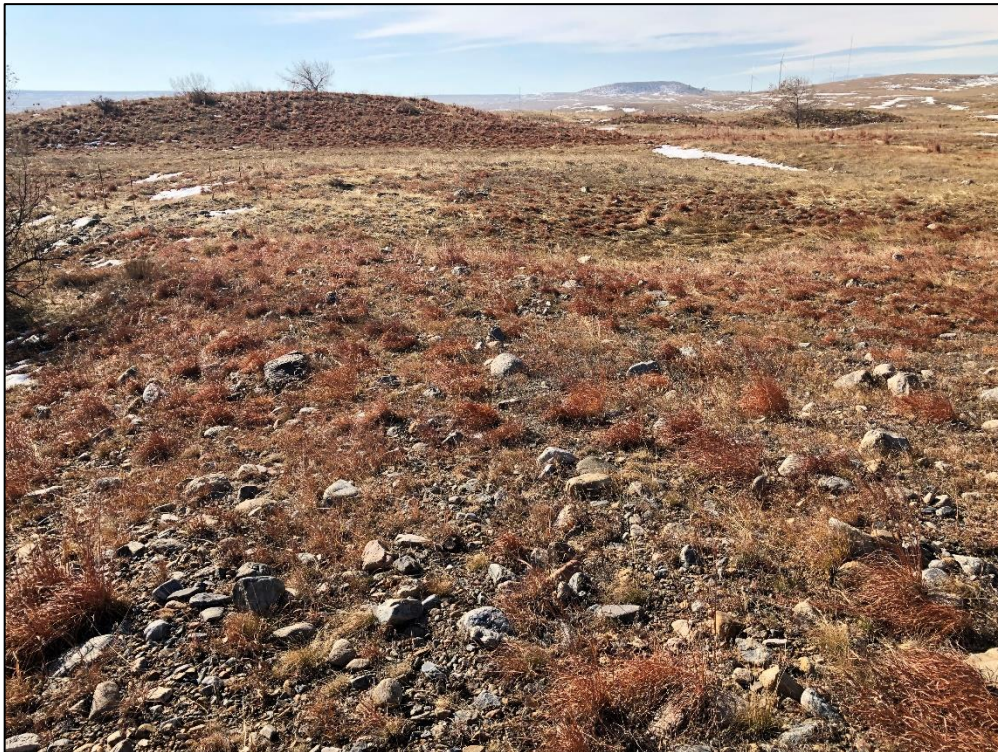
**Photo 18.** View looking west across reclaimed south mining area. Note all slopes graded 3H:1V or flatter and established vegetation consisting of grasses and some trees.

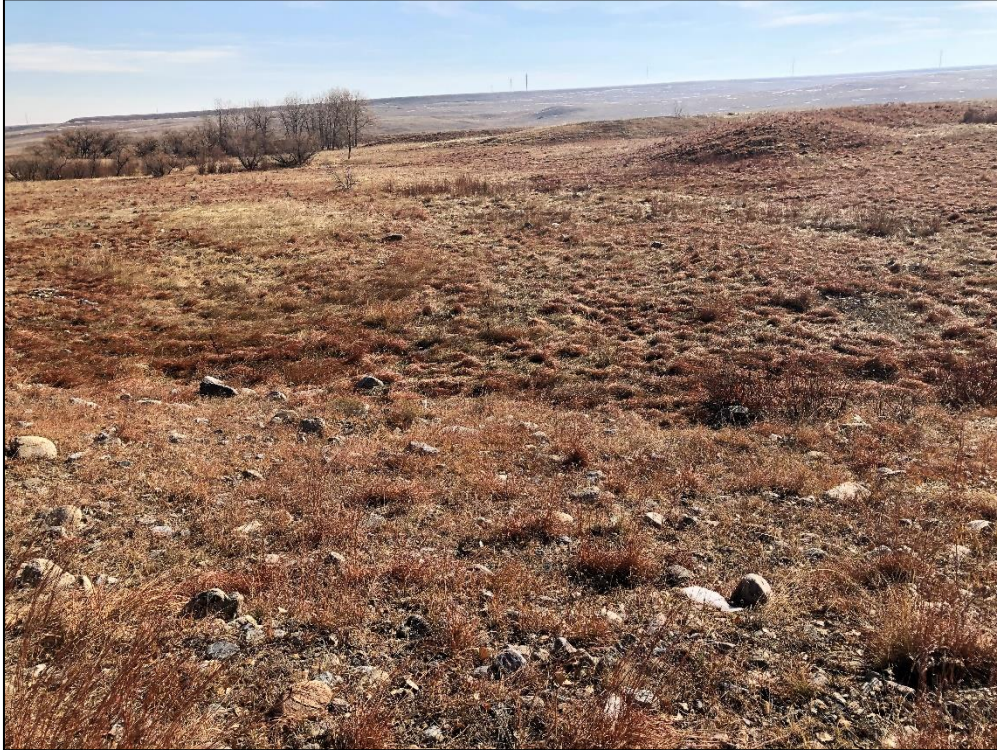
**Photo 19.** View looking south across reclaimed south mining area. Note all slopes graded 3H:1V or flatter and established vegetation consisting of grasses and some trees.

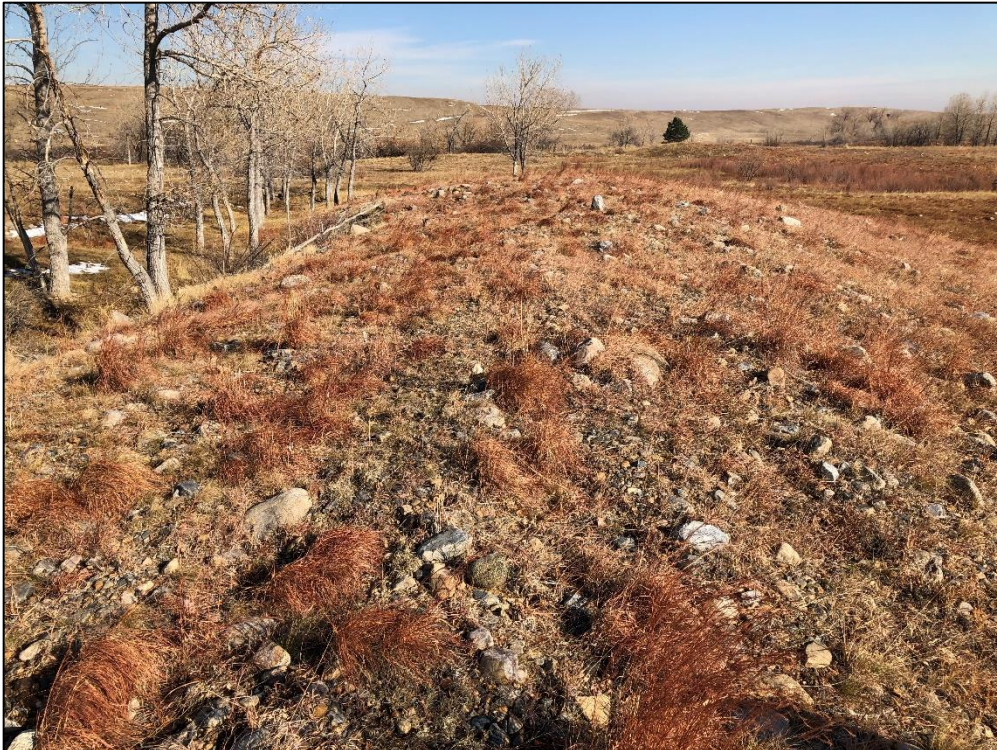
**Photo 20.** View looking east across reclaimed south mining area. Note all slopes graded 3H:1V or flatter and established vegetation consisting of grasses and some trees.

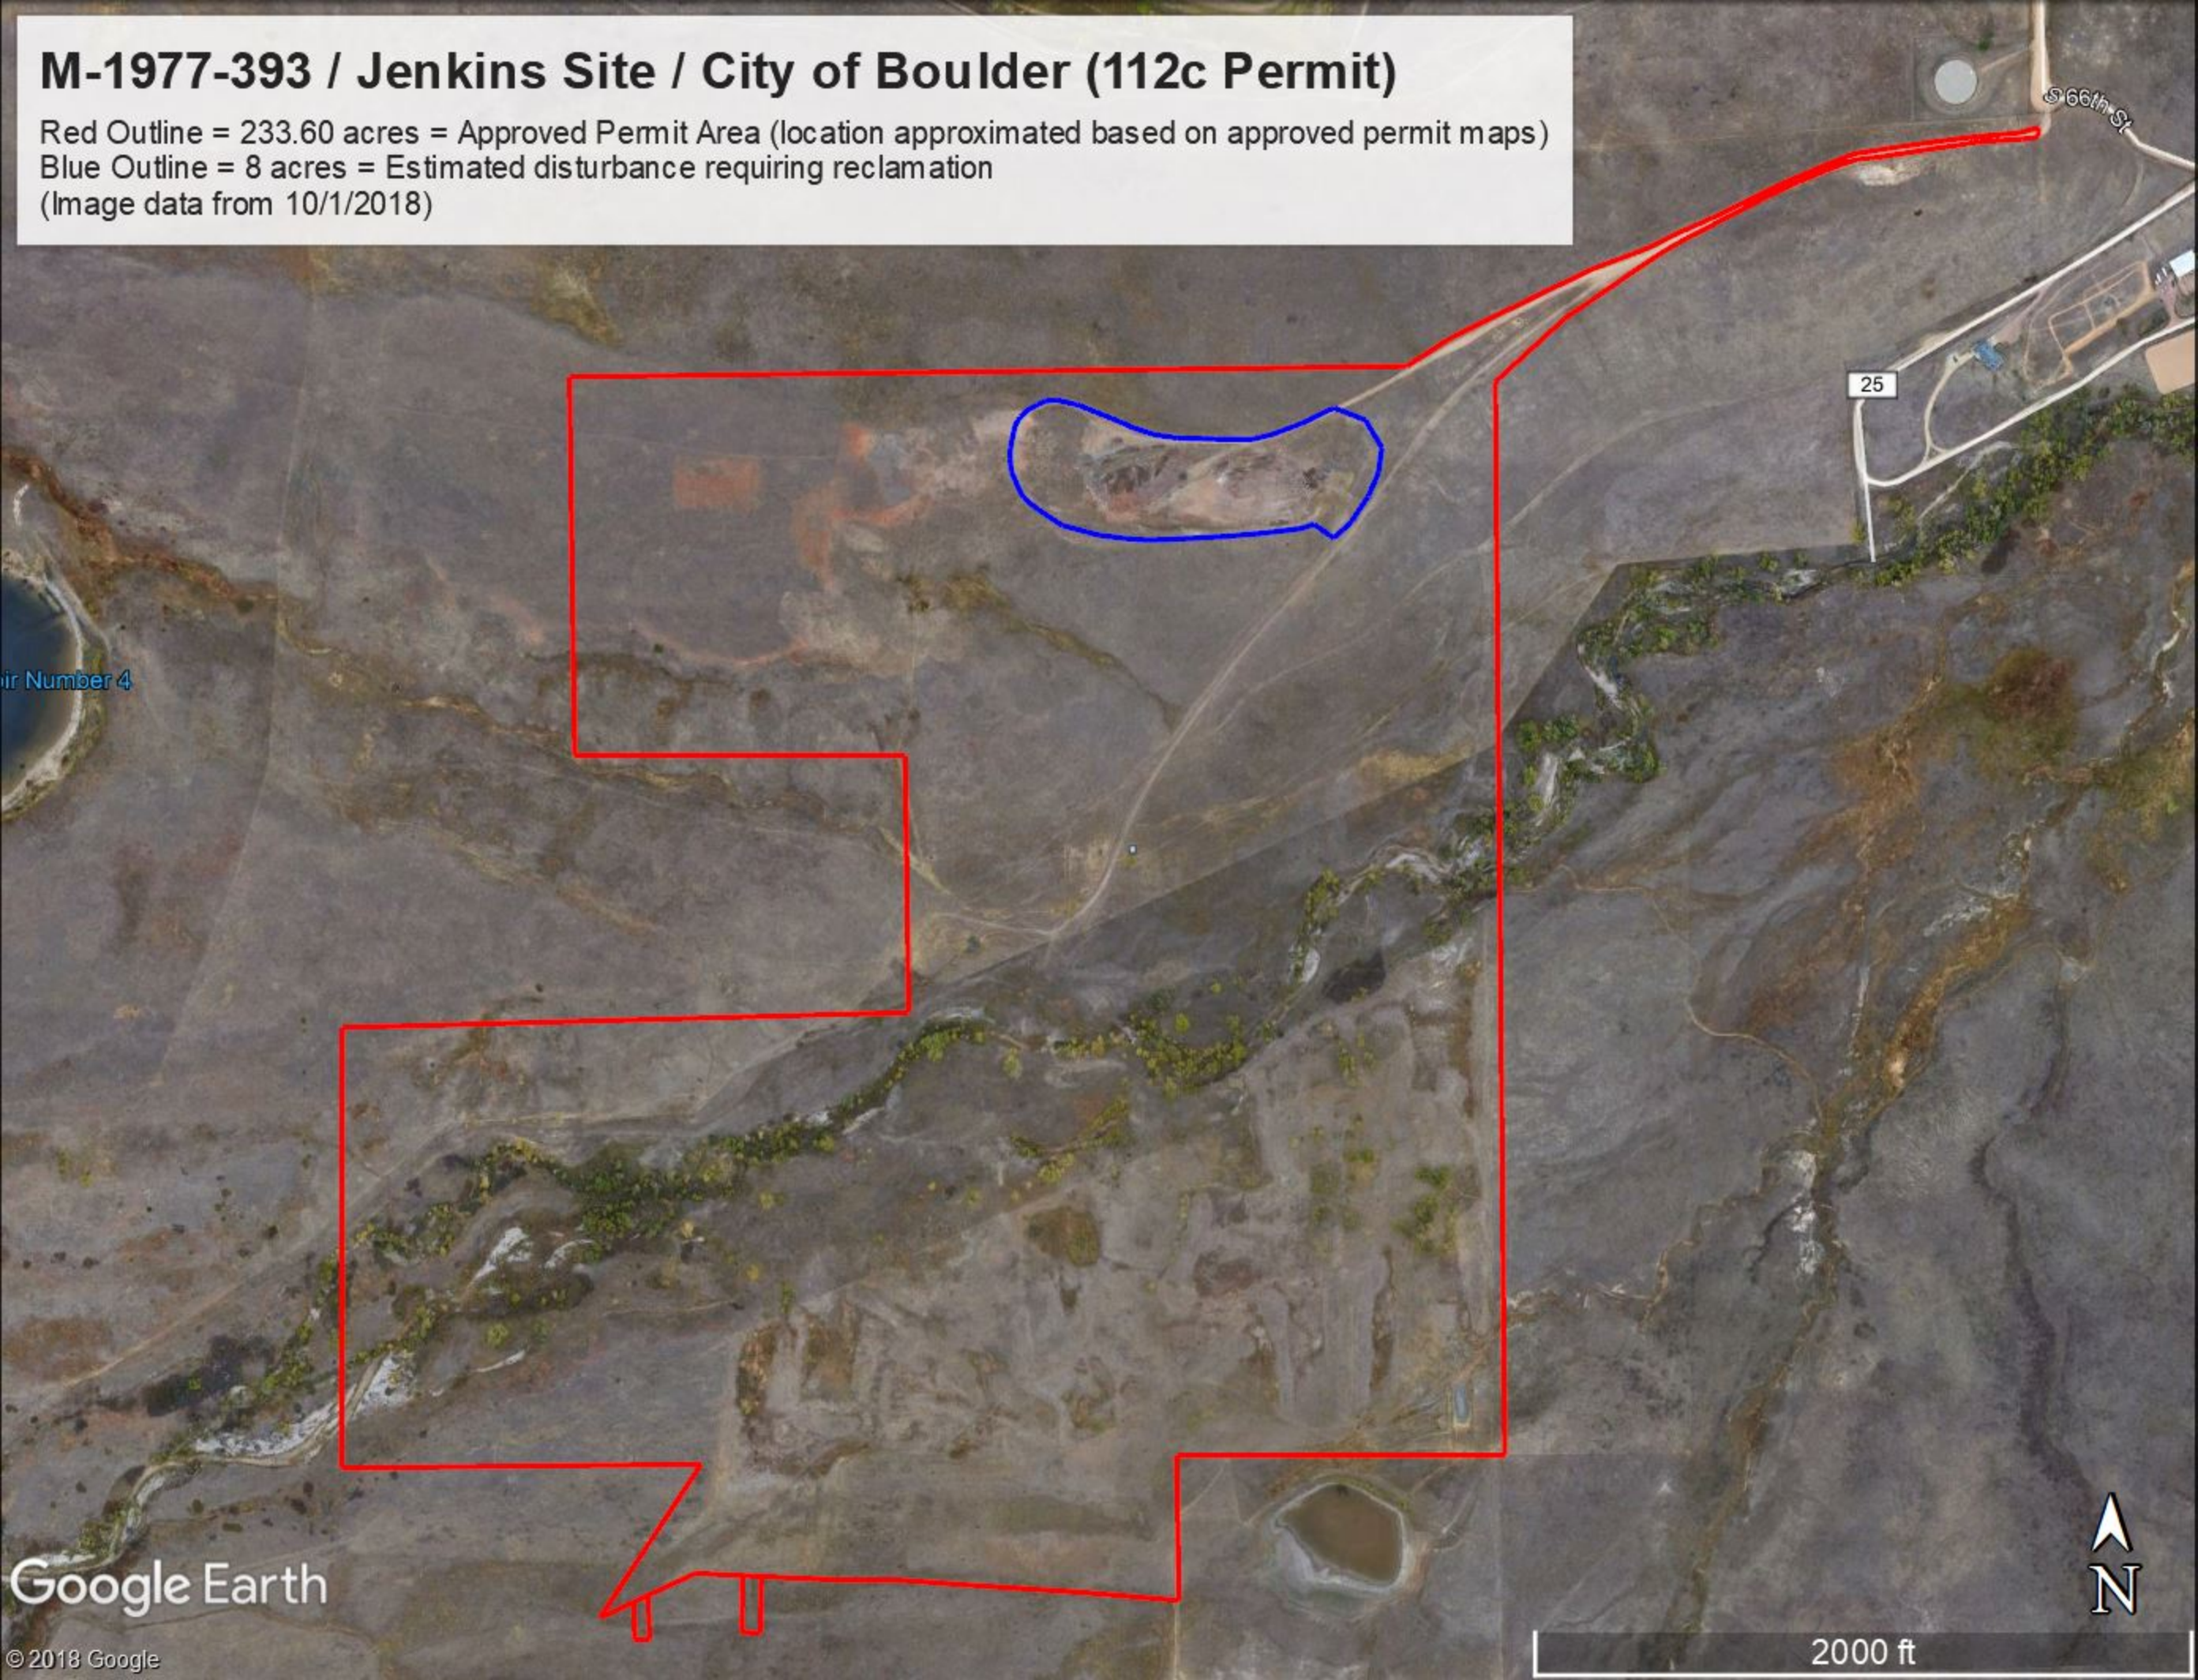
Red Outline = 233.60 acres = Approved Permit Area (location approximated based on approved permit maps)  
Blue Outline = 8 acres = Estimated disturbance requiring reclamation  
(Image data from 10/1/2018)
