**MINERALS PROGRAM INSPECTION REPORT**  
**PHONE: (303) 866-3567**

<b>MINE NAME:</b> Jenkins Site	<b>MINE/PROSPECTING ID#:</b> M-1977-393	<b>MINERAL:</b> Sand and gravel	<b>COUNTY:</b> Boulder
<b>INSPECTION TYPE:</b> Monitoring	<b>INSPECTOR(S):</b> Amy Eschberger	<b>INSP. DATE:</b> November 5, 2019	<b>INSP. TIME:</b> 08:30
<b>OPERATOR:</b> City of Boulder	<b>OPERATOR REPRESENTATIVE:</b> Chris Lawlor and Matt Ashley	<b>TYPE OF OPERATION:</b> 112c - Construction Regular Operation	
<b>REASON FOR INSPECTION:</b> Normal I&E Program	<b>BOND CALCULATION TYPE:</b> None	<b>BOND AMOUNT:</b> \$0.00	
<b>DATE OF COMPLAINT:</b> NA	<b>POST INSP. CONTACTS:</b> None	<b>JOINT INSP. AGENCY:</b> None	
<b>WEATHER:</b> Clear	<b>INSPECTOR'S SIGNATURE:</b>

# M-1977-393 / Jenkins Site / City of Boulder (112c Permit)

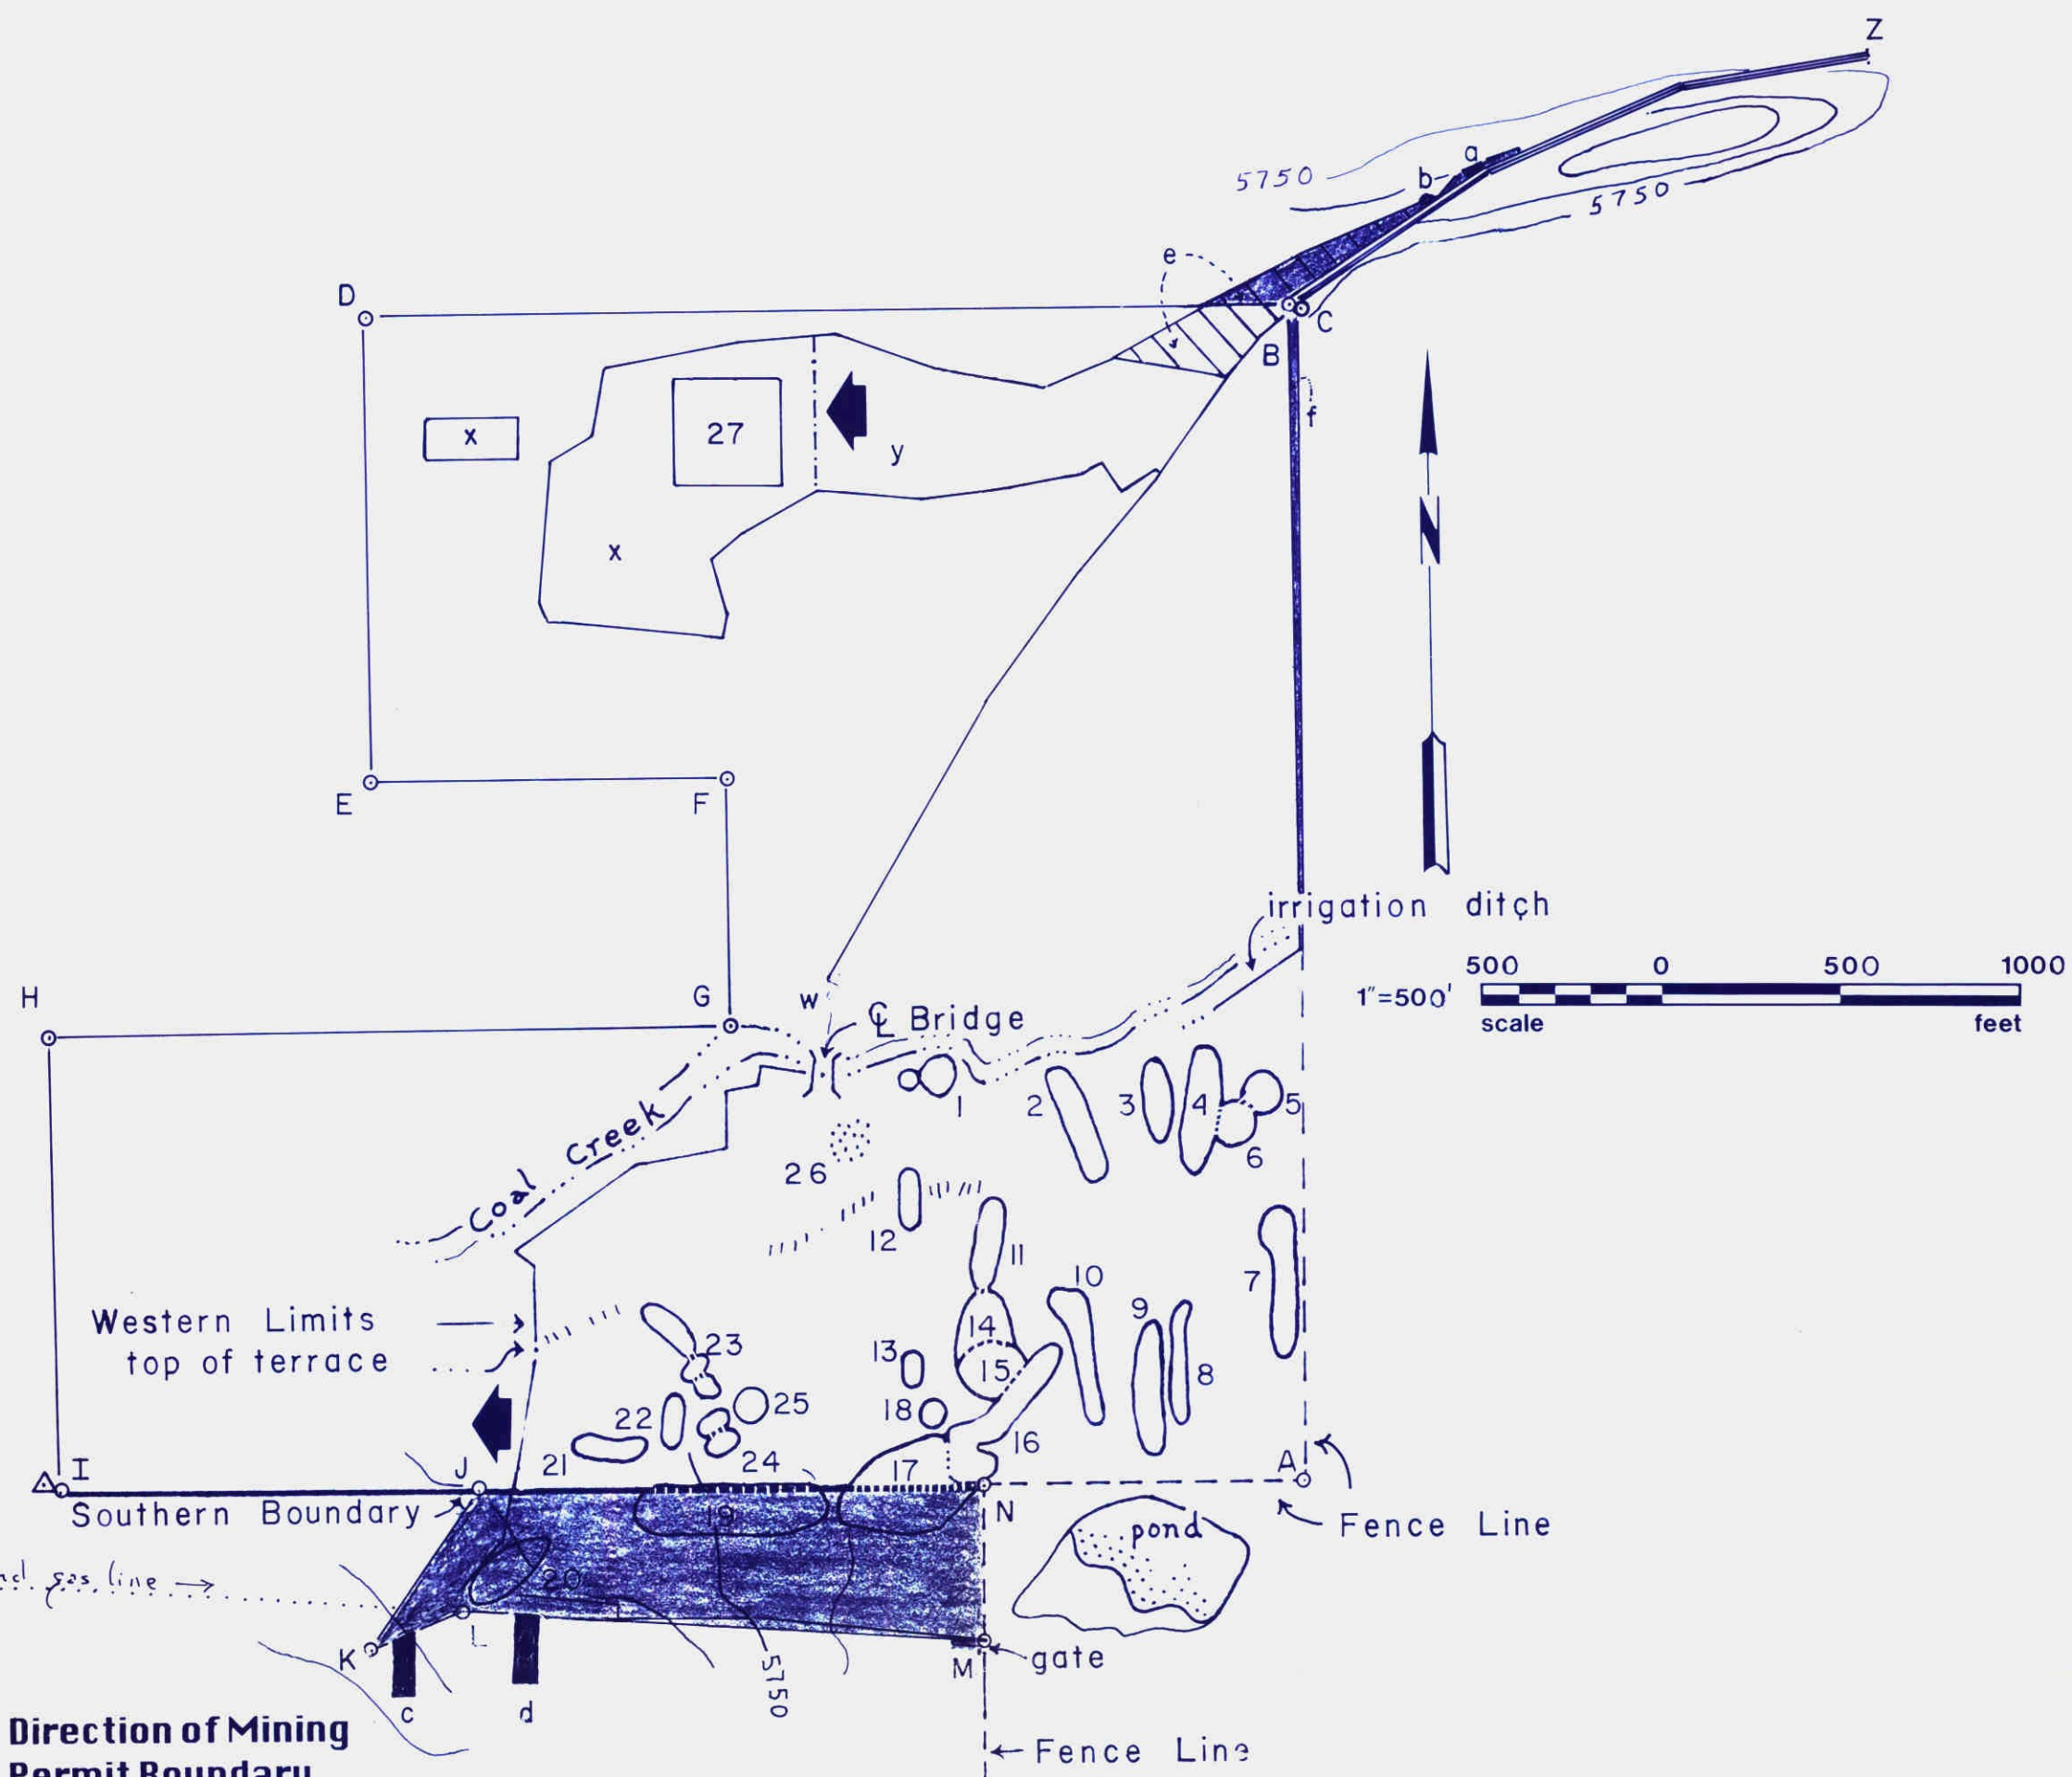
## **Exhibit F - Reclamation Plan Map**

- Point A - Fence corner and point of beginning.
- A to I - 3559' - reference line follows existing fence line.
- A to B - 3300' - set 90 degrees from the AI reference line.
- A to C - 3300' - C is 29'± from B @ 1°08'05" from BD line.
- Area f - 1/2 Degree between AB & AC to assure inclusion of all affected lands due to variations in fence line.
- Δ - Benchmark - approximate location f. previous maps.

- Point Z - Gate to access road.
- Z to B - Length of access road to NE corner = 1797'± x 24'±.
- Area a - Scale house & ramps.
- Area b - Parking area next to scale house.
- Area e - Access forks w/ unaffected land between.
- B to D - 2600' boundary line.
- D to E - 1300' boundary line.
- E to F - 1000' boundary line.
- F to G - 700' boundary line.
- Area x - Areas resoiled and seeded - Spring 1995.
- Area y - Existing Pit.
- #27 - stockpile area location = 300' x 300'.

- G to H - 1930' boundary line.
- H to I - 1300' boundary line.
- I to J - 1190' boundary line.
- J to K - 552' boundary line.
- K to L - 282' boundary line.
- L to M - 1463' boundary line.
- M to N - 437' boundary line.
- N to J - 1410' original Southern Boundary reference line.
- N to A - 959' boundary line.
- # areas - stockpile area locations #'s 1 to 26
- Area c - voluntary reclamation included in boundary.
- Area d - voluntary reclamation included in boundary.

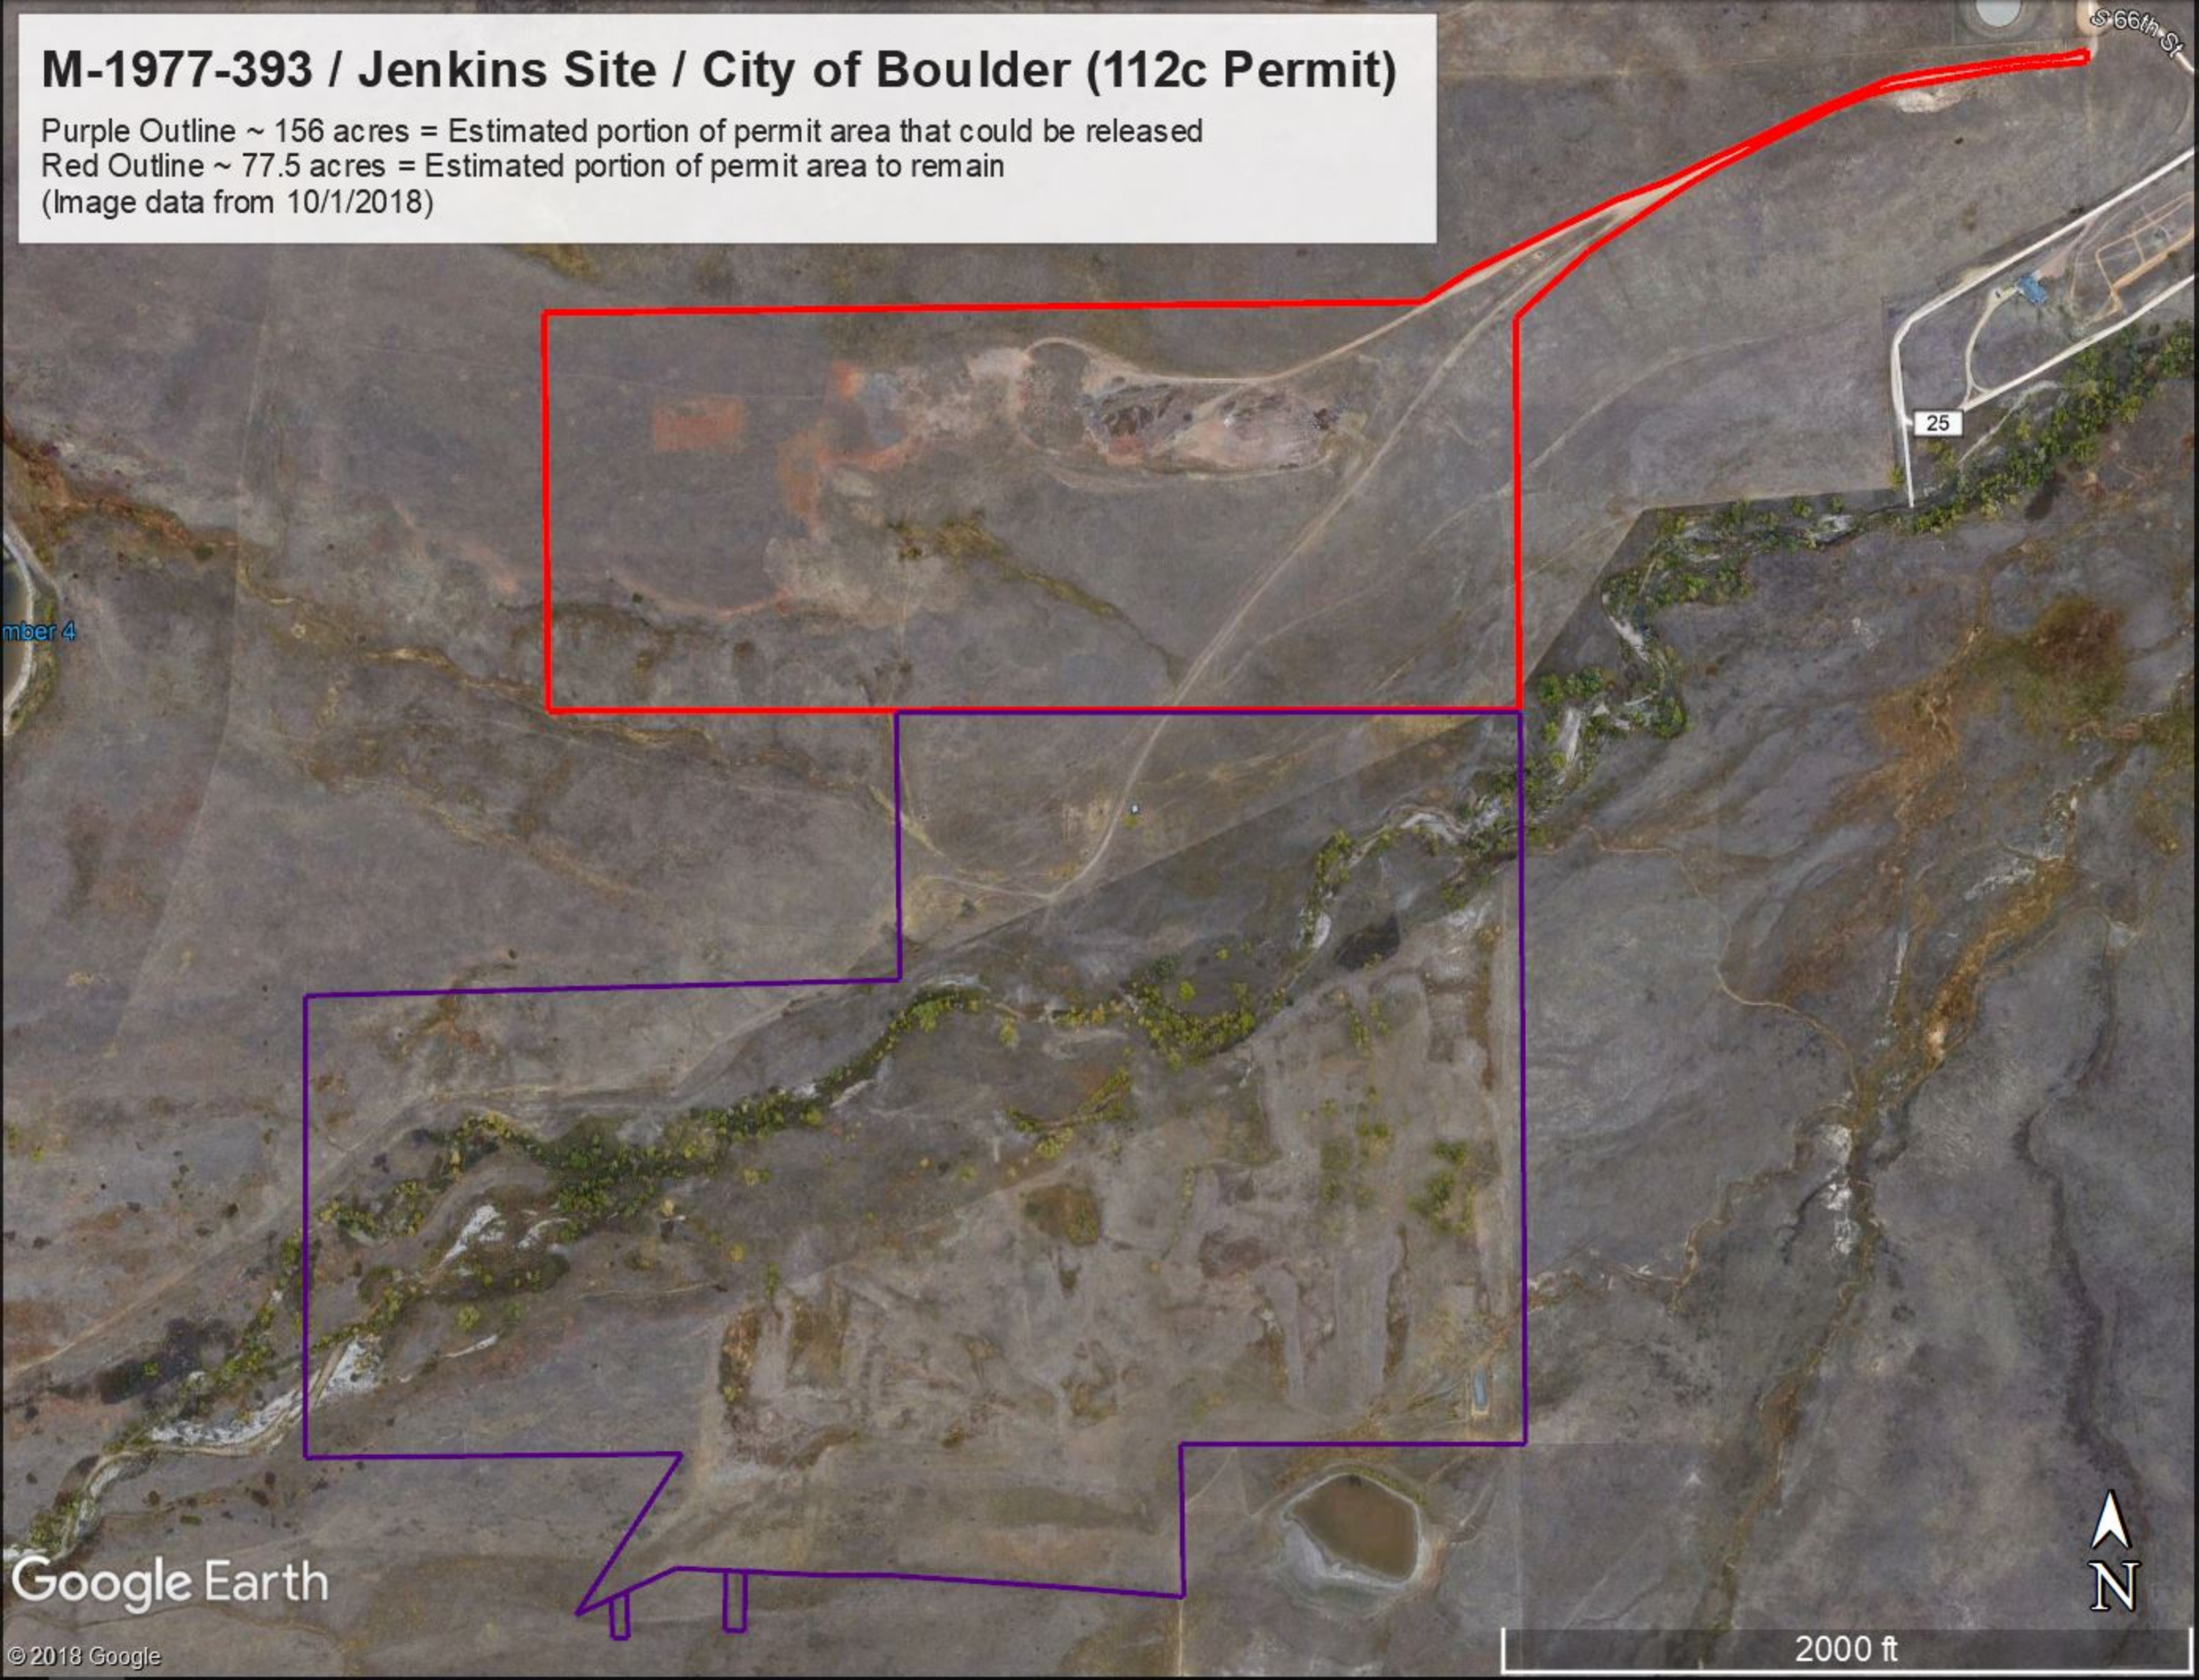
# M-1977-393 / Jenkins Site / City of Boulder (112c Permit)

Purple Outline ~ 156 acres = Estimated portion of permit area that could be released  
Red Outline ~ 77.5 acres = Estimated portion of permit area to remain  
(Image data from 10/1/2018)

The Division inspected the southern mining area located south of the creek, which has been in reclamation since 1995. The fencing installed in 1999 to restrict livestock grazing in this area was still in place. This area has a somewhat hummocky topography, with all slopes graded to 3H:1V or flatter. The area is stable with established vegetation consisting primarily of native grasses, with some mature trees growing in lower level areas. The south mining area appears to have been reclaimed in accordance with the approved reclamation plan. Therefore, the Division encourages the operator to submit an Acreage Reduction request (AR; see enclosed form) to release this portion of the permit area. The Division estimates the operator could release approximately 156 acres from the permit area (see enclosed Google Earth image of site showing releasable area), leaving approximately 77.5 acres in the portion of the permit area located north of the creek. However, the operator will need to survey the site and determine exactly how many acres are proposed for release, and provide a site map with the AR showing these area(s) accordingly.

If the Division approves an acreage reduction for the site, the operator will need to submit a Technical Revision (form enclosed) with a revised reclamation plan map (a revised mining plan map is not necessary given the site is in reclamation) showing the new permit area. If the operator wishes to propose any changes to the approved reclamation plan, such as to the revegetation plan (as proposed in 1997), this could be done through the same
