Re: Midwestern Farms, Permit No. M-1993-059, Follow-Up on Unresolved Problems

MINERALS PROGRAM INSPECTION REPORT
PHONE: (303) 866-3567

MINE NAME: Midwestern Farms	MINE/PROSPECTING ID#: M-1993-059	MINERAL: Sand and gravel	COUNTY: Prowers
INSPECTION TYPE: Monitoring	INSPECTOR(S): Amy Eschberger	INSP. DATE: September 11, 2019	INSP. TIME: 15:15
OPERATOR: Midwestern Farms	OPERATOR REPRESENTATIVE: Mel DePra	TYPE OF OPERATION: 112c - Construction Regular Operation

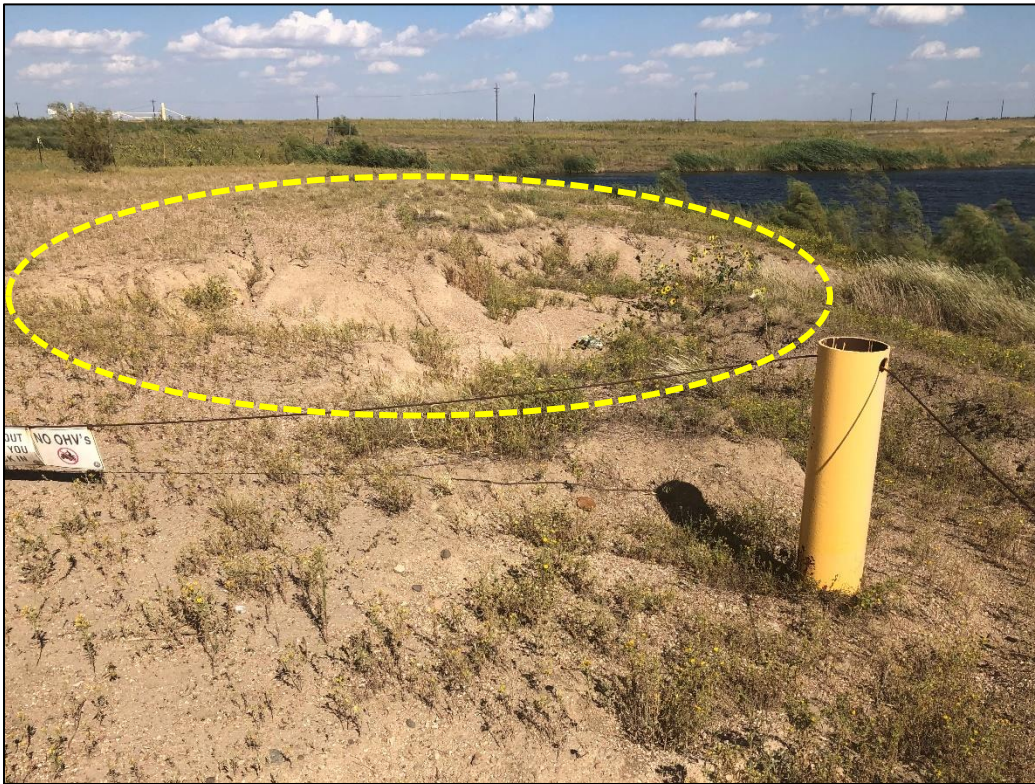
PROBLEM: Erosion gullies are present along pond shorelines at several locations. Additionally, the riprap blanket installed along the eastern pond shoreline under Technical Revision No. 6 (TR-6, approved on November 7, 2017) is not effectively controlling erosion at one location in particular, where pond water is overflowing the bank onto the adjacent farm road. This is a problem pursuant to C.R.S. 34-32.5-116(4)(j) and Construction Materials Rule 3.1.6(3) for failure to protect all surface areas of the affected land from erosion.

Photo 1. View looking east across erosion feature (circled) observed at northwestern edge of pond, near CPW-designated parking area.

CORRECTIVE ACTIONS: By the corrective action date, the operator shall provide the Division with photo documentation verifying the erosion damage on pond shorelines has been repaired, and the site has been reconstructed and stabilized to prevent further erosion damage. If the operator proposes an alternative method for

stabilizing the eastern pond shoreline (than the plan approved in TR-6), the operator must submit this proposal in the form of a Technical Revision with the appropriate fee of \$216.00 by the corrective action date.

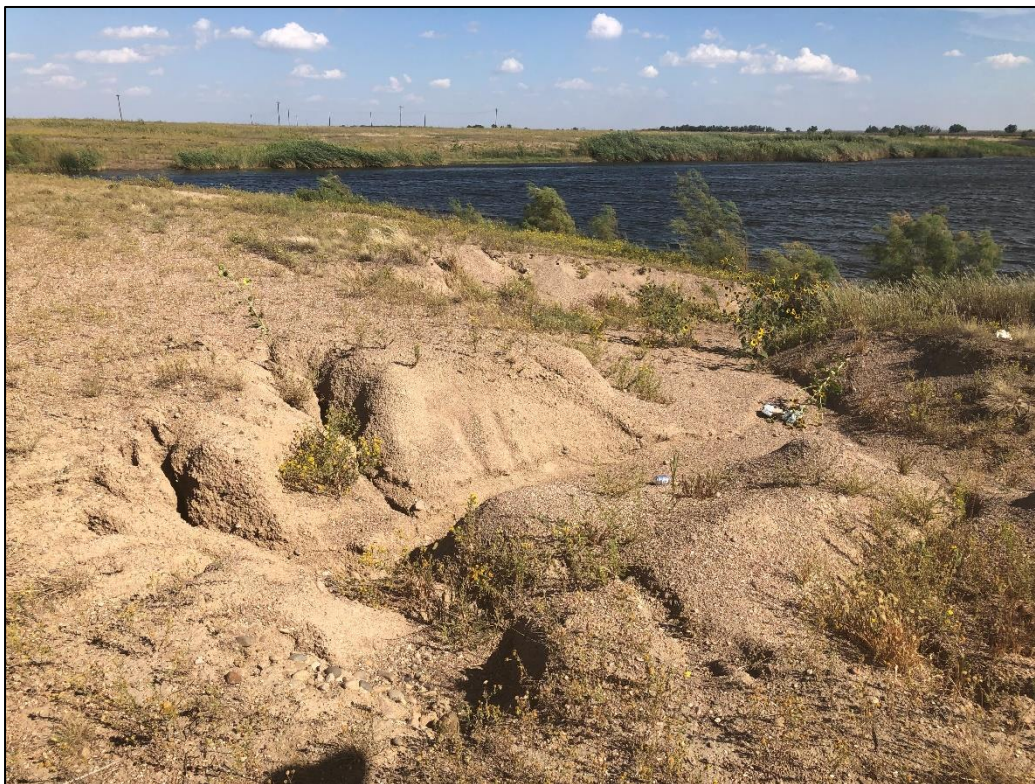
Photo 2. Closer view of erosion feature identified in Photo 1 (located at northwestern edge of pond).

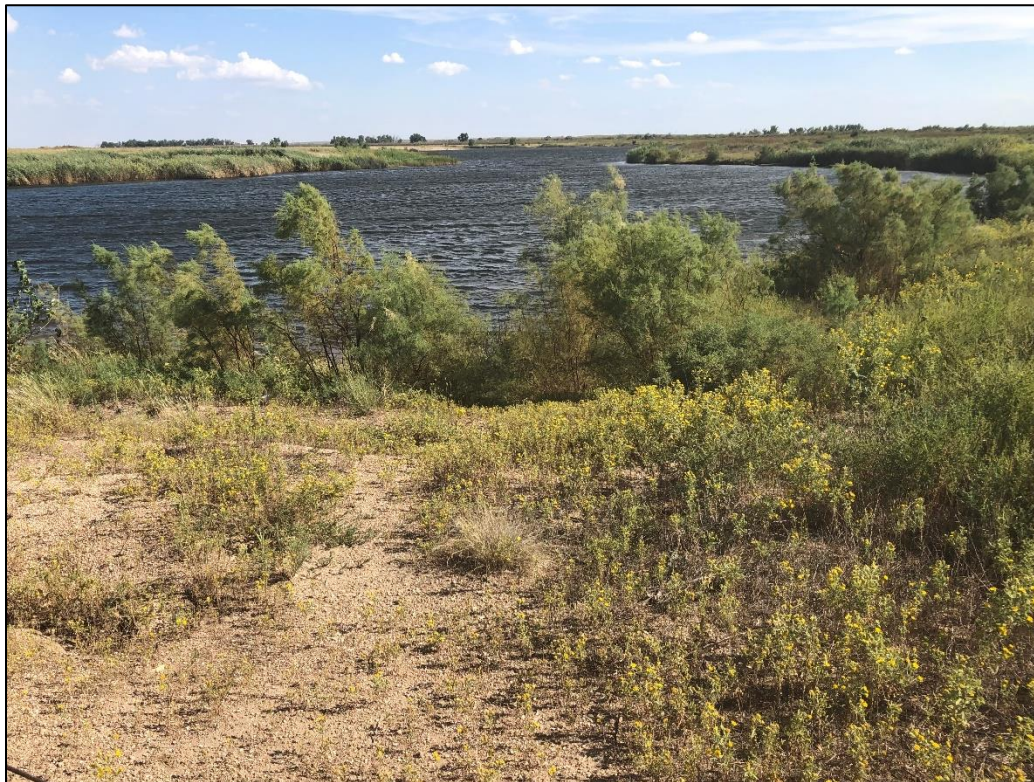
During the inspection, the Division observed numerous Tamarisk trees present on site, particularly along the western and southern pond shorelines, but also in disturbed areas north of the pond. The Division observed Field bindweed growing in several areas around the pond, especially in the disturbed areas southeast and northeast of the pond. The operator is clearly not implementing the approved weed control plan for the site.

Photo 3. View looking south, showing numerous Tamarisk trees present along northwestern pond shoreline.

CORRECTIVE ACTIONS: By the corrective action date, the operator shall implement the approved weed control plan for all state-listed noxious weed species on the affected lands, and provide proof to the Division that this was done. If the operator wishes to revise the approved weed control plan, the proposed plan must be submitted in the form of a Technical Revision with the appropriate fee of \$216.00 by the corrective action date. The Division recommends the operator consult with the county extension agency or weed control district office in developing a plan that includes specific control measures to be applied, a schedule for when control measures will be applied, and a post-treatment monitoring plan.

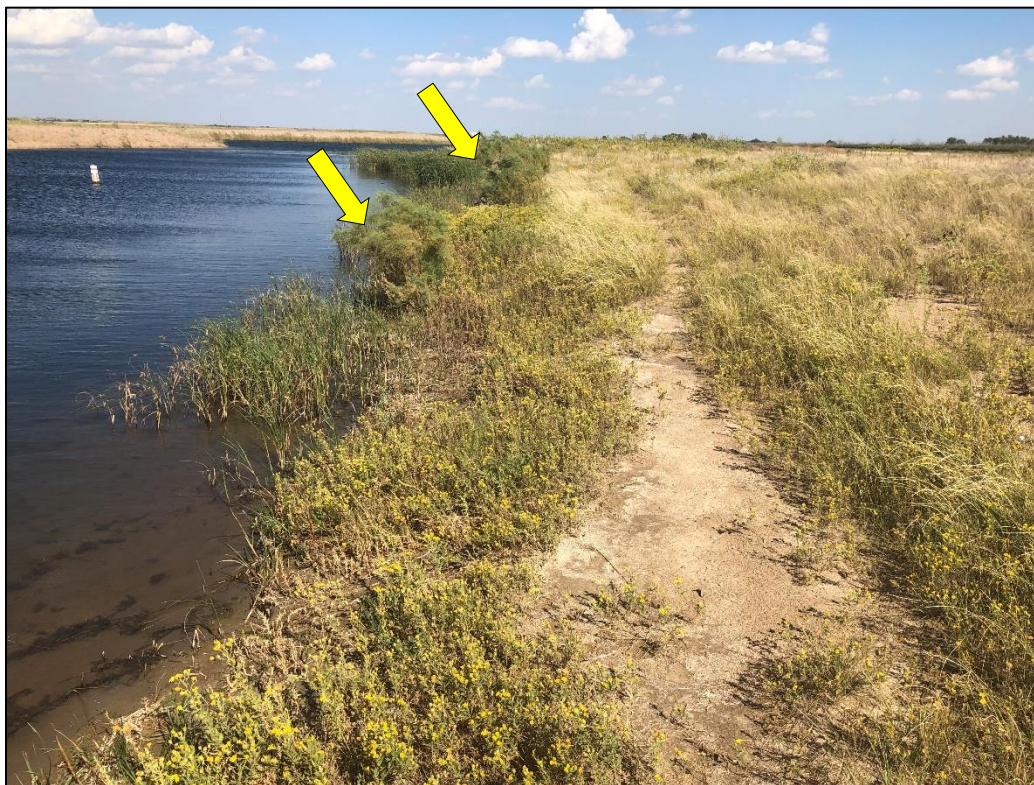
Photo 4. View looking east across southern pond shoreline, showing vegetative cover consisting of grasses and weeds, including Tamarisk trees (indicated).

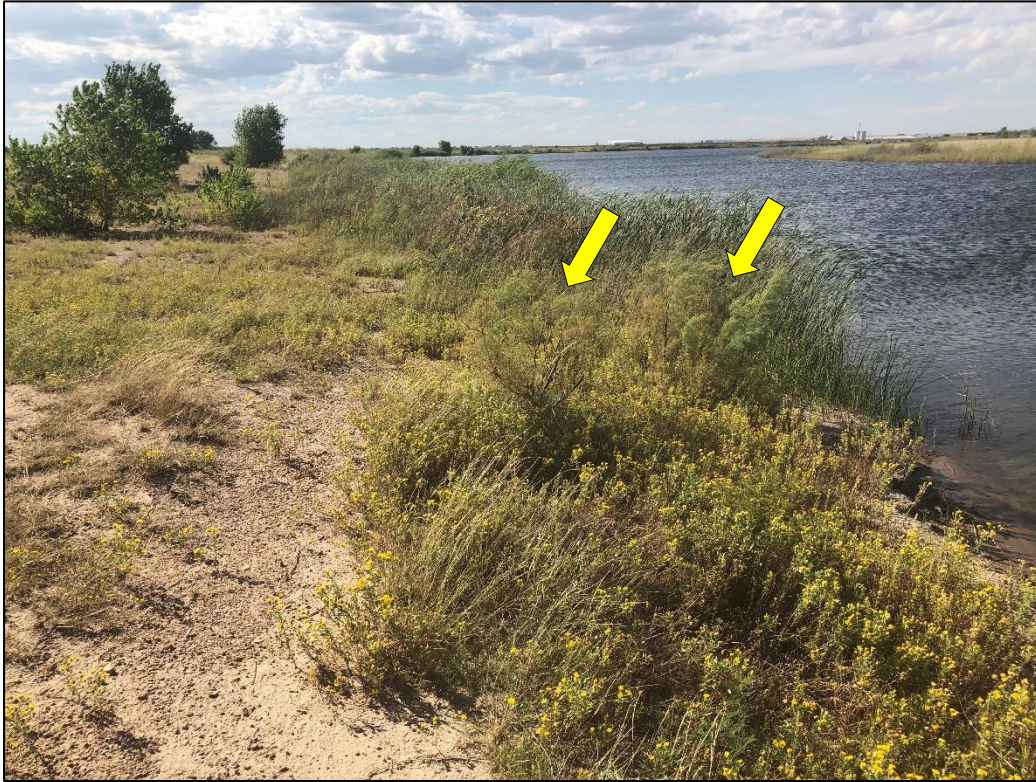
Photo 5. View looking west across southern pond shoreline, showing vegetative cover consisting of grasses and weeds, including Tamarisk trees (indicated).

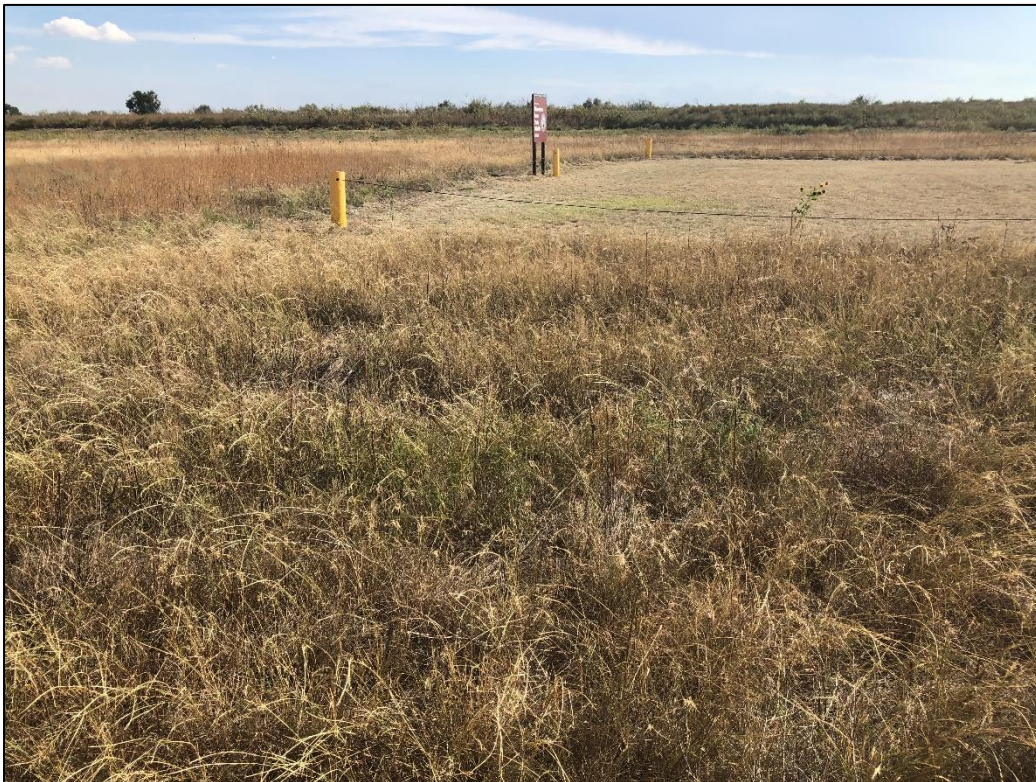
Photo 6. View looking south across area located south of pond (near CPW-designated parking area, shown at top, right), showing good grass establishment in this area.

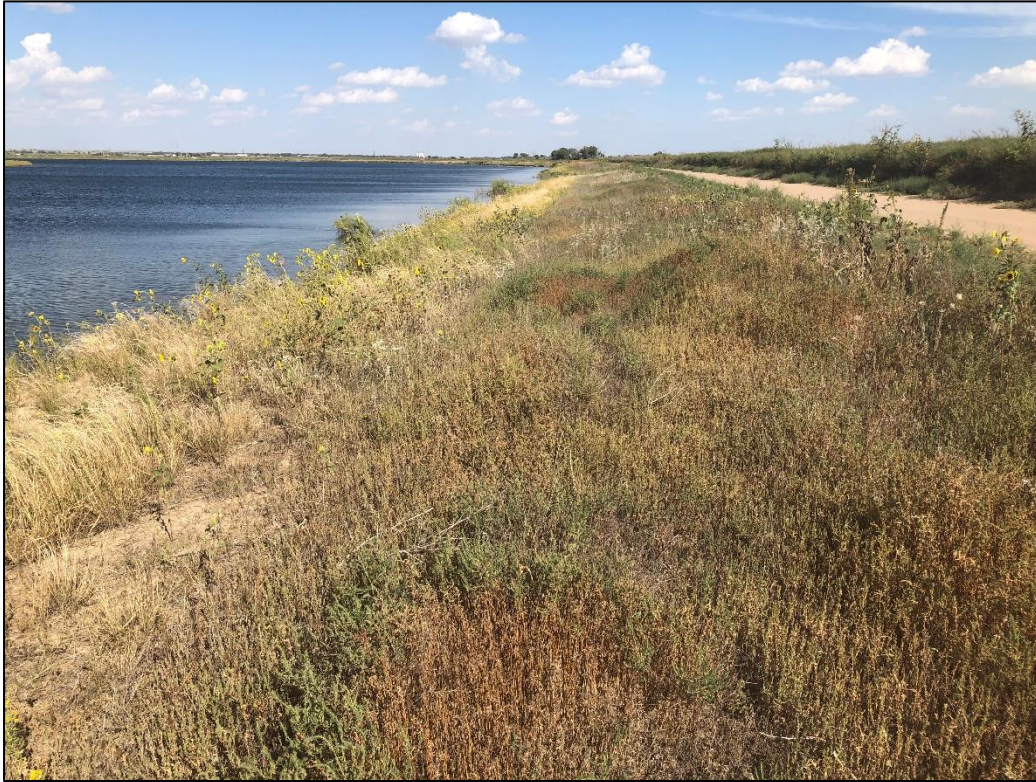
The Division observed the portions of the site undergoing revegetation, and could find very little if any evidence that the initial (2017) seeding event was successful. The vegetative cover present in these areas consisted primarily of weeds (e.g., kochia, wild sunflower, curlycup gumweed, marehail, field bindweed). According to Mr. Kaczmarek, CPW drill-seeded the areas located south and southeast of the pond in 2017, 2018, and 2019. CPW has also aerial sprayed the site for broadleaves a few times, the last of which occurred in April of 2019. This was done in hopes of giving the grass seed a chance to grow and establish. The Division observed established grasses, including yellow indian grass, big bluestem, sand dropseed, sideoats grama, and switchgrass, in the areas south and southeast of the pond. The Division also observed Illinois bundleflower growing in these areas (planted by CPW), which is a warm season legume that provides good wildlife food and cover. The vegetative cover present in the areas south and southeast of the pond (seeded by CPW) differs significantly from the areas north of the pond which have very little to no grass growth and abundant weeds. The Division recommends the operator plant a new cover crop and reseed the areas to be revegetated for final reclamation in accordance with the revegetation plan approved in TR-5. Ideally, the cover crop should be planted this September/early October, and the site reseeded this Spring.

Photo 7. View looking east across area located south of pond, showing vegetative cover consisting of grasses and weeds (primarily kochia).

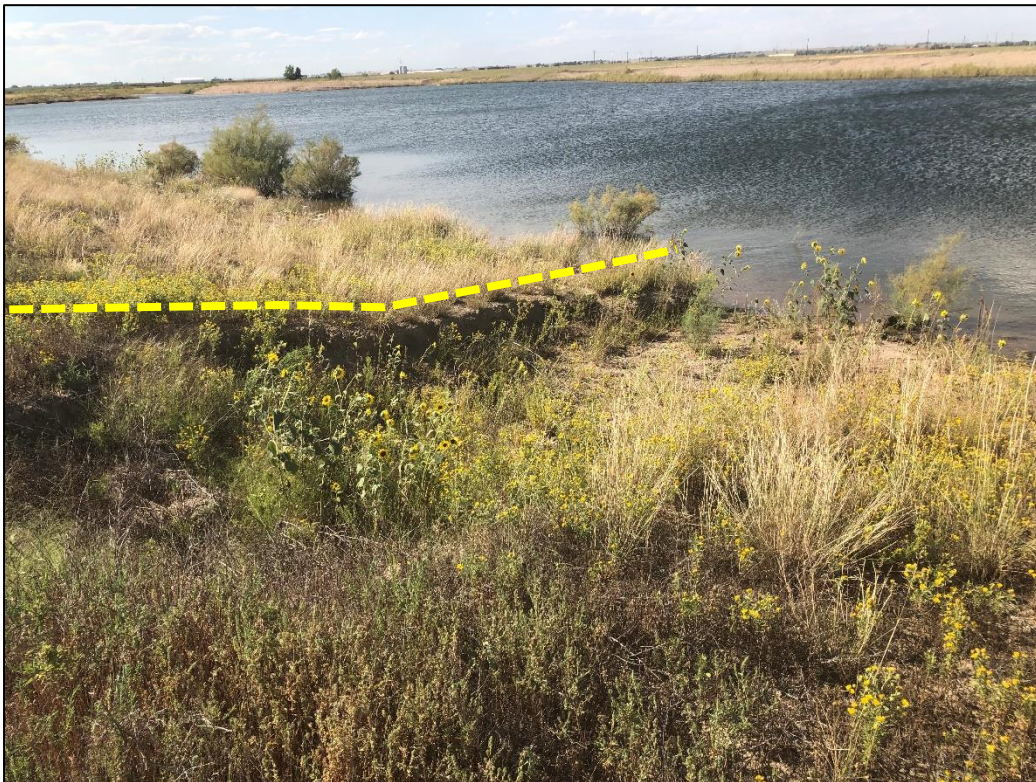
During the current inspection, the Division observed several locations along the pond shorelines where erosion gullies have formed (see enclosed Google Earth image of site showing approximate locations of erosion features observed). The Division also observed the section of the eastern pond shoreline on which the riprap blanket was installed per TR-6. The riprap appeared to be effectively controlling erosion along the majority of this shoreline. However, at one location, where the pond bank is closest to the adjacent farm road, the pond water was overflowing the bank onto the adjacent road. At this location, it appeared the pond bank had been graded too flat prior to placing the riprap, which did not properly account for seasonal fluctuations of the pond water level. According to Mr. Kaczmarek, pond water levels are currently about 16-18 inches higher than they are in winter months (when the shoreline was regraded for riprap placement). Additionally, the eastern pond shoreline receives a significant amount of wave action. Therefore, this low-lying portion of the eastern pond shoreline will require additional stabilization measures to keep the shoreline from eroding further, and migrating into the adjacent farm road and ditch. The Division is citing a problem in this report pursuant to C.R.S. 34-32.5-116(4)(j) and Construction Materials Rule 3.1.6(3) for failure to protect all surface areas of the affected land from erosion. The operator will need to repair the erosion damage present along pond shorelines and provide photo documentation to the Division that this has been done. If the operator proposes an alternative method for stabilizing the eastern pond shoreline (besides riprap placement), this proposal must be submitted in the form of a Technical Revision (see enclosed form).

Photo 8. View looking northwest across erosion feature (outside edge outlined) observed along southern pond shoreline.

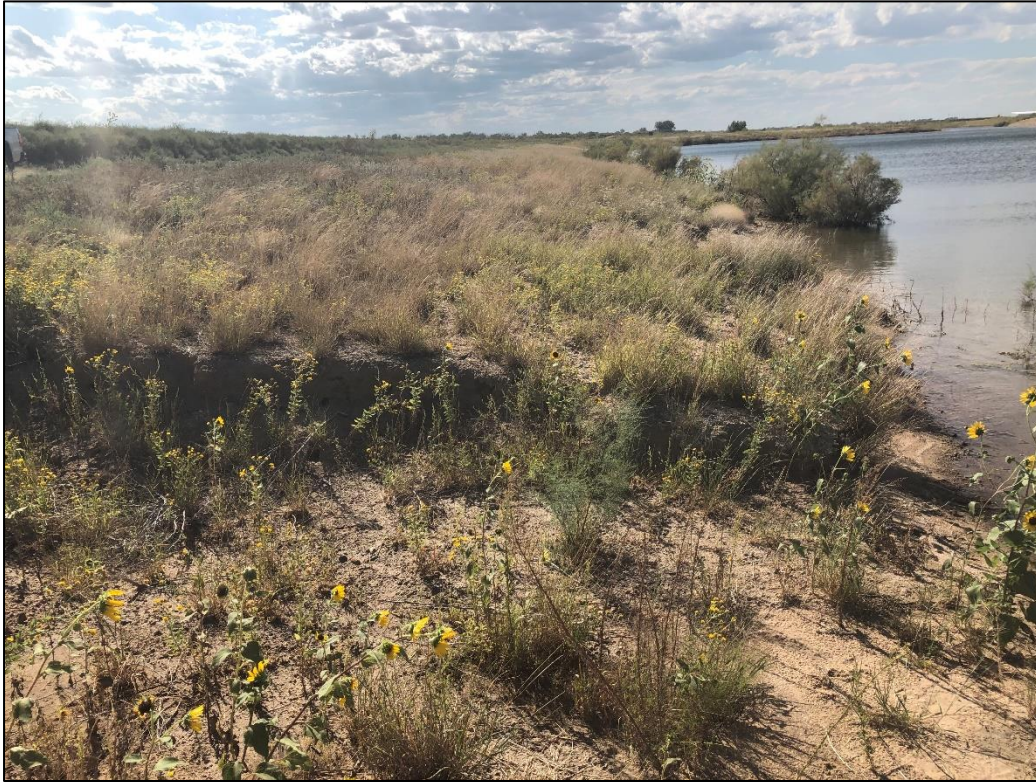
Photo 9. Closer view of erosion feature identified in Photo 8, standing at bottom of feature, looking west. Note Tamarisk trees present along shoreline (in background).

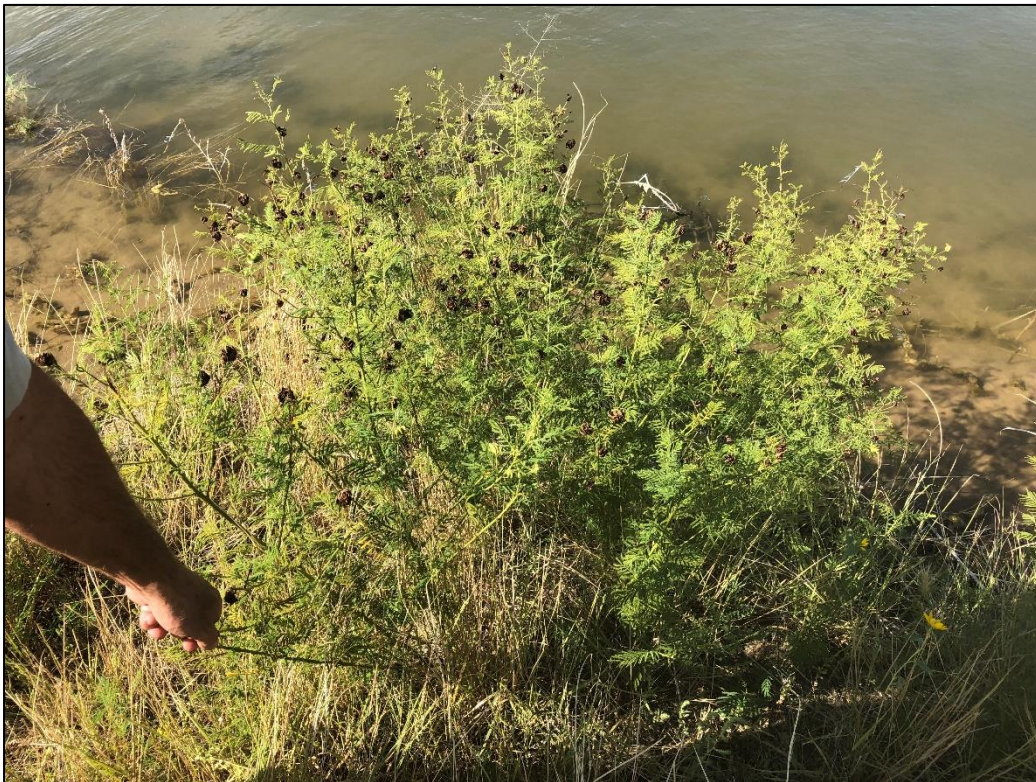
Photo 10. View of Illinois bundleflower (planted by CPW) growing on southern pond shoreline.

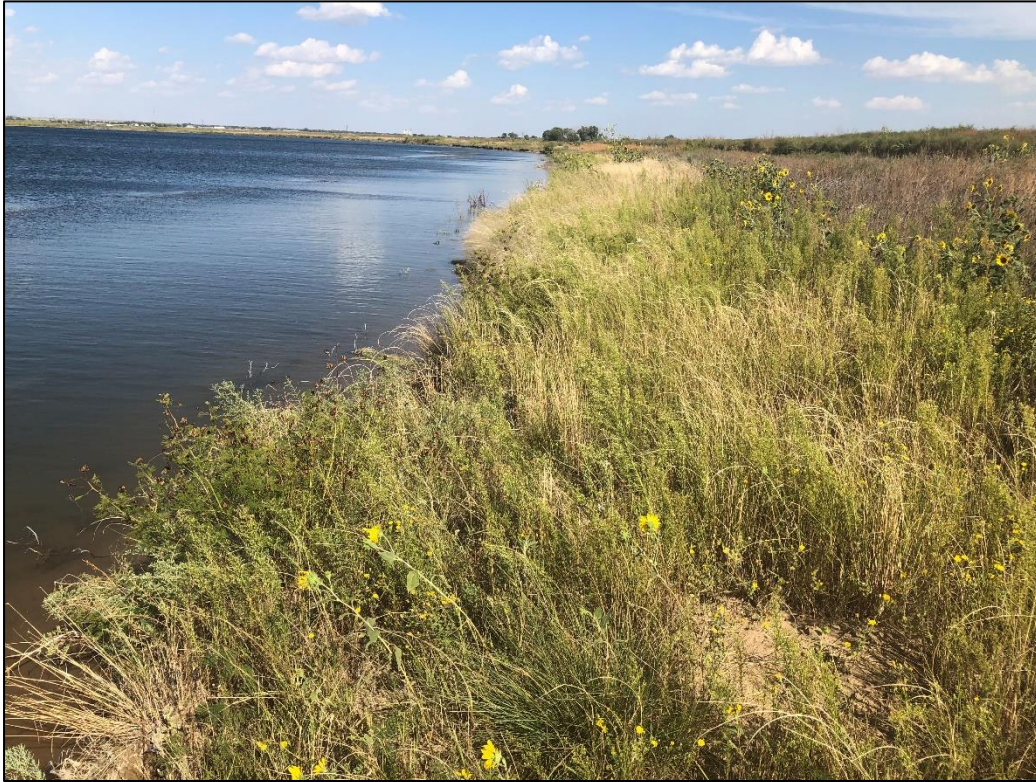
Photo 11. View looking east across southern pond shoreline, showing vegetative cover consisting of grasses, legumes, and weeds.

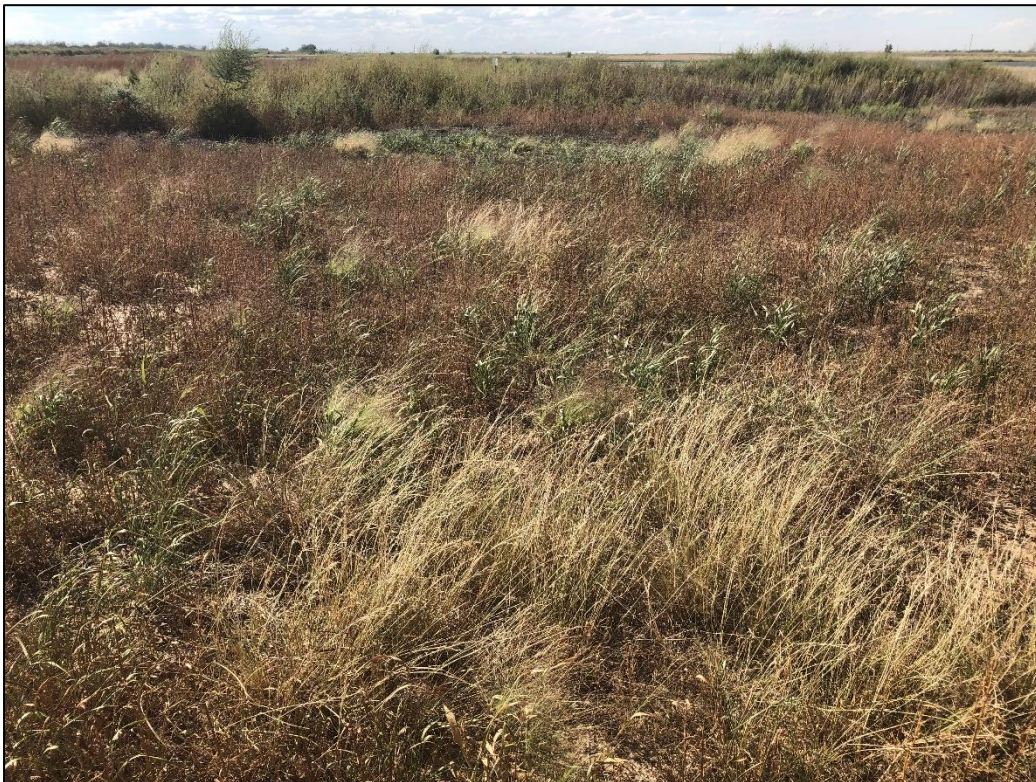
Photo 12. View looking west across area located southeast of pond, showing vegetative cover consisting of grasses (mainly sand dropseed and switchgrass) and weeds (mainly kochia and field bindweed).

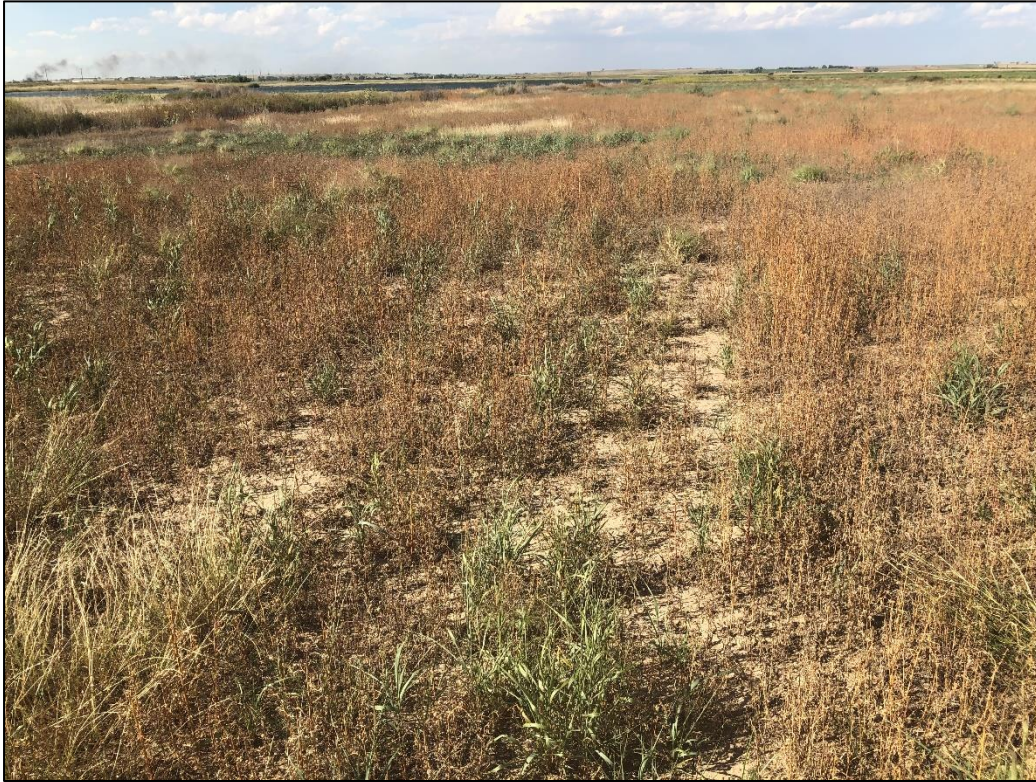
Photo 13. View looking north across area located southeast of pond, showing vegetative cover consisting of grasses (mainly sand dropseed and switchgrass) and weeds (mainly kochia and field bindweed).

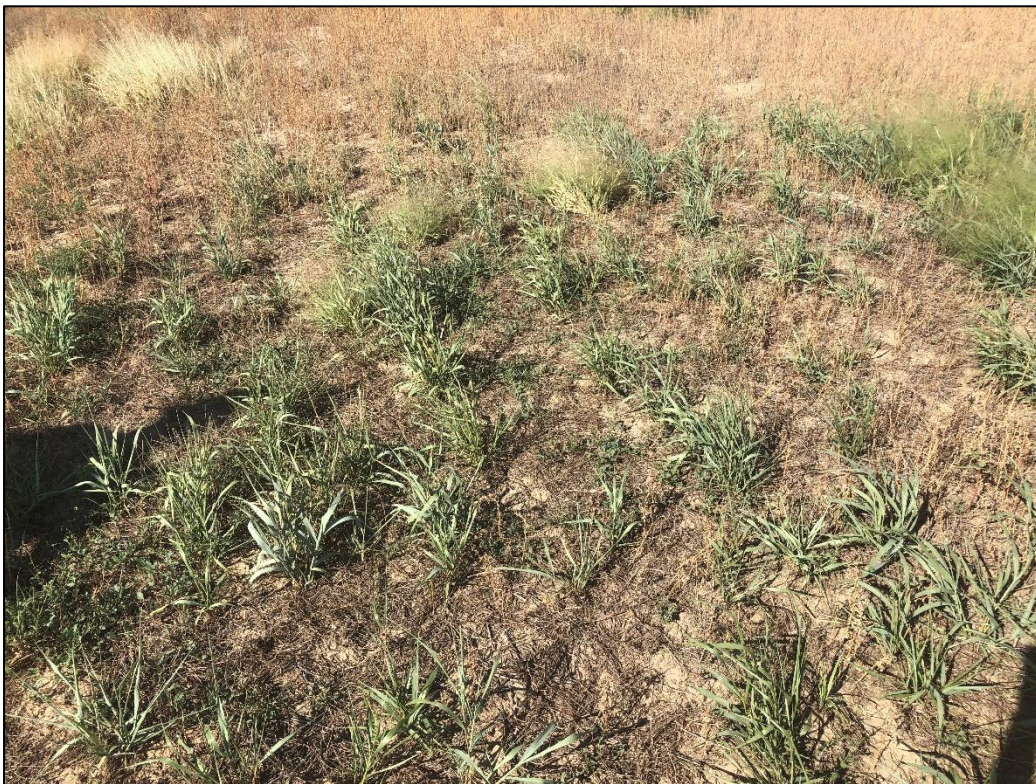
Photo 14. Closer view of ground in area located southeast of pond, showing vegetative cover consisting of grasses (mainly sand dropseed and switchgrass) and weeds (mainly kochia and field bindweed).

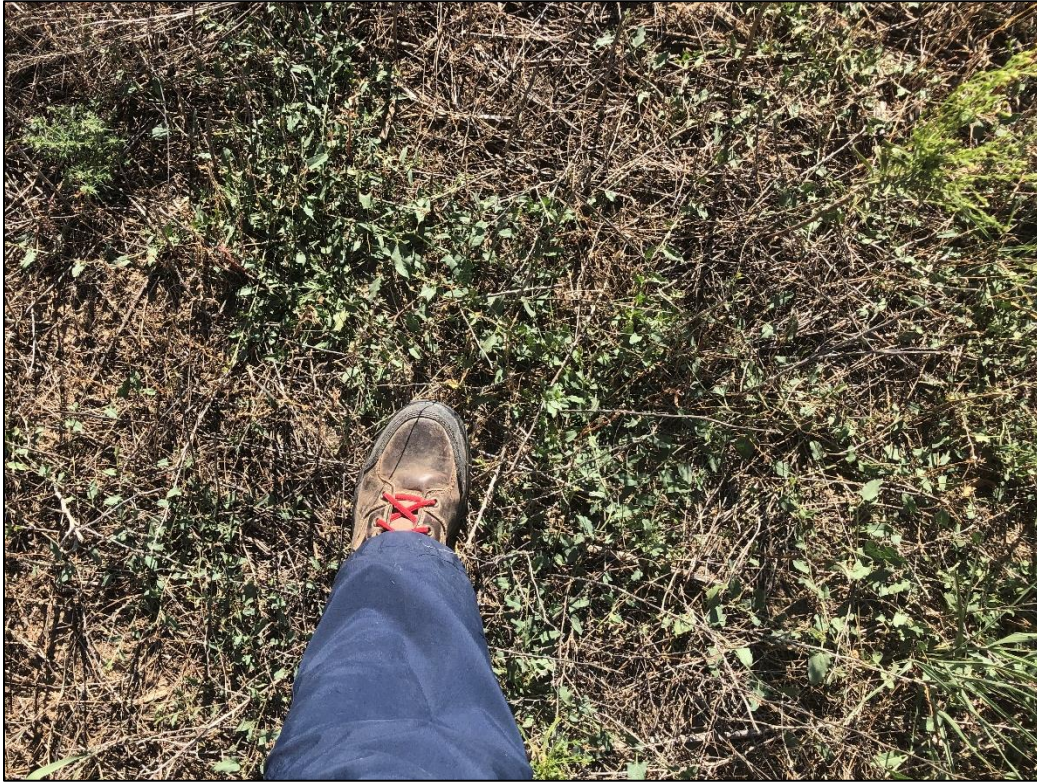
Photo 15. Ground view of area shown in Photo 13 located southeast of pond, showing field bindweed present in this area.

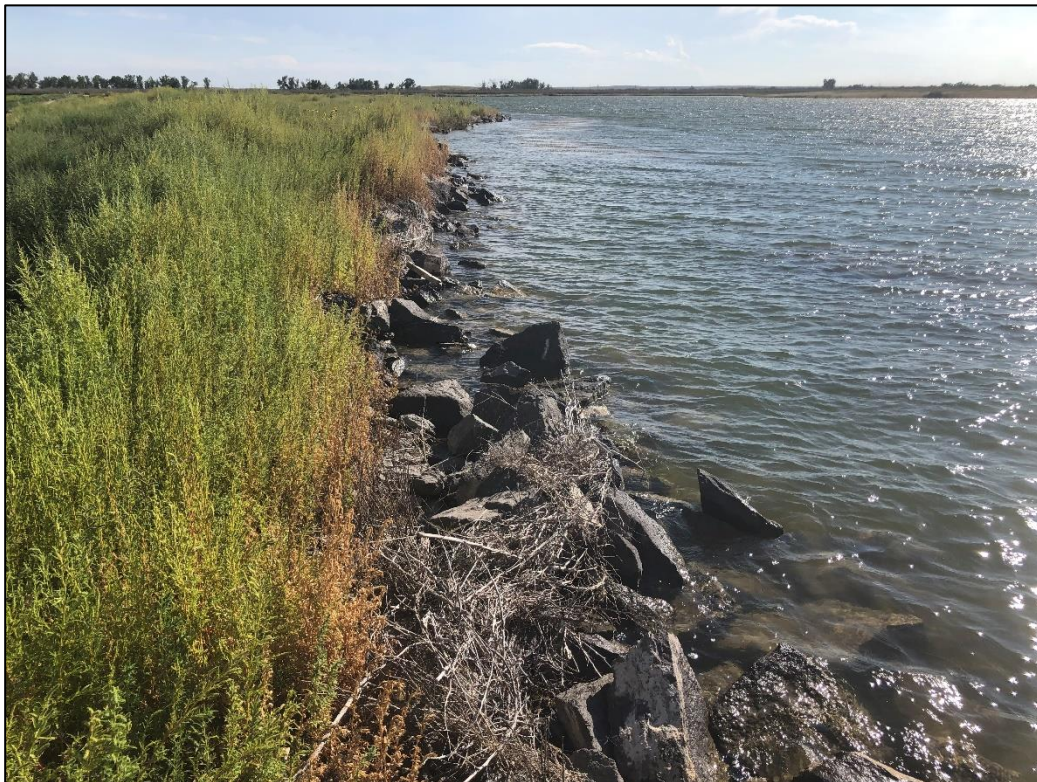
Photo 16. View looking south across eastern pond shoreline with riprap installed per TR-6. The riprap appears to be effectively controlling erosion along this portion of the shoreline.

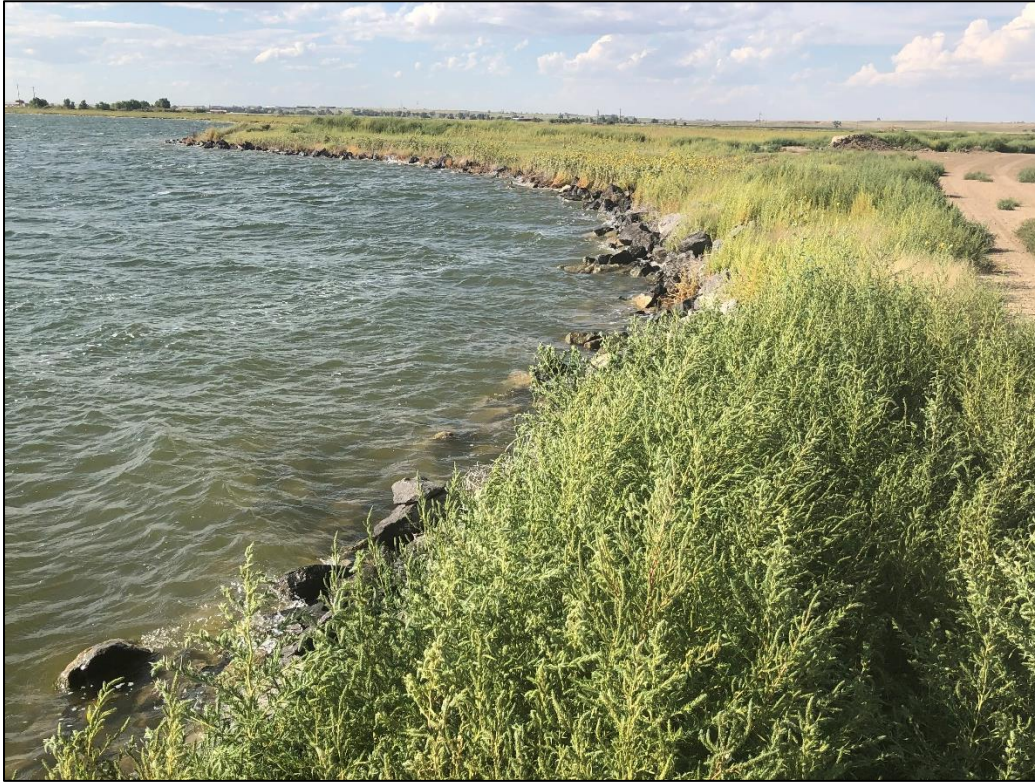
Photo 17. View looking north across eastern pond shoreline with riprap installed per TR-6. The riprap appears to be effectively controlling erosion along this portion of the shoreline.

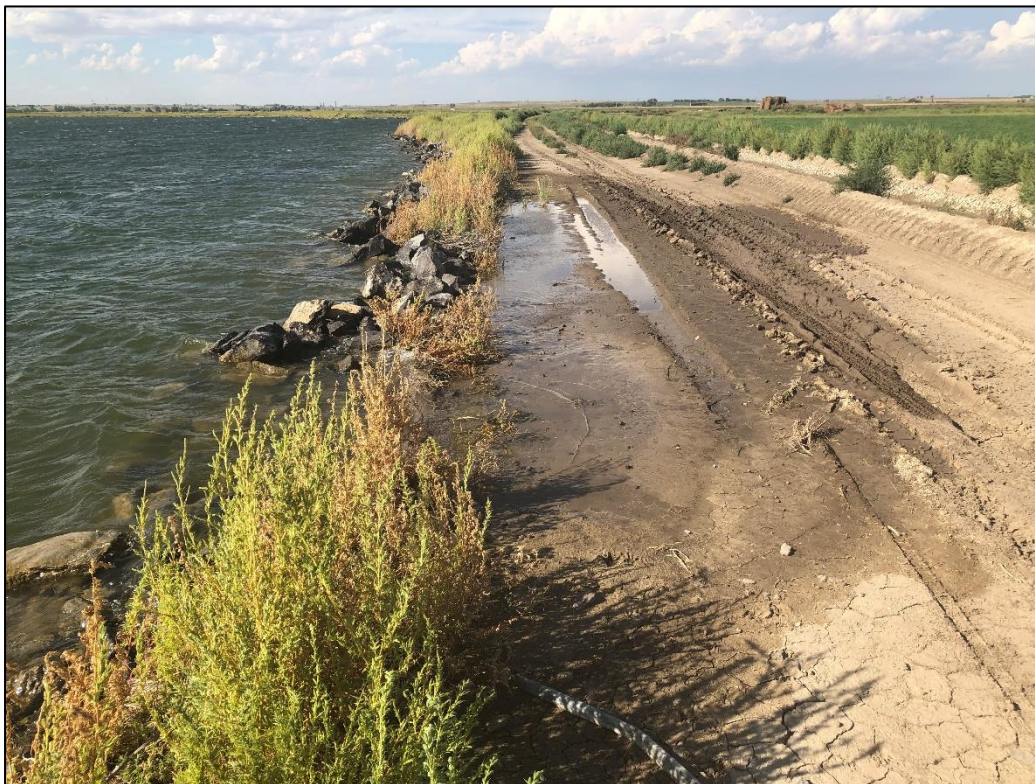
Photo 18. View looking north across portion of eastern pond shoreline where riprap placement is not effectively controlling erosion. Note pond water is overflowing bank onto adjacent farm road.

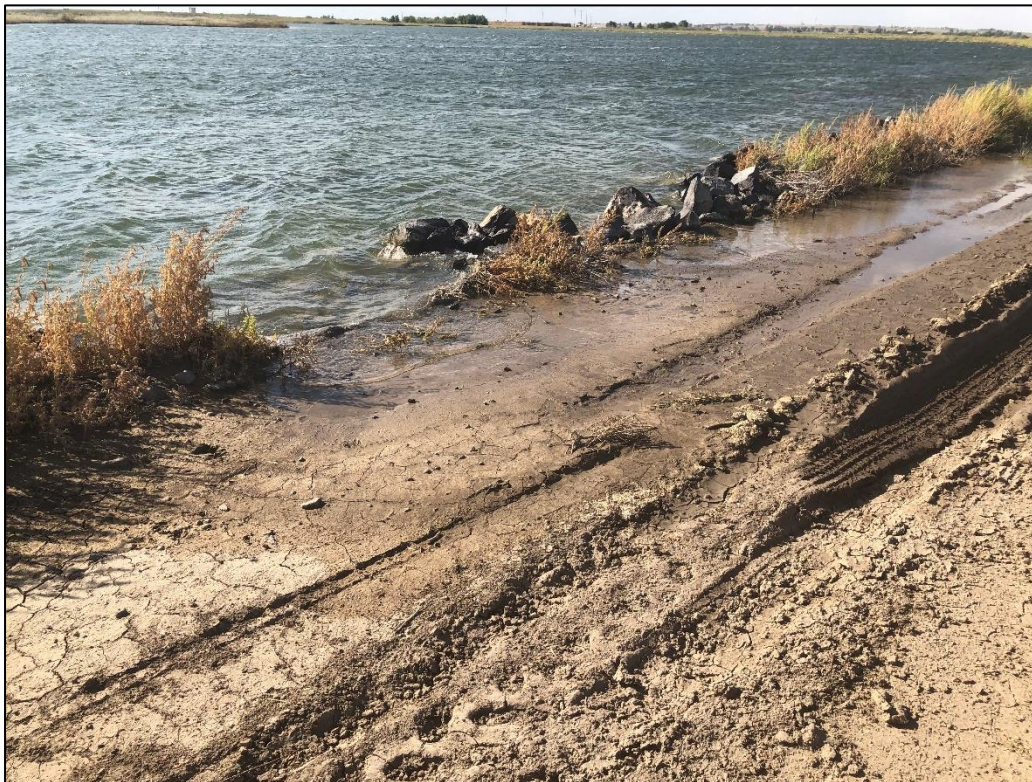
Photo 19. Closer view of area shown in Photo 18, looking northwest across portion of eastern pond shoreline where riprap placement is not effectively controlling erosion. Note pond water is overflowing bank onto adjacent farm road.

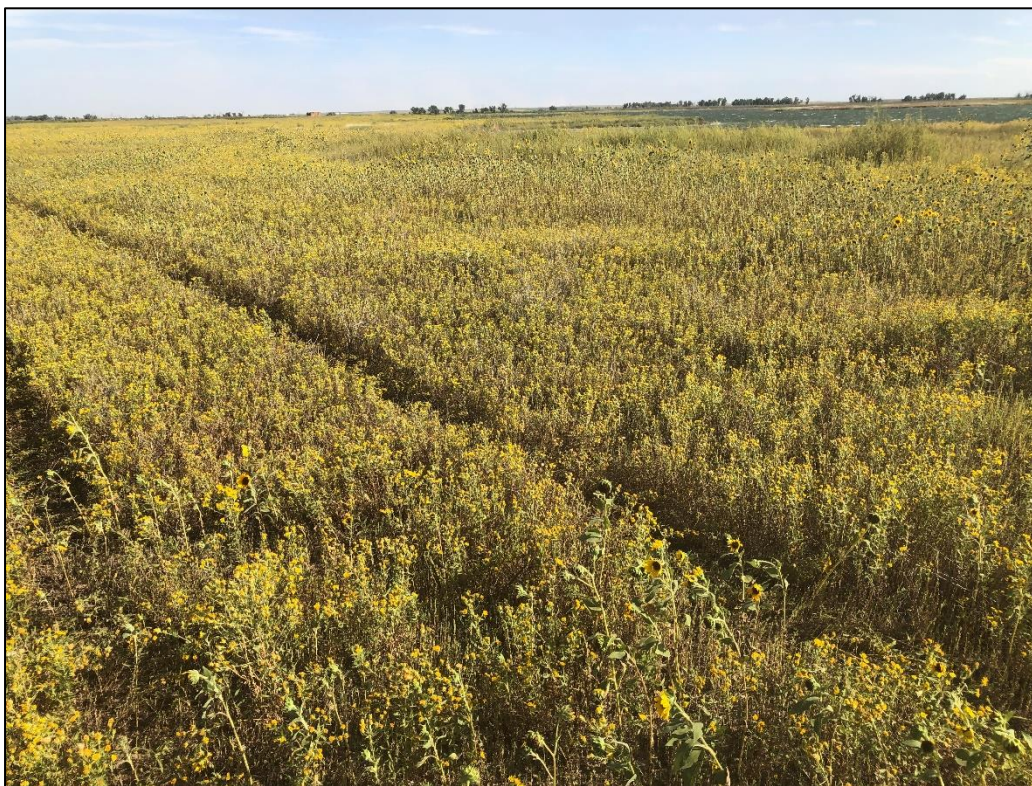
Photo 20. View looking southeast across area located northeast of pond, showing vegetative cover consisting primarily of weeds (e.g., wild sunflowers, field bindweed).

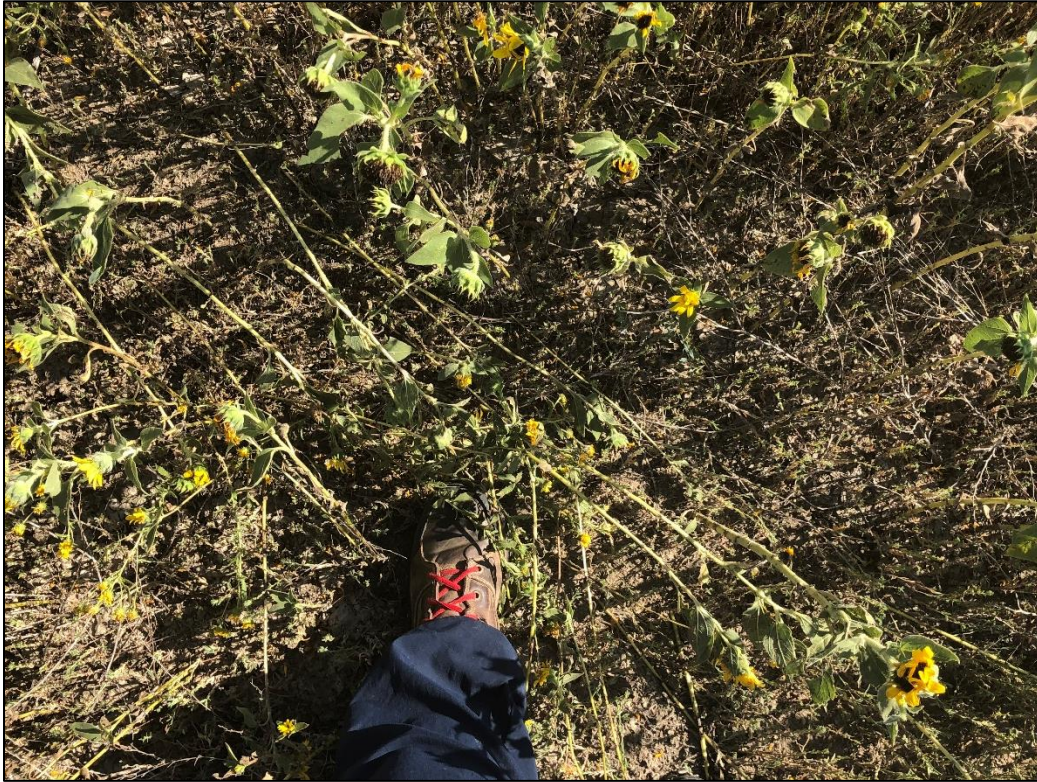
Photo 21. Ground view of area shown in Photo 20 located northeast of pond, showing field bindweed present in this area (beneath wild sunflowers).

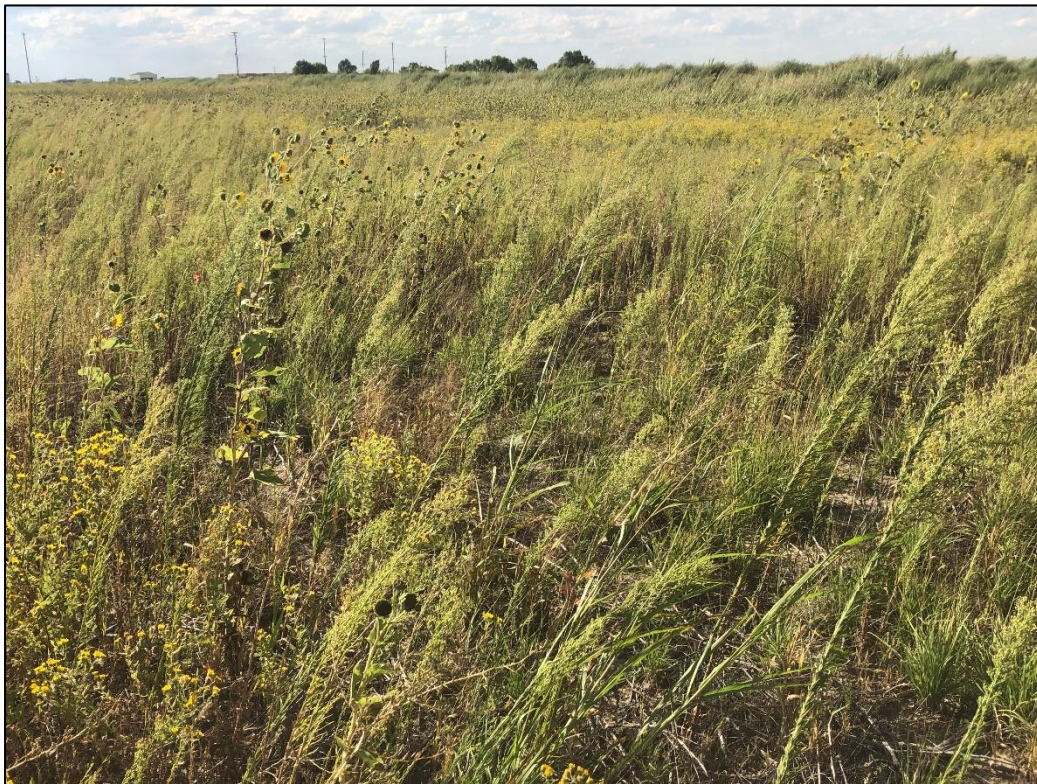
Photo 22. View looking west across area located north of pond, showing vegetative cover consisting primarily of weeds (e.g., wild sunflowers, marehail, curlycup gumweed, field bindweed).

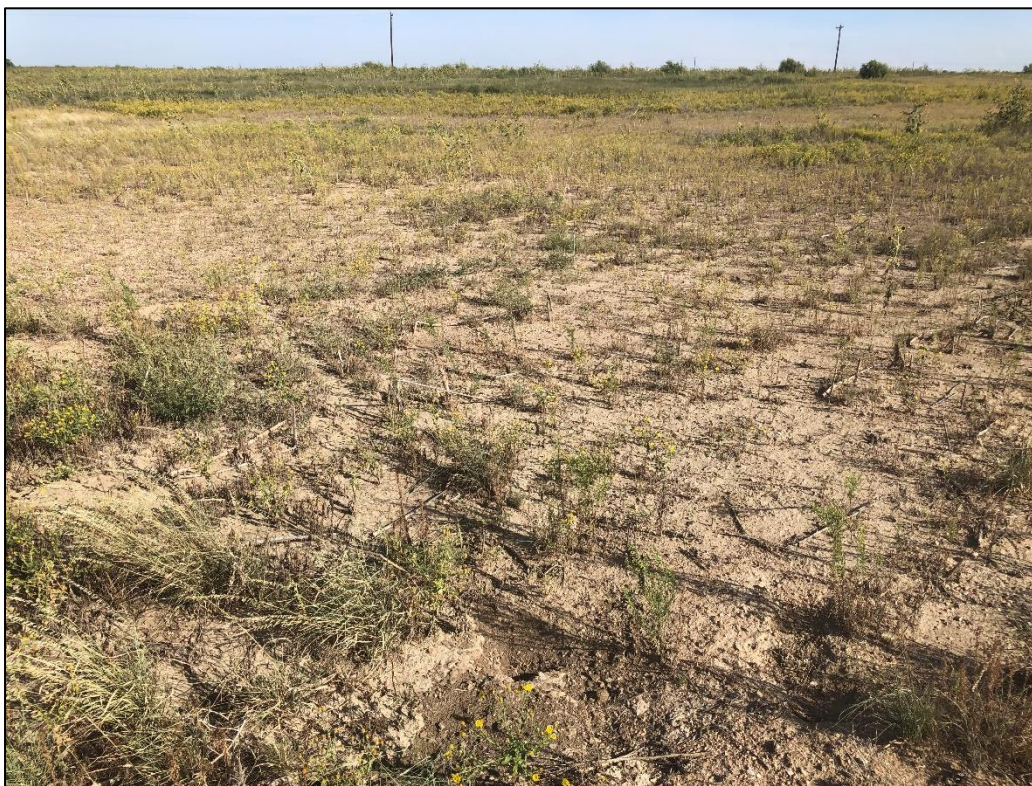
Photo 24. View looking southeast across area located north of pond with relatively sparse vegetative cover consisting of weeds and some grasses.

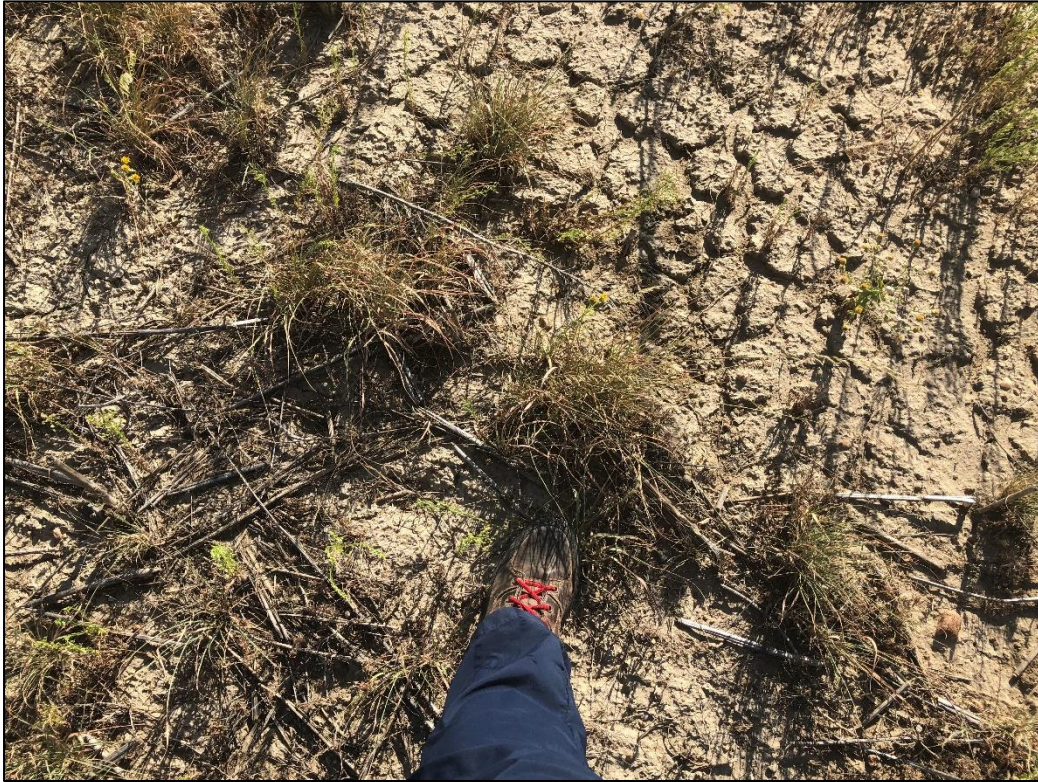
Photo 25. Ground view of area shown in Photo 24 located north of pond, showing some grasses present in this area.

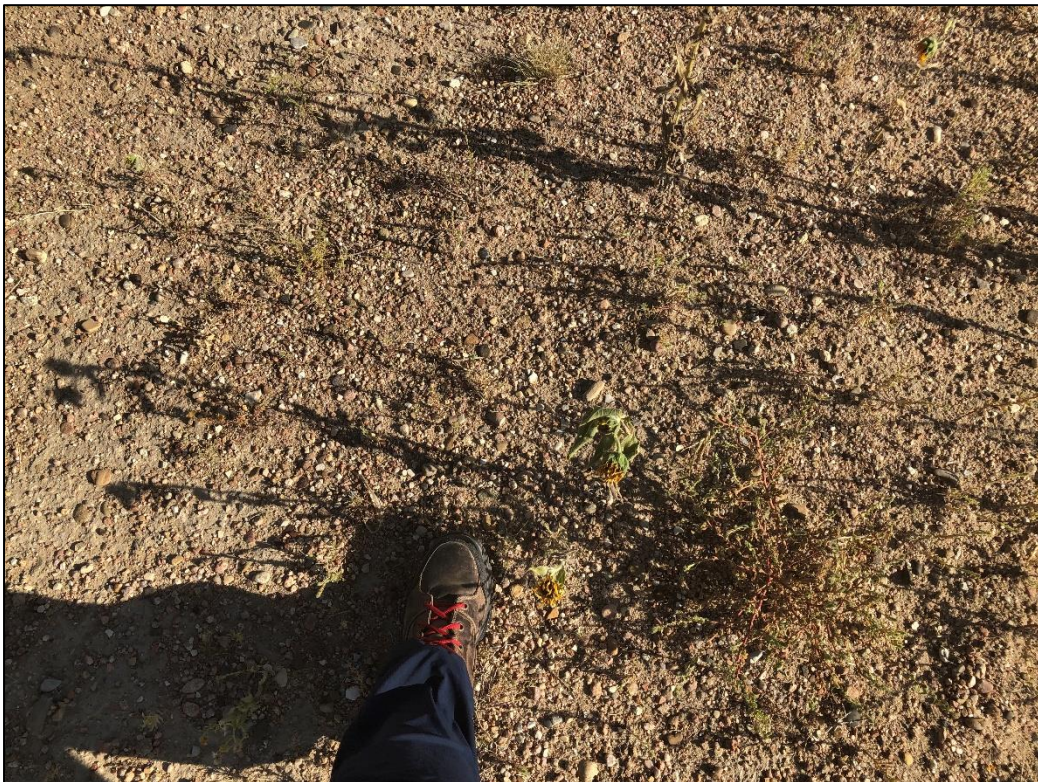
Photo 26. Ground view of area shown in Photo 24 located north of pond, showing sparse vegetative cover present in much of this area.
