Re: Midwestern Farms, Permit No. M-1993-059, Follow-Up on Unresolved Problems

MINERALS PROGRAM INSPECTION REPORT
PHONE: (303) 866-3567

MINE NAME: Midwestern Farms	MINE/PROSPECTING ID#: M-1993-059	MINERAL: Sand and gravel	COUNTY: Prowers
INSPECTION TYPE: Monitoring	INSPECTOR(S): Amy Eschberger	INSP. DATE: September 11, 2019	INSP. TIME: 15:15
OPERATOR: Midwestern Farms	OPERATOR REPRESENTATIVE: Mel DePra	TYPE OF OPERATION: 112c - Construction Regular Operation

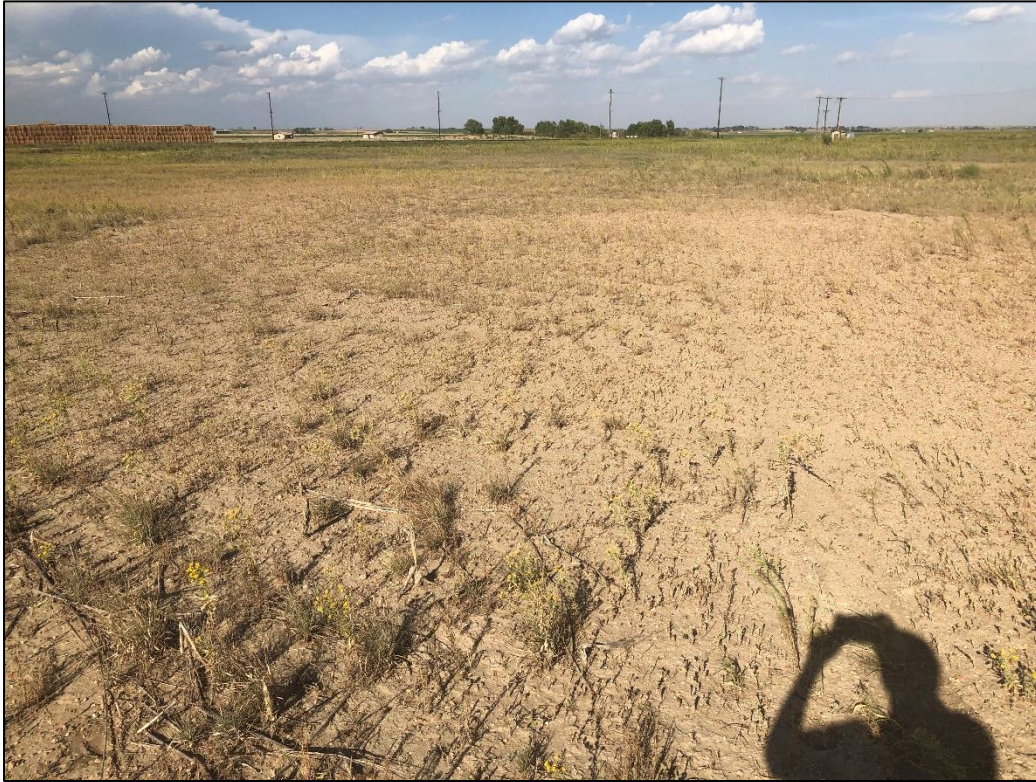
Photo 27. View looking northwest across area located northwest of pond, showing sparse vegetative cover consisting primarily of weeds with some grasses.

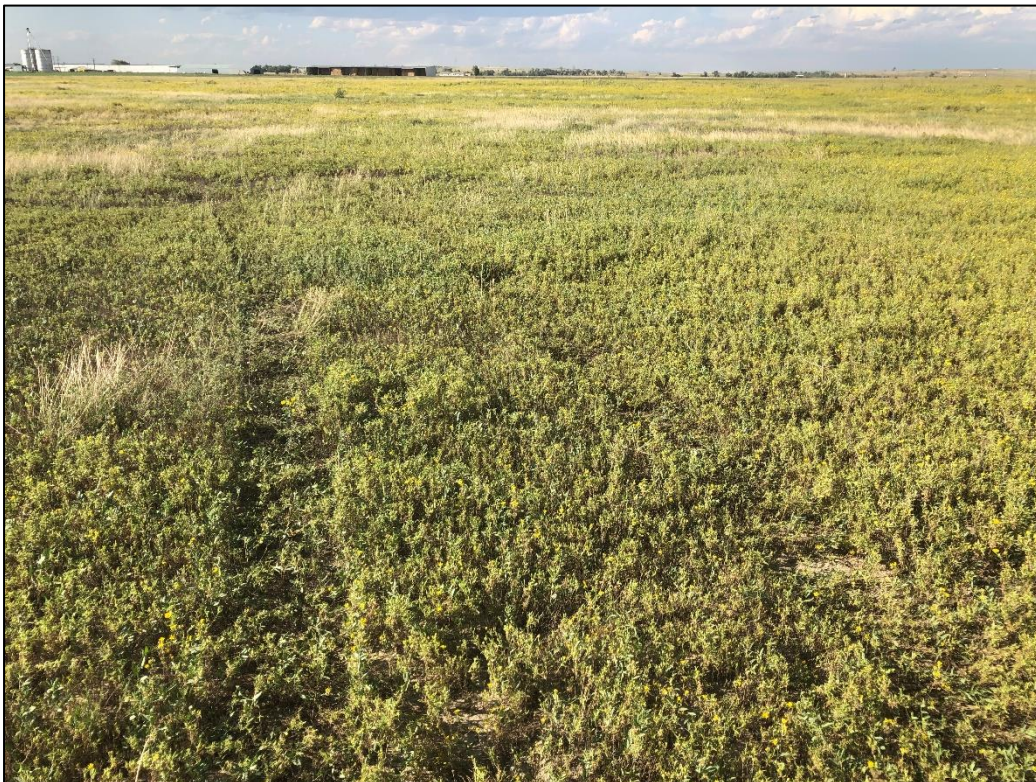
Photo 28. View looking north across area located northwest of pond, showing vegetative cover consisting primarily of weeds with some grasses.

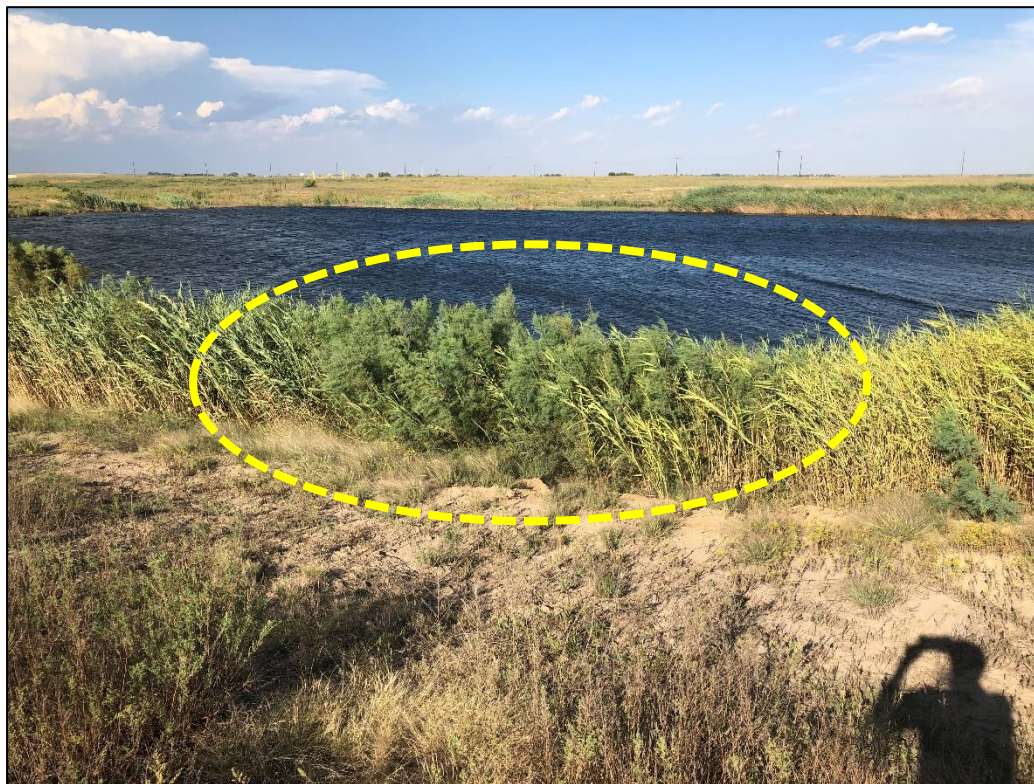
Photo 30. View looking east across northwestern portion of pond, showing Tamarisk trees present along northwestern pond shoreline (circled).

CORRECTIVE ACTIONS: By the corrective action date, the operator shall implement the approved weed control plan for all state-listed noxious weed species on the affected lands, and provide proof to the Division that this was done. If the operator wishes to revise the approved weed control plan, the proposed plan must be submitted in the form of a Technical Revision with the appropriate fee of \$216.00 by the corrective action date. The Division recommends the operator consult with the county extension agency or weed control district office in developing a plan that includes specific control measures to be applied, a schedule for when control measures will be applied, and a post-treatment monitoring plan.

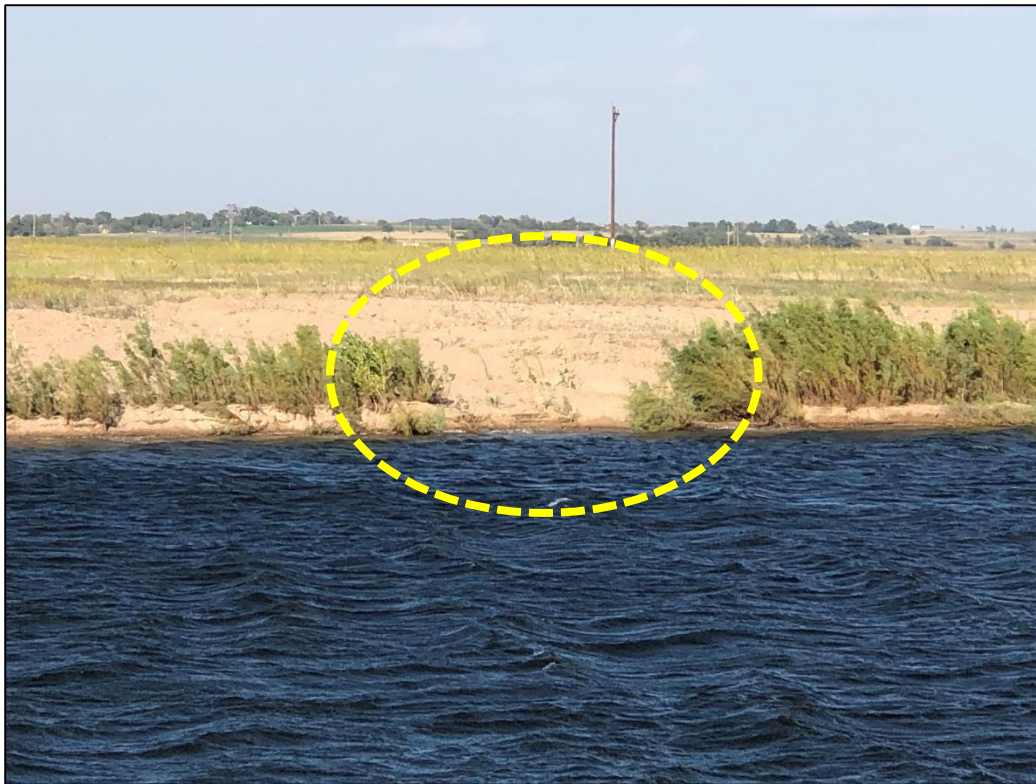
Photo 31. View looking east across northwestern portion of pond, showing erosion feature (circled) observed along northern pond shoreline.

CORRECTIVE ACTIONS: By the corrective action date, the operator shall provide the Division with photo documentation verifying the erosion damage on pond shorelines has been repaired, and the site has been reconstructed and stabilized to prevent further erosion damage. If the operator proposes an alternative method for

stabilizing the eastern pond shoreline (than the plan approved in TR-6), the operator must submit this proposal in the form of a Technical Revision with the appropriate fee of \$216.00 by the corrective action date.

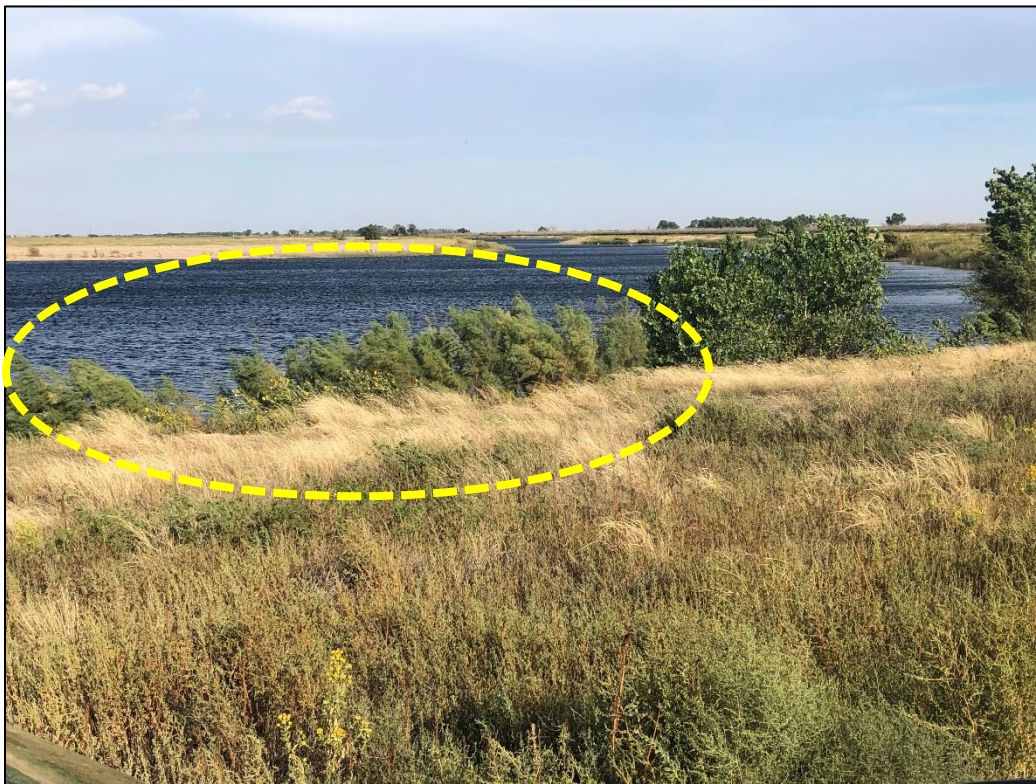
Photo 32. View looking east across area located southwest of pond, showing vegetative cover consisting of grasses and weeds. Note Tamarisk trees present along southern shoreline (circled).
