**MINERALS PROGRAM INSPECTION REPORT**  
**PHONE: (303) 866-3567**

<b>MINE NAME:</b> Dowe Flats Mine	<b>MINE/PROSPECTING ID#:</b> M-1993-041	<b>MINERAL:</b> Limestone and shale	<b>COUNTY:</b> Boulder
<b>INSPECTION TYPE:</b> Monitoring	<b>INSPECTOR(S):</b> Amy Eschberger	<b>INSP. DATE:</b> November 5, 2019	<b>INSP. TIME:</b> 14:30
<b>OPERATOR:</b> CEMEX, Inc.	<b>OPERATOR REPRESENTATIVE:</b> Cita Cisse, Scott Harcus, Robin Bay	<b>TYPE OF OPERATION:</b> 112c - Construction Regular Operation

This was a normal monitoring inspection of the Dowe Flats Mine (Permit No. M-1993-041) conducted by Amy Eschberger of the Division of Reclamation, Mining and Safety (Division). The operator was represented during the inspection by Cita Cisse, Scott Marcus, and Robin Bay. The site is located approximately two miles east of Lyons, Colorado in Boulder County. Access to the site is from the south off Hwy 66. **Photos 1-30** taken during the inspection are included with this report.

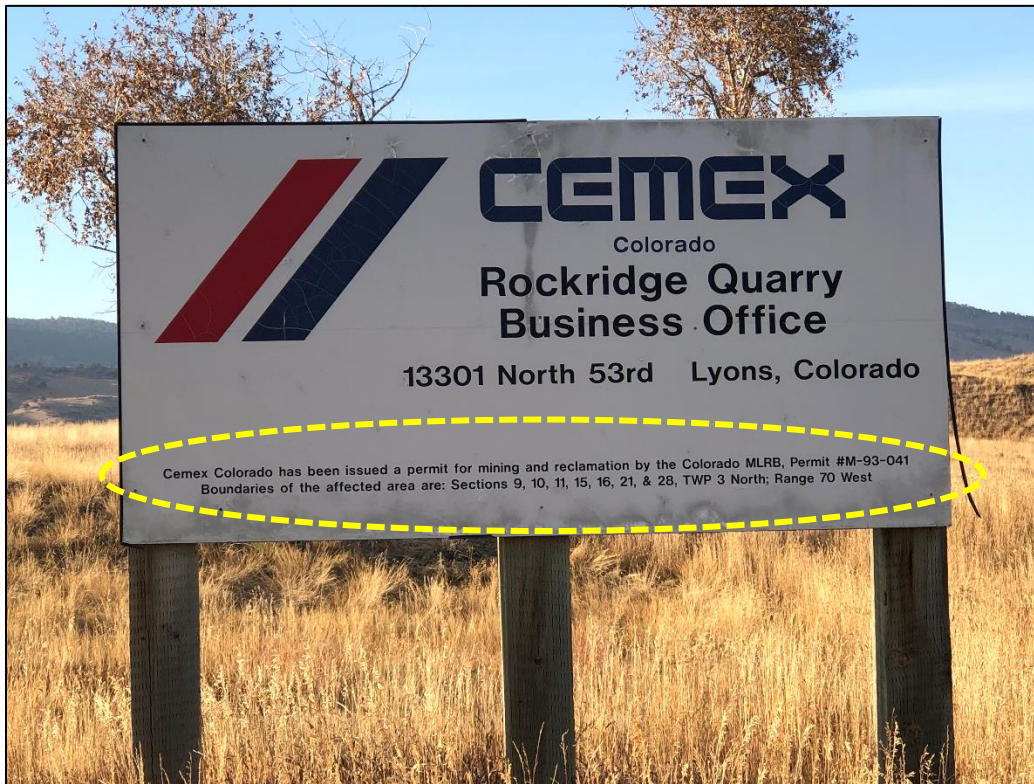
The Division observed a mine identification sign posted at the main site entrance off Hwy 66. The font size of the permit information on this sign was difficult to read from the access road. Therefore, the Division recommends the operator review Rule 3.1.12(1) (see enclosed rule) to ensure the permit identification sign meets the sizing requirements. The Division did not check boundary markers during this inspection, as the focus of the inspection was to provide Division staff new to the site an overview of the operation. However, the Division does intend to check boundary markers during the next site inspection, which will be conducted once the operator has provided updated maps depicting the entire approved permit and affected lands boundaries. In the meantime, the operator should be sure the approved permit boundary is marked by monuments or other markers that are clearly visible and adequate to delineate such boundaries in accordance with Rule 3.1.12(2). This would include the portion of the permit boundary located south of Hwy 66.

**Photo 1.** View of permit identification sign posted at main site entrance. Permit information on sign (circled) may not meet sizing requirements of Rule 3.1.12(1).

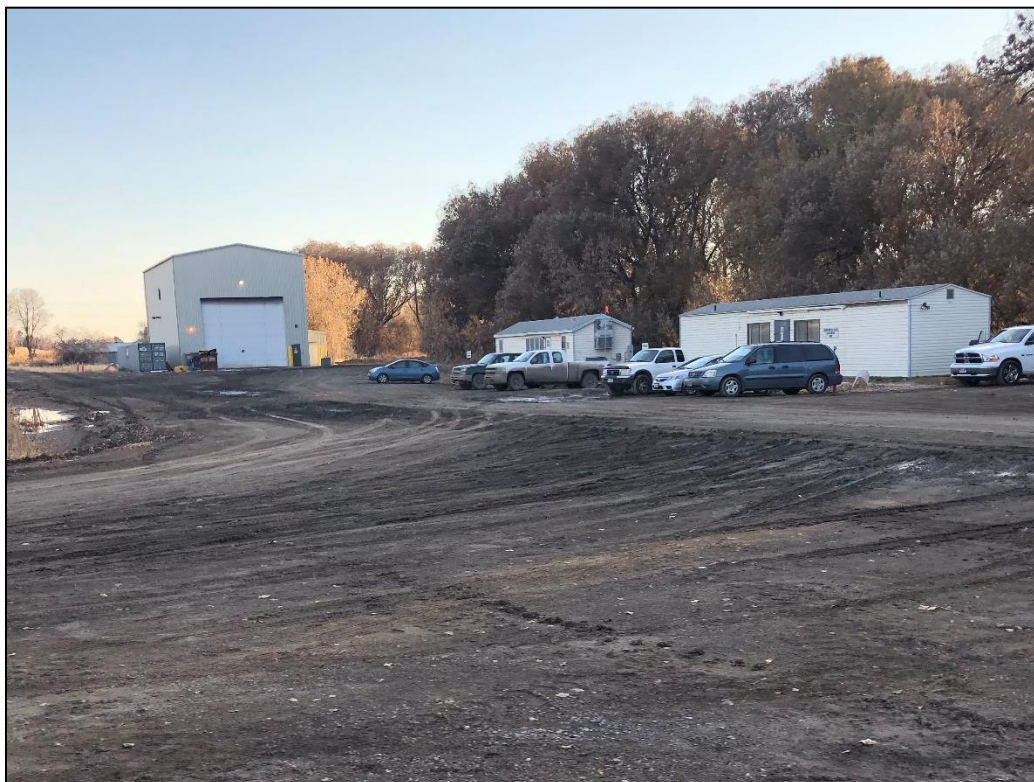
The Division observed the office and maintenance shop area and the fuel station located near the site entrance. The shop area includes a metal maintenance shop building with a slab on grade concrete foundation, and two office trailers set on concrete block foundations. The fuel station is located adjacent to the main access road near the mine entrance. The fuel is stored within a secondary containment unit. No problems were observed in these areas.

**Photo 2.** View looking south across maintenance shop area located near site entrance. Note maintenance building and two office trailers present in this area.

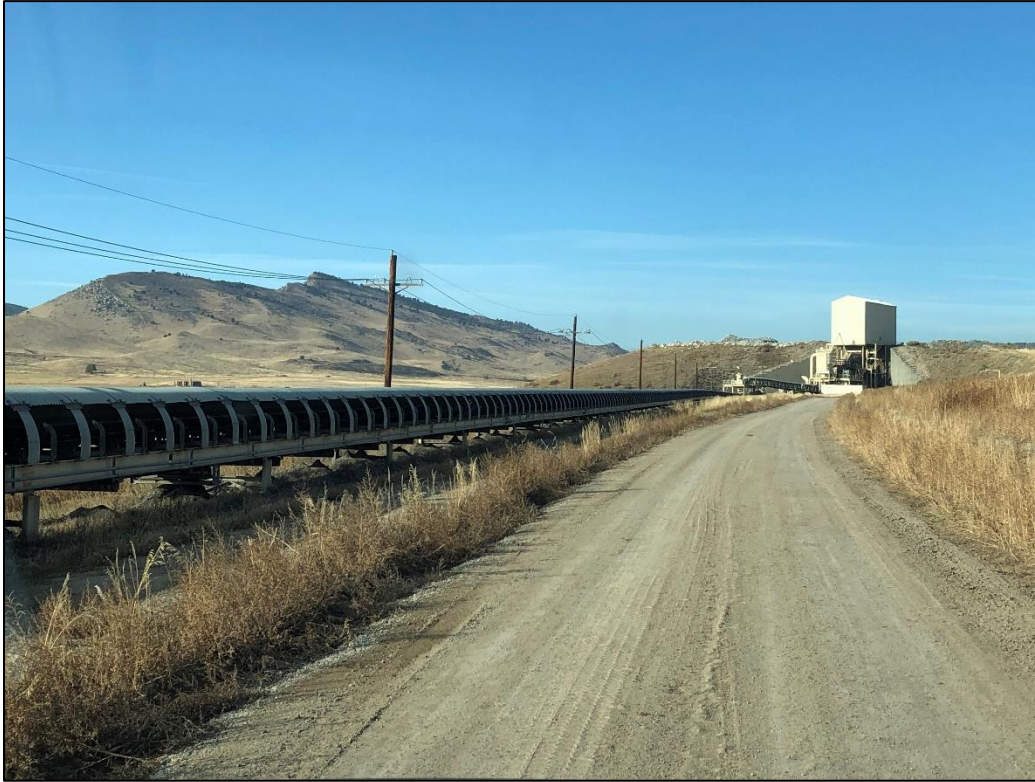
**Photo 3.** View looking north toward crusher facility (visible in distance), showing conveyor system (at left) which extends from crusher to plant site south of Hwy 66.

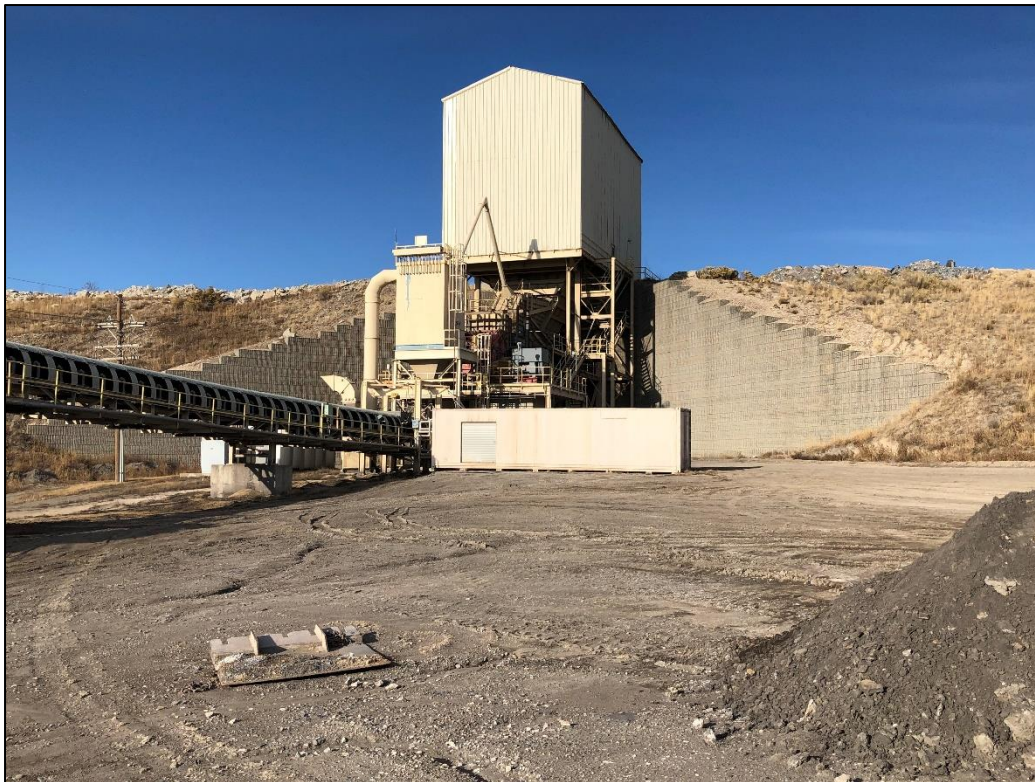
The crusher facility is located along the main haul road, south of the active mining area. A large steel housing and retaining wall are constructed around the crusher unit that feeds the conveyor system. The crusher facility and conveyor system were not in operation during the inspection. Mined material is stockpiled in an area above (north and east of) the crusher facility.

**Photo 4.** View looking north at crusher facility located near main haul road, south of active mining area. Note crusher is enclosed in a metal housing.

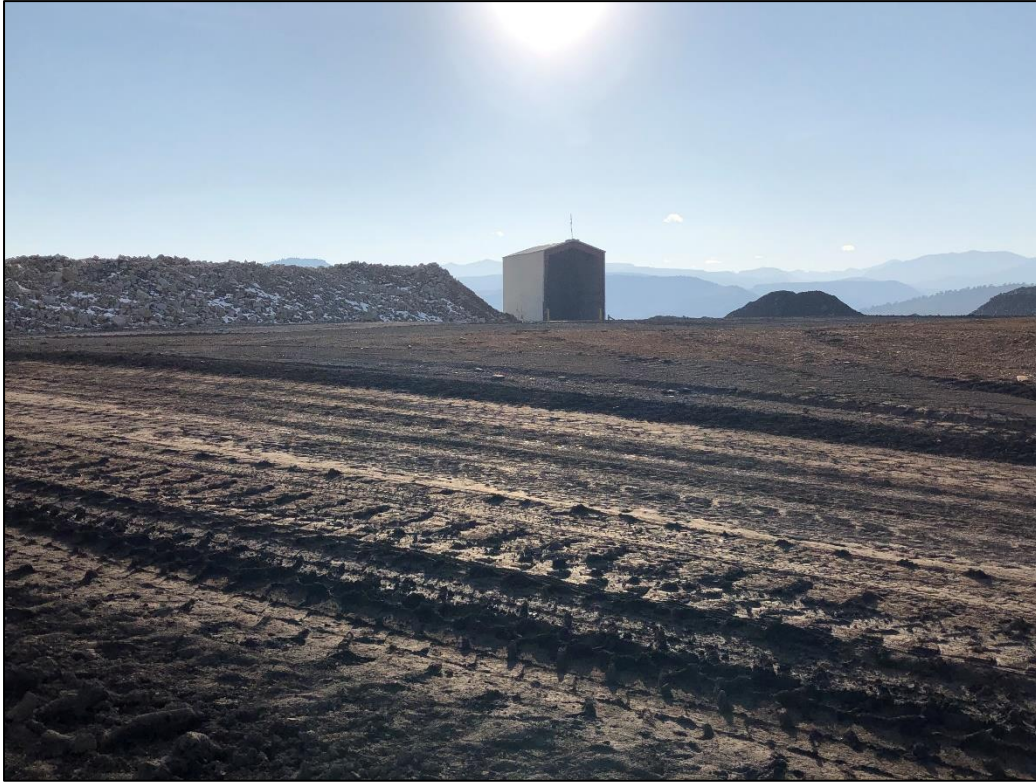
**Photo 5.** View looking southwest across material stockpiling area located above crusher facility, adjacent to main haul road.

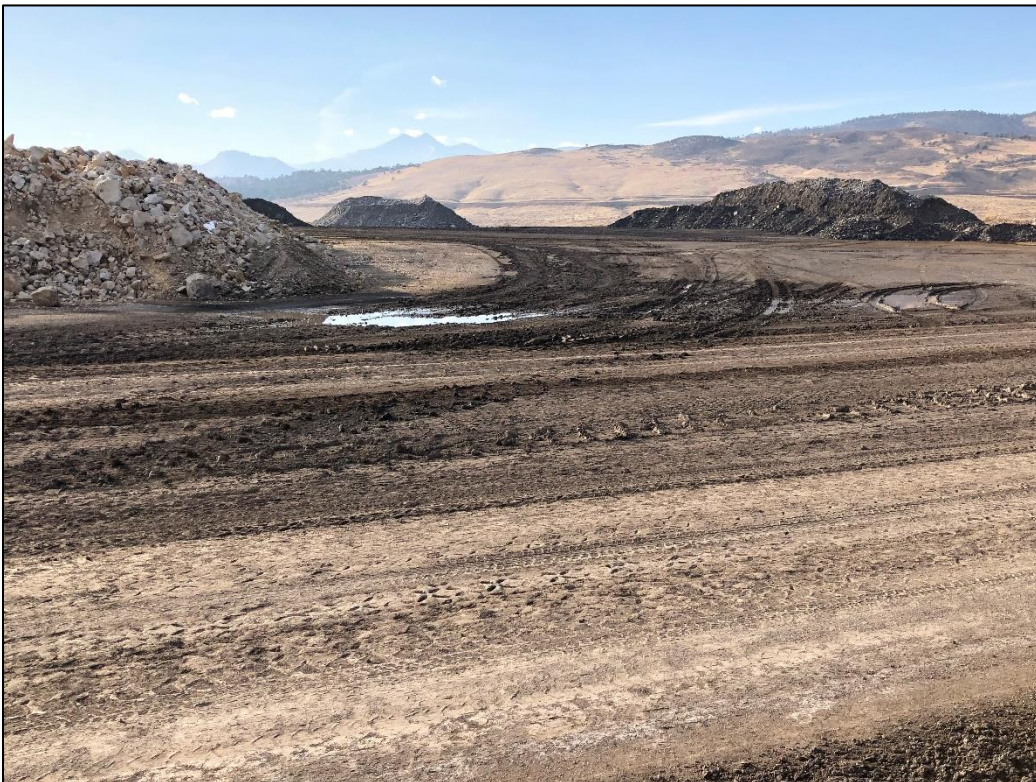
**Photo 6.** View looking northwest across material stockpiling area located above crusher facility, adjacent to main haul road.

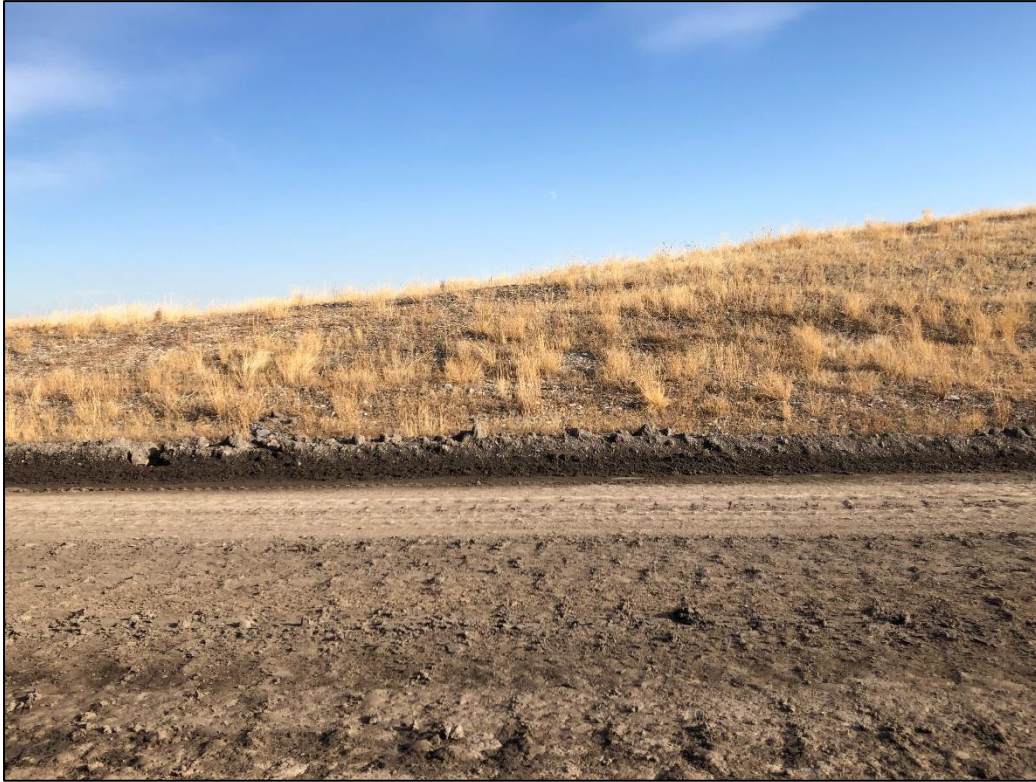
**Photo 7.** View looking east at topsoil berm along eastern edge of main haul road, stabilized with good grass cover.

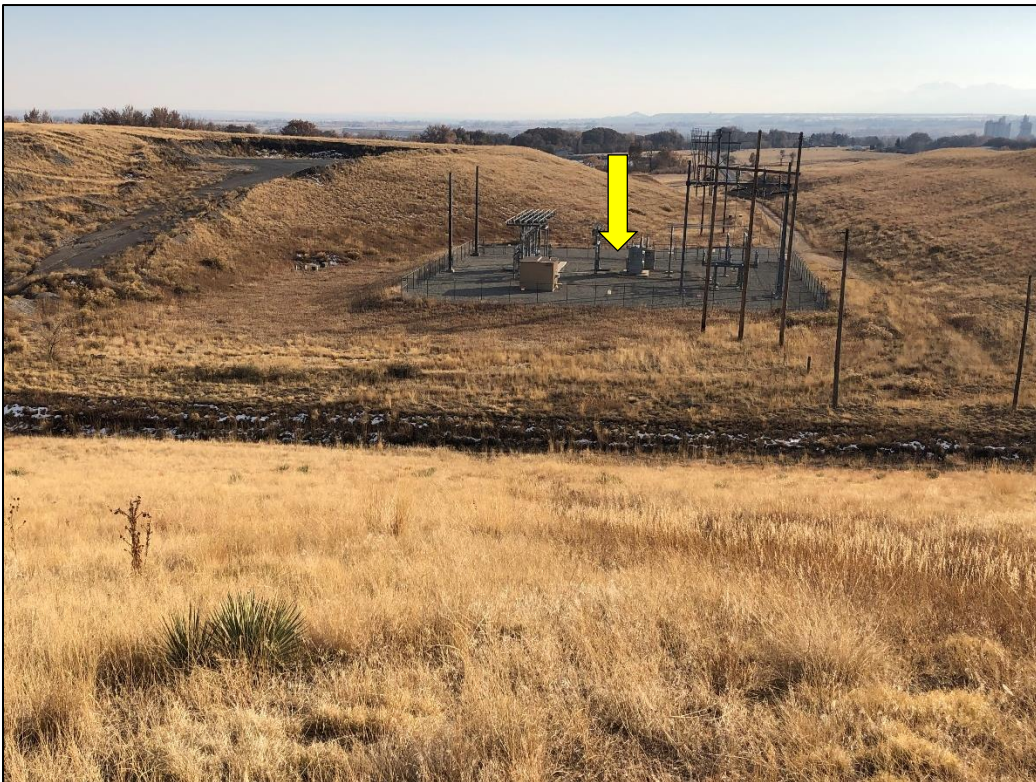
**Photo 8.** View looking southeast at two acre parcel (indicated) which was removed from permit area (through AR-2) for Poudre Valley Rural Electric Substation.

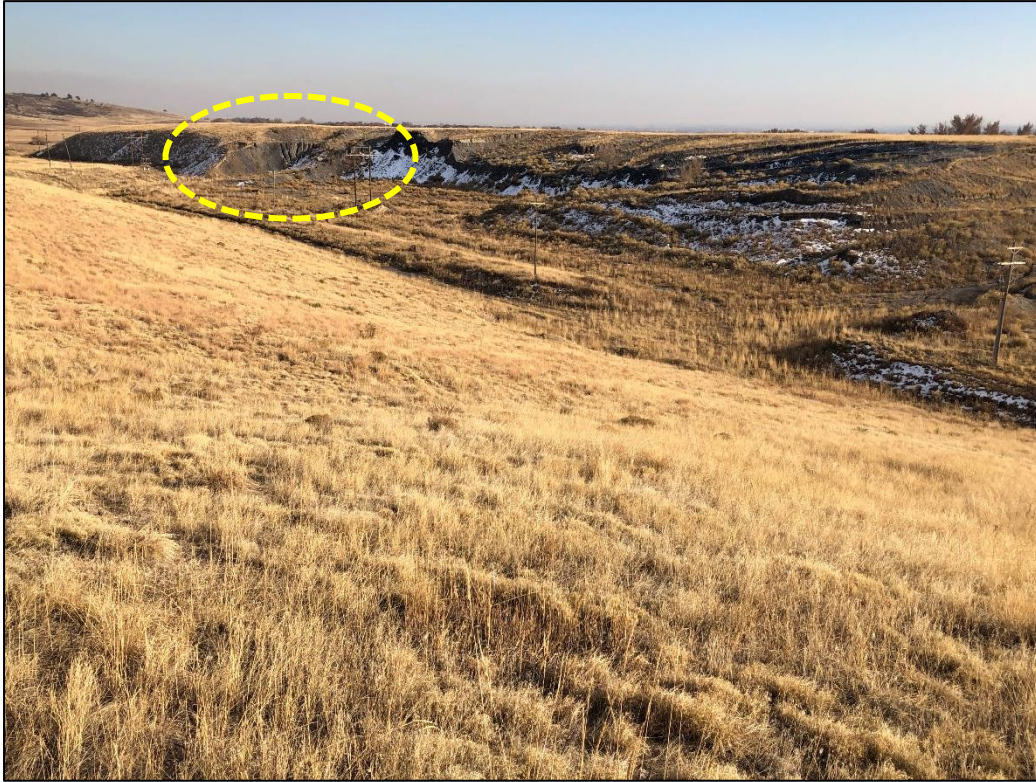
Salvaged topsoil is stored mainly along the eastern edges of the mining area. These stockpiles appeared to be stable with good vegetative cover. The Division observed the large overburden stockpile stored along the southern edge of the mine site. This stockpile was also stable with good vegetative cover, except for a portion of its northern side (facing the mine) where the operation has removed material from the stockpile for use in reclamation backfilling.

**Photo 9.** View looking southeast at large overburden stockpile stored at southern edge of mine, stabilized with good grass cover, except where material has been removed (area circled) for reclamation backfilling.

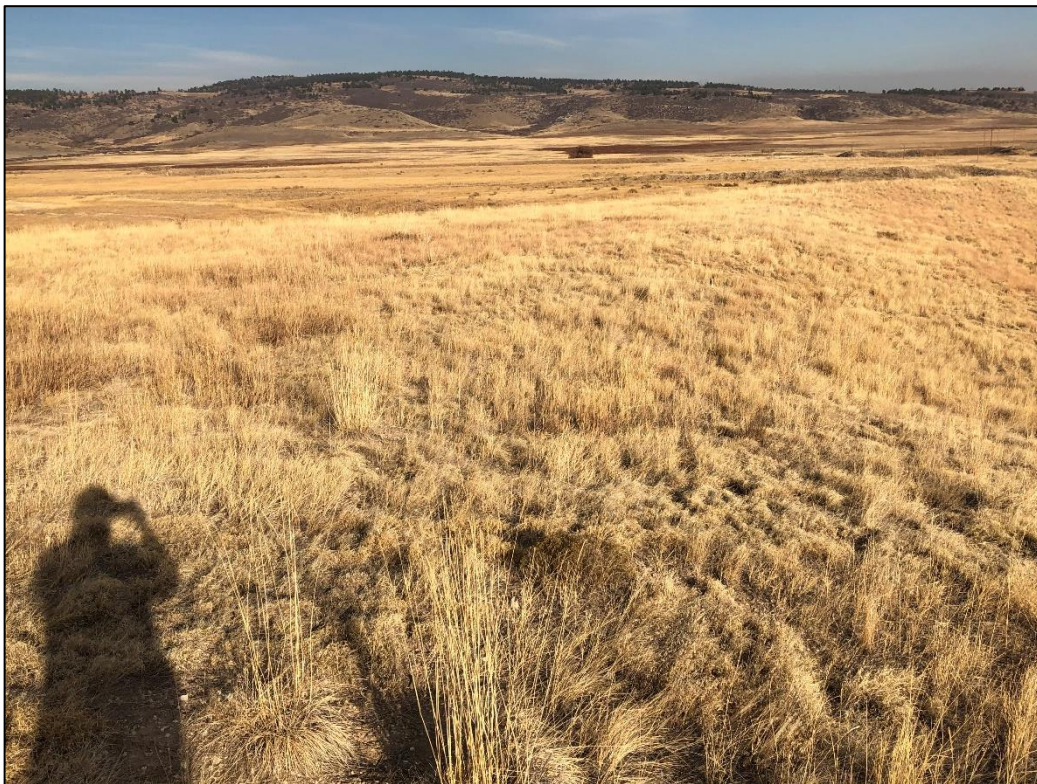
The Division observed the previously mined southern portion of the mine site, between the large overburden stockpile and the active pit area. This area (approximately 111 acres in size) was graded to match surrounding topography and is now well vegetated with native grasses, forbs, and some shrubs. It appeared this area has been in reclamation for many years and much if not all of it may be releaseable at this time. However, if the operator were to request a partial release of this area, the revised permit area must include access to any stockpiled material that will be needed for reclamation, including the large overburden stockpile.

**Photo 10.** View looking east across reclaimed area located south of active mining area, with slopes graded 3H:1V or flatter and established grass cover.

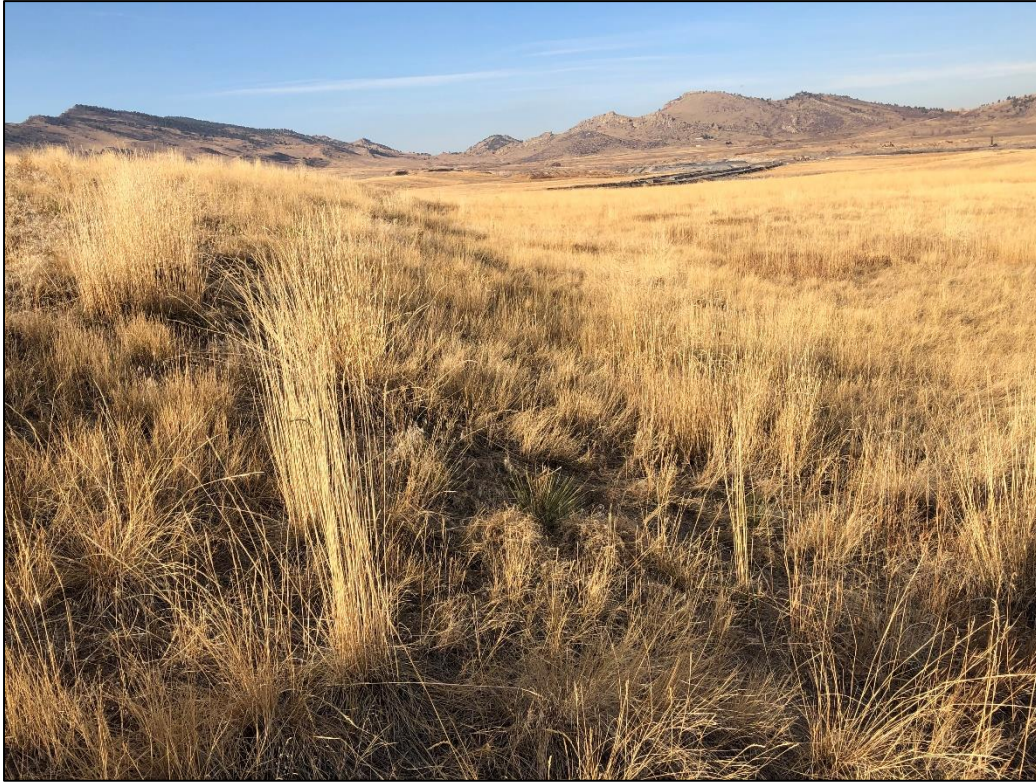
**Photo 11.** View looking north across reclaimed area located south of active mining area, with slopes graded 3H:1V or flatter and established grass cover.

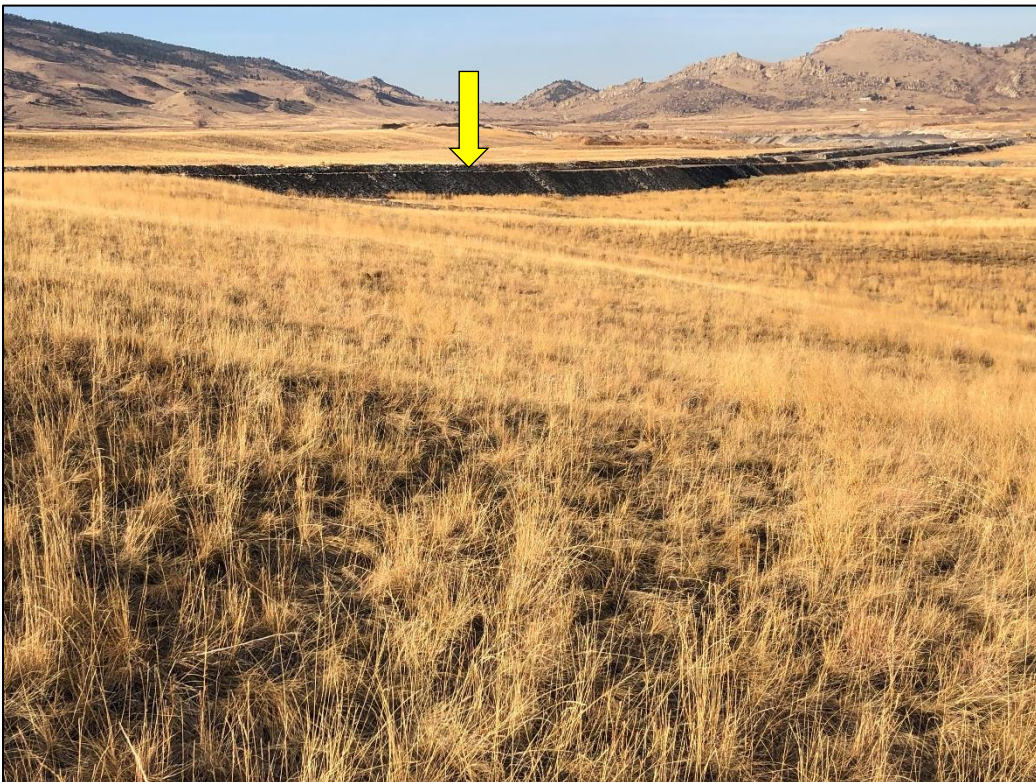
**Photo 12.** View looking northeast across reclaimed area located south of active mining area, with slopes graded 3H:1V or flatter and established grass cover. Note road constructed along northern edge of this area (indicated) to access 3<sup>rd</sup> Ridge pit.

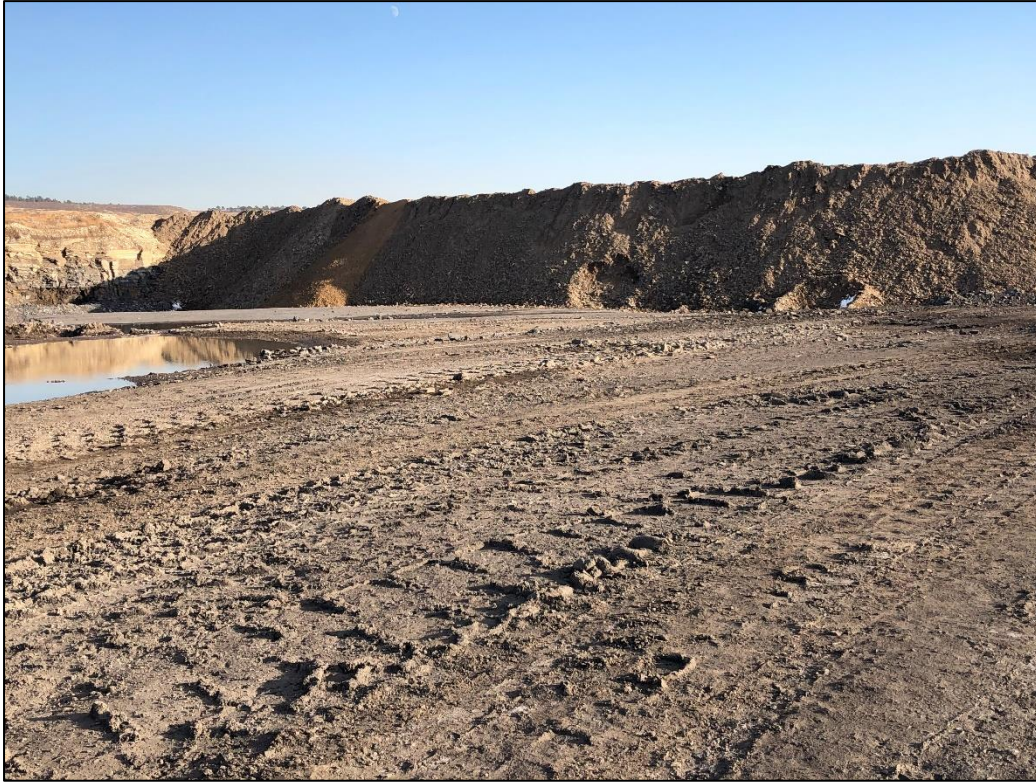
Hi-Cal pit was labeled as the Inter-Ridge mining area. This area appears to be in the process of being backfilled. The 3<sup>rd</sup> Ridge pit is located in the southeastern portion of the mining area. This pit is approximately 25-30 feet in depth with near vertical highwalls. The operation was drilling along the northern edge of the 3<sup>rd</sup> Ridge pit in preparation for blasting. The 4<sup>th</sup> Ridge pit is located east of the Hi-Cal pit, and is approximately 12-15 feet deep at this time. Some scattered pools of water were observed in portions of the 3<sup>rd</sup> Ridge and 4<sup>th</sup> Ridge pits which could most likely be attributed to recent storm events and snow melt. In recent years, the operation has backfilled portions of the active pits, including western and southern portions of the Hi-Cal pit and northern and southern portions of the 3<sup>rd</sup> Ridge pit. These areas will need to be retopsoiled and seeded once final grading has been completed.

**Photo 13.** View looking south across 3<sup>rd</sup> Ridge pit, showing backfilled southern portion of pit which will need to be retopsoiled and seeded once final grading is complete.

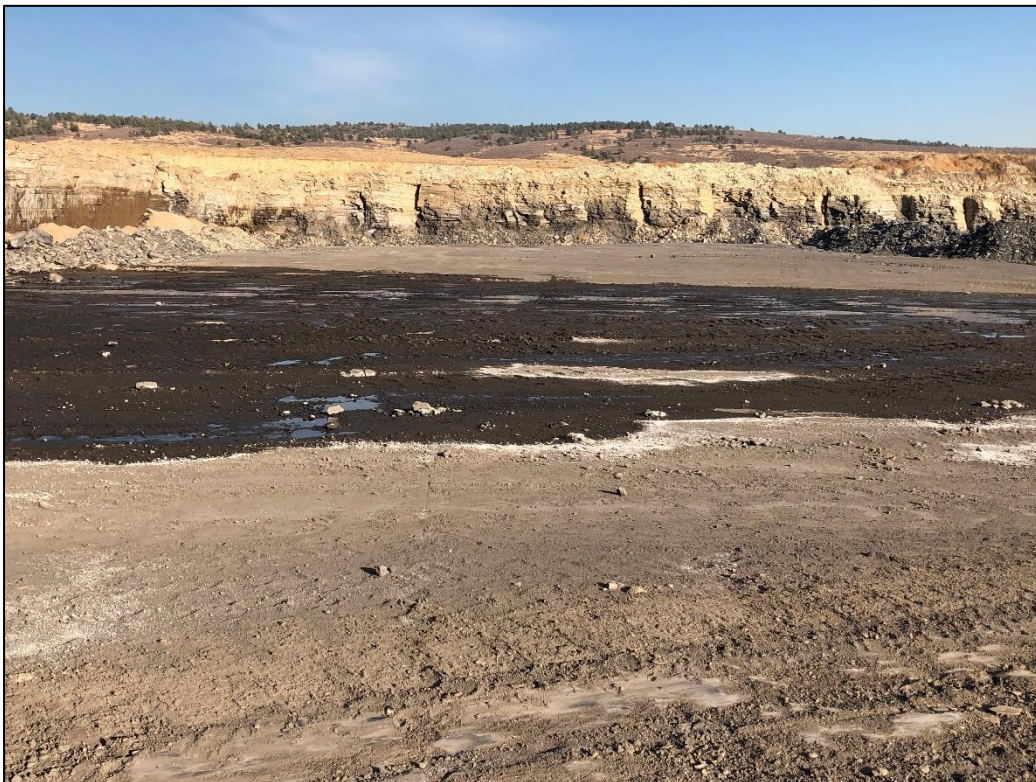
**Photo 14.** View looking east across 3<sup>rd</sup> Ridge pit, showing eastern pit wall (in background), approximately 20-25 feet in height with near vertical slopes.

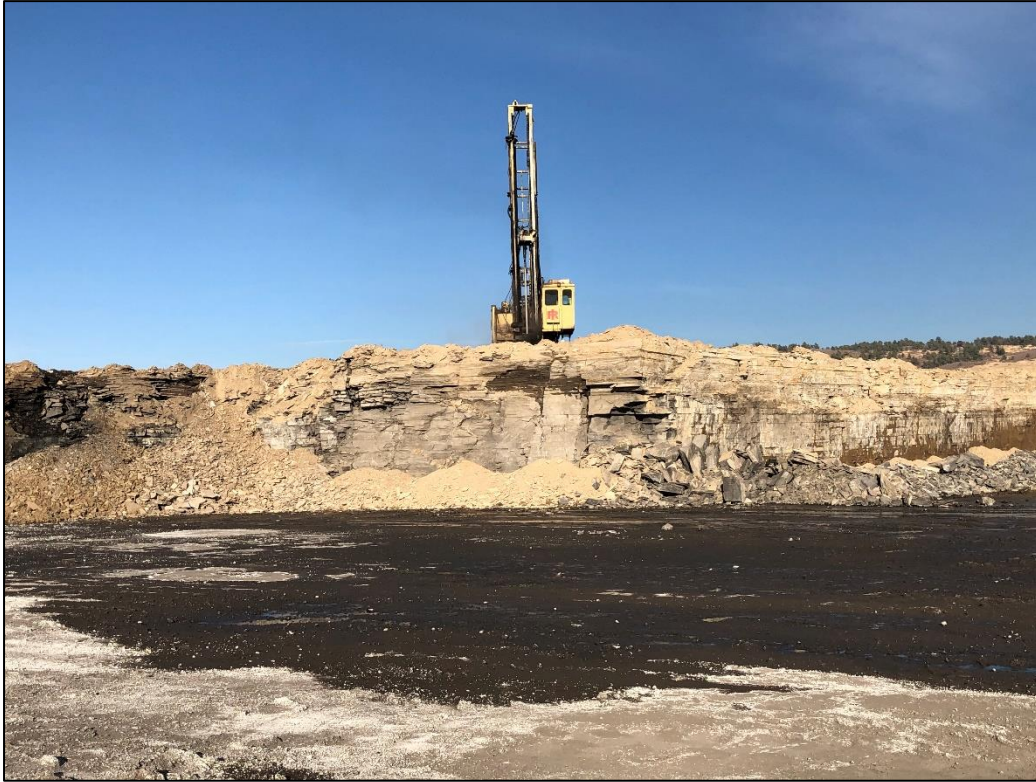
**Photo 15.** View looking northeast across 3<sup>rd</sup> Ridge pit, showing operation drilling along northern pit wall in preparation for blasting.

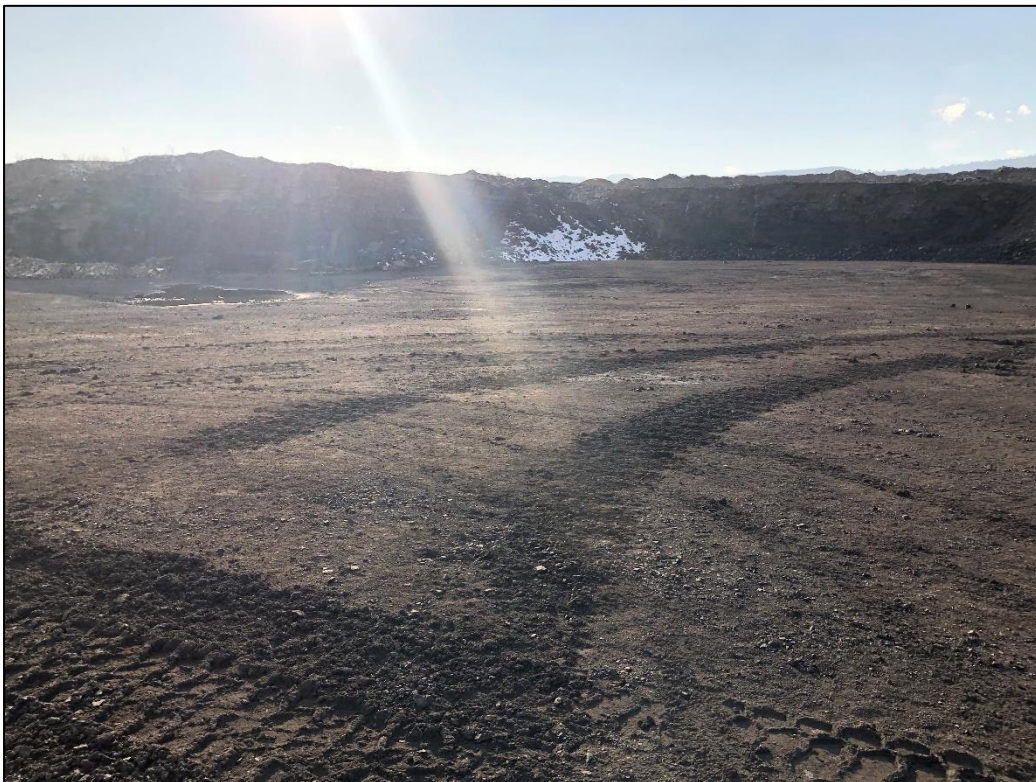
**Photo 16.** View looking north across 3<sup>rd</sup> Ridge pit, showing northern pit wall (in background), approximately 25-30 feet in height with near vertical slopes.

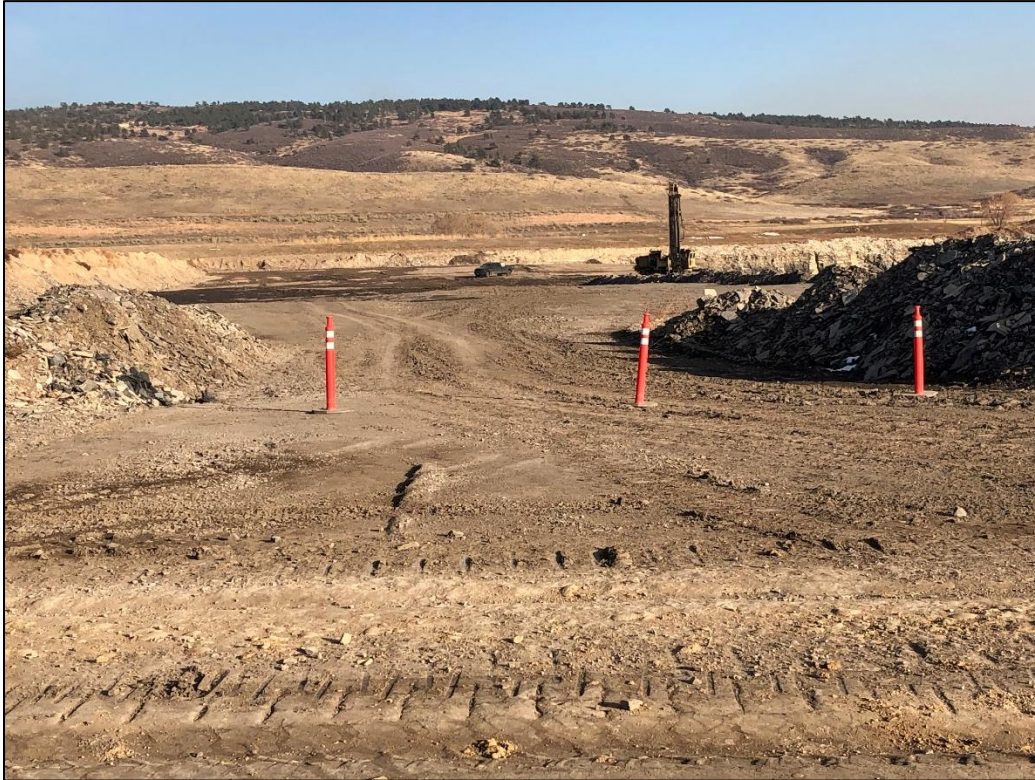
**Photo 17.** View looking east across area north of 3<sup>rd</sup> Ridge pit where drilling was occurring during inspection in preparation for blasting.

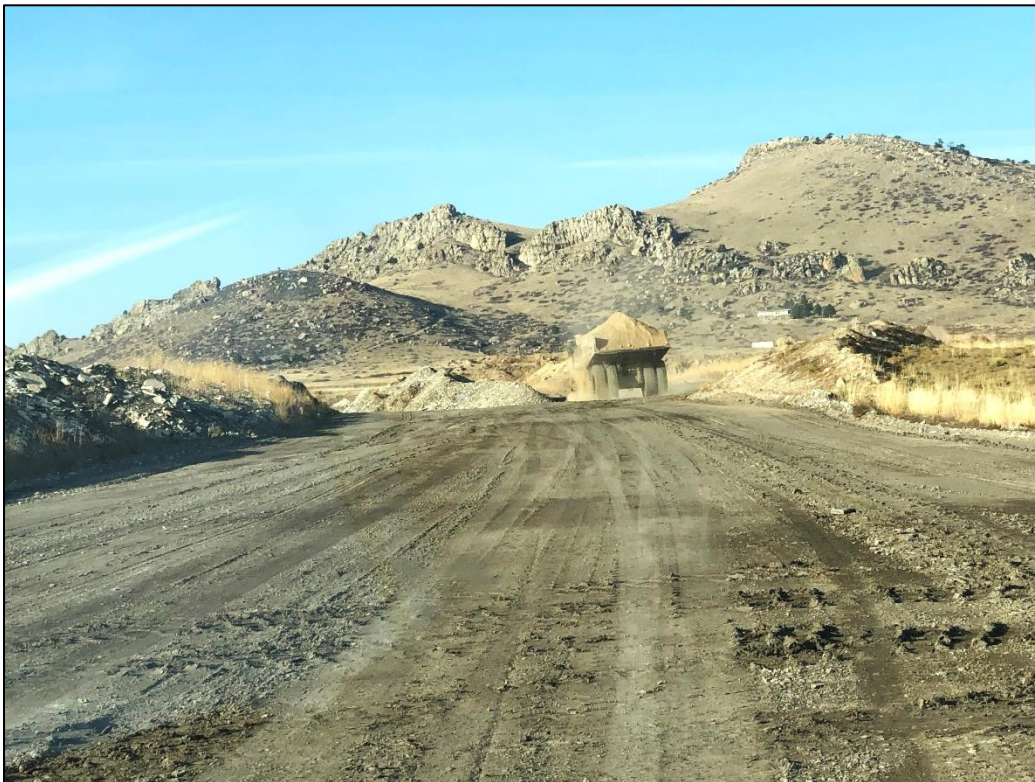
**Photo 18.** View looking north, showing active haul truck on site during inspection.

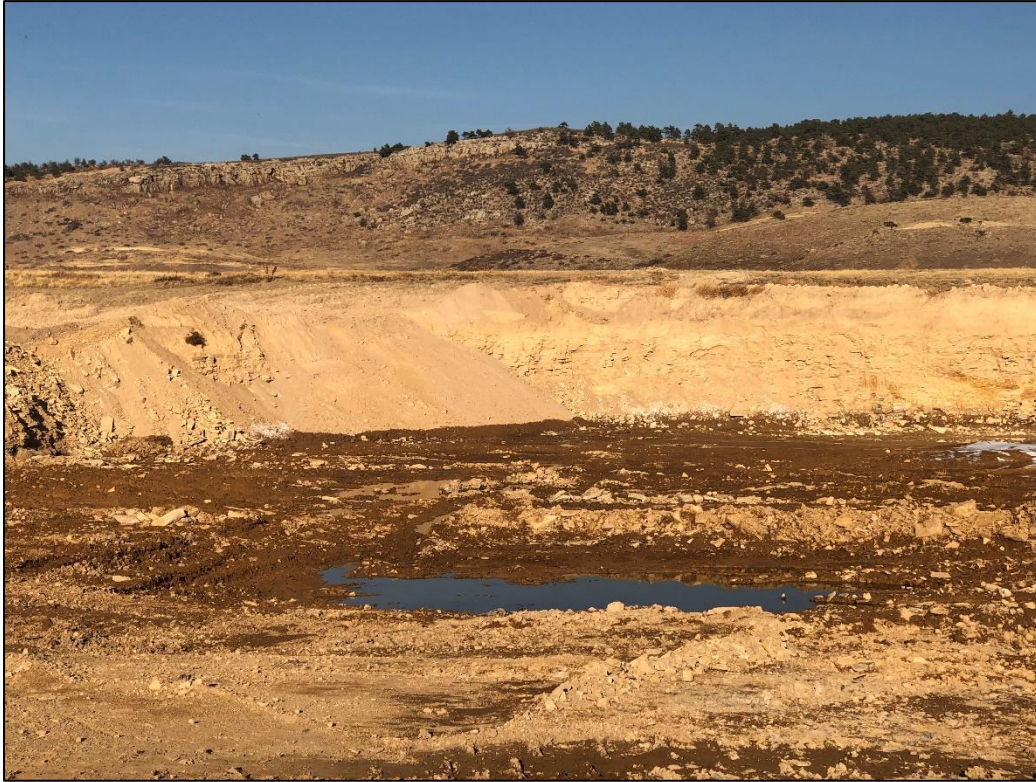
**Photo 19.** View looking north across 4<sup>th</sup> Ridge pit, showing northern pit wall approximately 15 feet in height with near vertical to 1H:1V slopes.

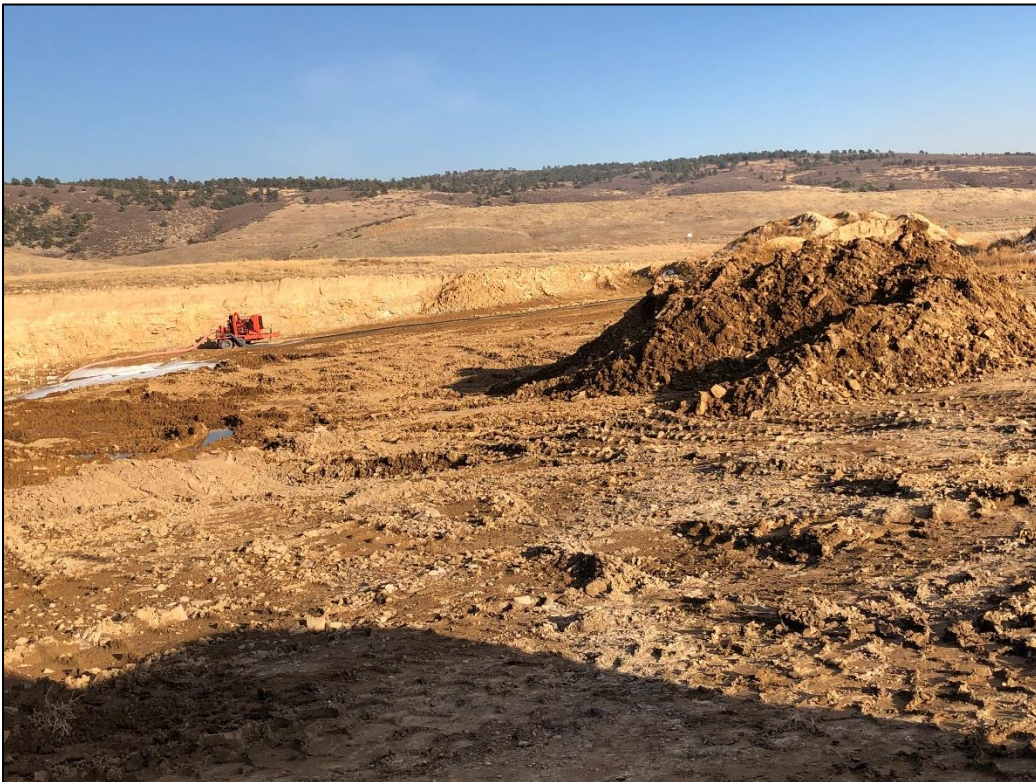
**Photo 20.** View looking east across 4<sup>th</sup> Ridge pit.

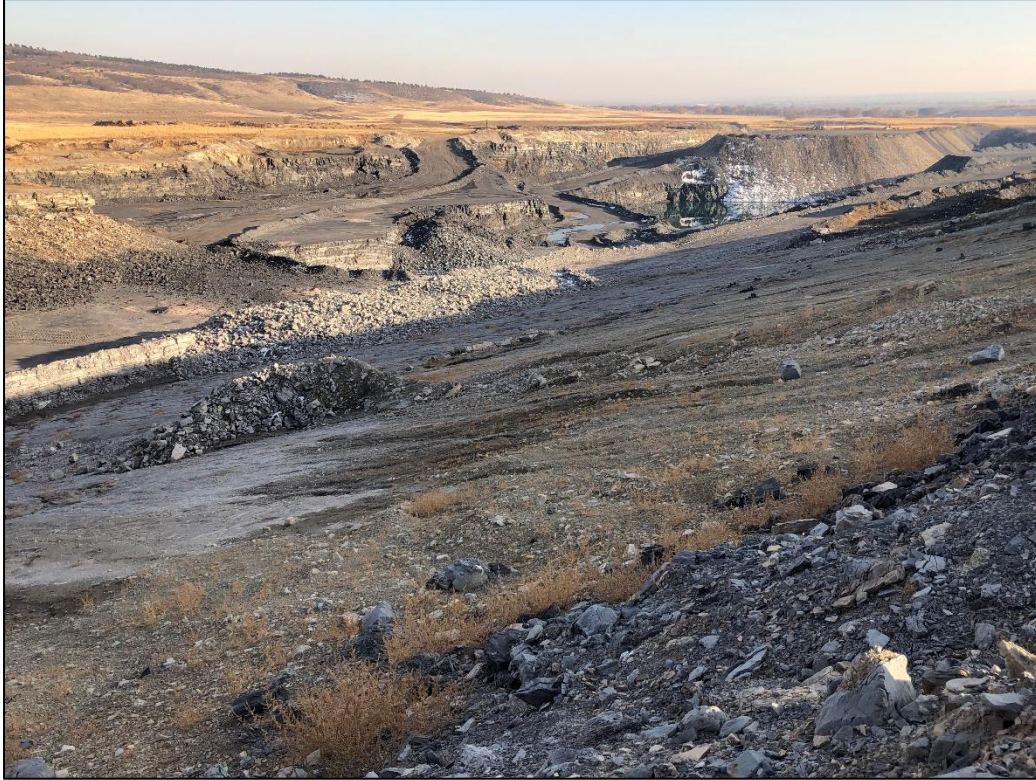
**Photo 21.** View looking southeast across Hi-Cal pit from its northwestern edge. Note western pit slope (in foreground) graded to 3H:1V or flatter.

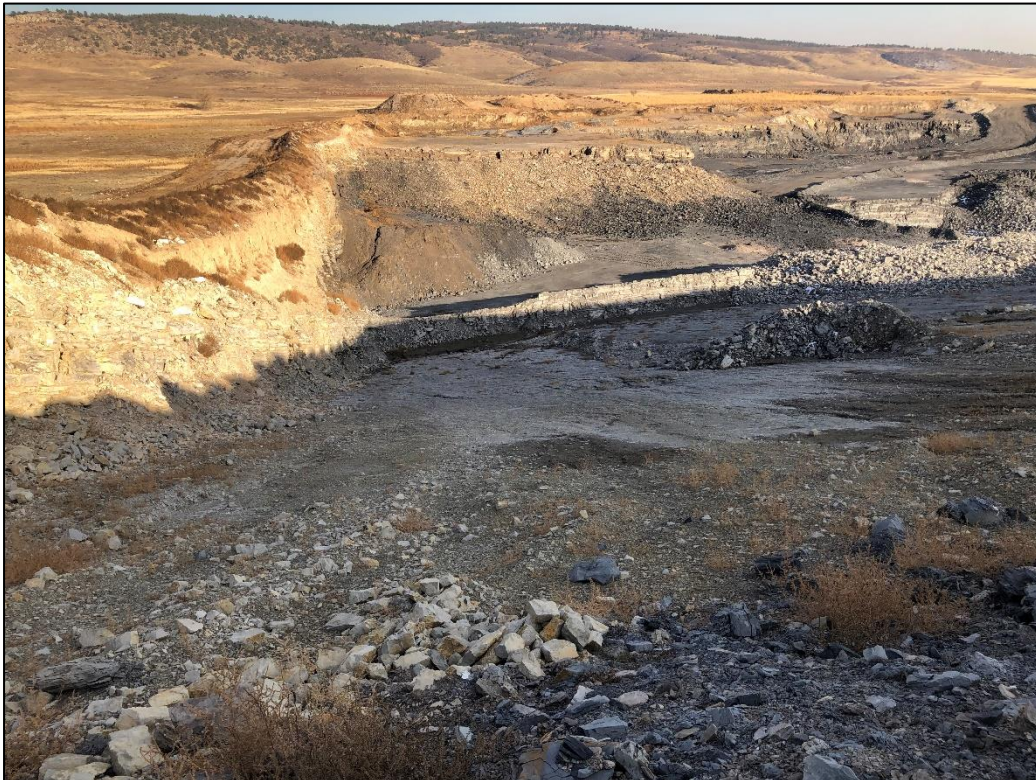
**Photo 22.** View looking east across northern portion of Hi-Cal pit from its northwestern edge.

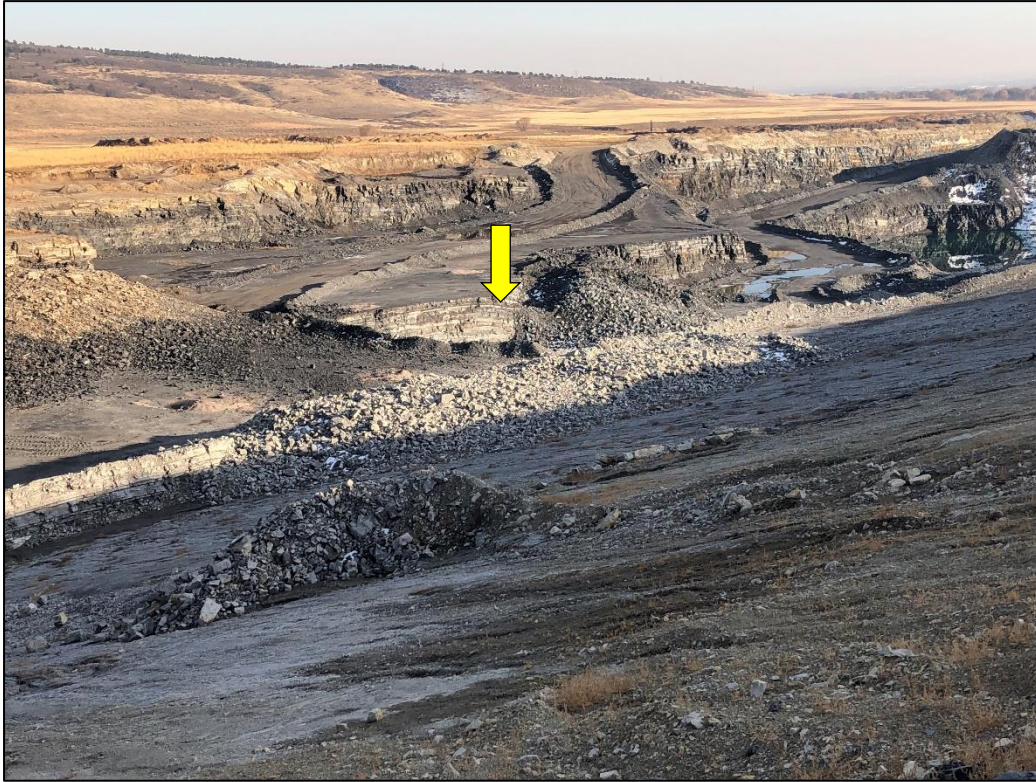
**Photo 23.** View looking southeast across center of Hi-Cal pit from its northwestern edge. Most recent excavation area at north-central portion of pit floor (indicated).

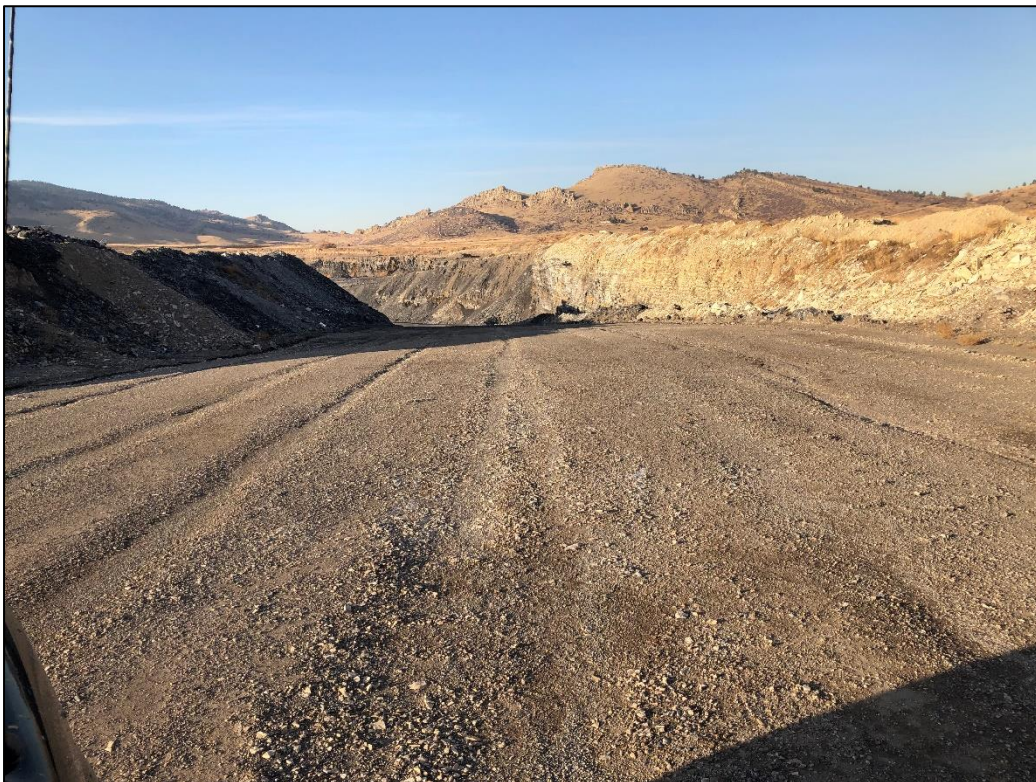
**Photo 24.** View looking north across area designated as Inter-Ridge pit, located at southern edge of Hi-Cal pit. This area appears to be in the process of being backfilled.

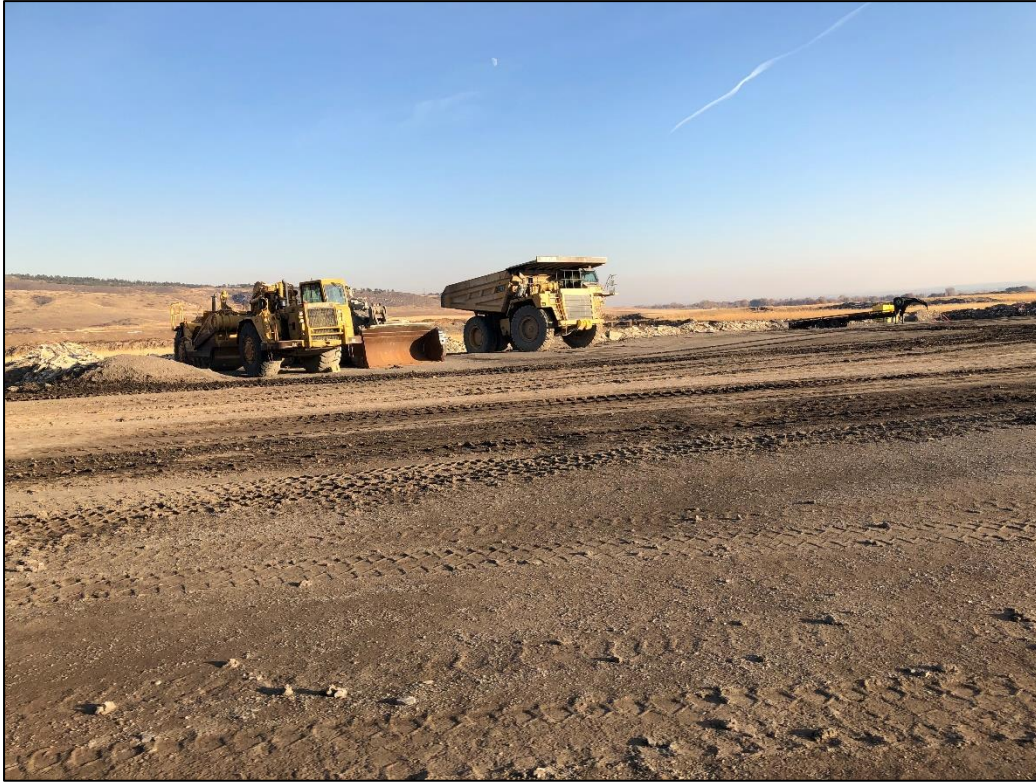
**Photo 25.** View looking east across equipment storage area located adjacent to main haul road, southeast of Hi-Cal pit.
