**MINERALS PROGRAM INSPECTION REPORT**  
**PHONE: (303) 866-3567**

<b>MINE NAME:</b> Dowe Flats Mine	<b>MINE/PROSPECTING ID#:</b> M-1993-041	<b>MINERAL:</b> Limestone and shale	<b>COUNTY:</b> Boulder
<b>INSPECTION TYPE:</b> Monitoring	<b>INSPECTOR(S):</b> Amy Eschberger	<b>INSP. DATE:</b> November 5, 2019	<b>INSP. TIME:</b> 14:30
<b>OPERATOR:</b> CEMEX, Inc.	<b>OPERATOR REPRESENTATIVE:</b> Cita Cisse, Scott Harcus, Robin Bay	<b>TYPE OF OPERATION:</b> 112c - Construction Regular Operation

This was a normal monitoring inspection of the Dowe Flats Mine (Permit No. M-1993-041) conducted by Amy Eschberger of the Division of Reclamation, Mining and Safety (Division). The operator was represented during the inspection by Cita Cisse, Scott Marcus, and Robin Bay. The site is located approximately two miles east of Lyons, Colorado in Boulder County. Access to the site is from the south off Hwy 66. **Photos 1-30** taken during the inspection are included with this report.

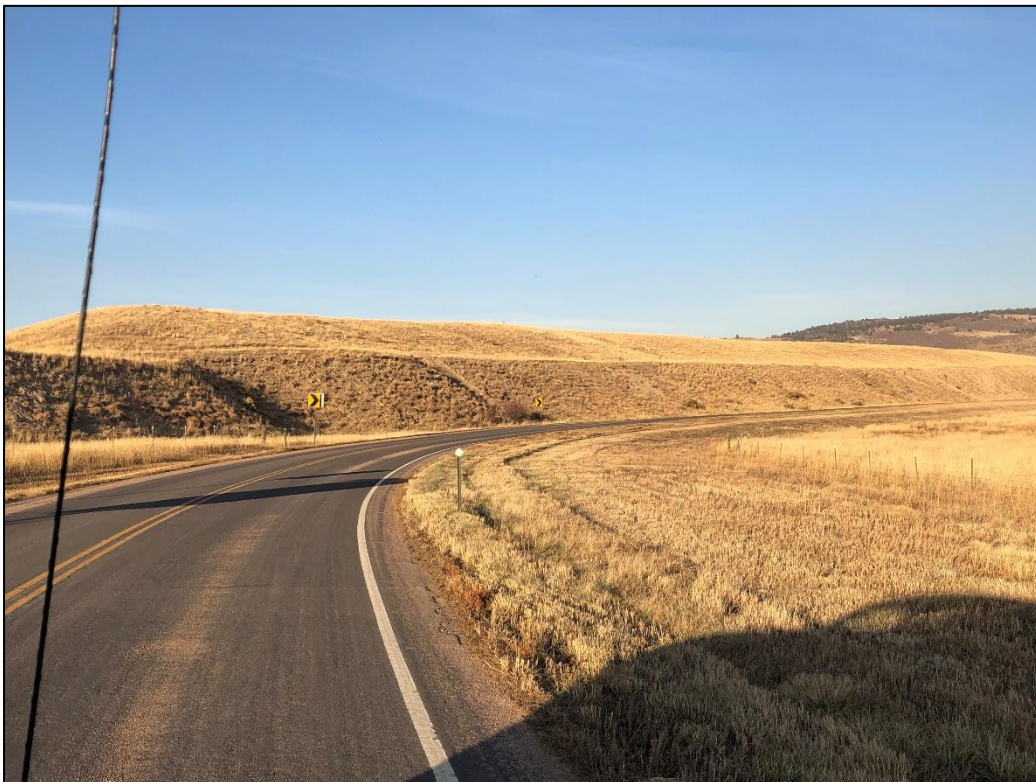
**Photo 26.** View looking northeast at large overburden stockpile stored along southern edge of mine, north of Vestal Rd. Note this side of the pile has good grass cover.

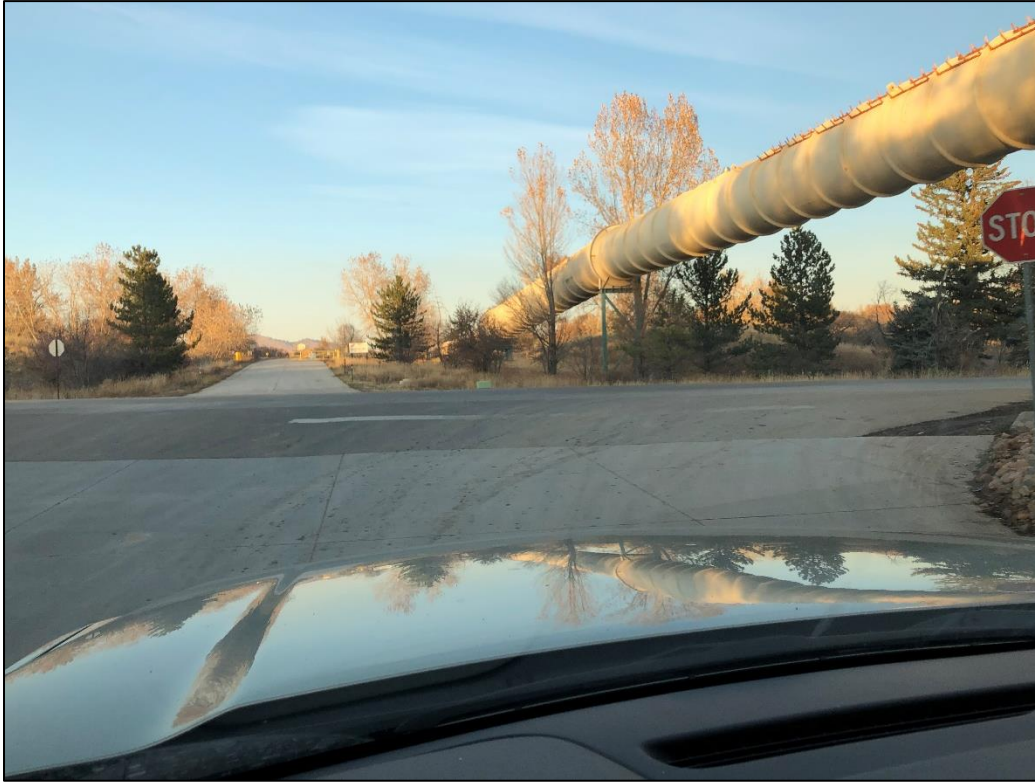
**Photo 27.** View looking north, showing portion of above ground conveyor system (at right) installed across Hwy 66. This area appears to be within the approved permit boundary.

A 2<sup>nd</sup> problem is cited in this report (see pages 1 and 2), requiring the operator to revise the reclamation plan to describe how the conveyor system and associated infrastructure will be reclaimed. This information can either be included with the Technical Revision submitted for the 1<sup>st</sup> problem cited, or submitted under a separate Technical Revision.

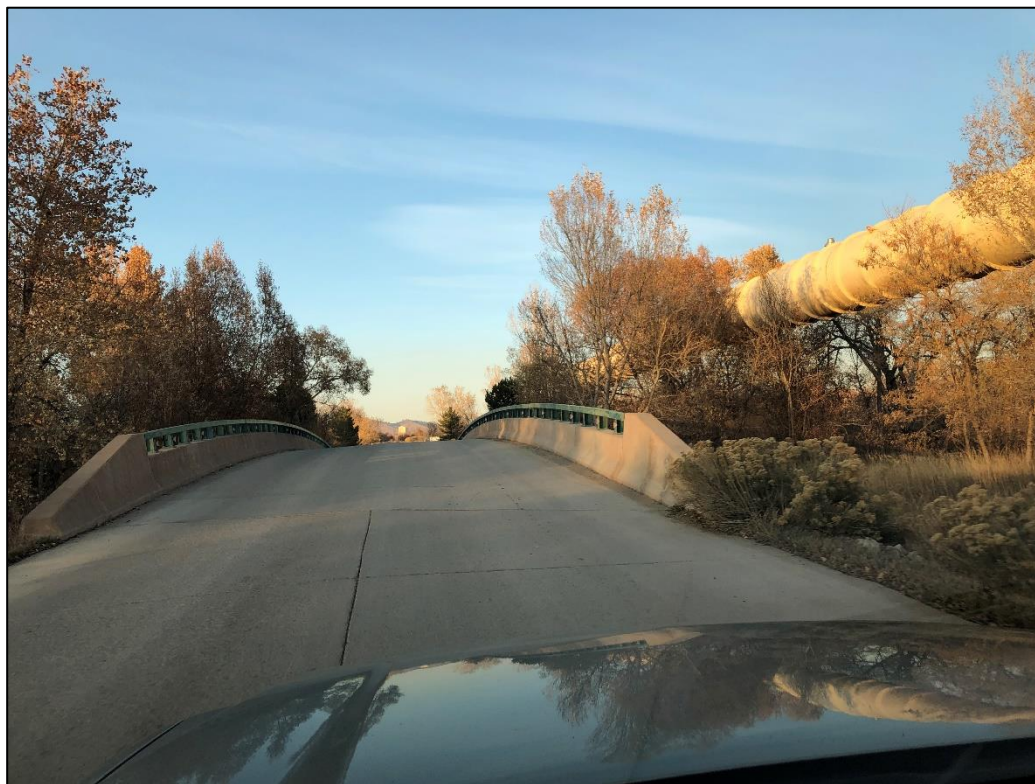
**Photo 28.** View looking north across paved road and bridge constructed across St Vrain Creek in the early 1990's in association with installation of the conveyor system. This area appears to be within the approved permit boundary.

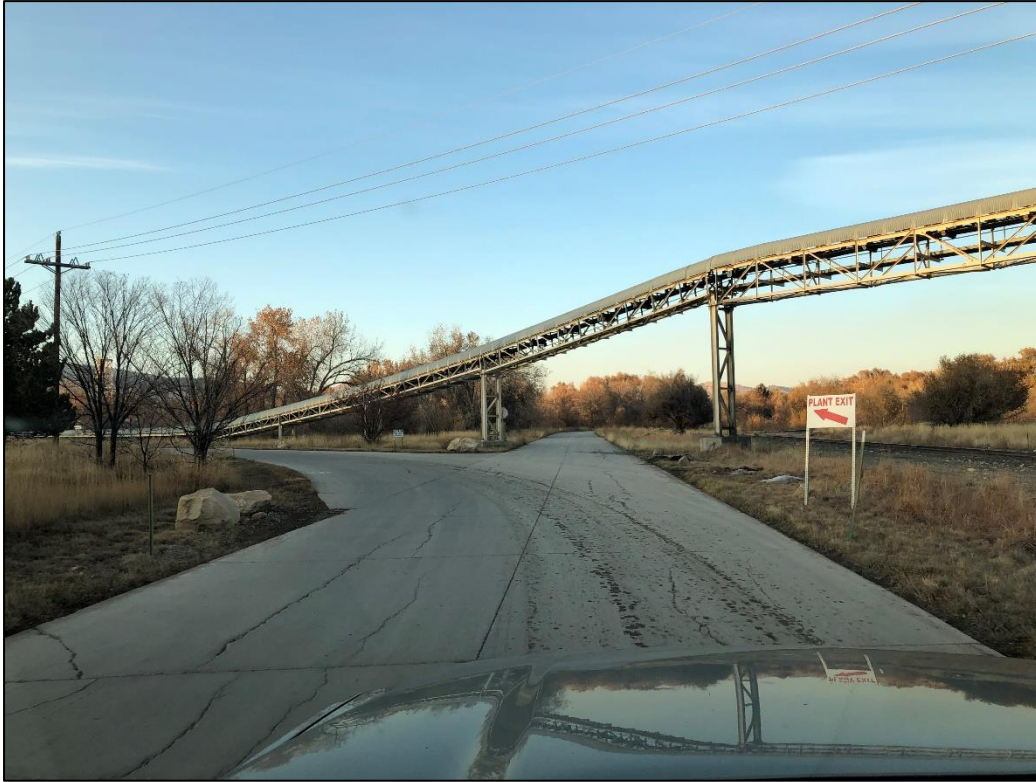
**Photo 29.** View looking north at area where conveyor system crosses over N 51<sup>st</sup> St (main entrance to plant site south of Hwy 66). This area appears to be within the approved permit boundary.

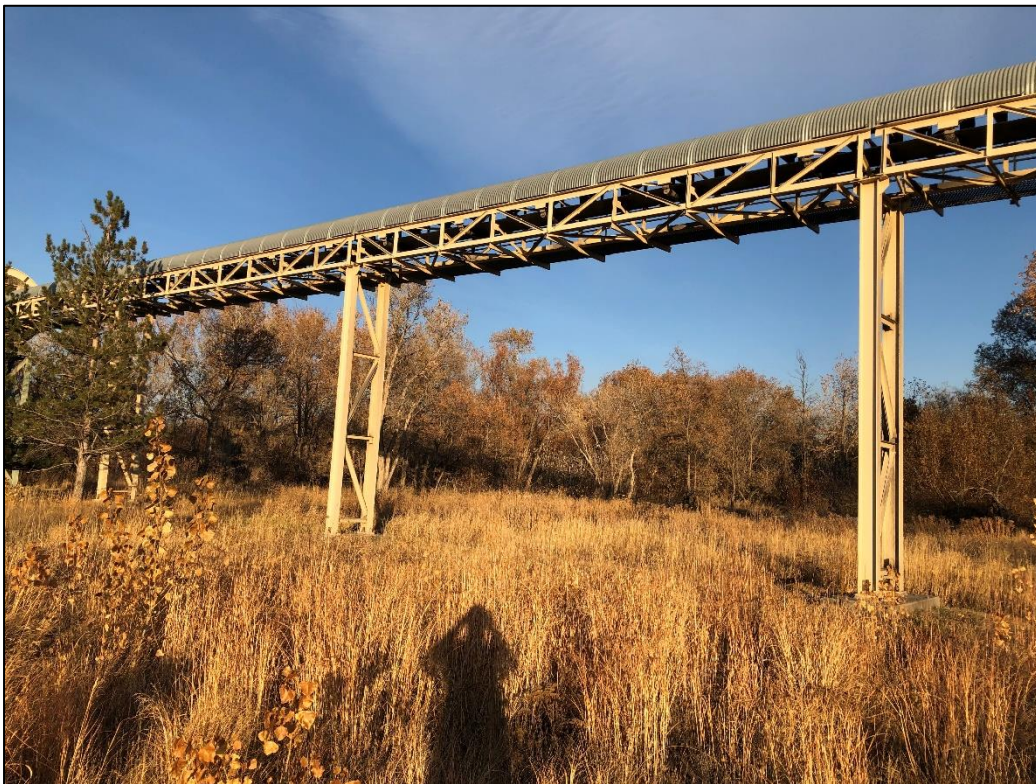
**Photo 30.** View looking northeast across portion of above ground conveyor system just south of St Vrain Creek. This area appears to be within the approved permit boundary.

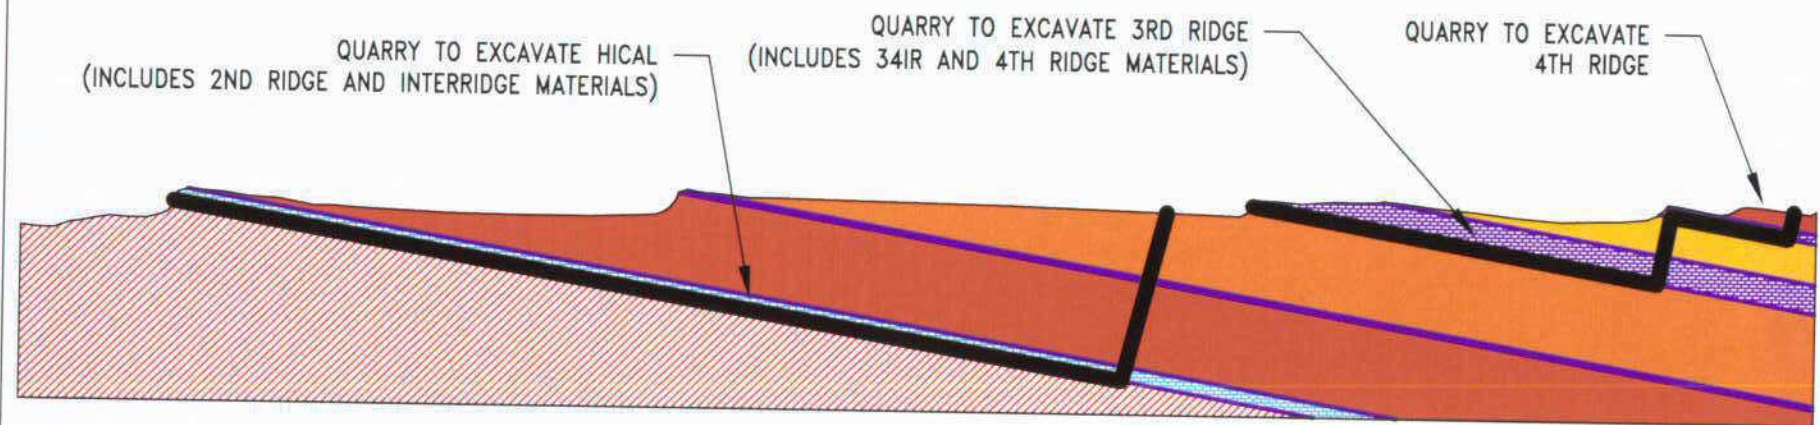
FIGURE 4: TYPICAL CROSS SECTION OF QUARRY CONFIGURATION AND ROCK UNITS TO BE MINED

This is a 112c operation permitted for 1,854.45 acres to mine limestone and shale for use in the operator's cement plant (Lyons Quarry; Permit No. M-1977-208), located just south of this site, on the other side of Hwy 66. Four horizons have been targeted for mining at this site based principally on their calcium carbonate content and utilization potential at the cement plant. The west limb of a southward plunging syncline contains the four beds of interest; all outcrop along a general north-south strike and exhibit gentle dips to the east. The four ridges overlap due to the stratigraphic superposition of the limestone beds. The western-most seam (also stratigraphically the lowest) is referred to as the Hi-Cal Ridge. Expressions of the other horizons are more subdued and these are known locally as the 2<sup>nd</sup>, 3<sup>rd</sup>, and 4<sup>th</sup> Ridges (see enclosed Figure 4: Typical Cross Section of Quarry Configuration and Rock Units to be Mined, received with TR-2 on May 26, 2009).

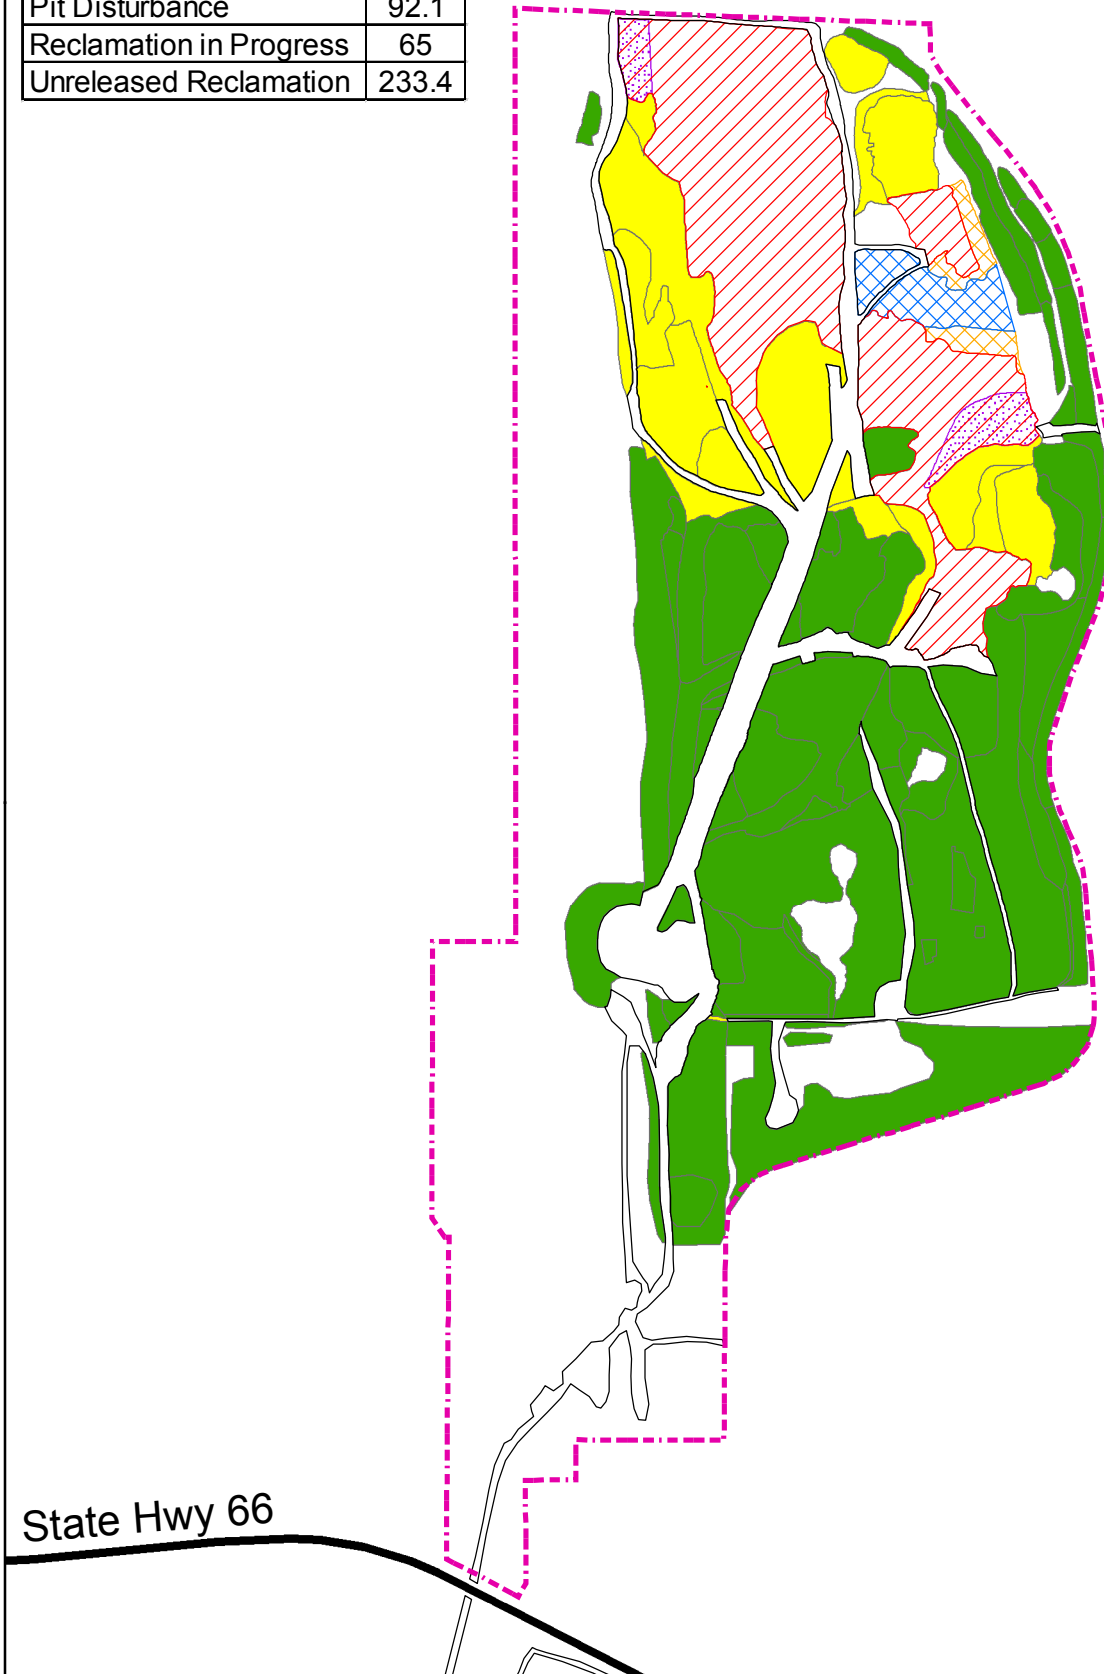
It should be noted, the annual report maps submitted by the operator show an incorrect permit boundary (see enclosed annual report map received on September 7, 2019). The area labeled as the permit boundary on these maps appears to include only the mine disturbance area north of Hwy 66, but not the rest of the permit boundary present on both sides of this road. The originally approved permit area of 1,911.0 acres has been revised through three permit revisions, including, AM-1 (approved in 1994) which added 44.4 acres, giving a new permit area of 1,955.4 acres, Acreage Reduction No. 1 (AR-1; approved in 2004) which removed 13.07 acres, giving a new permit area of 1,942.33 acres, and Acreage Reduction No. 2 (AR-2; approved in 2005) which removed 87.88 acres, giving the current permit area of 1,854.45 acres. The operator should be sure that future annual report maps show the correct permit boundary or affected land boundary, as revised through these three revisions.

Area	Acres
Pit Disturbance	92.1
Reclamation in Progress	65
Unreleased Reclamation	233.4

Dowe Flats Quarry Permit Boundary	Unreleased Reclamation
Pit Disturbance Boundary	Reclamation in Progress
2018-2019 New Mining Disturbance	Anticipated Reclamation 2019
Anticipated 2019 Mining Disturbance

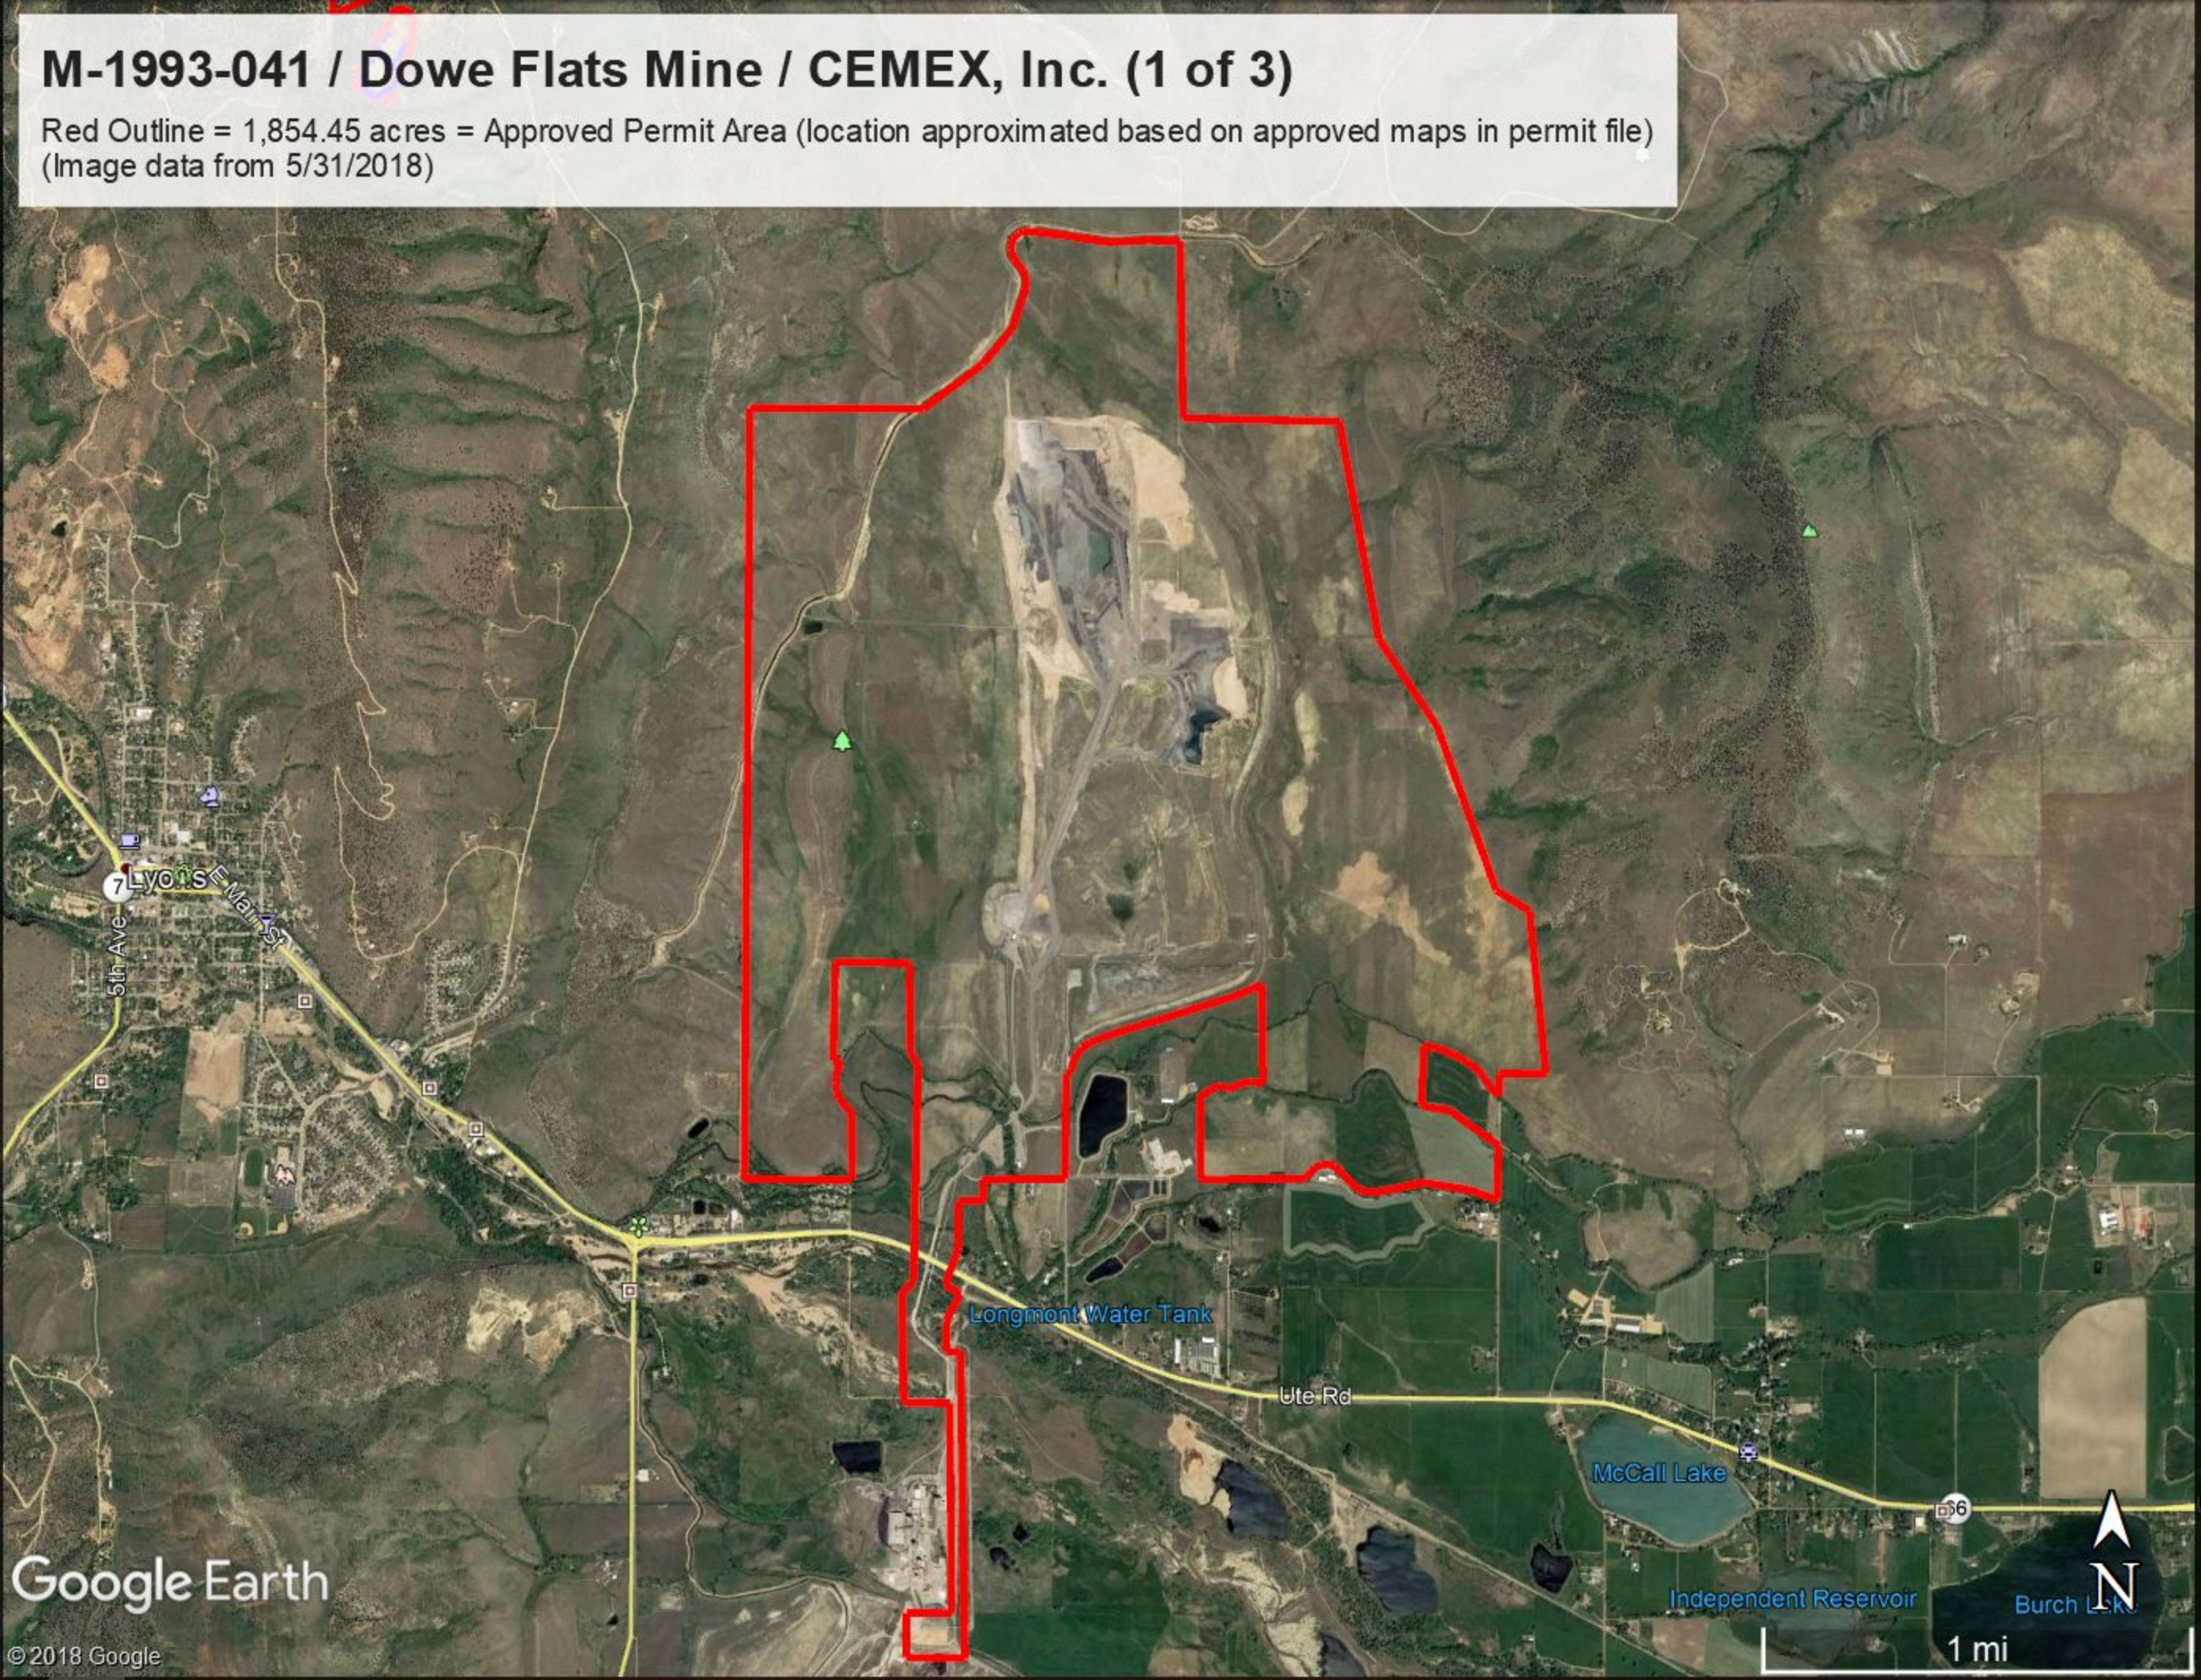
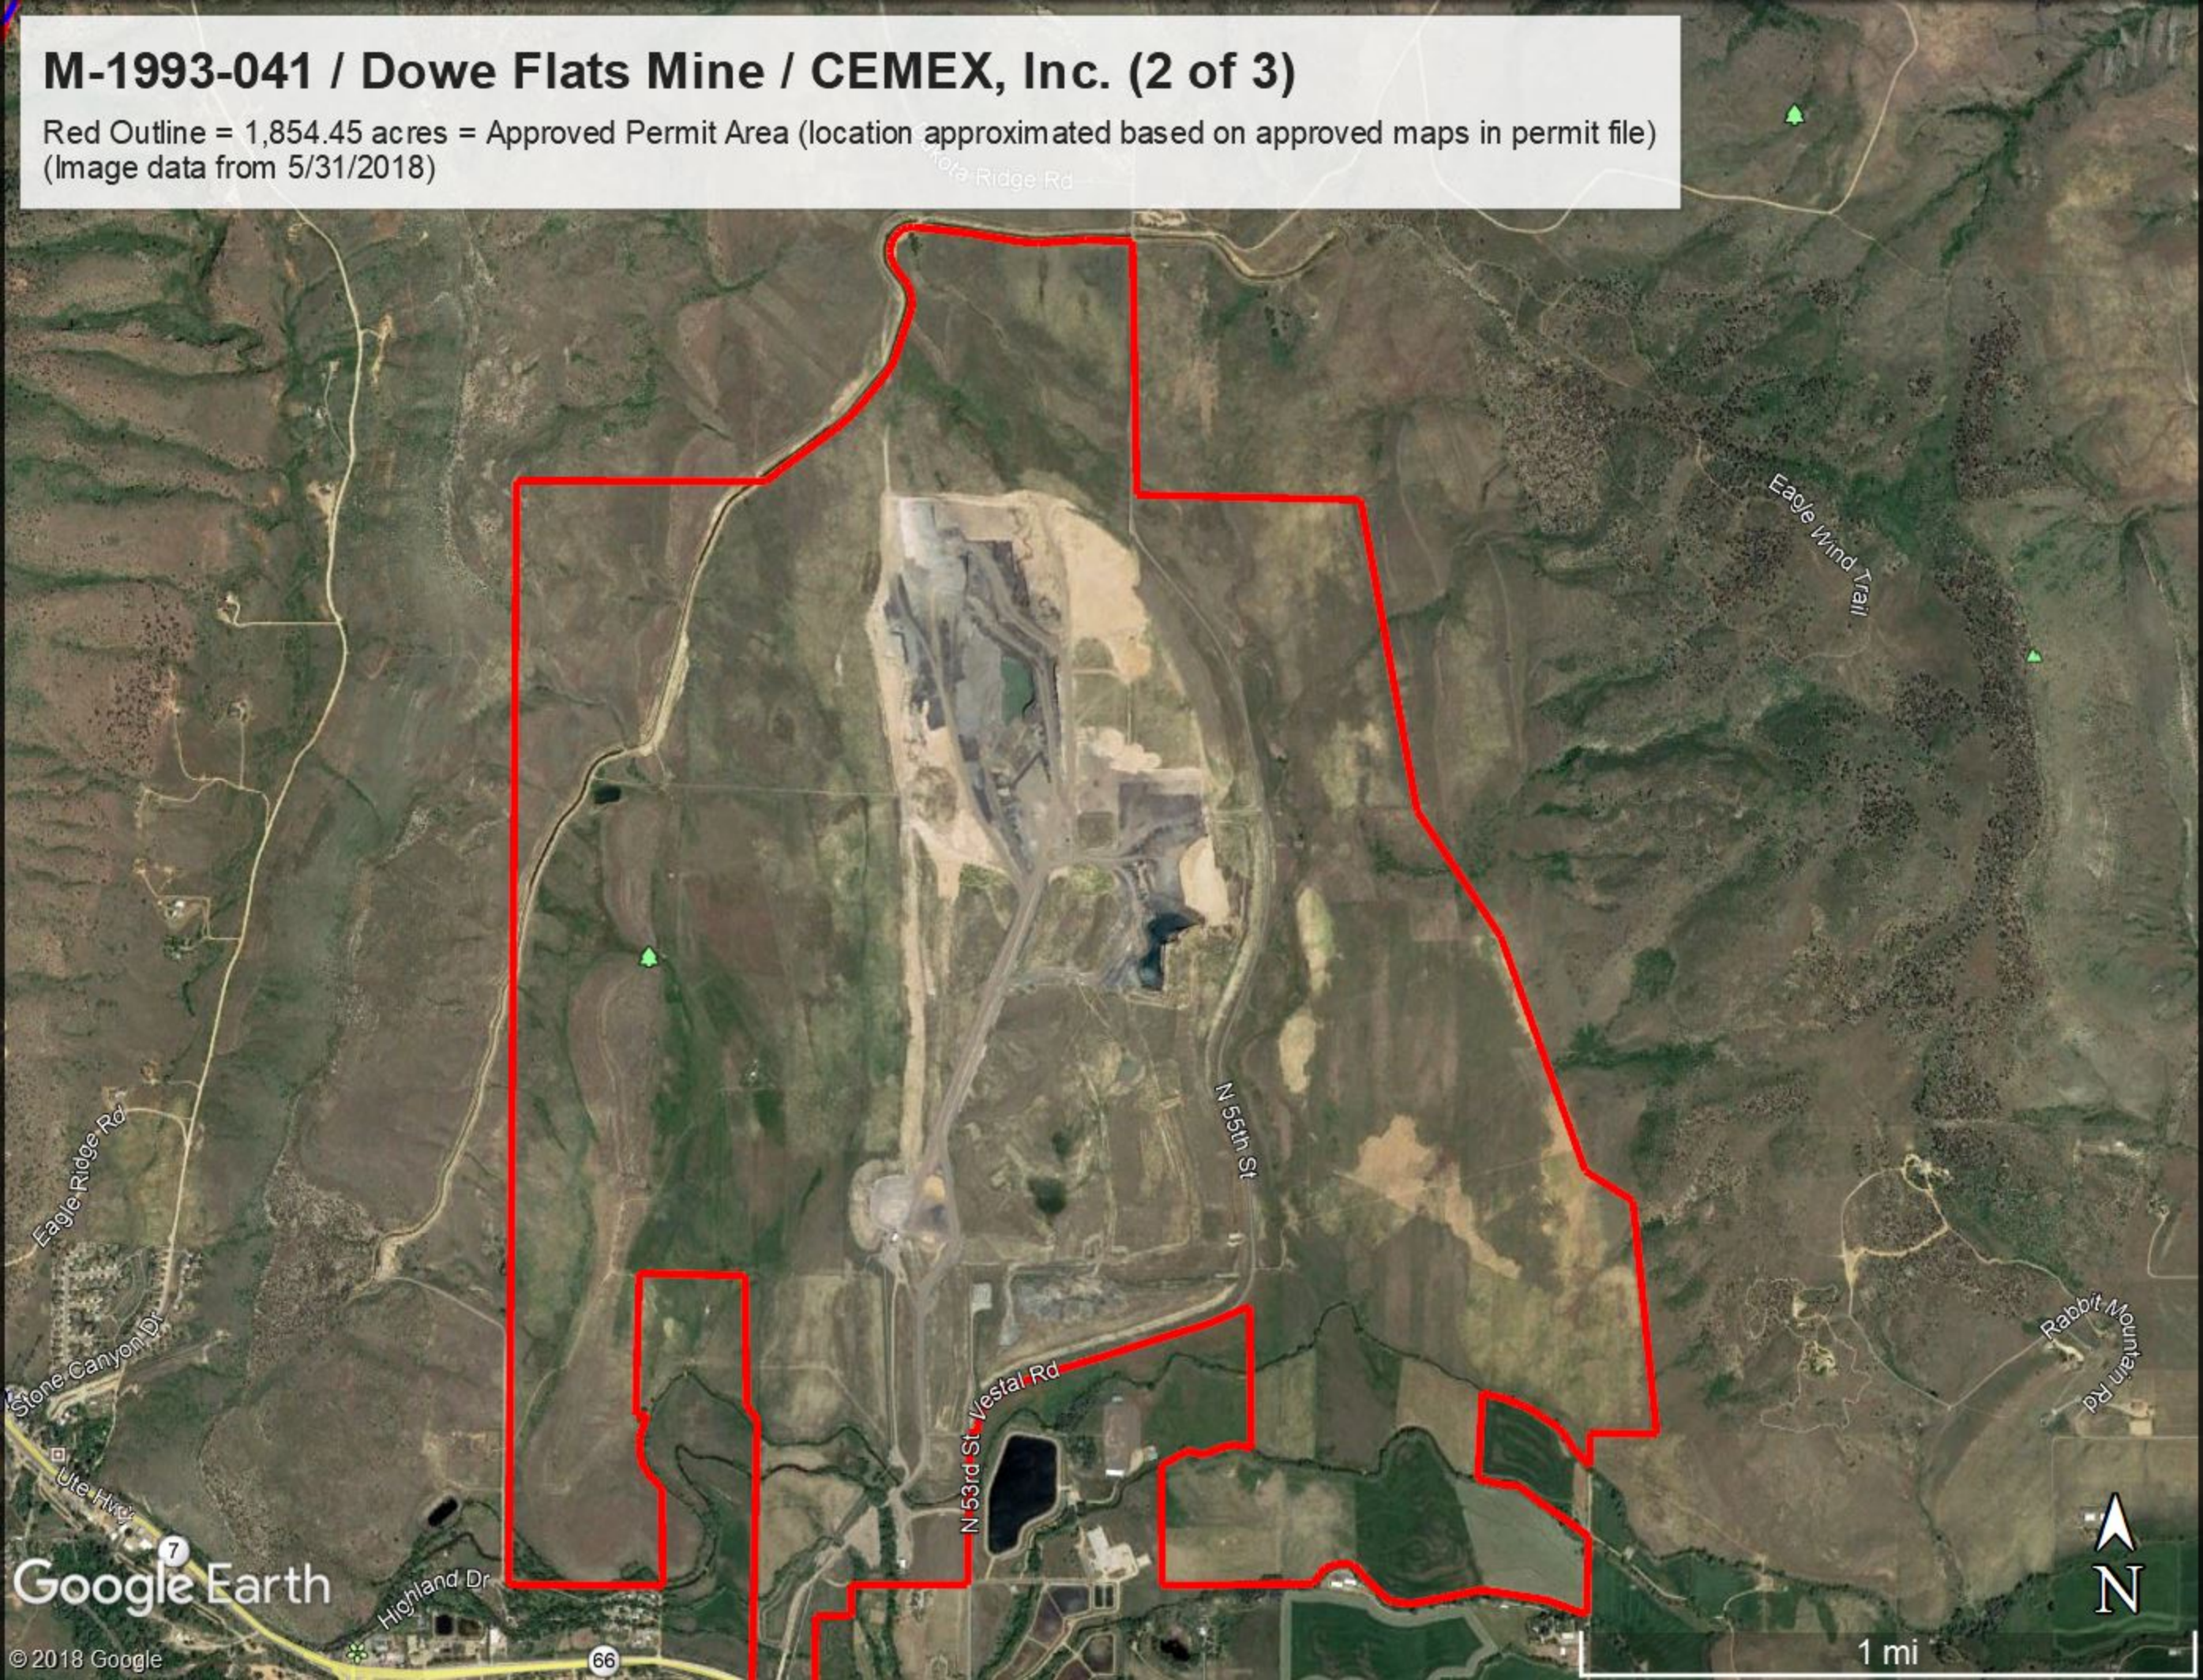
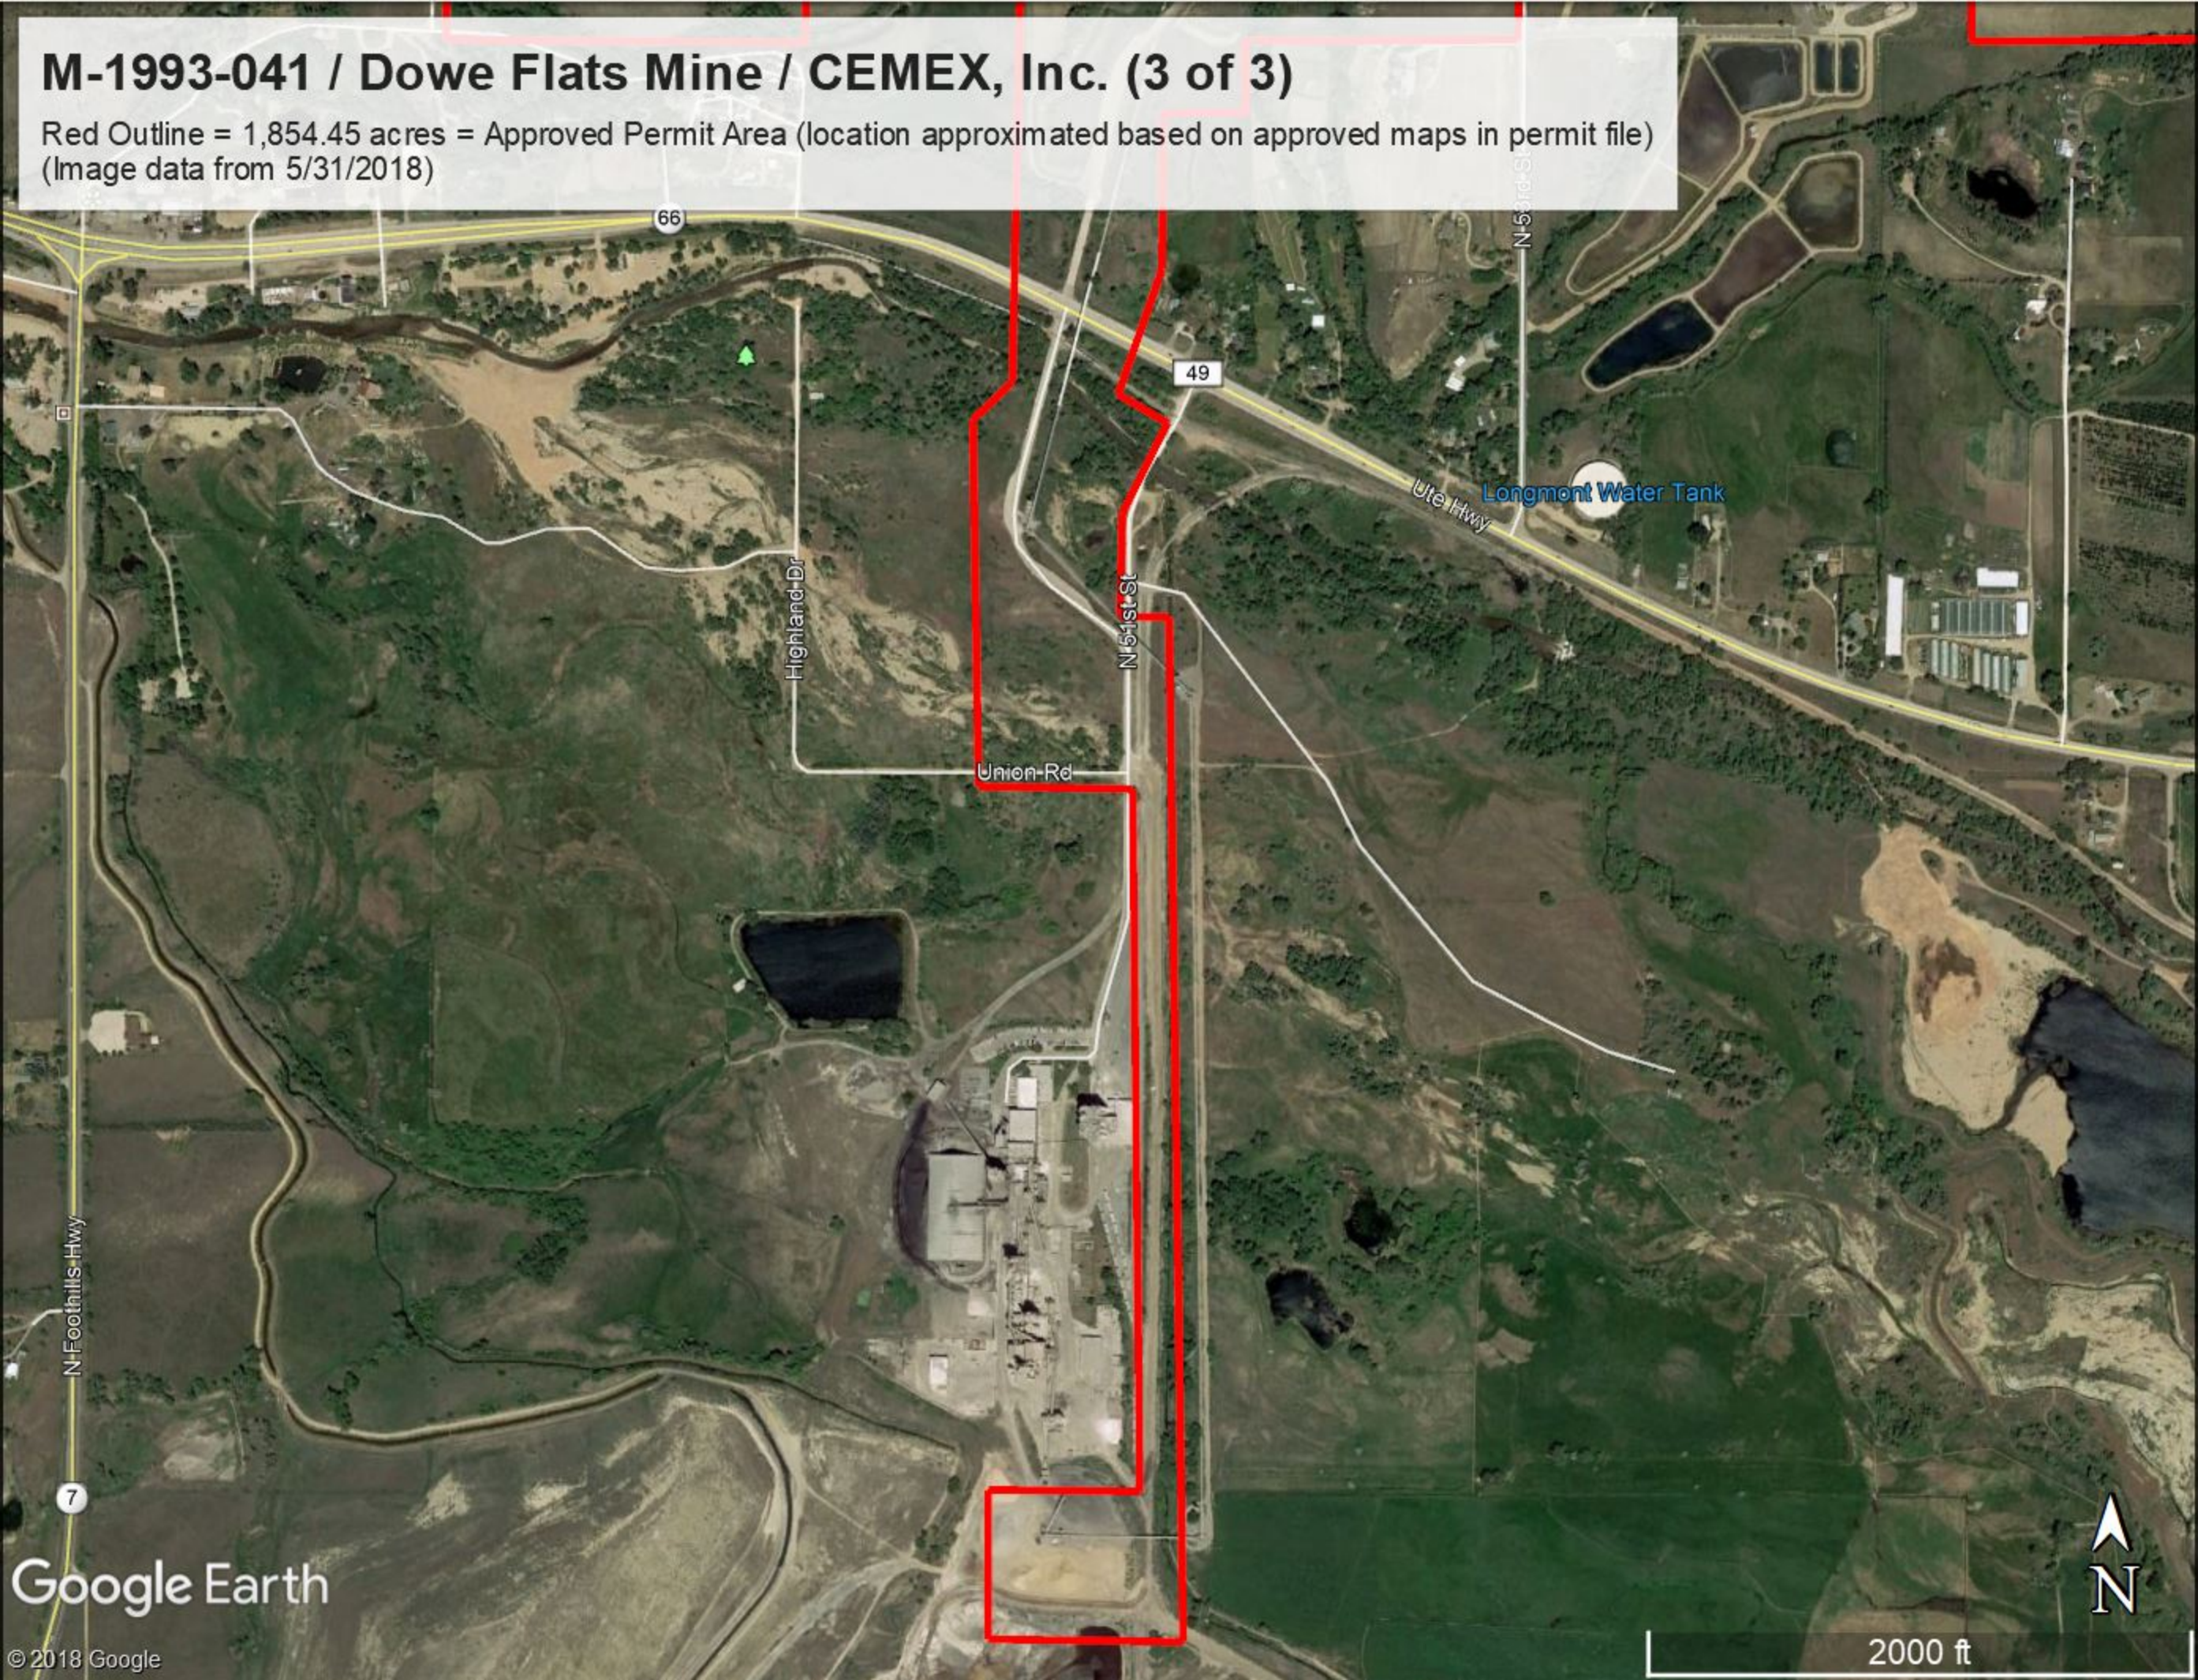
The Division was unable to find updated mining and reclamation plan maps in the permit file which depict the entire approved permit boundary and affected land boundary, particularly the portion located south of Hwy 66. Therefore, the operator will need to provide updated mining and reclamation plan maps for the site that meet the requirements of Rules 6.2.1(2), 6.4.3, and 6.4.6 (see enclosed rules). These maps should depict both the approved permit boundary (comprising 1,854.45 acres) and the affected lands boundary (comprising 464.9 acres). These updated maps should be submitted with the Technical Revision required for Problems #1 and #2 cited in this report (see pages 1 and 2). Enclosed with this report are a total of 12 site maps that were submitted with the original application, AM-1, AR-1, AR-2, and TR-2, which the operator may find useful. Also enclosed with this report are Google Earth images 1-3 of the site showing what the Division believes to be the approved permit area based on the approved maps in the permit file.

Red Outline = 1,854.45 acres = Approved Permit Area (location approximated based on approved maps in permit file)  
(Image data from 5/31/2018)

- c) Provide an updated mining plan map that depicts the entire approved permit boundary and affected lands boundary (including areas south of Hwy 66), and meets the requirements of Rules 6.2.1(2) and 6.4.3.
