**MINERALS PROGRAM INSPECTION REPORT**  
**PHONE: (303) 866-3567**

<b>MINE NAME:</b> Dowe Flats Mine	<b>MINE/PROSPECTING ID#:</b> M-1993-041	<b>MINERAL:</b> Limestone and shale	<b>COUNTY:</b> Boulder
<b>INSPECTION TYPE:</b> Monitoring	<b>INSPECTOR(S):</b> Amy Eschberger	<b>INSP. DATE:</b> November 5, 2019	<b>INSP. TIME:</b> 14:30
<b>OPERATOR:</b> CEMEX, Inc.	<b>OPERATOR REPRESENTATIVE:</b> Cita Cisse, Scott Harcus, Robin Bay	<b>TYPE OF OPERATION:</b> 112c - Construction Regular Operation

This was a normal monitoring inspection of the Dowe Flats Mine (Permit No. M-1993-041) conducted by Amy Eschberger of the Division of Reclamation, Mining and Safety (Division). The operator was represented during the inspection by Cita Cisse, Scott Marcus, and Robin Bay. The site is located approximately two miles east of Lyons, Colorado in Boulder County. Access to the site is from the south off Hwy 66. **Photos 1-30** taken during the inspection are included with this report.

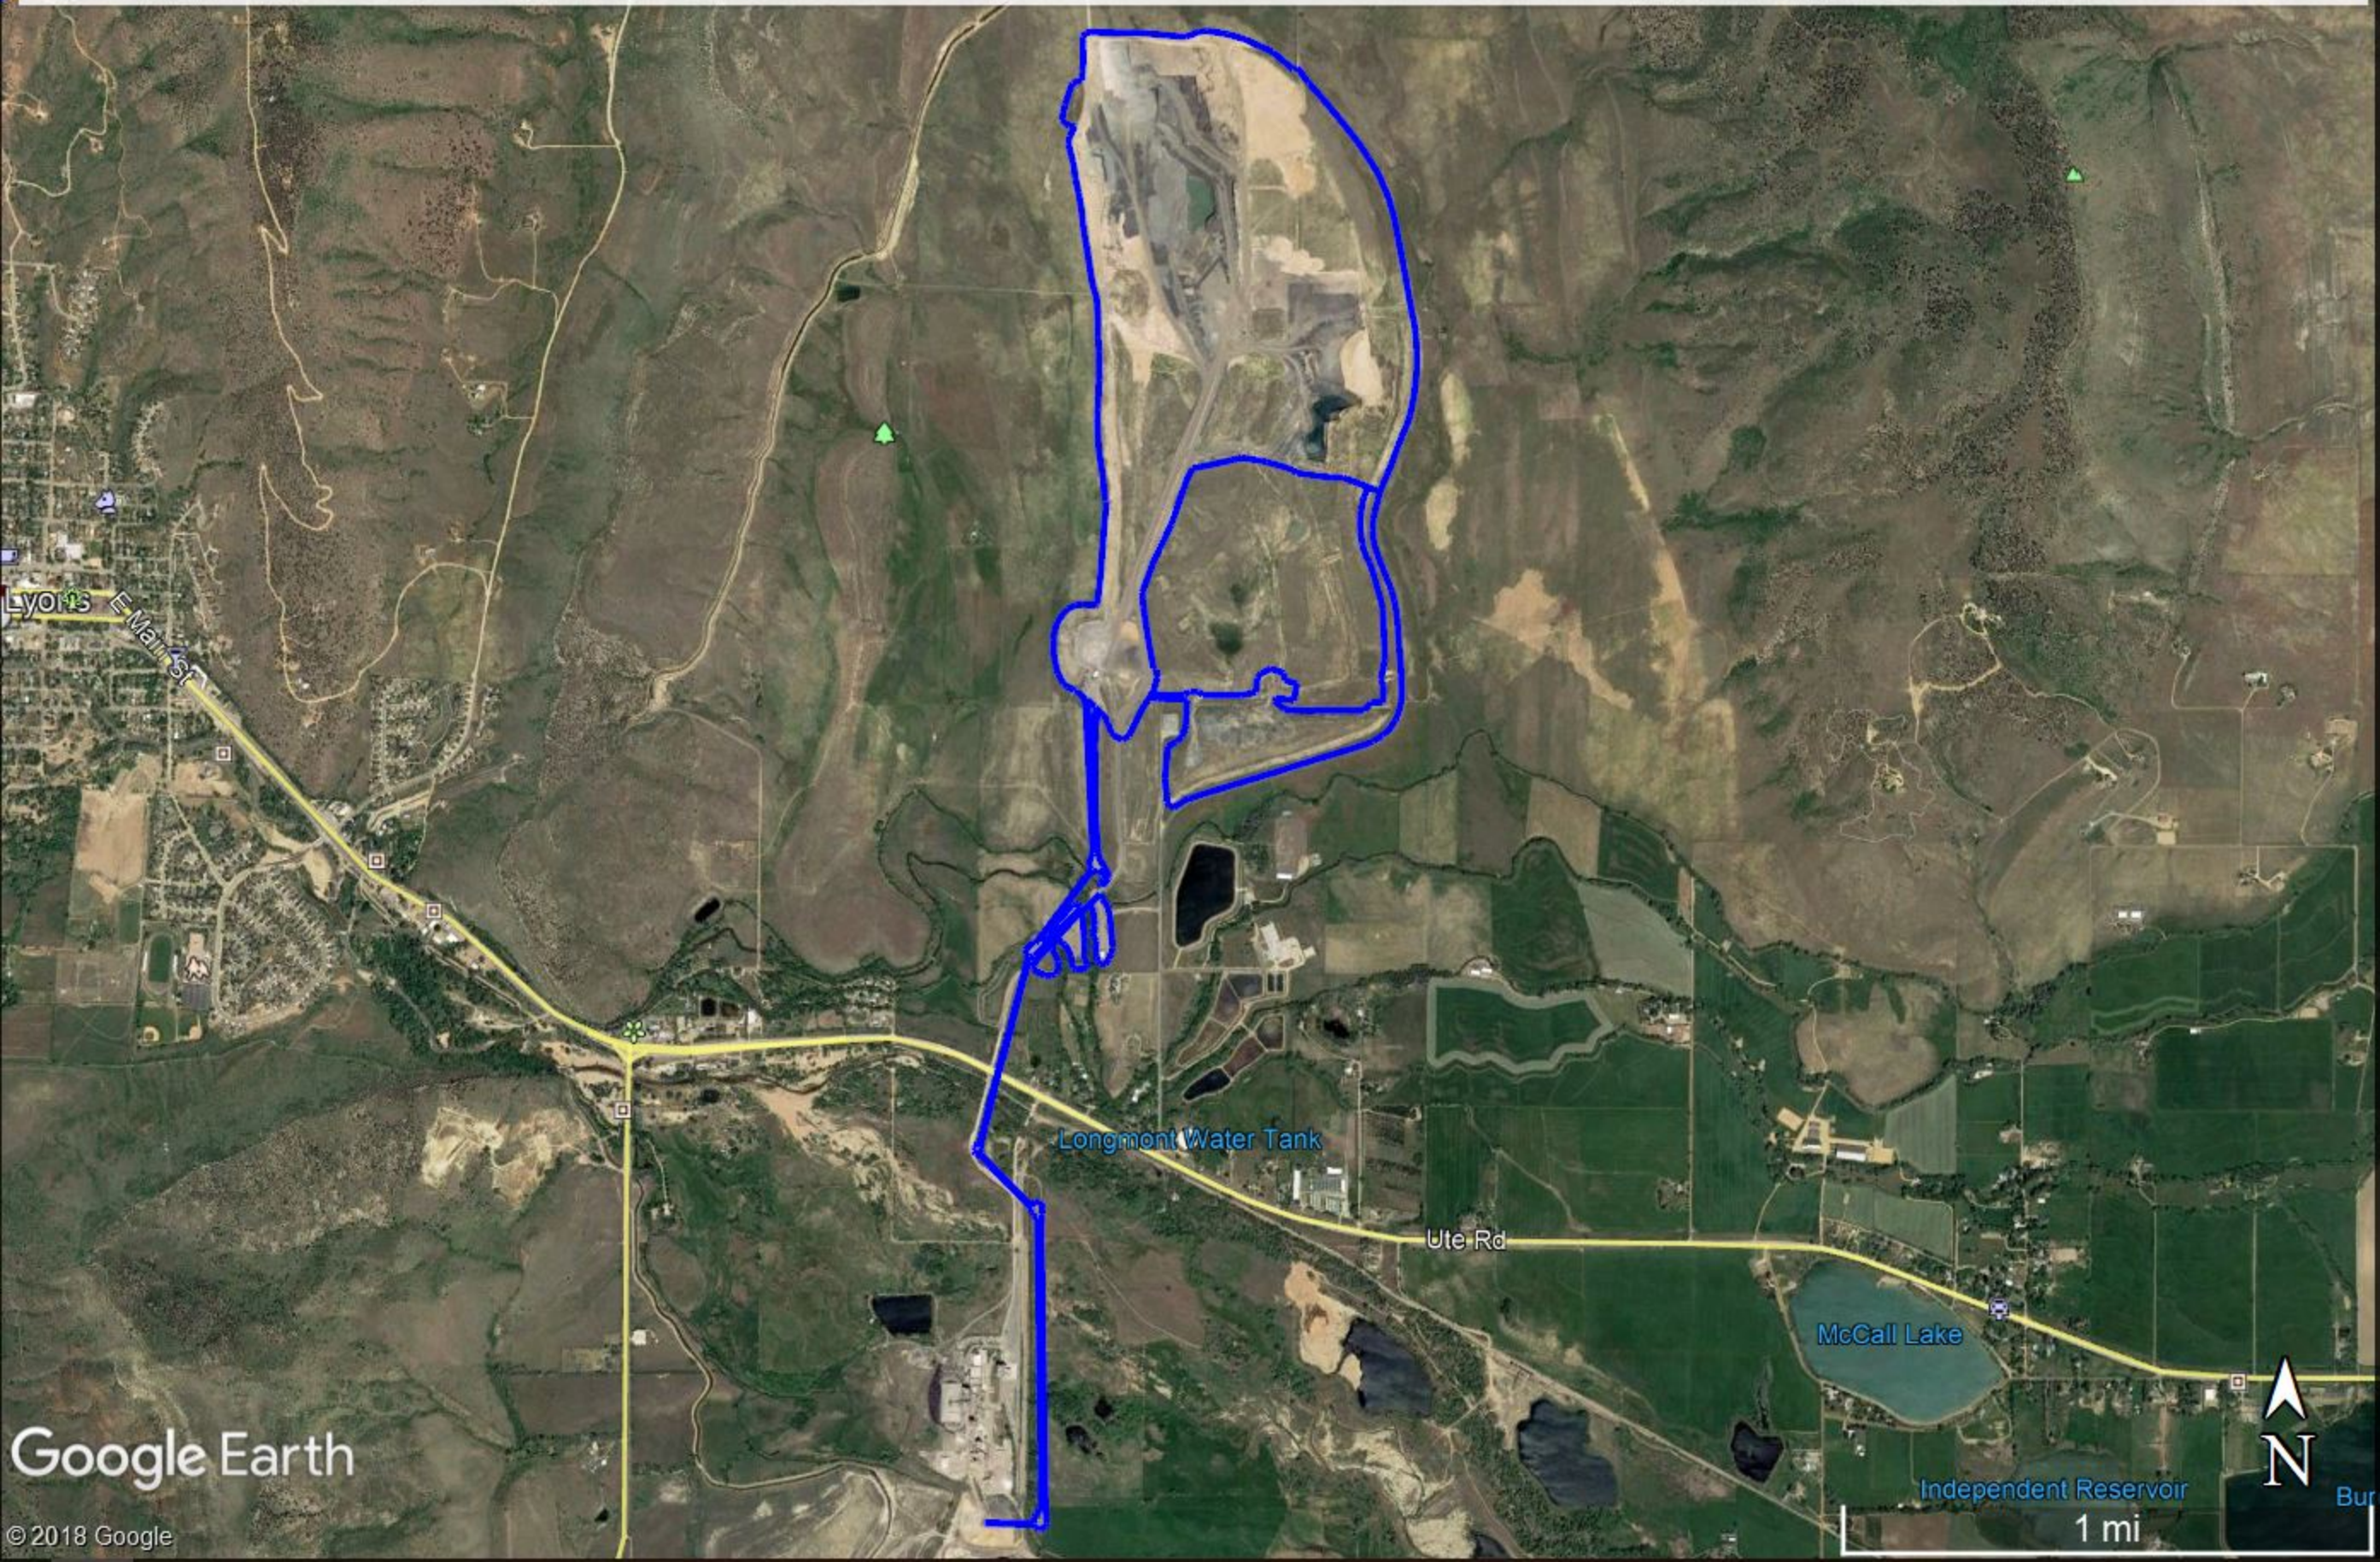
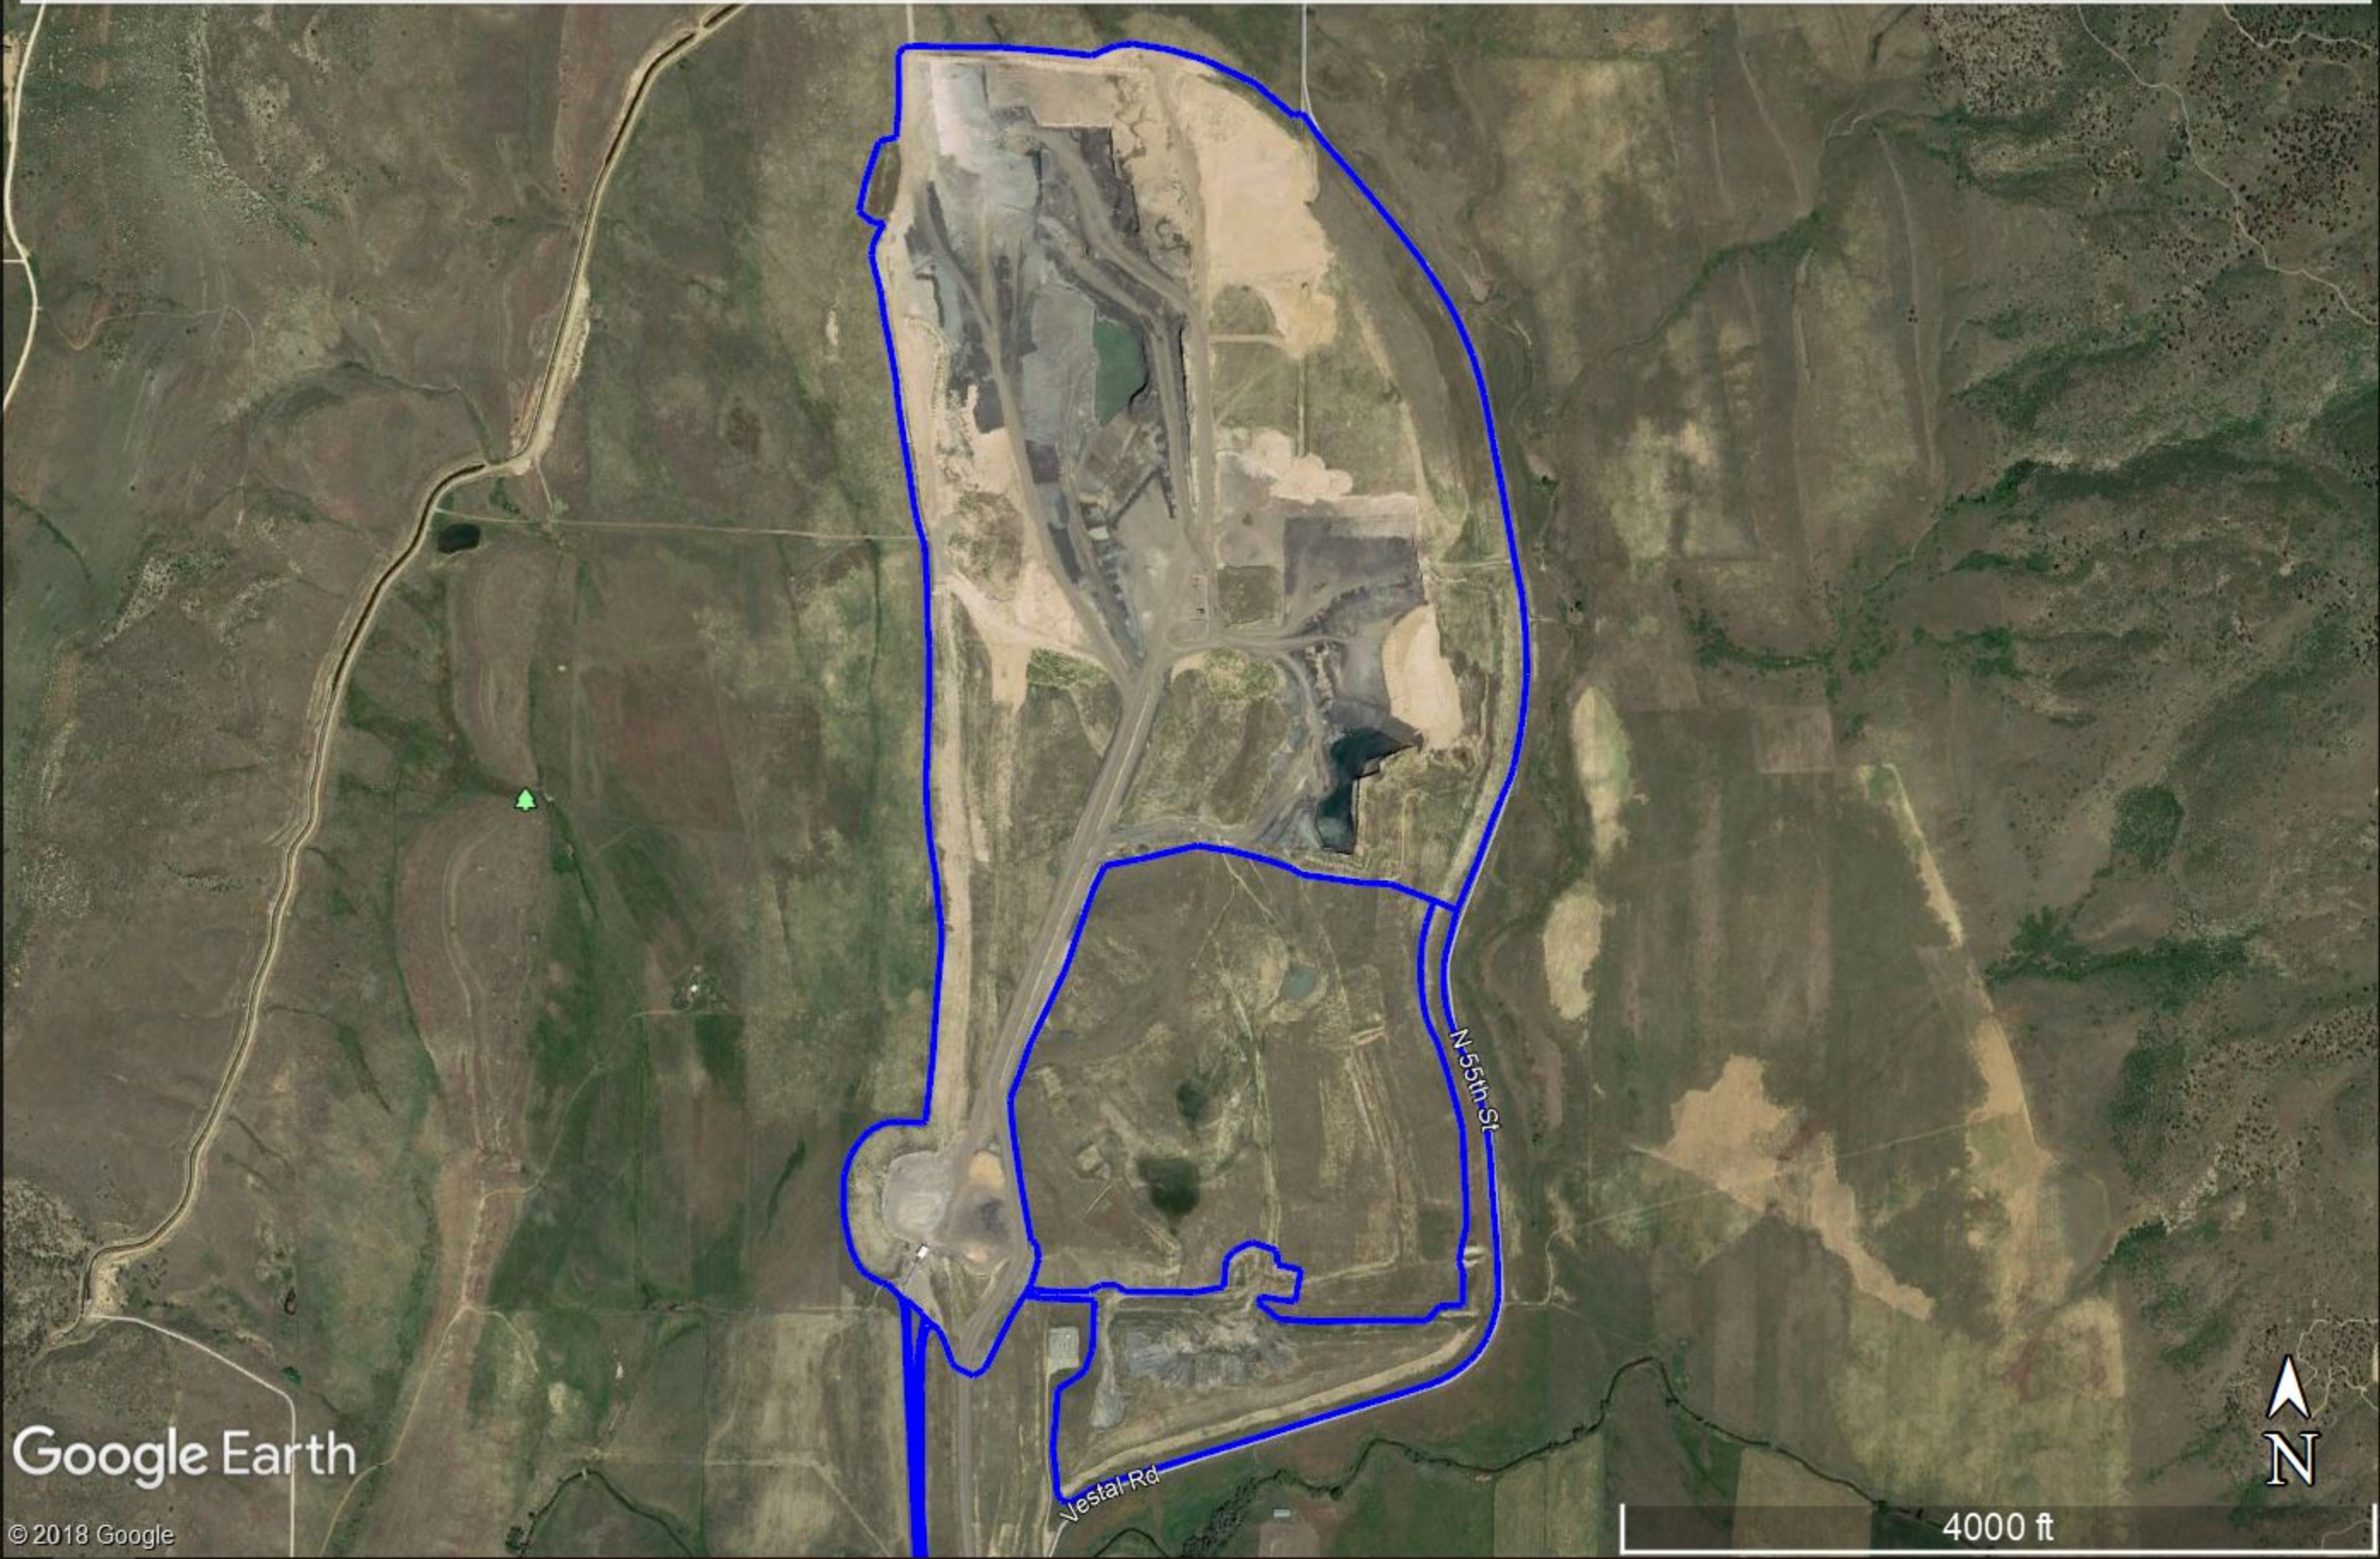
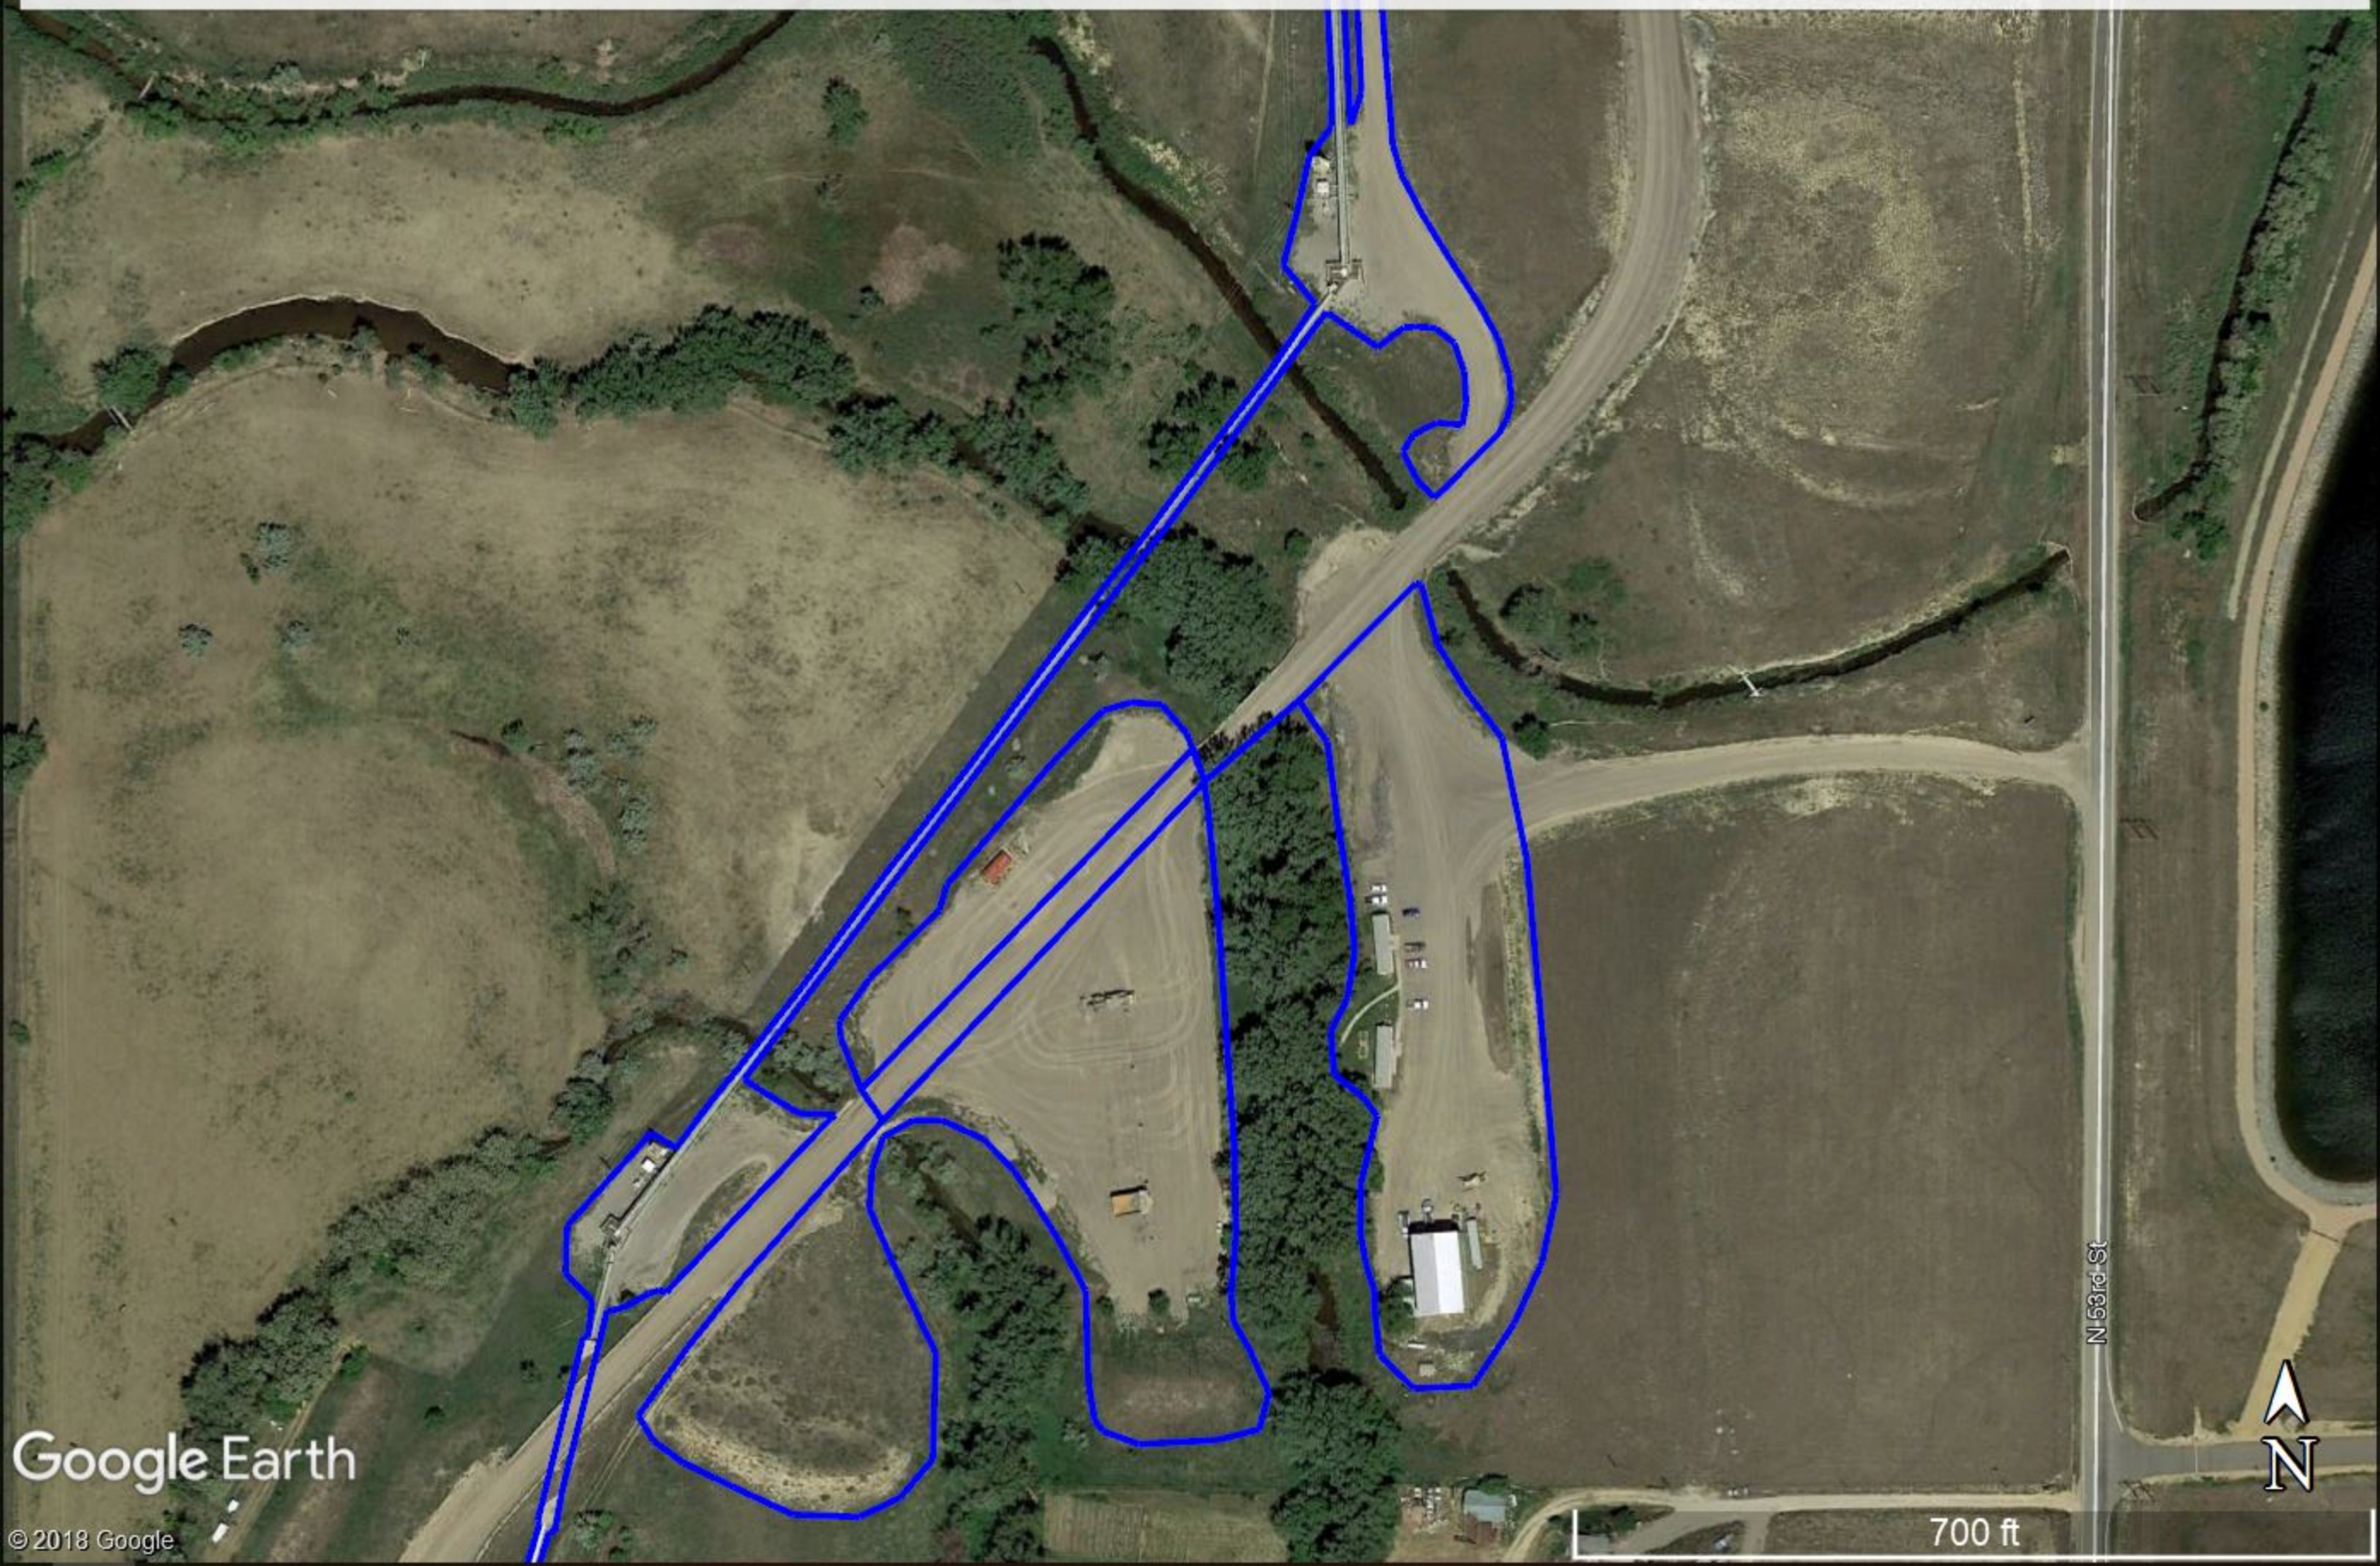
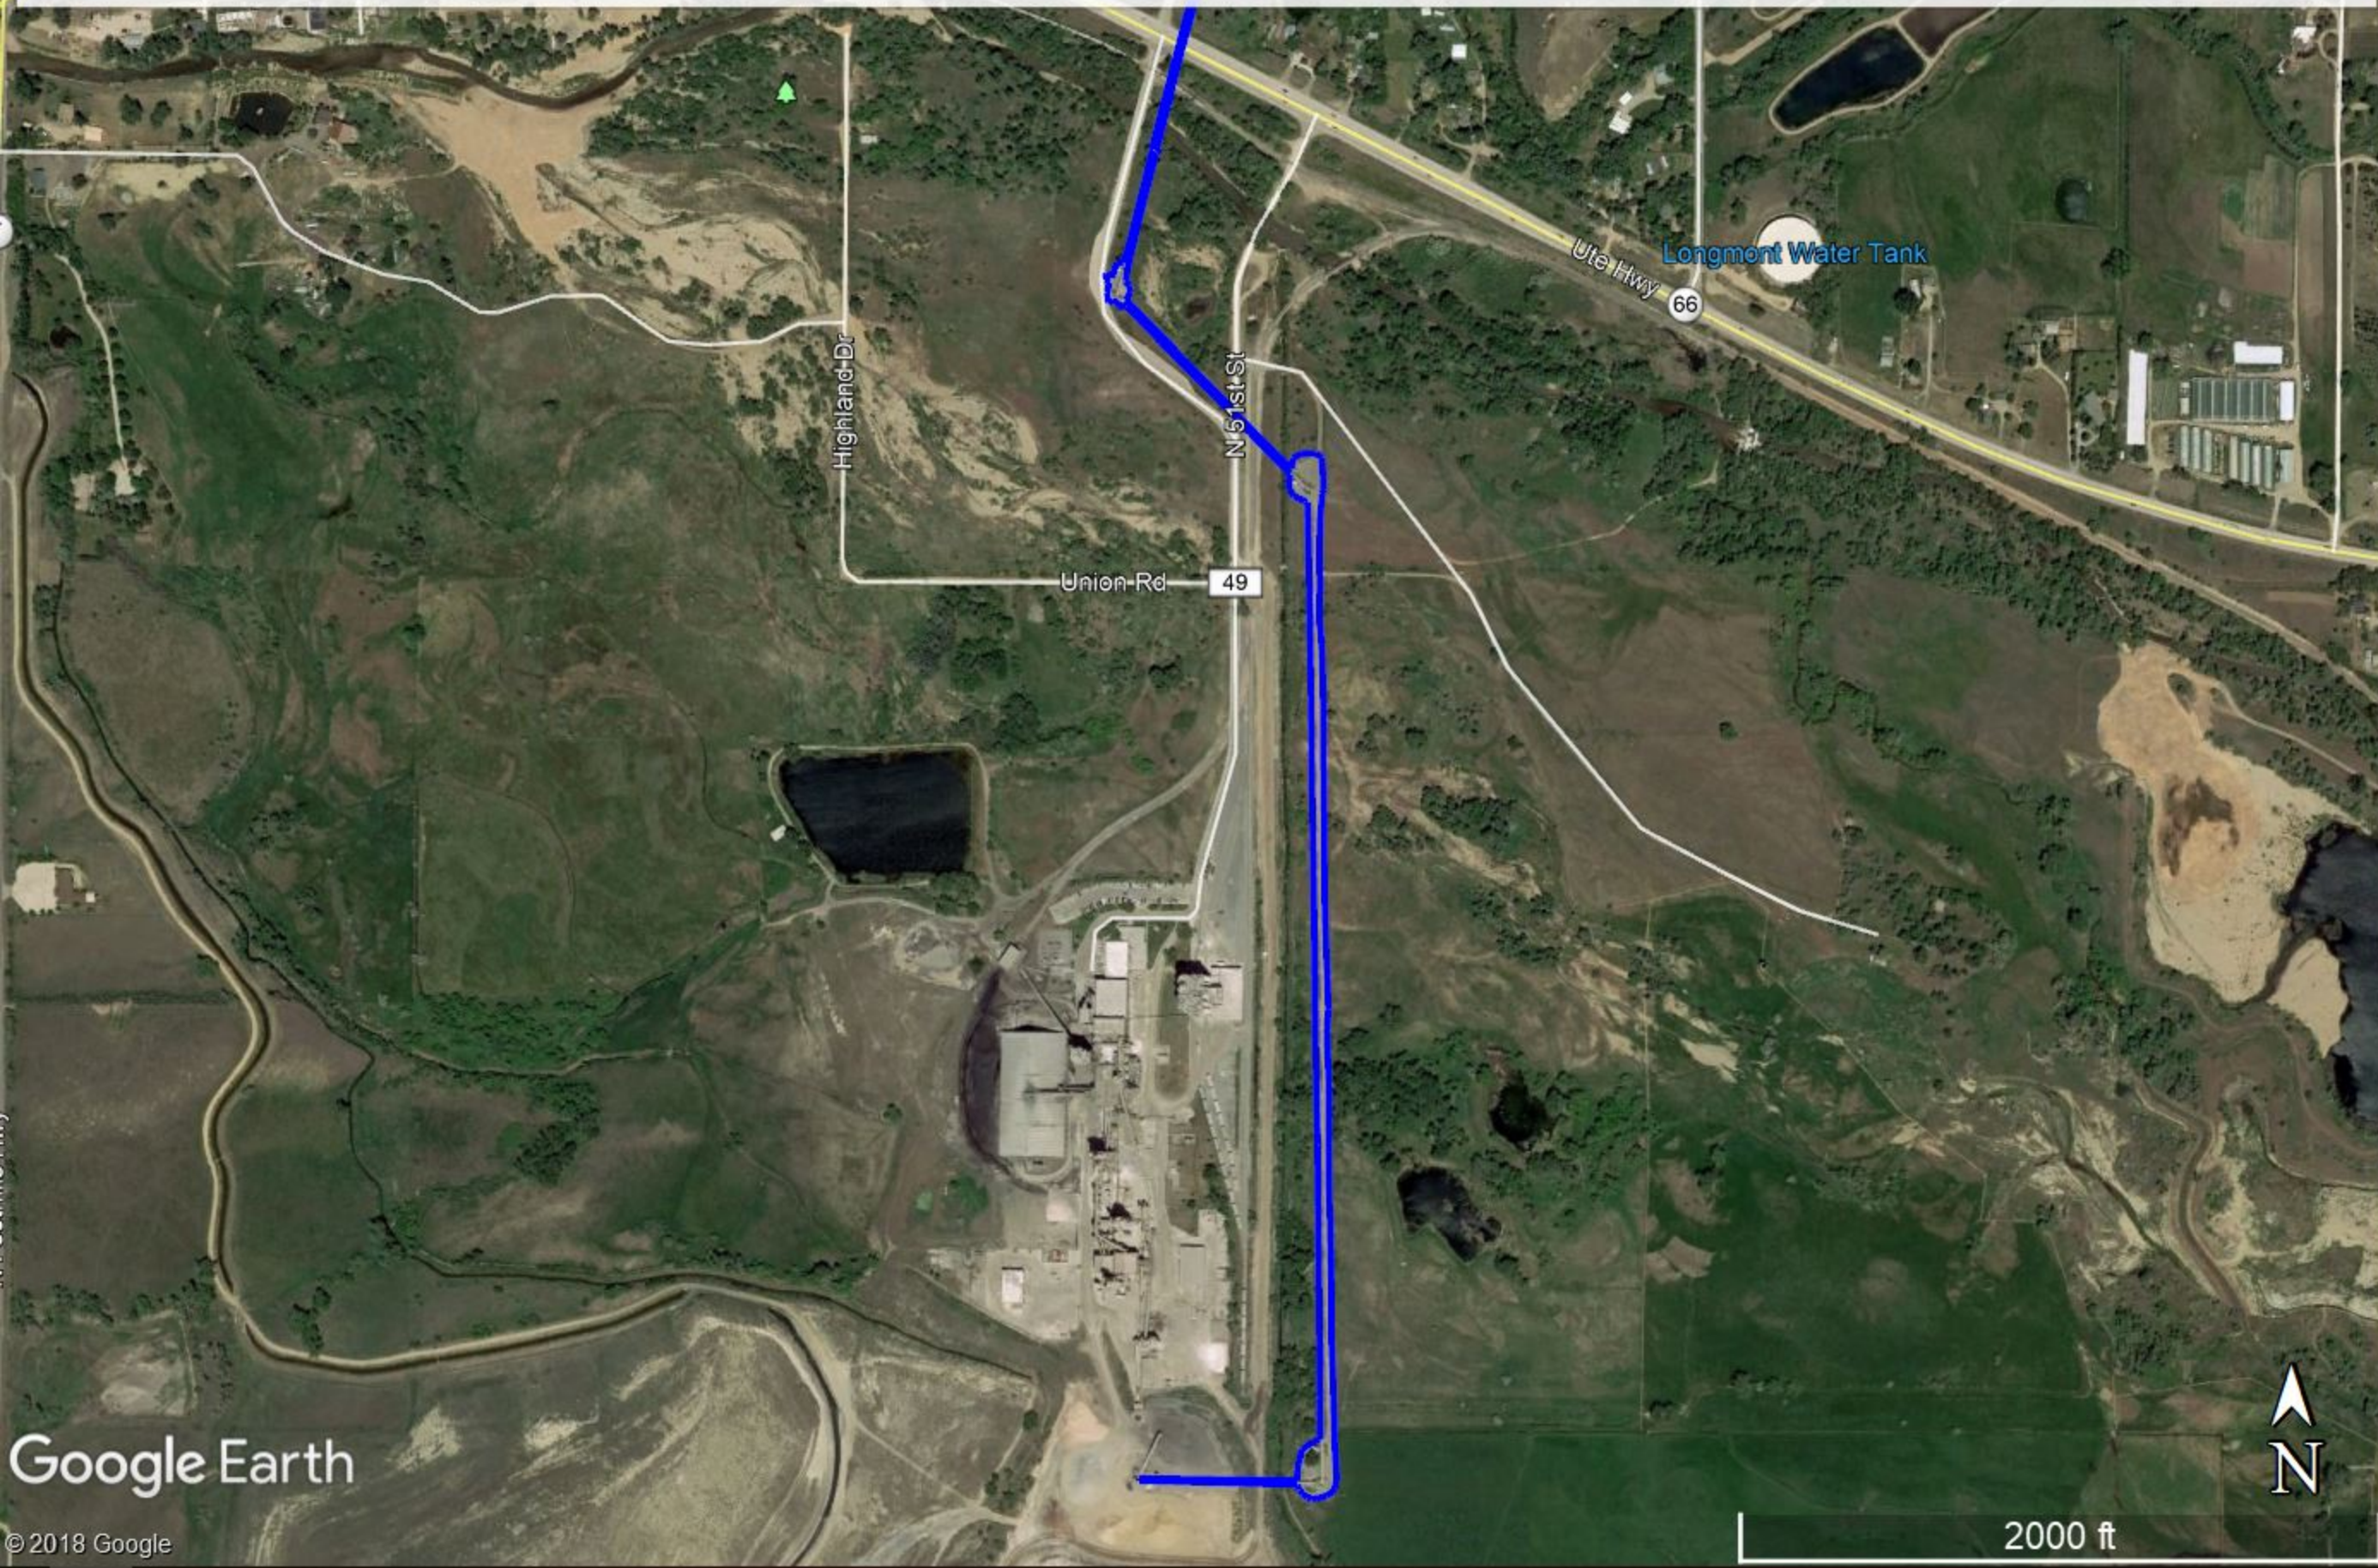
The Division estimates (based on the most recent aerial image available for the site in Google Earth, dated May 31, 2018), total unreclaimed disturbance to total 385.15 acres (see enclosed Google Earth images 1-4 of site

showing total unreclaimed disturbance). This includes 329 acres of disturbance associated with the active pit and crusher areas, 42.6 acres of disturbance associated with overburden and topsoil stockpiles (located outside of the active pit area), 6.7 acres of disturbance associated with the maintenance shop, fuel station, and equipment storage areas (located near the mine entrance), and 6.85 acres of disturbance associated with the conveyor system.

The Division's estimated disturbance at the site (385.15 acres) far exceeds the maximum amount of disturbance (105 acres) that is authorized for the operation per TR-2. Therefore, a problem is cited in this report (see page 1), requiring the operator to submit a Technical Revision (form enclosed) to increase the maximum amount of disturbance to reflect, at a minimum, existing site conditions. This revision shall include a description of current disturbances and the reclamation that remains for these areas.

Blue Outline = 385.15 acres = Total Unreclaimed Disturbance (329 acres active pit and crusher areas + 42.6 acres overburden and topsoil stockpiles outside active pit area + 6.7 acres maintenance shop, fuel storage, and equipment storage areas + 6.85 acres conveyor system and assoc. infrastructure)  
(Image data from 5/31/2018)

**CORRECTIVE ACTIONS:** By the corrective action date, the operator shall submit a Technical Revision, with the required \$216 fee, to update and clarify the current approved mining plan to reflect existing and proposed activities; specifically to increase the maximum disturbed area to, at a minimum, include existing disturbance at the site (estimated by the Division to be 385.15 acres). Additionally, the revision must include an updated mining plan map in accordance with Rules 6.2.1(2) and 6.4.3, which depicts the entire approved permit boundary (1,854.45 acres) and affected lands boundary (464.9 acres).

**CORRECTIVE ACTIONS:** By the corrective action date, the operator shall submit an updated bond estimate in accordance with Rule 6.4.12 that includes all information necessary to calculate the costs of reclamation that would be incurred by the state for, at a minimum, the existing disturbance at the site, including demolition/removal costs for the existing conveyor system. This bond estimate should be included with the Technical Revision submittal required by Problem #2 above.
