August 10, 2004
File No. 04030-000

Re: Elk Creek Quarry
Geologic and Slope Stability Evaluation

ATTACHMENT B
ELK CREEK QUARRY
GEOLOGIC MAP

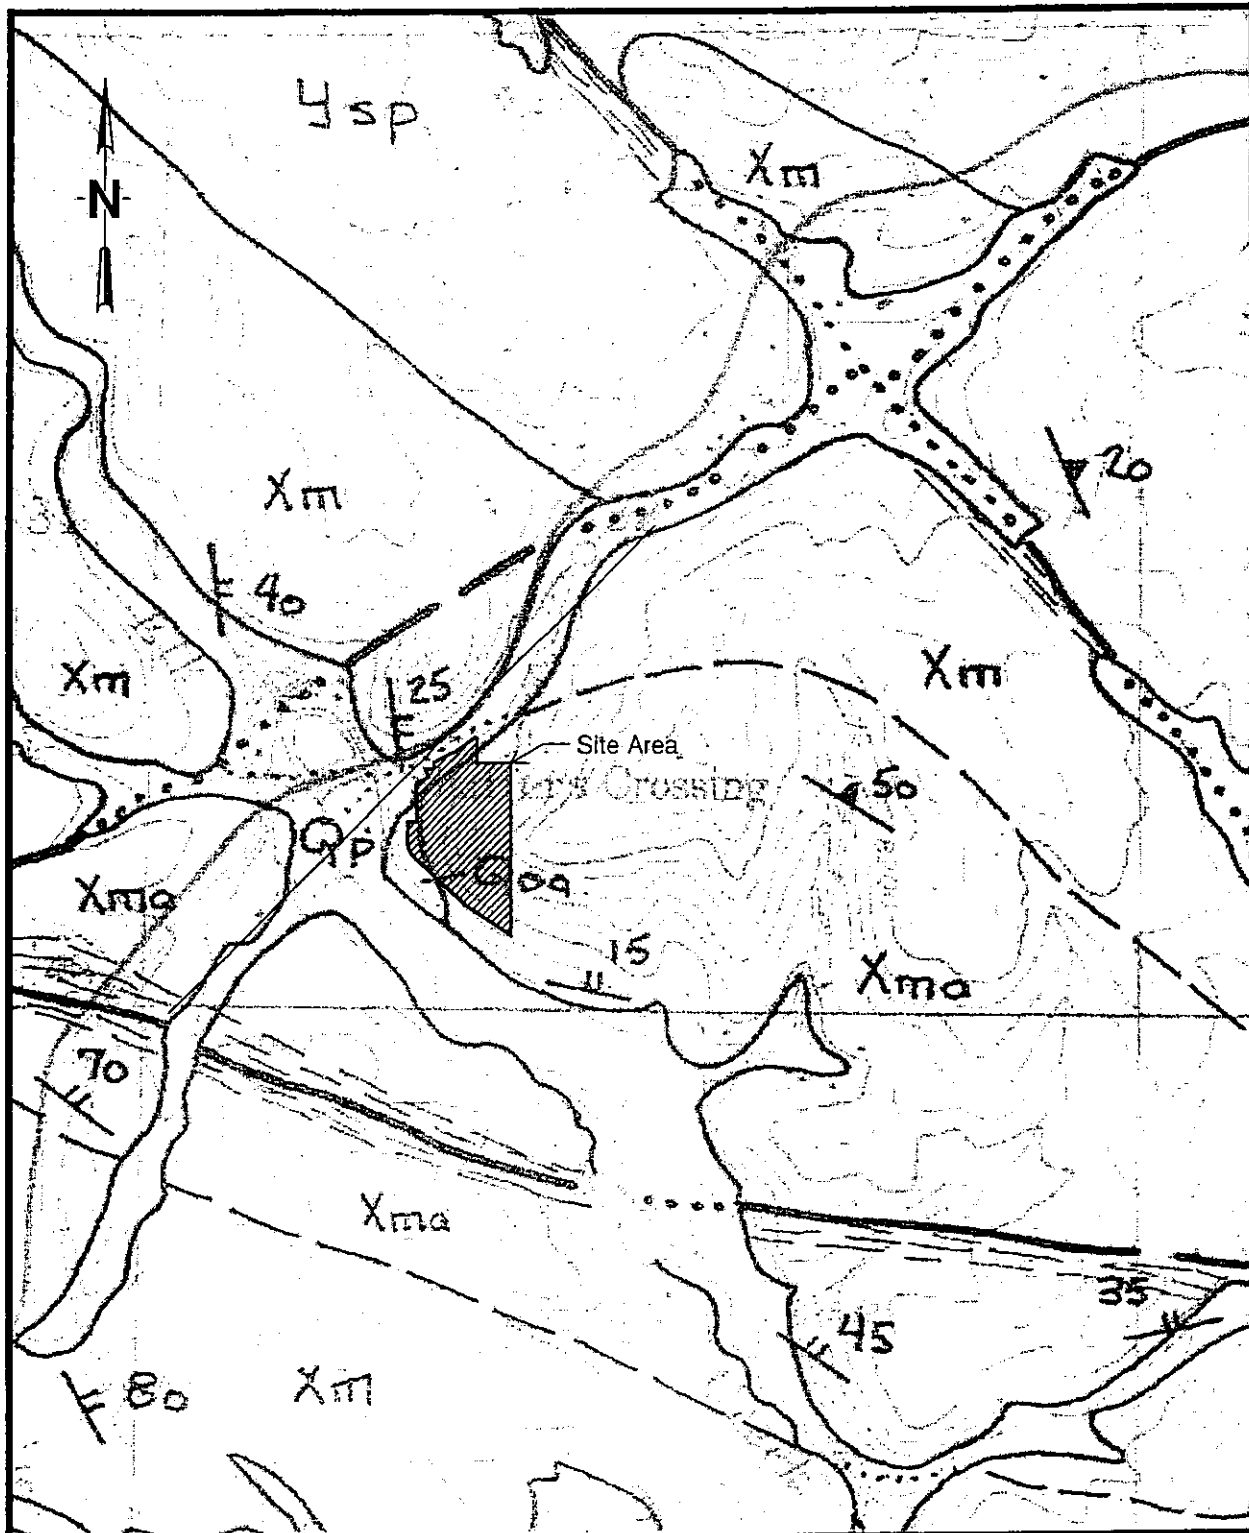
1. See attached Explanation Key.
2. From Reconnaissance Geologic Map of the Pine Quadrangle; Map MF-598; by Bryant Bruce; 1974

**ELK CREEK QUARRY
GEOLOGIC MAP
JEFFERSON COUNTY, COLORADO**

The Fox report appears to be based on the Reconnaissance Geologic Map of the Pine Quadrangle (1:24,000)². A copy of an excerpt from that map showing the project site area is included as Attachment B to this report. The geologic information included in this reference confirms bedrock consisting of migmatitic biotite gneiss with biotite schist, granitic gneiss, and amphibolite. General geologic structure mapped near the quarry includes north to northwesterly striking, easterly to northeasterly dipping foliation and metamorphic compositional layering generally parallel to the foliation. Dips are shallow to moderately steeply dipping, and generally into the hillside at the quarry site.

A site topographic map was included in the original DMG permit application. This map is included as Attachment A to this report. The Geologic Map prepared for this report and included in Attachment B also shows the pre-mining topography. In addition, Elk Creek has developed a very detailed site topographic map prepared by Falcon Surveying, Inc. based on a June 2, 2004 field survey. A copy of the new detailed topographic map showing existing conditions (1 in. = 40 ft; 1 ft contour interval) is provided elsewhere in the rezoning submittal.

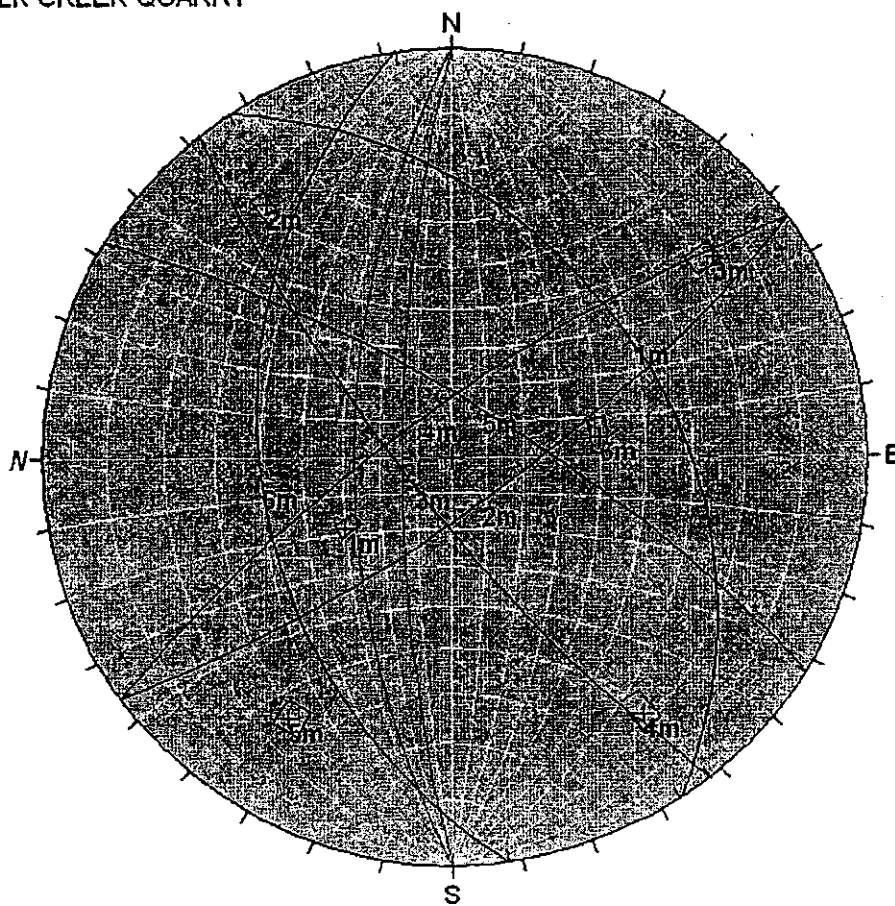
DESIGN JOINT SETS

Orientations		
ID	Dip / Direction	
1	63	/ 270
2	76	/ 270
1 m	35	/ 057
2 m	75	/ 144
3 m	77	/ 232
4 m	76	/ 324
5 m	74	/ 032
6 m	40	/ 262

Equal Angle
Lower Hemisphere
6 Poles
6 Entries

The joint mapping data is summarized in both spreadsheet and stereonet format in Attachment C and the following average joint data are interpreted from these mapping data:

Strike	Dip	Joint Designation	Remarks
N33W	35NE	J-f	Foliation (Primary)
N58W	74NE	J-1	Secondary
N54E	75SE	J-2	Secondary
N38W	77SW	J-3	Secondary
N54E	76NW	J-4	Secondary
N27W	41SW	J-5	Tertiary
N20E	40NW	J-6	Tertiary

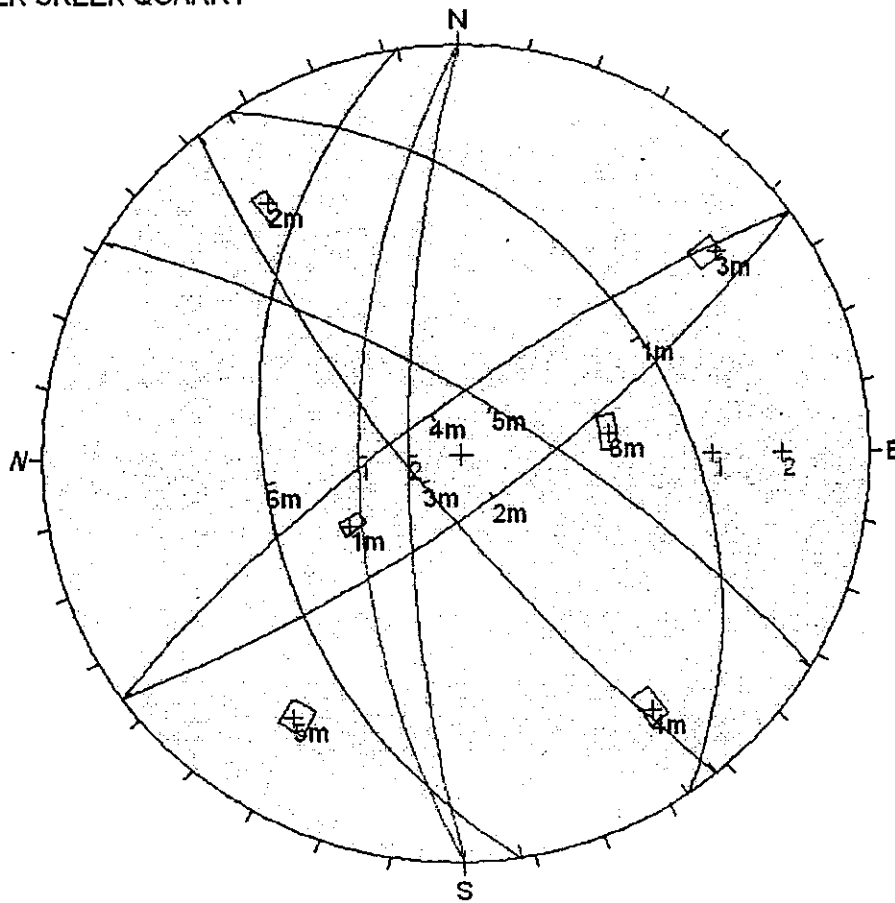
DESIGN JOINT SETS

ID		Dip / Direction
1		63 / 270
2		76 / 270
1	m	35 / 057
2	m	75 / 144
3	m	77 / 232
4	m	76 / 324
5	m	74 / 032
6	m	40 / 262

Equal Angle
Lower Hemisphere
6 Poles
6 Entries

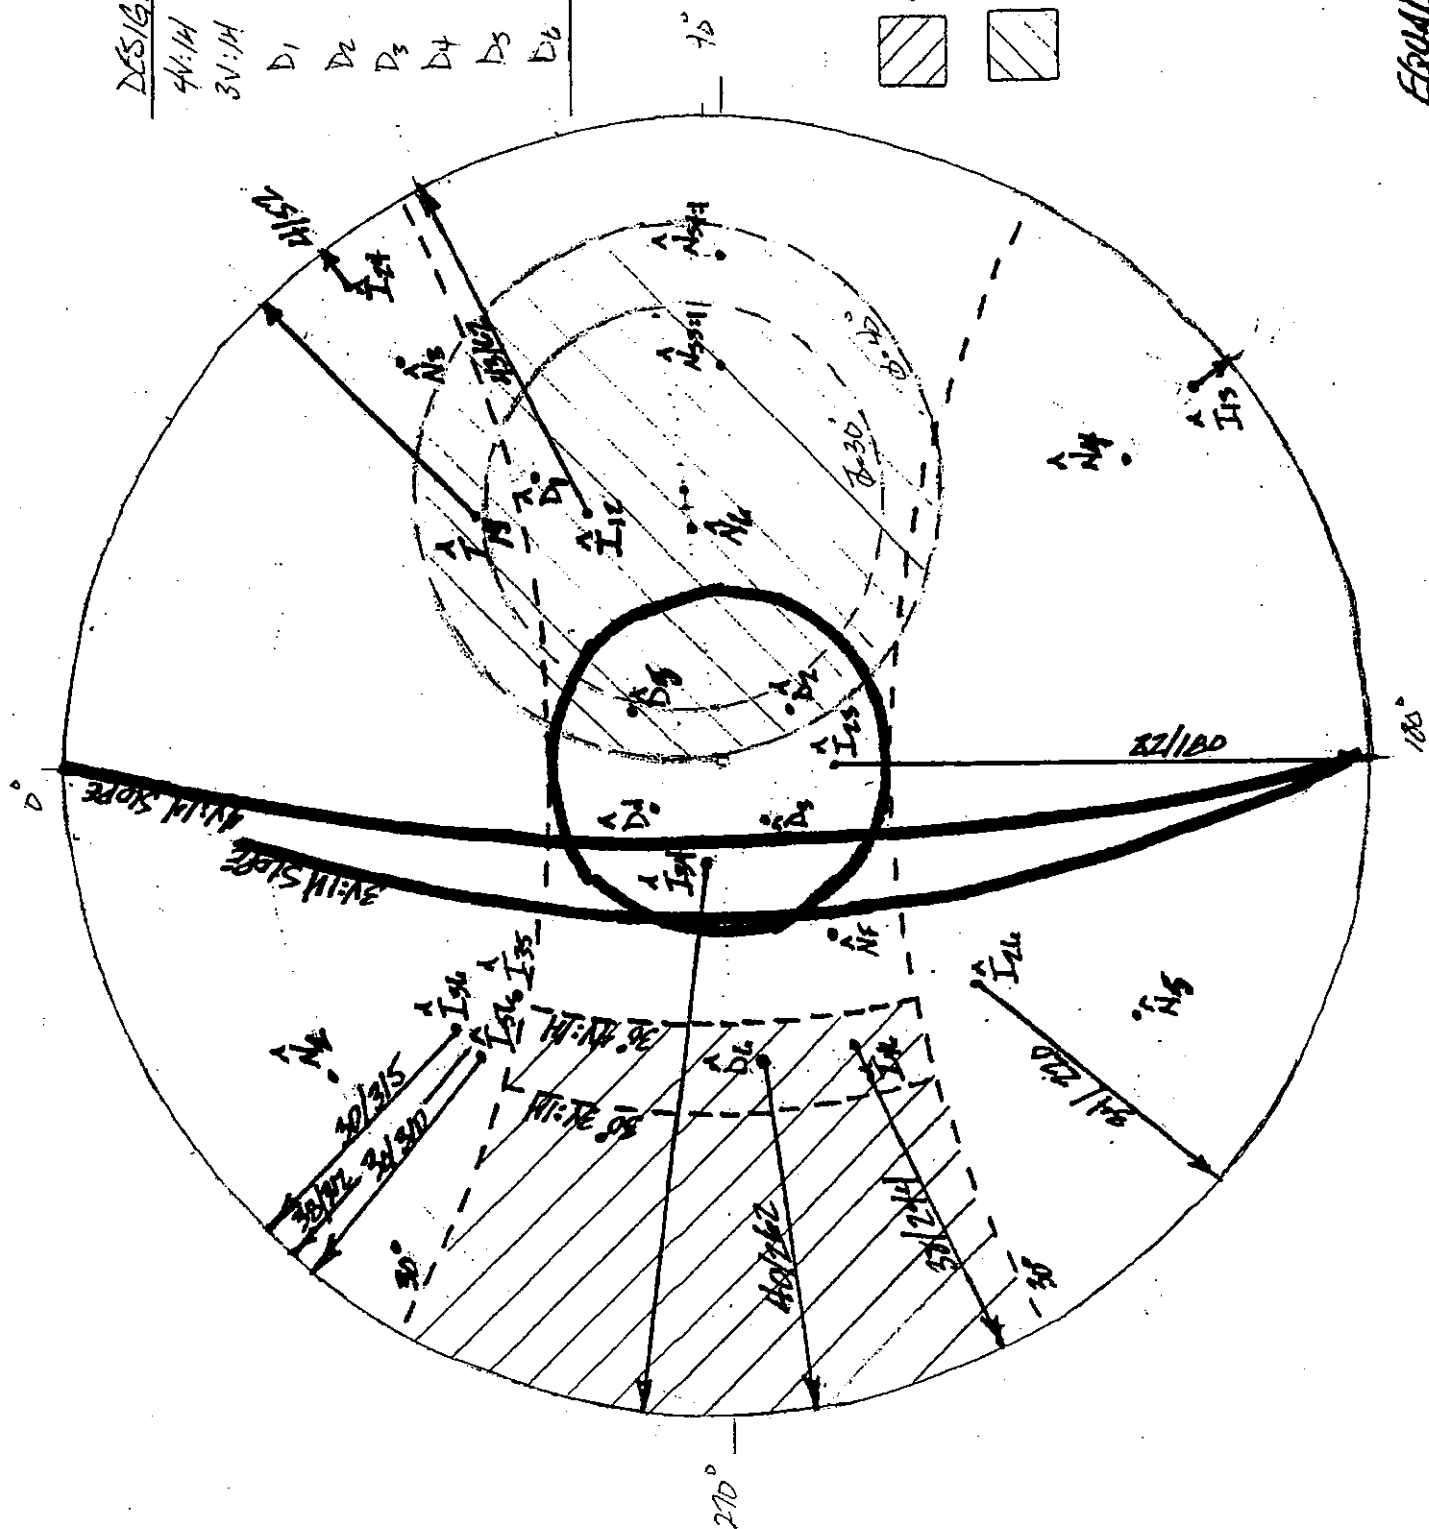
ELK CREEK QUARRY
SLOPE STABILITY
EVALUATION INFORMATION

DESIGN JOINTS

POTENTIAL
TOPPLING ZONE

POTENTIAL SLIDING PLANES

IDENTIFICATION NUMBER	DIP (DEG.)	DIP DIRECTION (DEG.)	$F_{\phi=30}$	$F_{\phi=50}$
\hat{D}_6	40	262	<1.0	>1.0
\hat{I}_{36}	30	315	>1.0	>1.0
\hat{I}_{35}	38	312	<1.0	>1.0
\hat{I}_{52}	30	310	>1.0	>1.0
\hat{I}_{46}	38	244	<1.0	>1.0
\hat{I}_{24}	34	220	<1.0	>1.0

1. TOPPLING IS NOT KINEMATICALLY OR MECHANICALLY ADMISSIBLE FOR THE 6 MAPPED JOINTS.
2. SLIDING ALONG JOINT NO. 6 IS KINEMATICALLY AND MECHANICALLY ADMISSIBLE IN THE UPPER WEATHERED ROCK. WITHIN THE GENERAL ROCK MASS, SLIDING ALONG JOINT NO. 6 IS KINEMATICALLY ADMISSIBLE BUT MECHANICALLY INADMISSIBLE GIVEN ITS PERSISTENCE AND THE STRENGTH PARAMETERS OF THE ROCK MASS.
3. WEDGES CREATED BY \hat{I}_{35} , \hat{I}_{46} & \hat{I}_{24} ARE KINEMATICALLY & MECHANICALLY ADMISSIBLE WITHIN THE CREEK BUT NOT THE GENERAL MASS.
4. SPOT BOLTING MAY BE REQUIRED FOR \hat{I}_{35} & \hat{I}_{46} .

The stereonet analysis and summary included in Attachment D shows potential sliding plane and wedge failures. These all assume continuous, through-going joint features, which is a conservative assumption for this rock mass. Analysis shows potential slope failures if the slope were steepened to 1:4 from the originally proposed 1:2 configuration, but acceptable slope conditions for a quarry development if steepened to 1:3 as Elk Creek is presently proposing (12 ft benches by 35 ft highwalls = 1:2.9).

For slope failures to occur, planar or wedge failures must first be kinematically (geometrically) possible or admissible. In addition, for given possible planar or wedge failure modes, the material strength properties of the rock must be low enough for these failures to be mechanically possible or admissible. Factors of safety less than one were considered as cases where failure was mechanically possible or admissible. Such analyses were run for all kinematically admissible planes and wedges for both weathered and unweathered rock using internal friction angles of 30 degrees and 40 degrees, respectively.

For the proposed 1:3 slopes, our analyses indicate that sliding failure is kinematically admissible only on the averaged westerly dipping joint set, but that this is mechanically admissible only in the upper weathered rock. Toppling failure is not kinematically admissible for any of the six joint sets analyzed. Of five wedge failure modes identified in the analyses, three are kinematically and mechanically admissible in the upper weathered rock, but not in the general rock mass. Two of the wedges might require spot bolting, but limited individual wedge failure in final highwalls is usually considered acceptable in quarry operations. As an example, DMG permitting for the Morrison Quarry in a similar rock mass assumed up to 15 to 20 percent such failures to be acceptable. The upper weathered rock should be laid back to 1:1 for long term stability.
