Re: King I Mine, C-1981-035
Stoner Engineering: Quarterly Inspection: Water Quality Improvements
4th Quarter 2019

Re: King Coal I – Quarterly Water Quality Improvements Inspection

On November 25, 2019, Ryan Griglak, P.E. visited the GCC Energy, LLC King I Mine site to conduct the quarterly inspection of the water quality features installed to prevent contaminated storm water runoff from escaping the site in events smaller than the 100-year storm event.

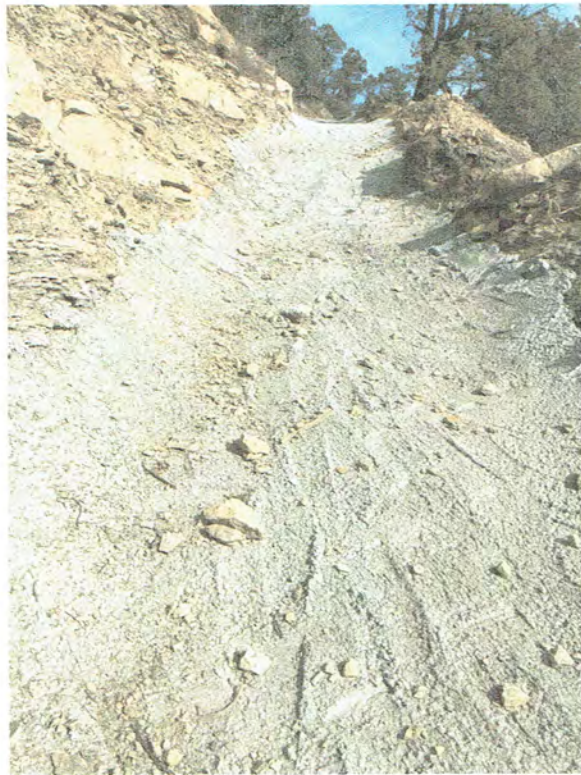
Pic. 2 – Concrete channel section from new upper section of Reach 1.

The sedimentation traps at the entrance to the site are in good condition. The work to the upper portion of Reach 1 has been completed. The realignment of the lower portion of Reach 1 has been staked for construction. The steep section of channel connecting the upper and lower sections of Reach 1 has had the concrete channel installed to protect against excessive erosion (see Pic. 2). The section of Reach 10 where runoff is escaping from the channel section and causing erosion along the side of the channel is still in need of some repairs. While this runoff is still routed to the sediment ponds, it will result in excessive erosion to the existing hillside and should be repaired.

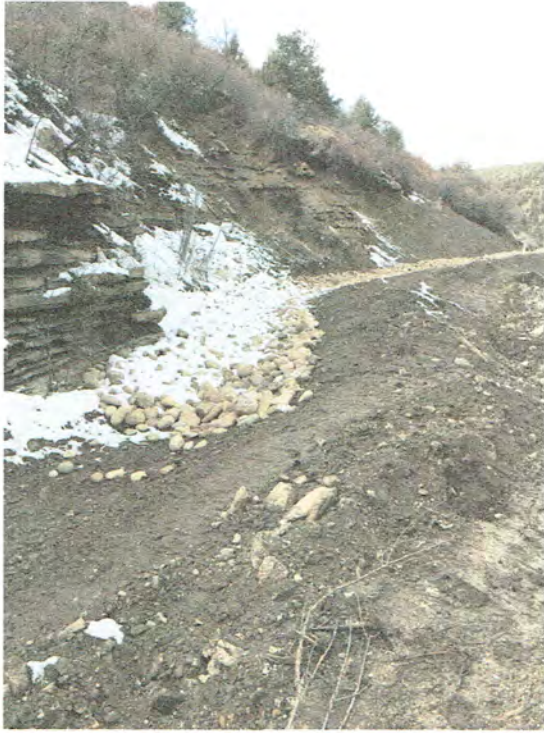
Pic. 3 – New clean water channel for Reach 3 relocation.

The installation of the new under-drain system has been completed for the TR-27 waste pile expansion. The extended under-drain was terminated into the area inlet just east of the old bath house. The west clean water ditch has been constructed along the west portion of the property (see Pic. 3). Reach 8 is being prepped for the installation of the new culvert for the new haul road. The area inlet connecting Reach 7 to the under-drain has experienced some sedimentation as a result of the ongoing construction operations and the recent snowfall. While the area has been protected with berming and soil erosion control logs, the surrounding grading currently directs the majority of the surface runoff into the area inlet (see Pic. 4). The erosion control measures around the area inlet should either be improved or the surface water flows from the upstream stockpiling area should be rerouted around the inlet to prevent excessive sediment from entering Reach 7.
