**COLORADO**  
Division of Reclamation,  
Mining and Safety  
Department of Natural Resources

<b>Permit Number:</b> C-1981-037 <b>Mine Name:</b> GEC Strip Mine <b>Operator:</b> GEC Minerals, Inc. <b>Operator Address:</b> Dr W Corley 2605 Constellation Drive Colorado Springs, CO 80906	<b>County:</b> Fremont <b>Operation Type:</b> Surface <b>Permit Status:</b> Revoked <b>Ownership:</b> Private
	<b>Operator Representative Present:</b>  None
<b>Operator Representative Signature: (Field Issuance Only)</b>

<b>Inspection Start Date:</b> December 23, 2019 <b>Inspection Start Time:</b> 09:00 <b>Inspection End Date:</b> <b>Inspection End Time:</b>		<b>Inspection Type:</b> Coal Complete Inspection <b>Inspection Reason:</b> Normal I&E Program <b>Weather:</b> Cloudy	
<b>Joint Inspection Agency:</b>  None		<b>Joint Inspection Contacts:</b>  None	
<b>Post Inspection Agency:</b>  None		<b>Post Inspection Contacts:</b>  None	
<b>Inspector(s):</b>  Zach Trujillo	<b>Inspector's Signature:</b>

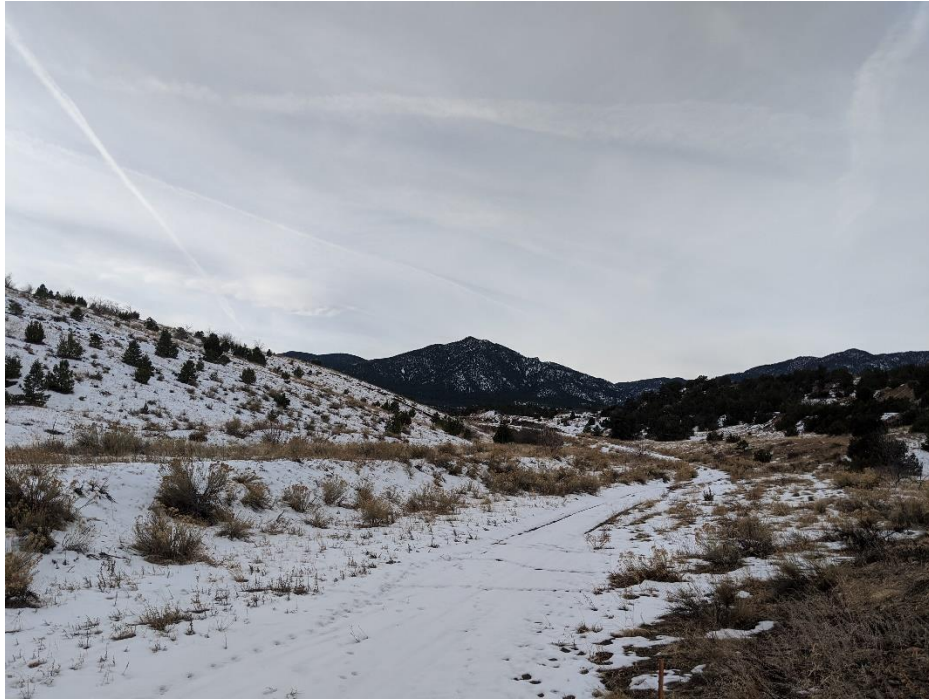
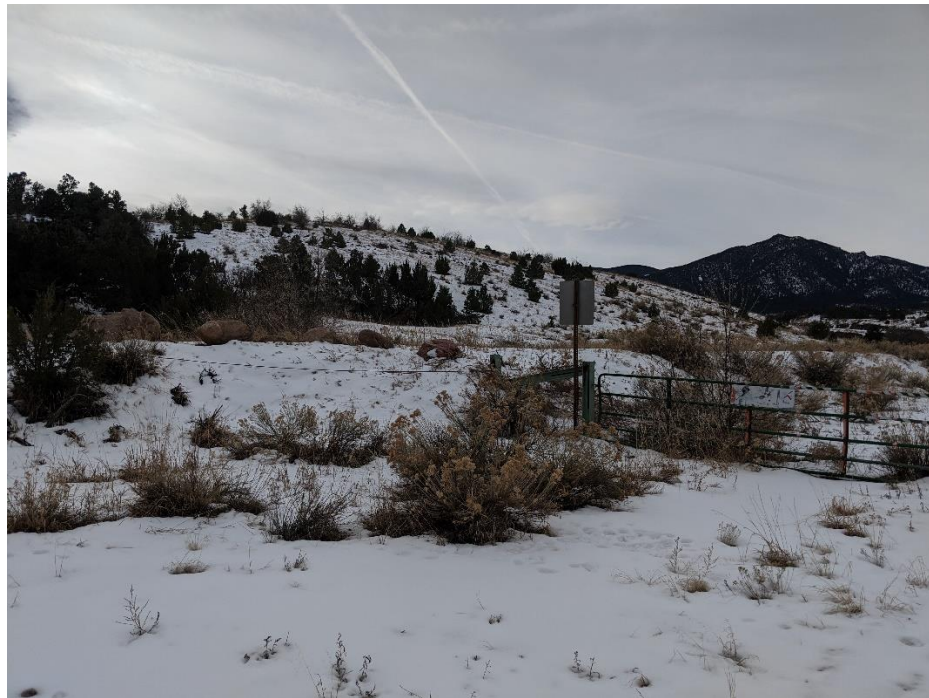
The inspection for the GEC Mine was done at the locked gate along the county road to the site. A portion of Chen's Hill was visible from this location. From that location, no rills or gullies could be observed due to the line of sight as well as snow cover. As documented in previous reports, the slope has multiple gullies.

From the County Road, the Division was able to inspect the embankment of Pond A. The embankment was snow covered but appeared stable. While the Division could not view the top of the embankment, it has been well documented that this pond is completely full of sediment.
