MINERALS PROGRAM INSPECTION REPORT
PHONE: (303) 866-3567

MINE NAME: Jolly Pit	MINE/PROSPECTING ID#: M-2012-010	MINERAL: Borrow material for	COUNTY: Las Animas
INSPECTION TYPE: Monitoring	INSPECTOR(S): Daniel Cunningham	INSP. DATE: January 15, 2020	INSP. TIME: 11:00
OPERATOR: Las Animas County	OPERATOR REPRESENTATIVE: Joe Porras	TYPE OF OPERATION: 112c - Construction Regular Operation	
REASON FOR INSPECTION: Normal I&E Program		BOND CALCULATION TYPE: NA	BOND AMOUNT: \$0.00
DATE OF COMPLAINT: NA		POST INSP. CONTACTS: None	JOINT INSP. AGENCY: None
WEATHER: Clear	INSPECTOR'S SIGNATURE:

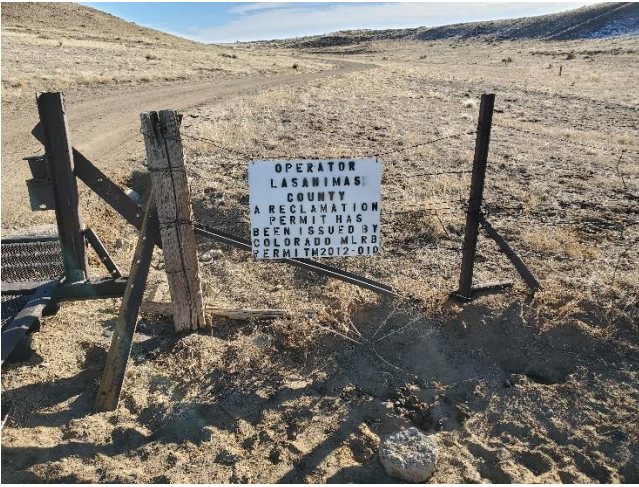
The site identification sign was posted a good distance away from the mine site, however it is the only entrance to the area. Permit markers were observed to be in place throughout the entire operation. All activity appeared to be in compliance with the approved mining plan including a high wall of approximately 25 feet with a slope of 0.5:1 and topsoil piles being vegetated and stable. No issues requiring corrective action were observed during this inspection.

Photo 1: Mine Entrance sign

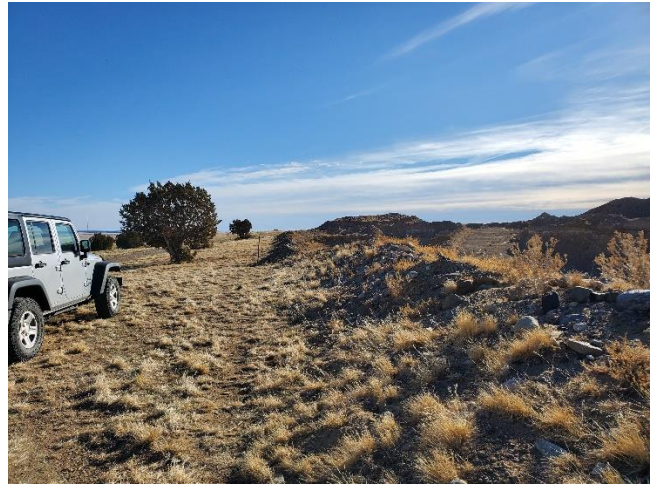
Photo 2: Boundary Marker

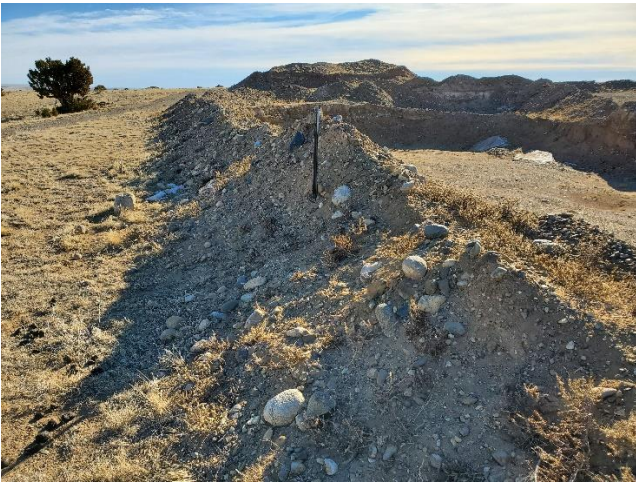
During the inspection it was observed that mining has occurred right up to the boundary markers on the North and West side of the disturbed area. The Division cautions the Operator that land outside of the approved permit boundary must not be affected. The Operator indicated that during reclamation they will slope from the bottom of the pit to the top and will not disturb the area outside the permit. The Operator was informed that if any area outside the permit boundary was to be disturbed, they would need to submit and receive approval of an amendment to change their existing plan and increase the permit area prior to affecting land outside the approved boundary.

Photo 3: Disturbance right up to boundary marker

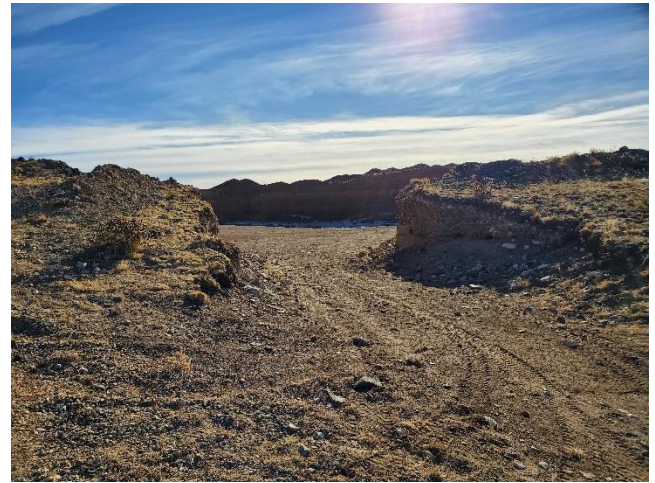
Photo 4: High wall

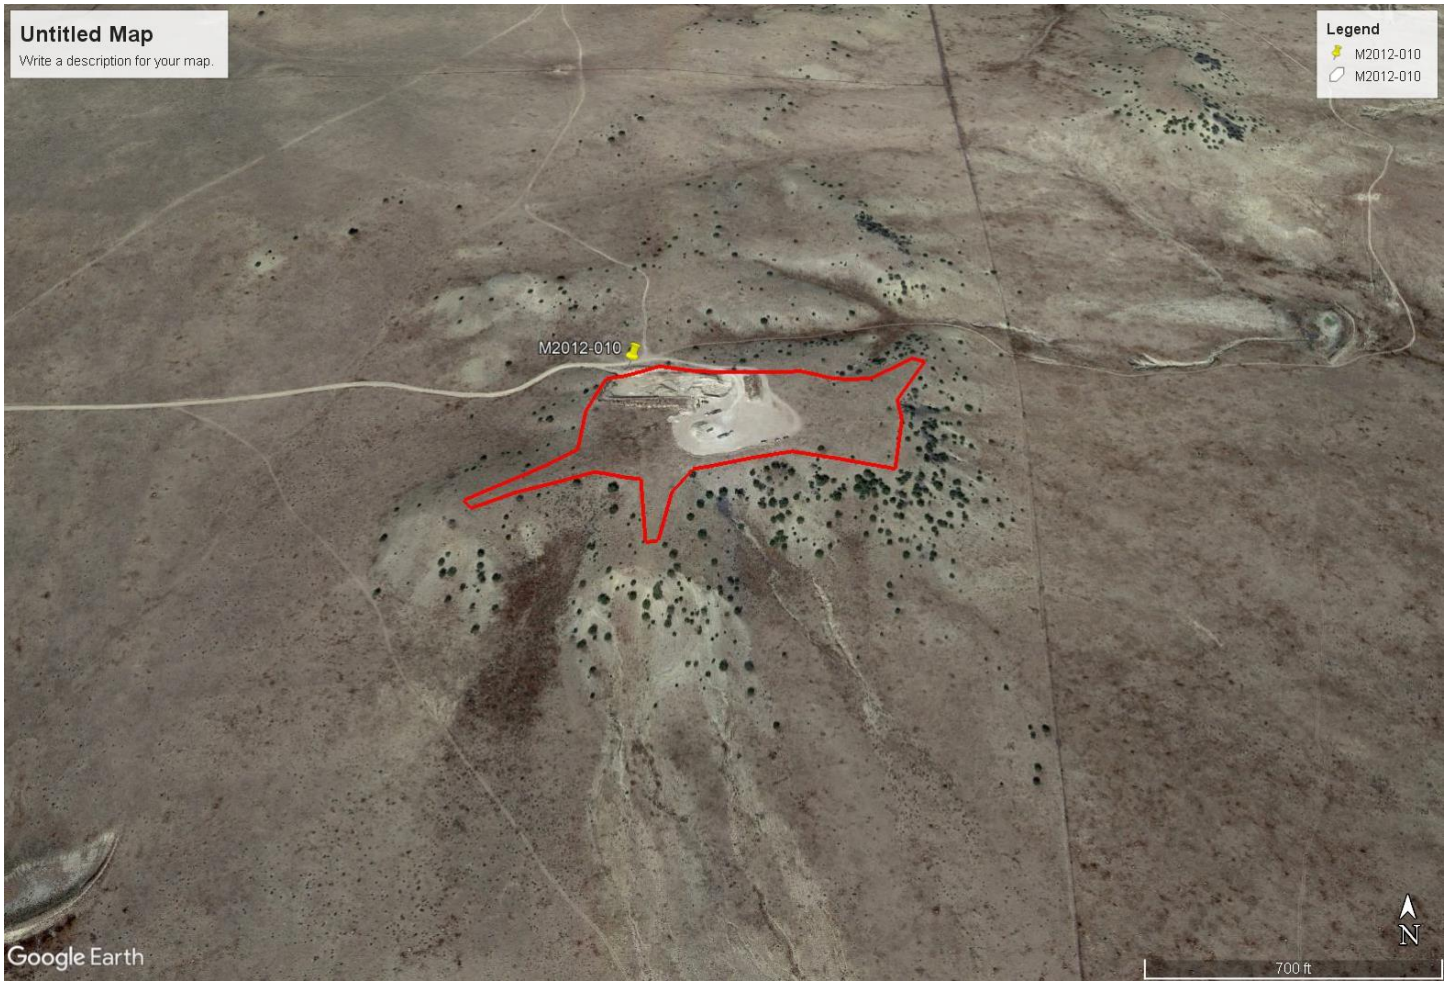
This was a routine monitoring inspection conducted at the Jolly Pit by DRMS representatives DJ Cunningham, Jared Ebert, and Rob Zuber. Joe Porras of Las Animas County attended the inspection. This site is an active, 12 acre, 112c permit held by Las Animas County (Operator). Mining activity was not taking place at the time of the inspection. Approximately 4 acres of the 12 permitted acres has been disturbed to date as can be seen on the attached, GPS located, permit boundary map.
