MINERALS PROGRAM INSPECTION REPORT
PHONE: (303) 866-3567

MINE NAME: Sandoval Land and Cattle Pit	MINE/PROSPECTING ID#: M-2001-015	MINERAL: Sand and gravel	COUNTY: Las Animas
INSPECTION TYPE: Monitoring	INSPECTOR(S): Daniel Cunningham	INSP. DATE: January 15, 2020	INSP. TIME: 12:00
OPERATOR: Las Animas County	OPERATOR REPRESENTATIVE: Allen Winford	TYPE OF OPERATION: 110c - Construction Limited Impact

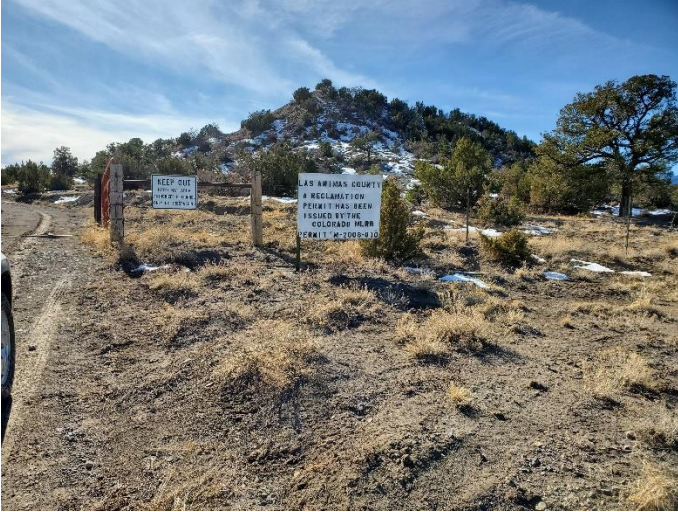
Photo 1: Mine entrance sign

PROBLEM: The permit number on the entrance sign was incorrect. This is a problem at this time for failure to maintain the required mine entrance sign in accordance with Rule 3.1.12.

The site identification sign was posted at the mine site, however the permit number was incorrect. This issue is cited as a problem at the beginning of this report. Las Animas County will need to submit proof of a corrected sign no later than March 21, 2020. Boundary markers were noted throughout the permitted area.

CORRECTIVE ACTIONS: Submit evidence that the sign has been corrected with the approved permit number (M-2001-015) displayed. **CORRECTIVE ACTION DUE DATE:** 3/21/20

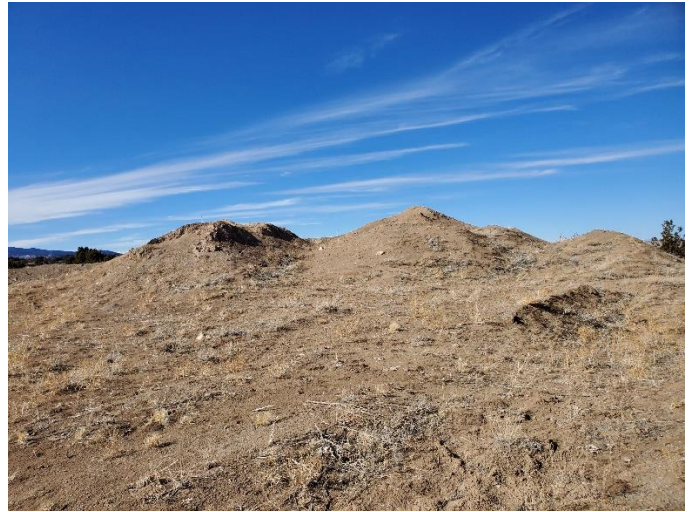
Photo 2: Topsoil stockpile

PROBLEM: Topsoil stockpiles were not configured and stabilized with vegetation to protect against wind and water erosion in accordance with Rule 3.1.9.

Existing topsoil stockpiles were not configured and seeded with appropriate vegetation to help prevent erosion in accordance with Rule 3.1.9. This issue was also noted in the June 2nd, 2016 inspection report and has not been corrected. Las Animas County will need to submit proof of reshaping the topsoil stockpile and evidence the topsoil stockpiles have been seeded.

CORRECTIVE ACTIONS: Submit evidence the topsoil stockpiles have been reconfigured and seeded with an appropriate seed mixture to stabilize them from erosion. **CORRECTIVE ACTION DUE DATE:** 3/21/20

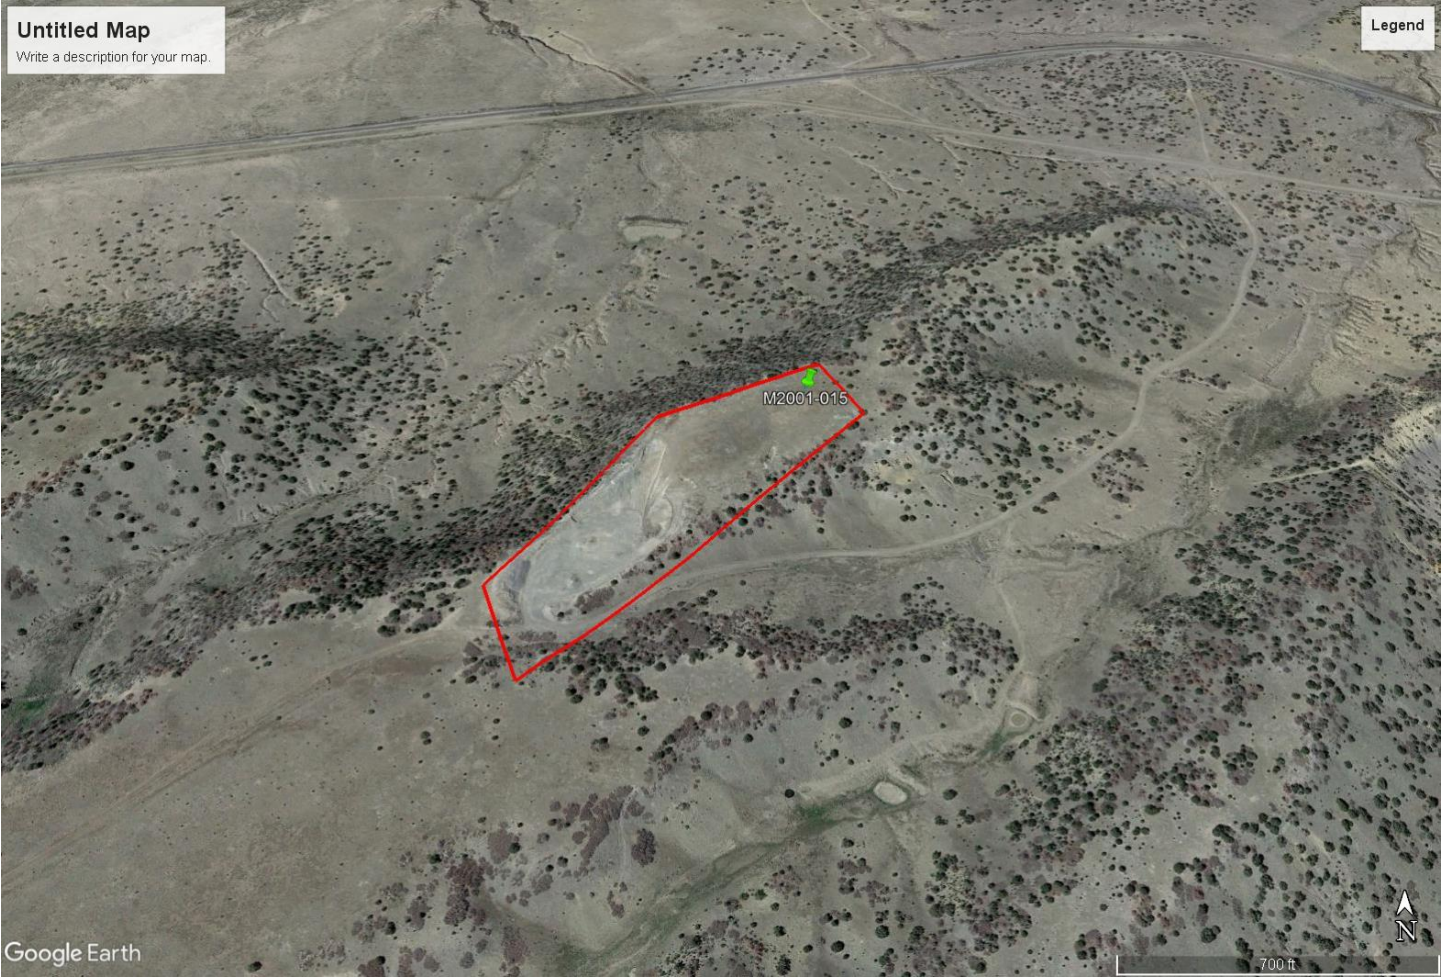
An aerial photo of the site has been included to depict the general condition of the site at this time. All activity appeared to be in compliance with the approved mining plan, with the exception of the problems cited above, and no other issues requiring corrective action were observed during this inspection.
