MINERALS PROGRAM INSPECTION REPORT
PHONE: (303) 866-3567

MINE NAME: Bokelman-Walters	MINE/PROSPECTING ID#: M-2006-080	MINERAL: Sand and gravel	COUNTY: Larimer
INSPECTION TYPE: Monitoring	INSPECTOR(S): Amy Eschberger	INSP. DATE: January 16, 2020	INSP. TIME: 11:30
OPERATOR: Loveland Ready-Mix Concrete, Inc.	OPERATOR REPRESENTATIVE: Stephanie Fancher	TYPE OF OPERATION: 112c - Construction Regular Operation	
REASON FOR INSPECTION: Normal I&E Program	BOND CALCULATION TYPE: Complete Bond	BOND AMOUNT: \$644,075.00	
DATE OF COMPLAINT: NA	POST INSP. CONTACTS: None	JOINT INSP. AGENCY: None	
WEATHER: Clear	INSPECTOR'S SIGNATURE:

M-2006-080 / Bokelman-Walters / Loveland Ready-Mix Concrete, Inc. (112c)

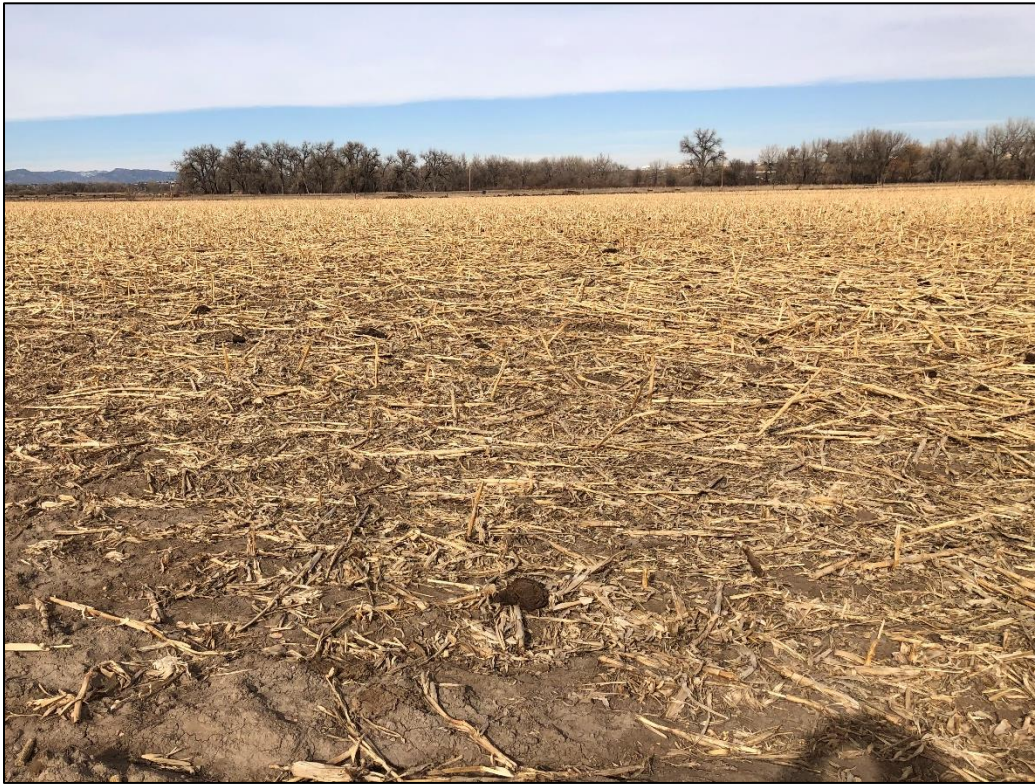
Photo 1. View looking northwest across undisturbed Phase II mining area in eastern portion of permit area, north of access road.

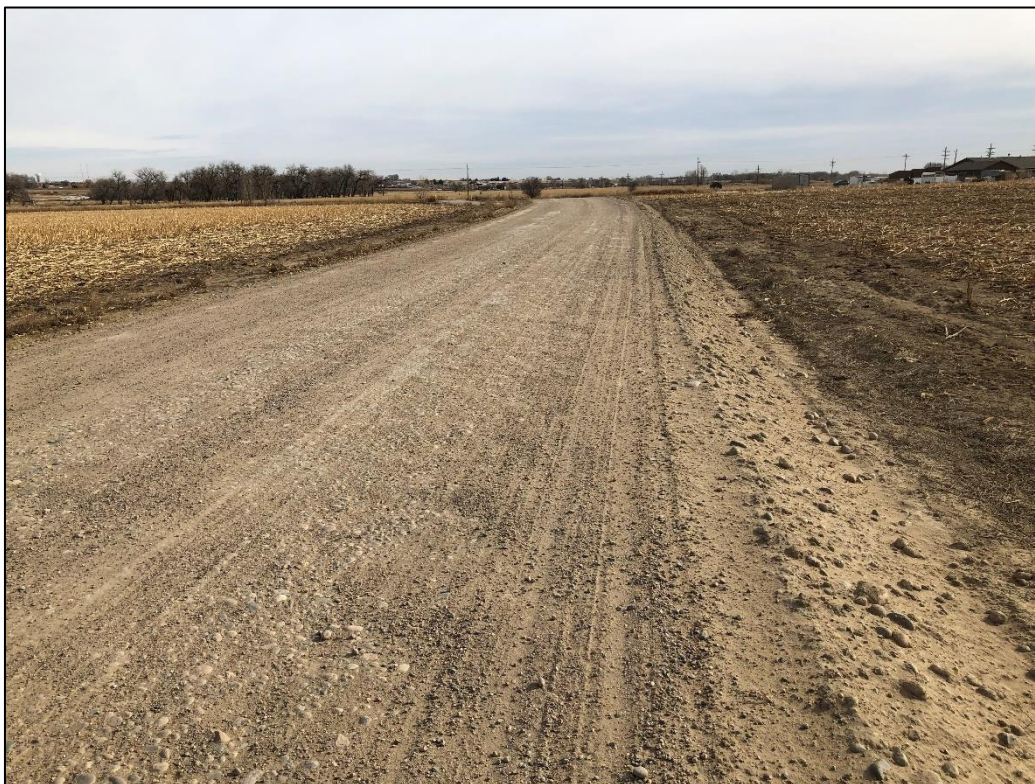
Photo 2. View looking east across main haul road constructed across property from South County Line Road to Phase I mining area. This road will remain for reclamation.

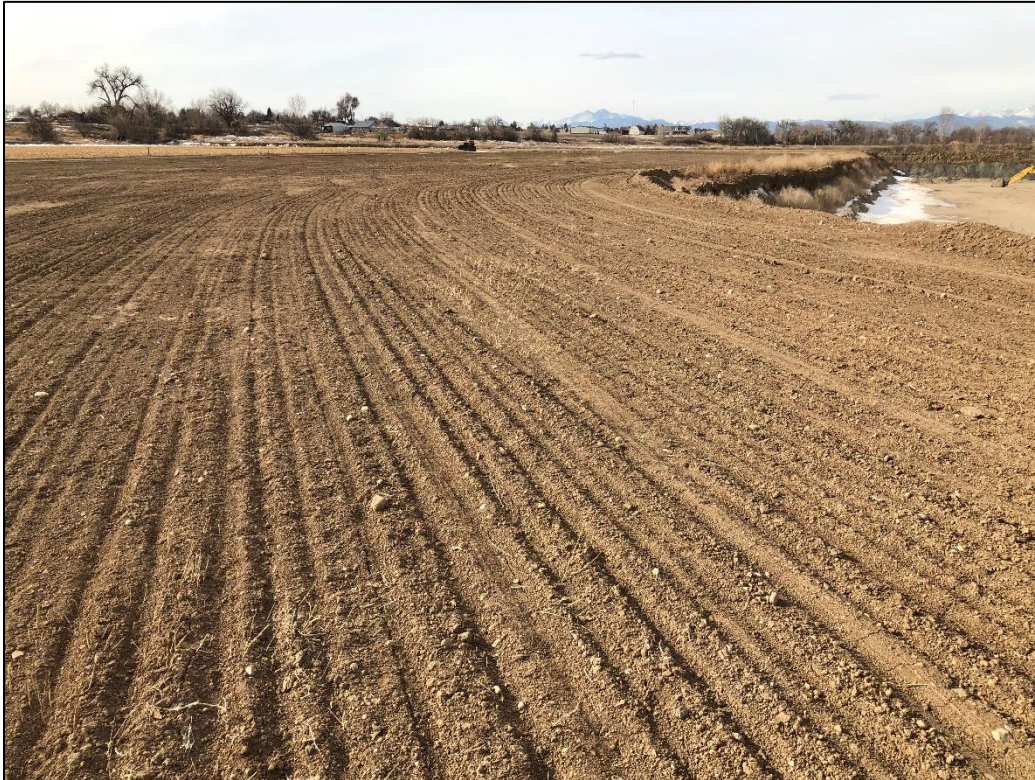
Photo 3. View looking west across disturbed area between southern edge of Phase I Cell 2 pit and slurry wall enclosure, which will be mined.

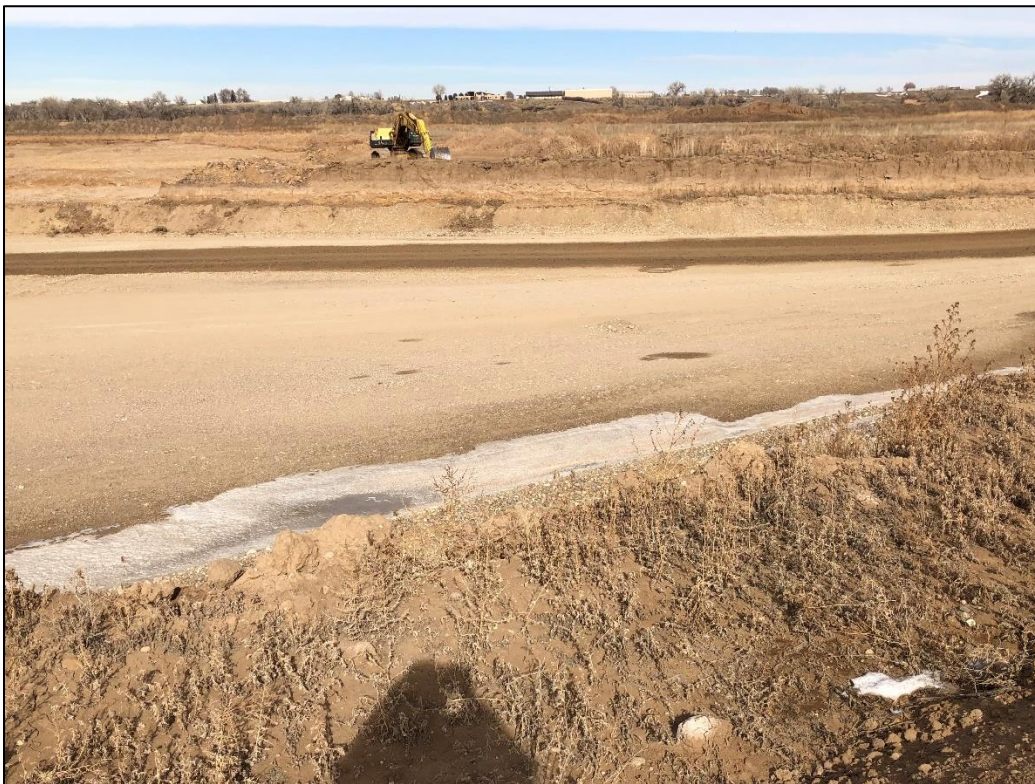
Photo 4. View looking north across southeastern portion of Phase I Cell 2 pit. Internal pit walls (in background) have near vertical slopes.

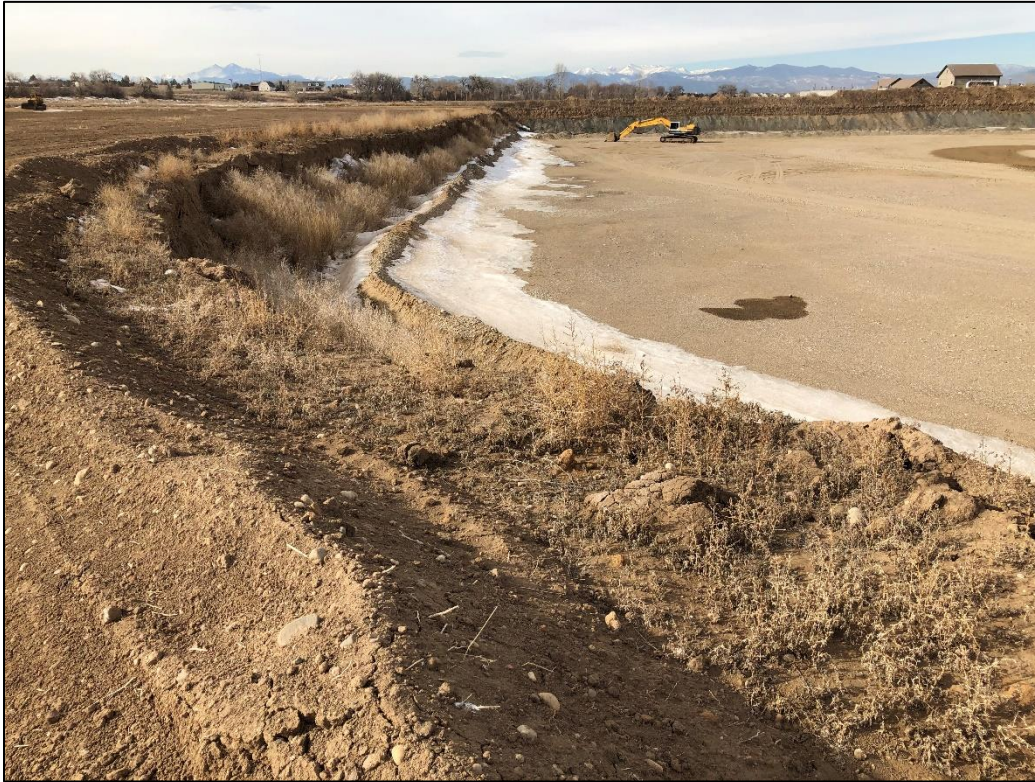
Photo 5. View looking west across south pit wall of Phase I Cell 2 pit, with slopes of 0.5H:1V to 1H:1V. This is considered an internal pit wall given its distance from the slurry wall, so its slopes can be steeper than 2H:1V.

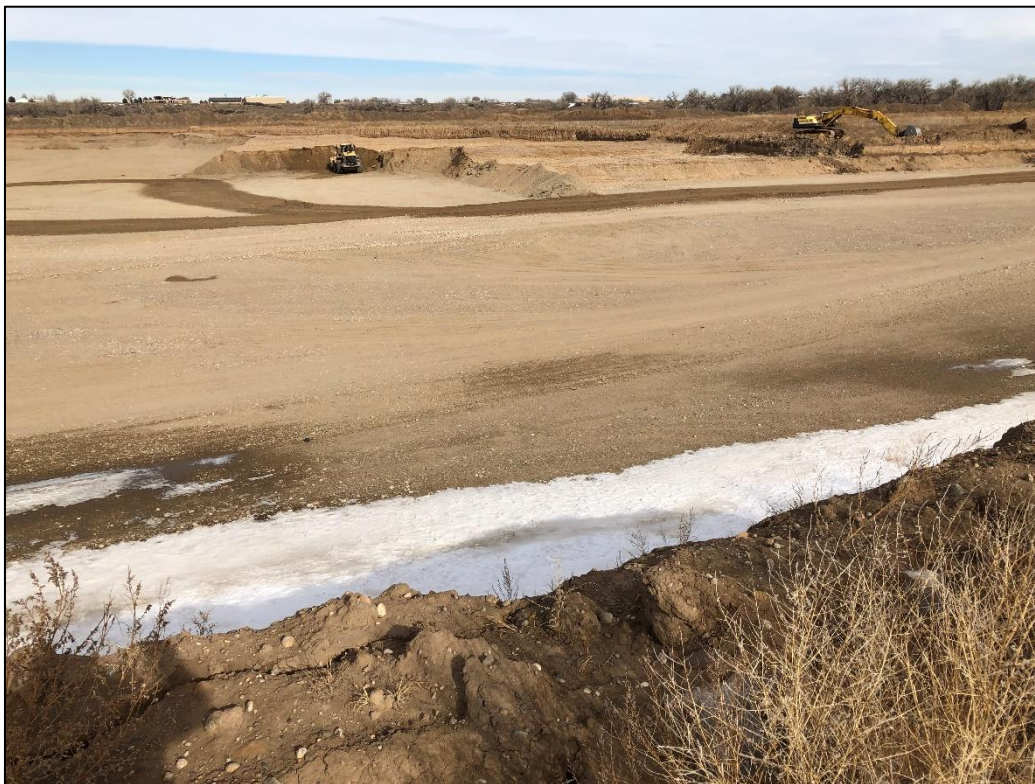
Photo 6. View looking northeast across Phase I Cell 2 pit, showing current excavation activities near center of pit, mining generally eastward.

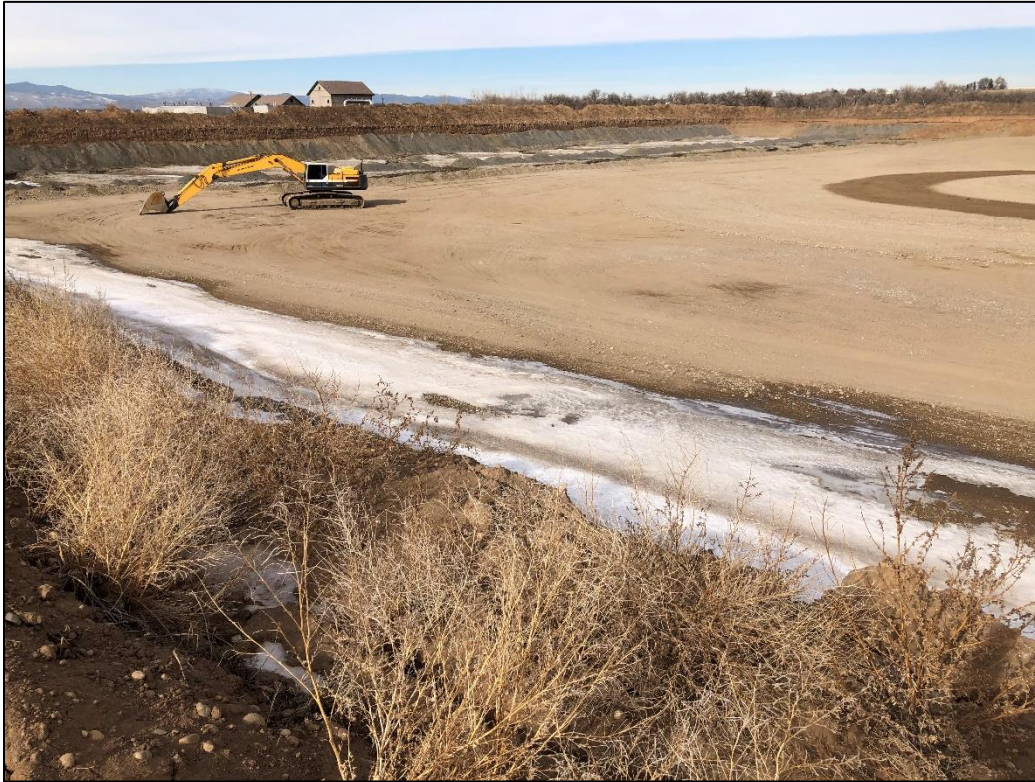
Photo 7. View looking northwest across Phase I Cell 2 pit, showing western pit wall in background.

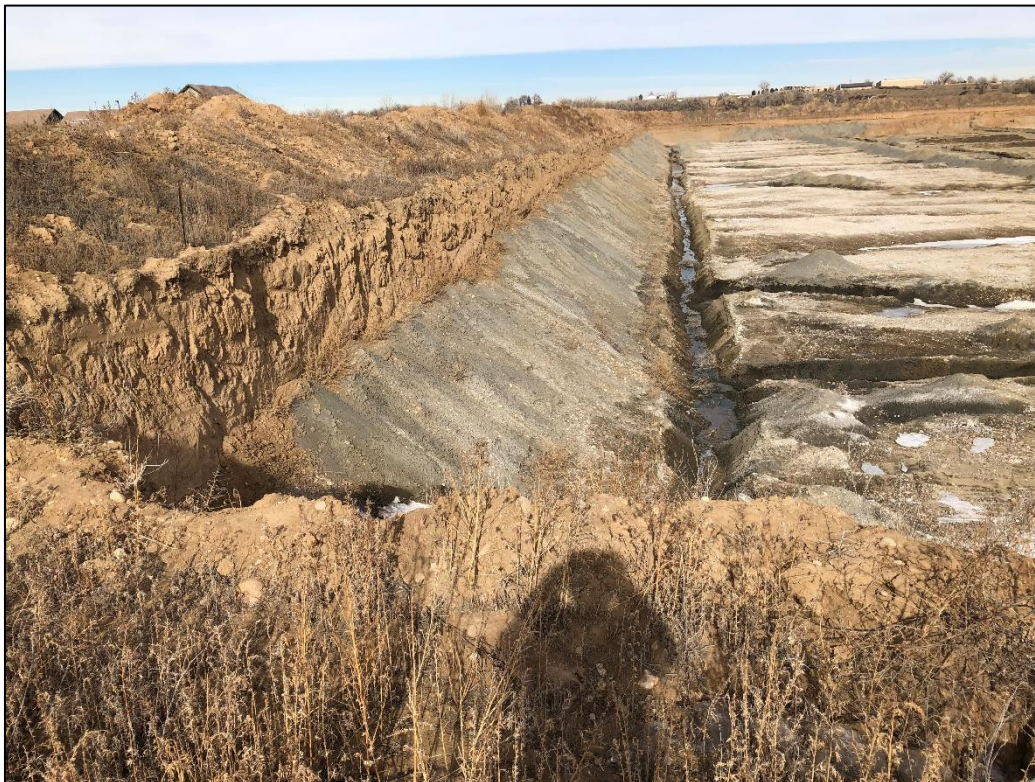
Photo 8. View looking north across western pit wall of Phase I Cell 2 pit, with slopes of 2.5H:1V (except for top 2-3 feet). Note topsoil bermed along top of pit wall.

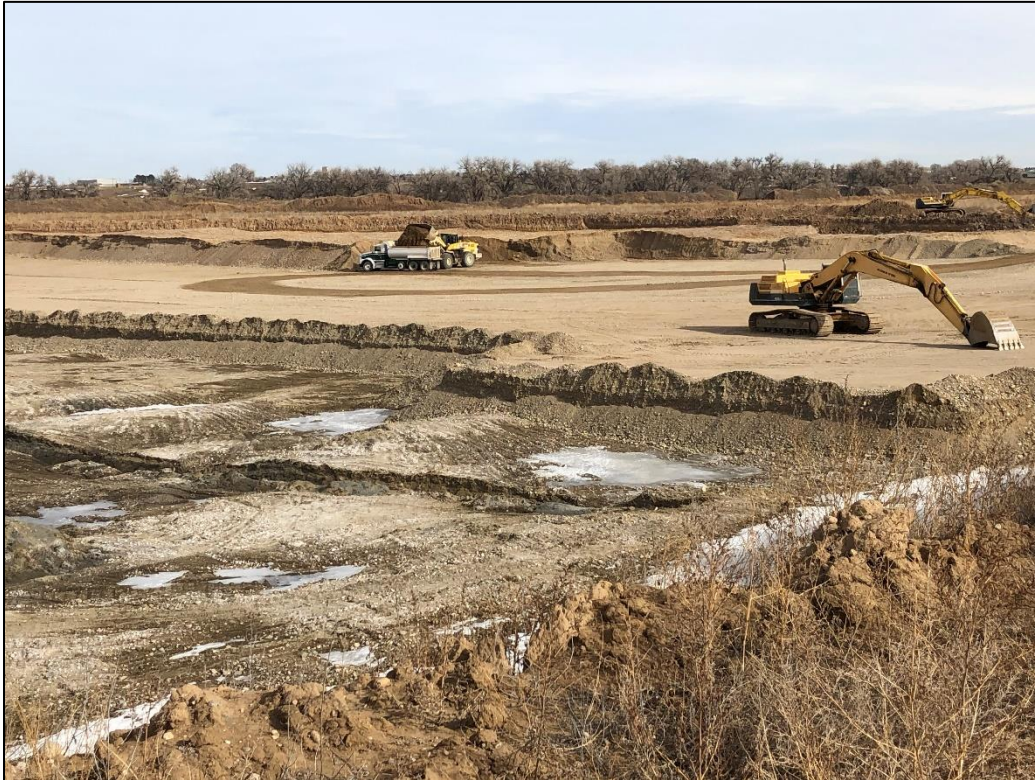
Photo 9. View looking northeast across Phase I Cell 2 pit, showing current excavation activities near center of pit, mining generally eastward.

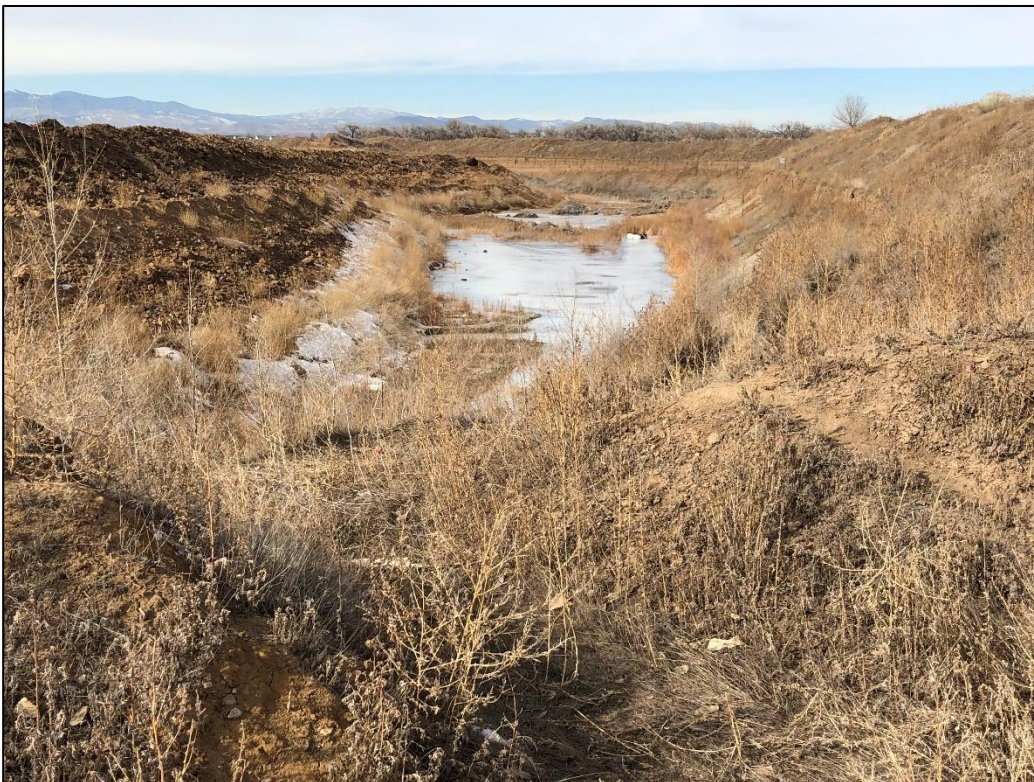
Photo 10. View looking west along northern edge of Phase I Cell 2 pit, where water is pumped from pit to sediment pond.

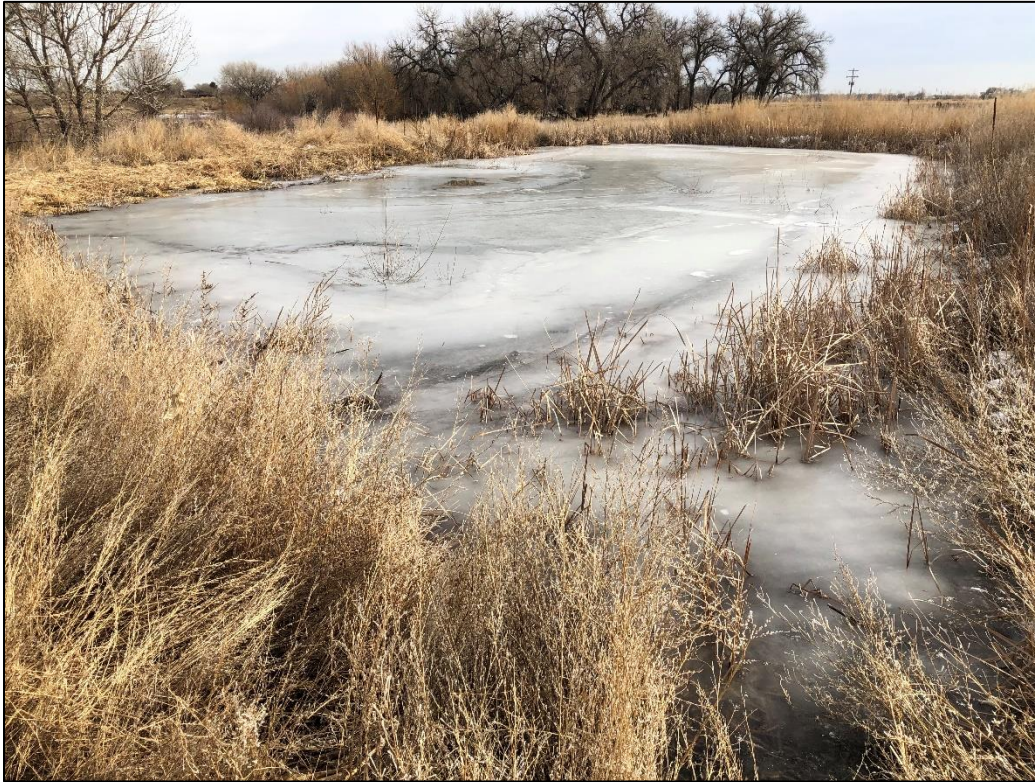
Photo 11. View looking east across sediment pond located between northern edge of undisturbed Phase I Cell 3 and the river. Note pond full of (ice-capped) water during inspection.

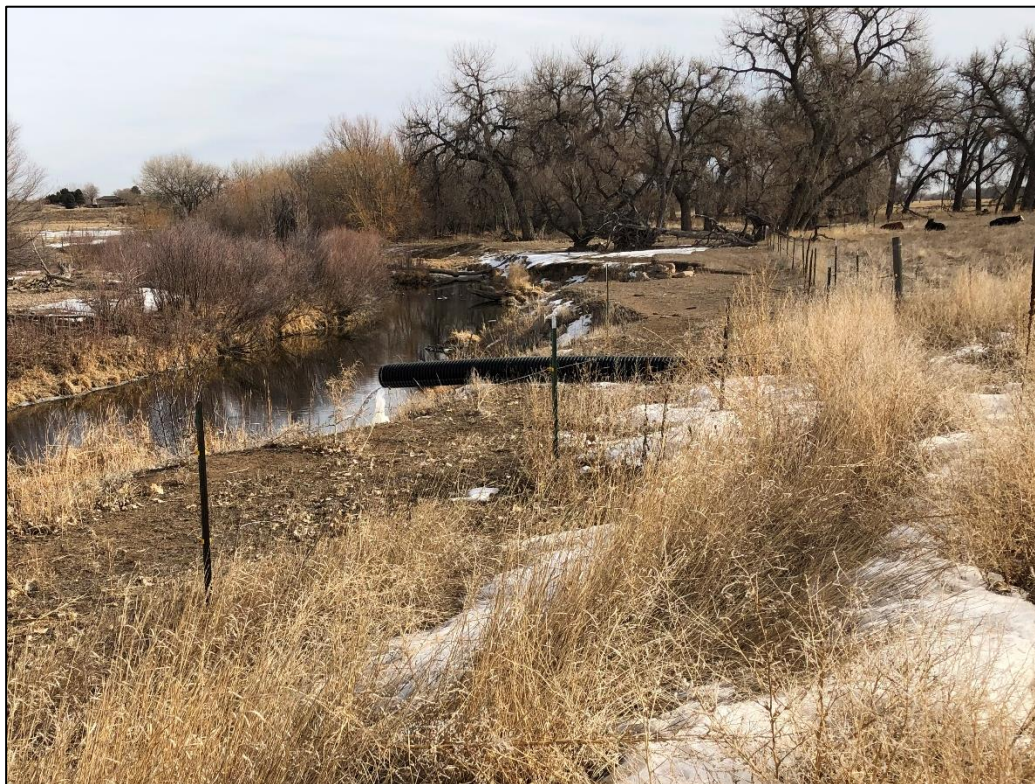
Photo 12. View looking east/southeast, showing sediment pond overflow pipe discharging water to river during inspection.

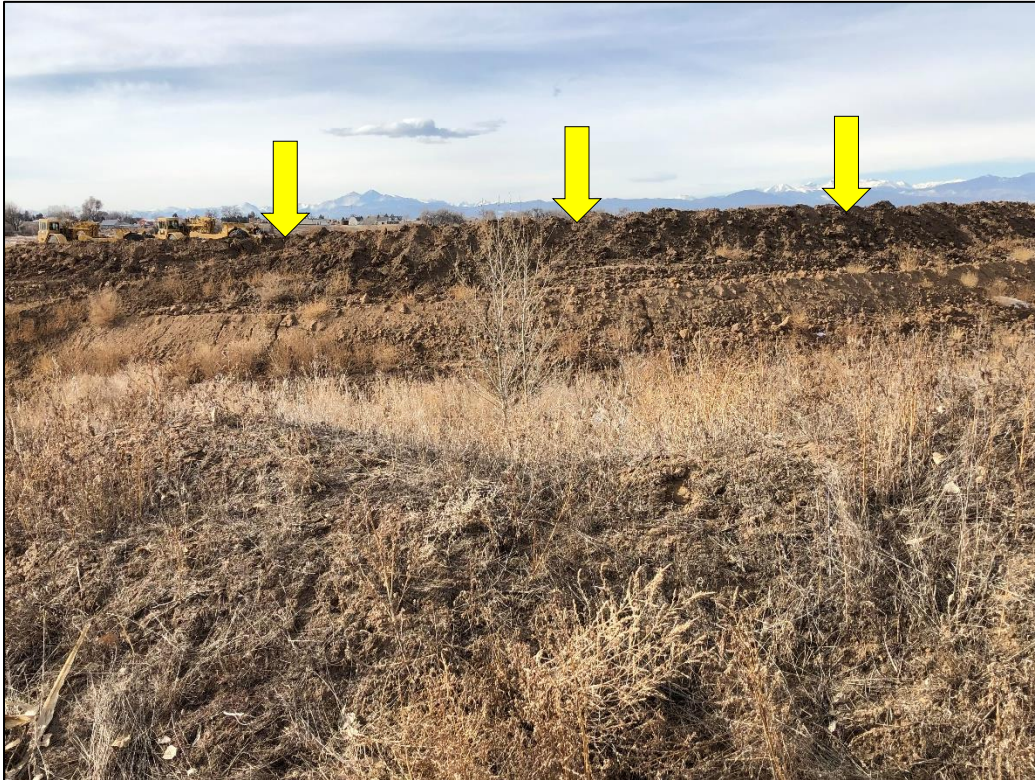
Photo 13. View looking southwest from northern edge of Phase I slurry wall, showing Phase I Cell 1 pit backfilled above historic grade (indicated in background).

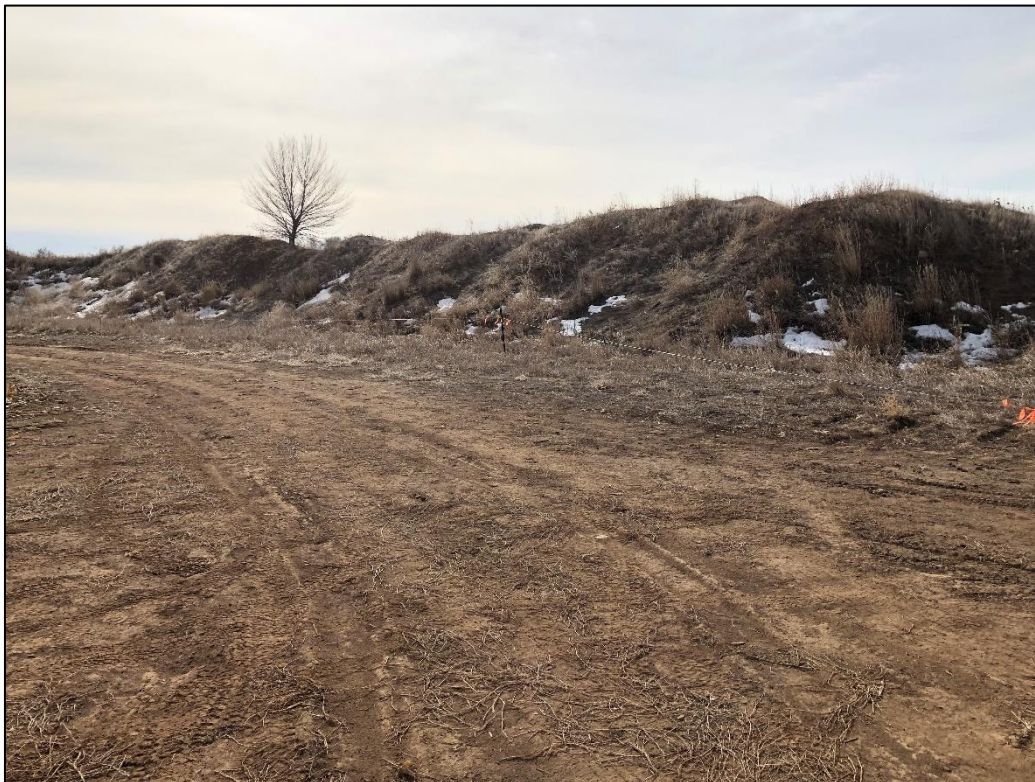
Photo 14. View looking south at topsoil bermed along northeastern edge of Phase I Cell 2 pit. This stockpile was stable with good grass cover.

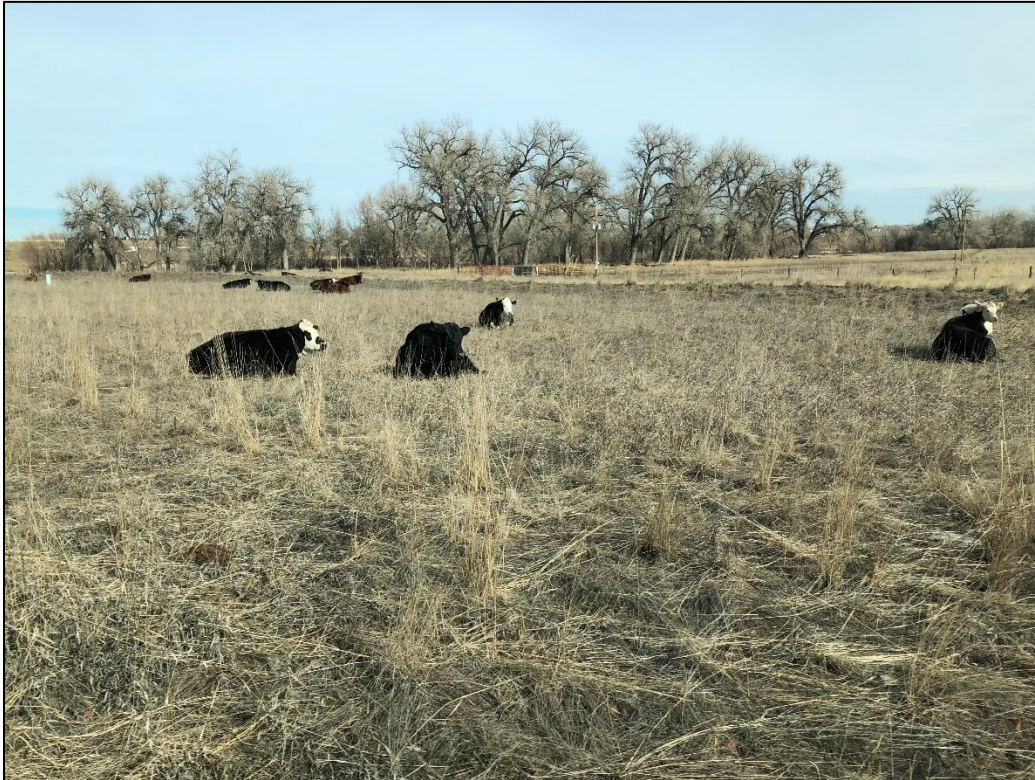
Photo 15. View looking northeast across undisturbed Phase I Cell 3 currently leased out for cattle grazing.

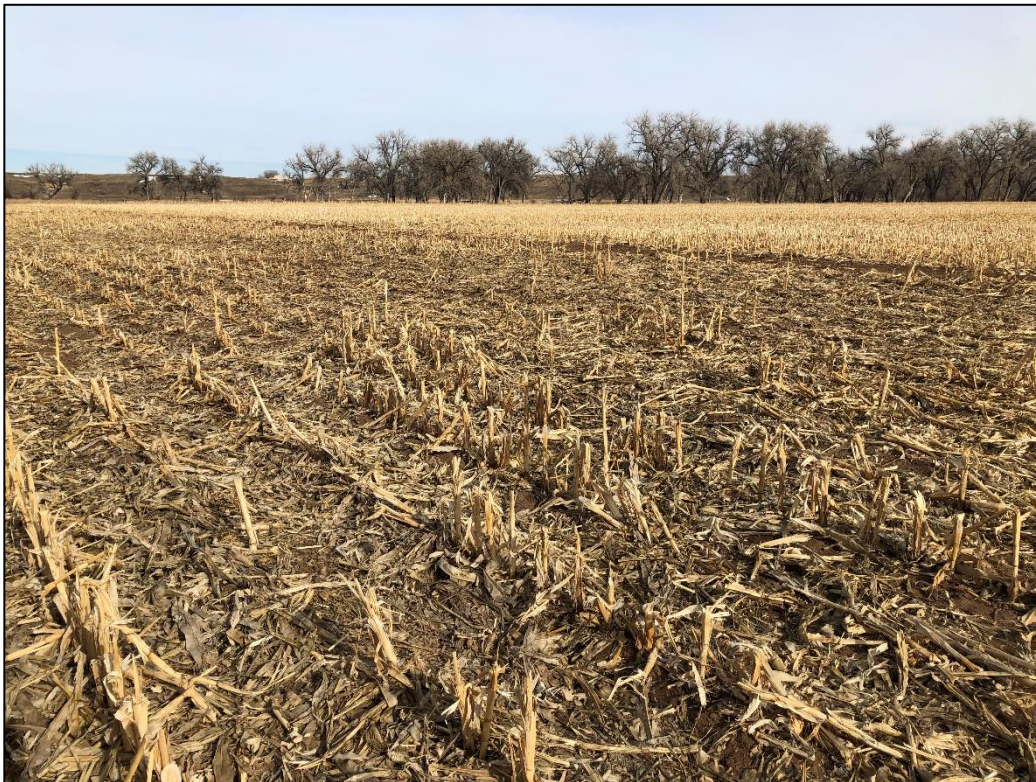
Photo 16. View looking northeast across undisturbed Phase I Cell 4 currently used for crop production.

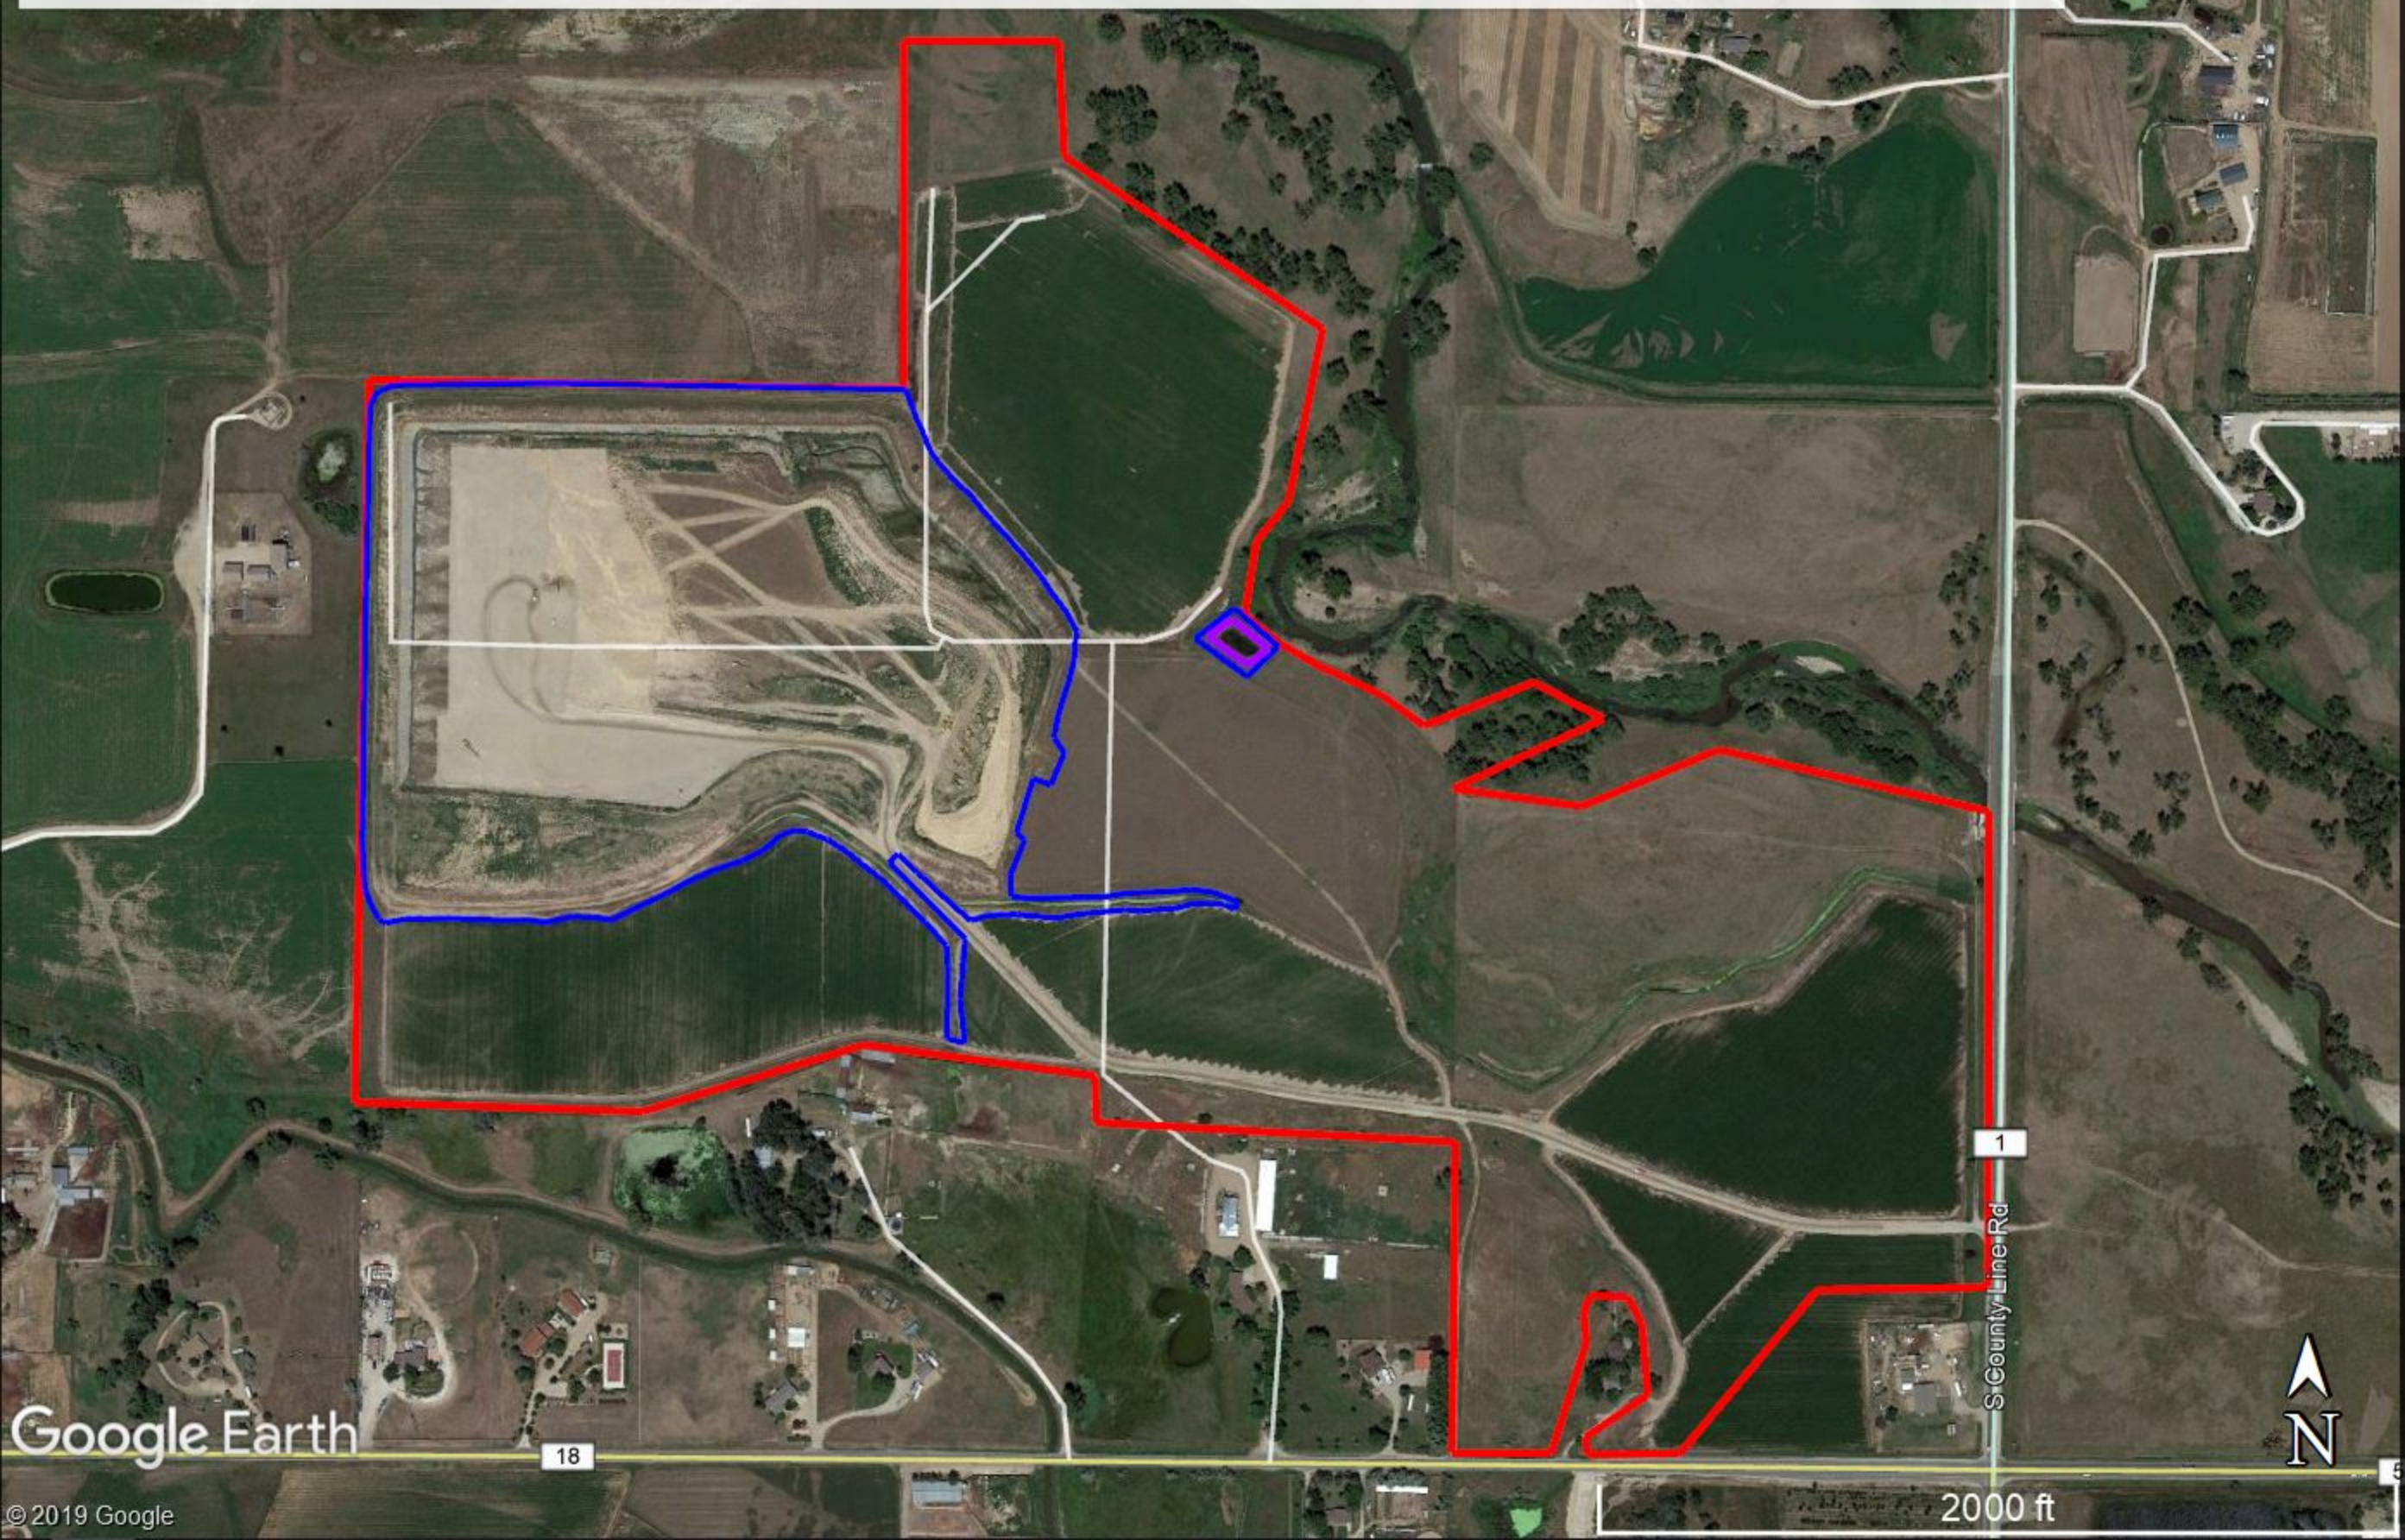
The Division estimates the operation has disturbed approximately 48.3 acres at this time (not including the main access road which will remain after reclamation). This includes 47.9 acres of disturbance in the Phase I mining area and 0.4 acres of disturbance associated with the sediment pond. The operation is currently approved for a

Red Outline = 162.37 acres = Approved Permit Area (location approximated based on approved maps)

Blue Outline = 48.3 acres = Disturbed Area (47.9 acres Phase I mining area + 0.4 acre sediment pond area)

Purple Outline = 0.18 acre = Sediment Pond
