MINERALS PROGRAM INSPECTION REPORT

MINE NAME: Stage Stop Pit	MINE/PROSPECTING ID#: M-1984-025	MINERAL: Sand and gravel	COUNTY: Saguache
INSPECTION TYPE: Monitoring	INSPECTOR(S): Stephanie Mitchell	INSP. DATE: February 18, 2020	INSP. TIME: 10:30
OPERATOR: Southway Construction Company, Inc.	OPERATOR REPRESENTATIVE:	TYPE OF OPERATION: 112c - Construction Regular Operation

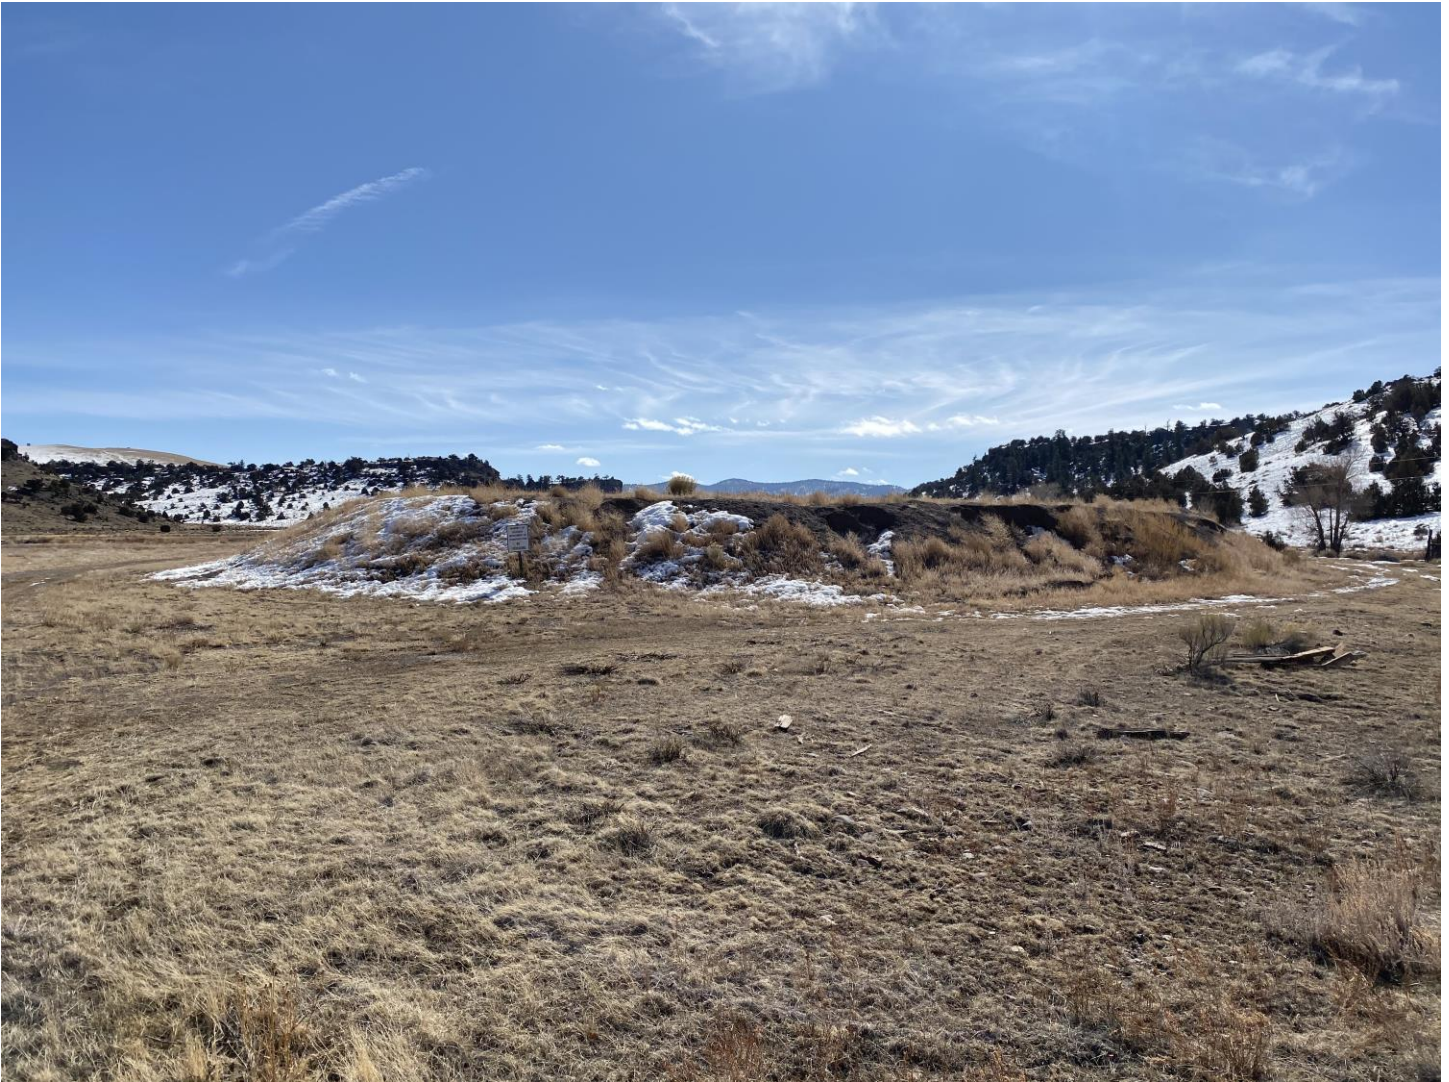
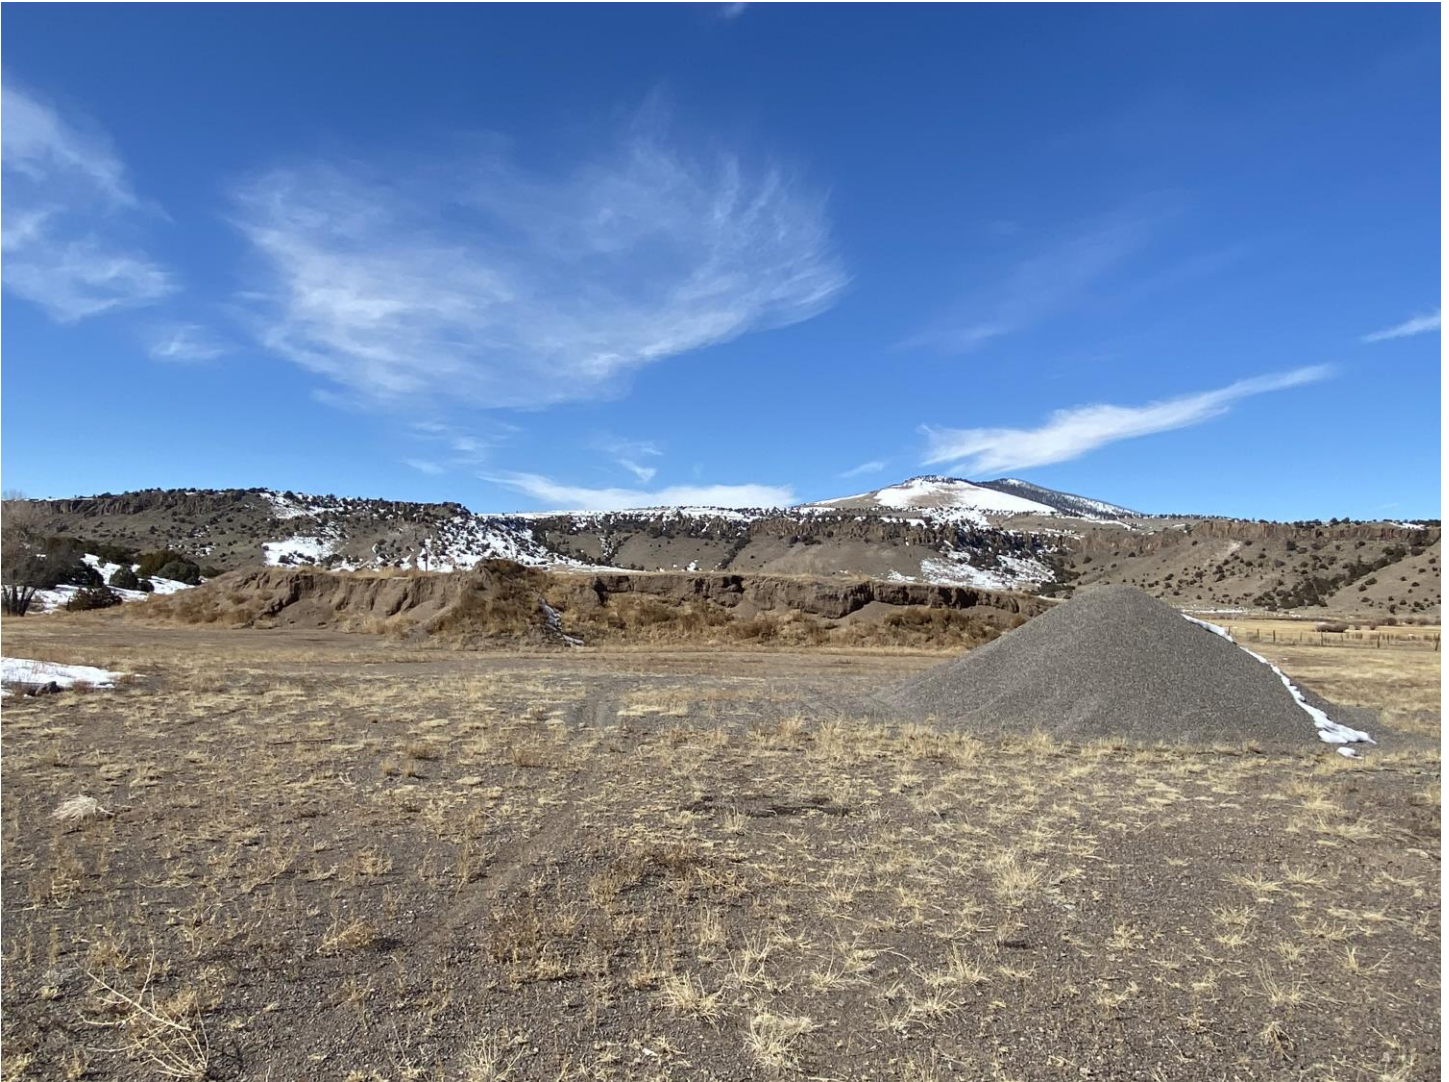
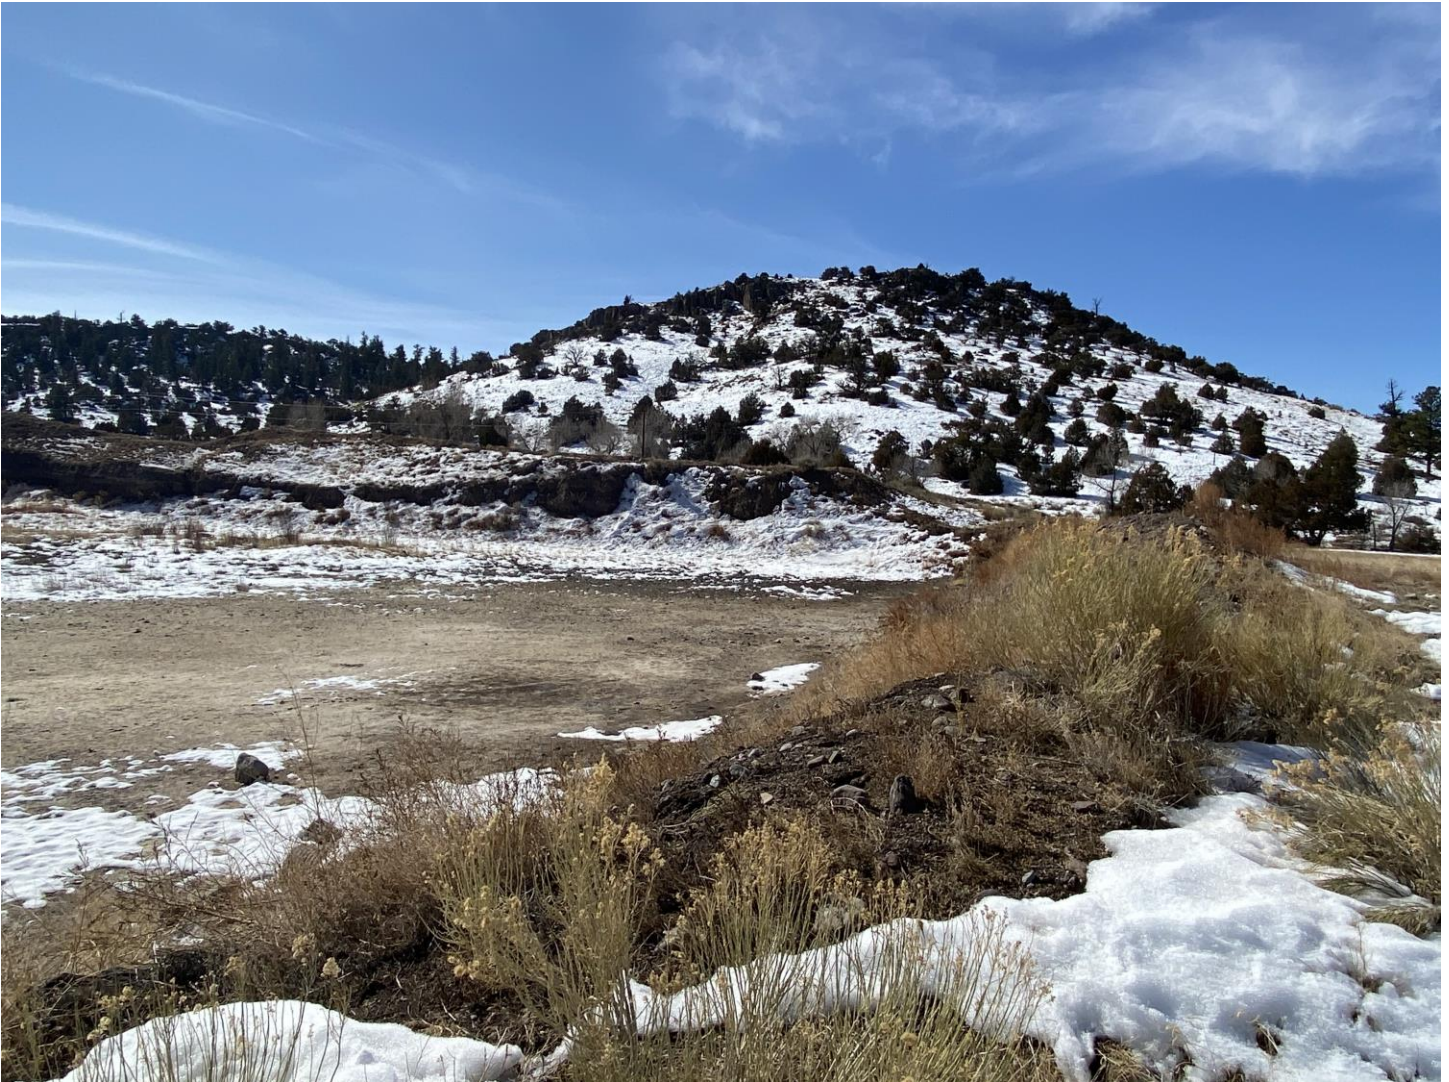
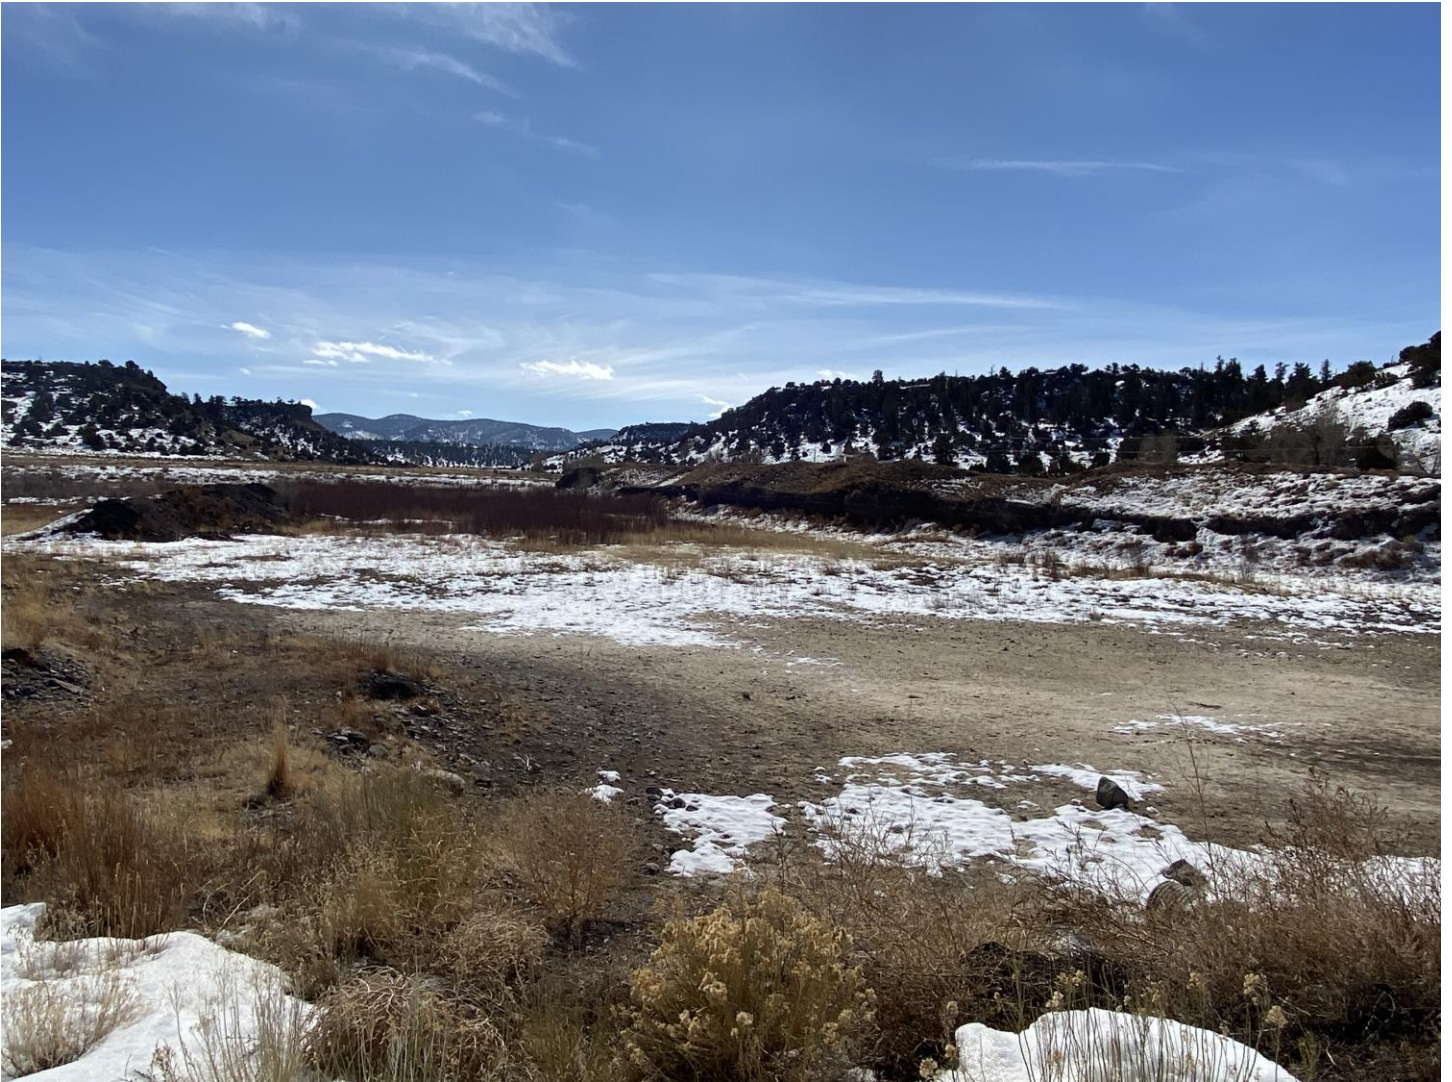
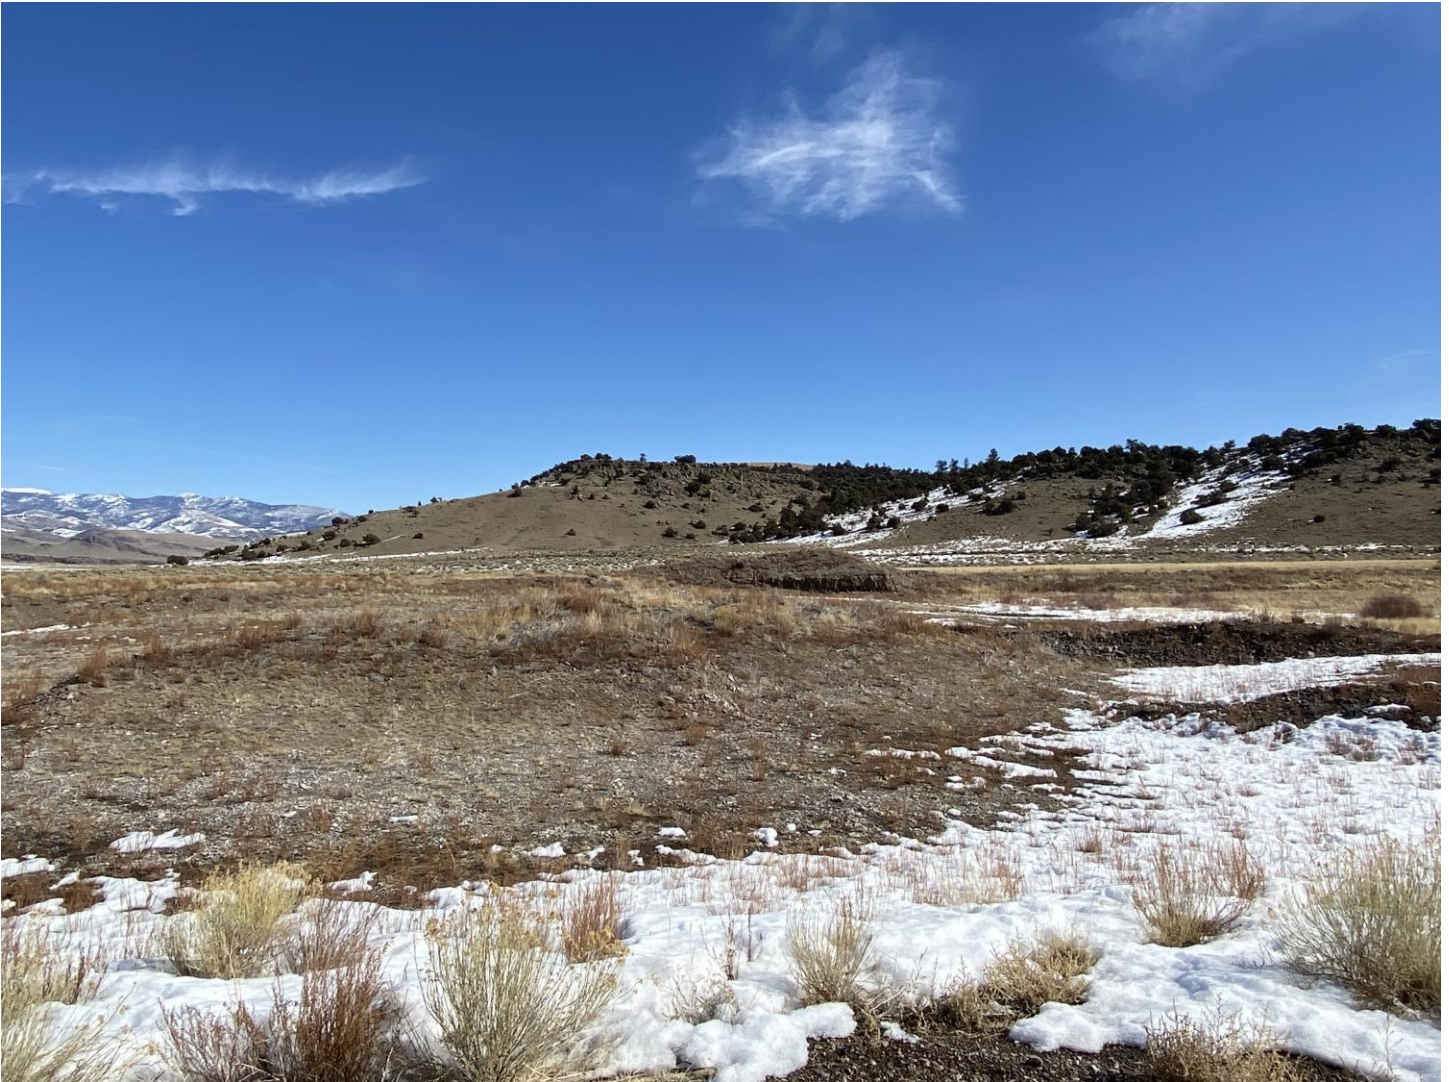
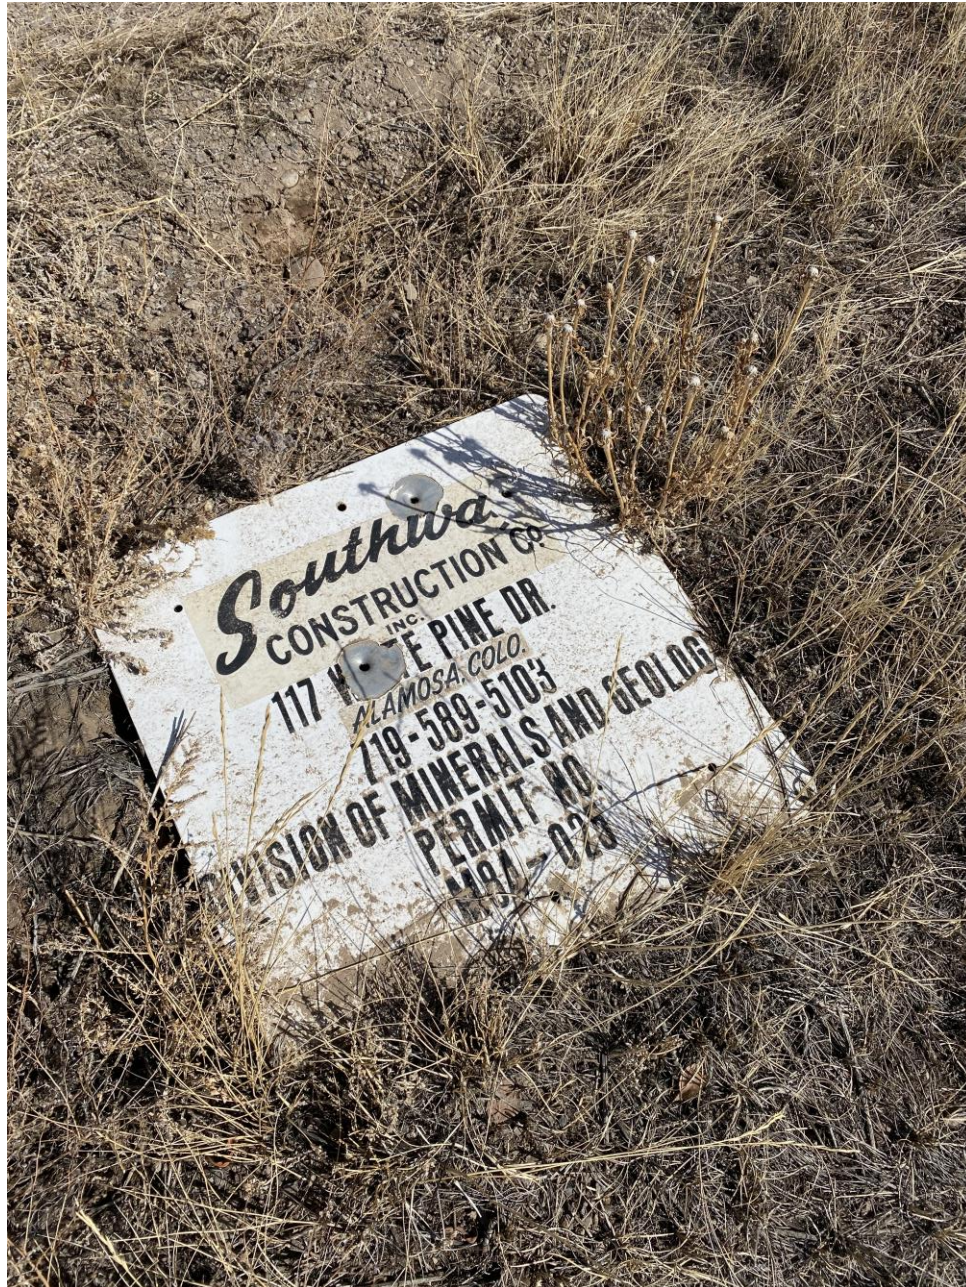
PHOTOGRAPHS

The Mine Identification sign was not at the entrance to the mine site to be in compliance per Rule 3.1.12 (2). The sign was knocked over and on the ground not visible to the general public. This is noted as a problem at the beginning of this inspection report. Please post the sign back up and send a picture of it posted to abate the problem. The permit boundaries were delineated by fencing.

The current disturbance is located in the northern portion of the permit area and is approximately 31.8 acres in size, and moving to the east. Topsoil has been stripped and is stockpiled as a berm along the southwest and northwest part of the permit boundary of the site and is stabilized with vegetative cover. No erosion or sedimentation issues were observed.

CORRECTIVE ACTIONS: The operator shall, at the entrance of the mine site, post a sign which shall be clearly visible from the access road with the following: the name of the operator, a statement that a reclamation

permit for the operation has been issued by the Colorado Mined Land Reclamation Board; and the permit number. The operator shall submit photo documentation that a proper sign has been posted by the corrective action date.
