MINERALS PROGRAM INSPECTION REPORT
PHONE: (303) 866-3567

MINE NAME: Robinson Sons Gravel Pit No. 1	MINE/PROSPECTING ID#: M-2008-076	MINERAL: Sand and Gravel	COUNTY: Las Animas
INSPECTION TYPE: Monitoring	INSPECTOR(S): Daniel Cunningham	INSP. DATE: February 26, 2020	INSP. TIME: 10:30
OPERATOR: Robinson Sons, Inc.	OPERATOR REPRESENTATIVE: Daniel Robinson	TYPE OF OPERATION: 112c - Construction Regular Operation

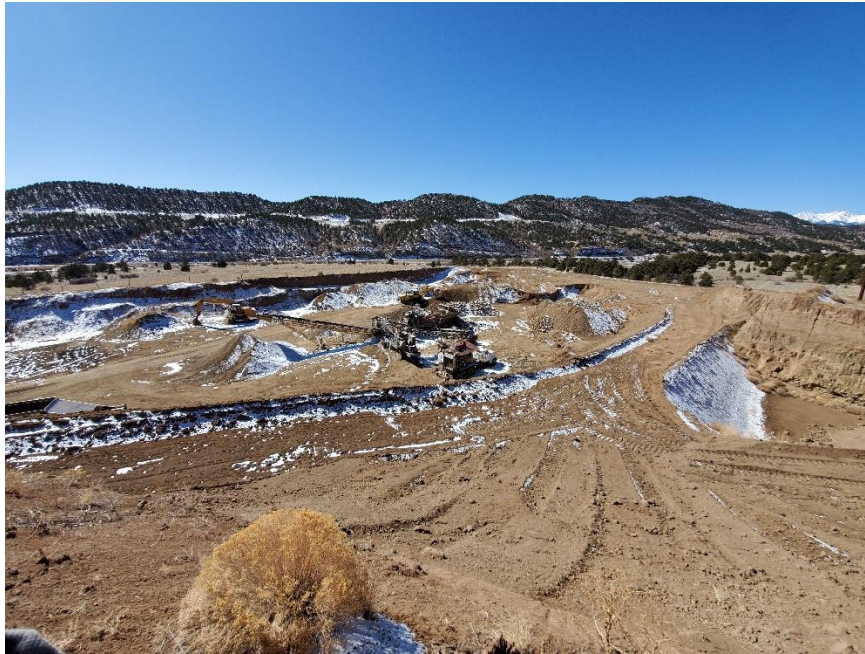
Area 1, which consists of the southern portion of the permitted area, showed the most reclamation with much of the southern high walls having been graded and backfilled with slopes at a 3H:1V angle. A loader was seen on the permitted area moving material around to further backfill and grade the remaining 750 feet of high wall located in the southwestern section of the permit area. Several large stockpiles were observed throughout the pit floor, along with a trash area. In addition to the stockpiles, a pile of overburden material that needs to be spread out for reclamation was also found on the pit floor. The Division estimates about 70% of the earthwork for Area 1 has been completed.

A berm was noted in the middle of the permitted area that was preventing natural drainage from occurring. This berm will need to be graded to allow for positive drainage in the area. Material was also located within the 25 foot buffer zone of the power poles located on the permitted area within Area 1. This material will need to be carefully moved away from the buffer zone of the poles.

Photo 1: Area 1

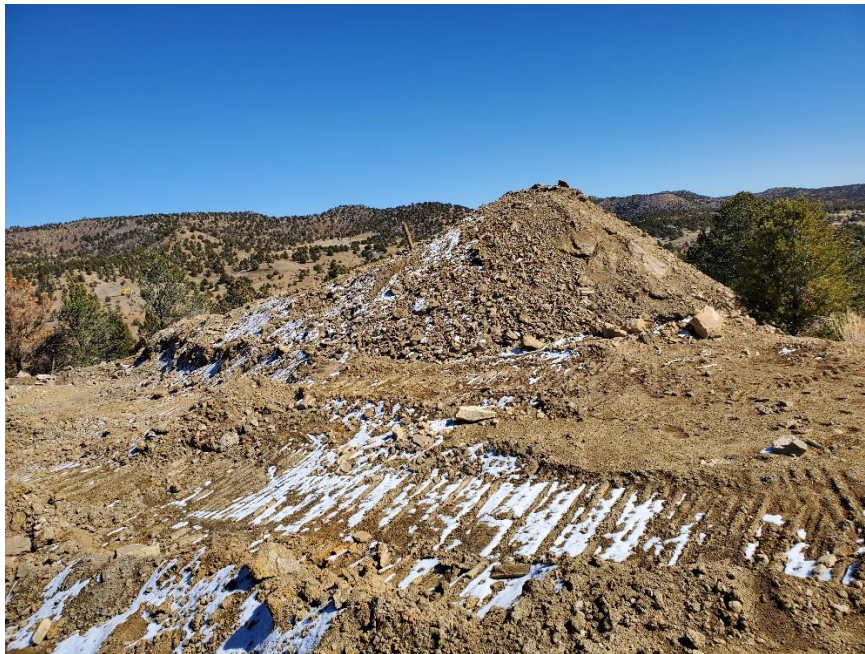
Area 2, consist of an eastern section of the permit with a lower and upper area on top of a hill. The area has seen little to no reclamation since the last inspection. This area seems to be a stockpile area with a crusher located at the top of the hill and several stockpiles scattered throughout.

Photo 2: Area 2

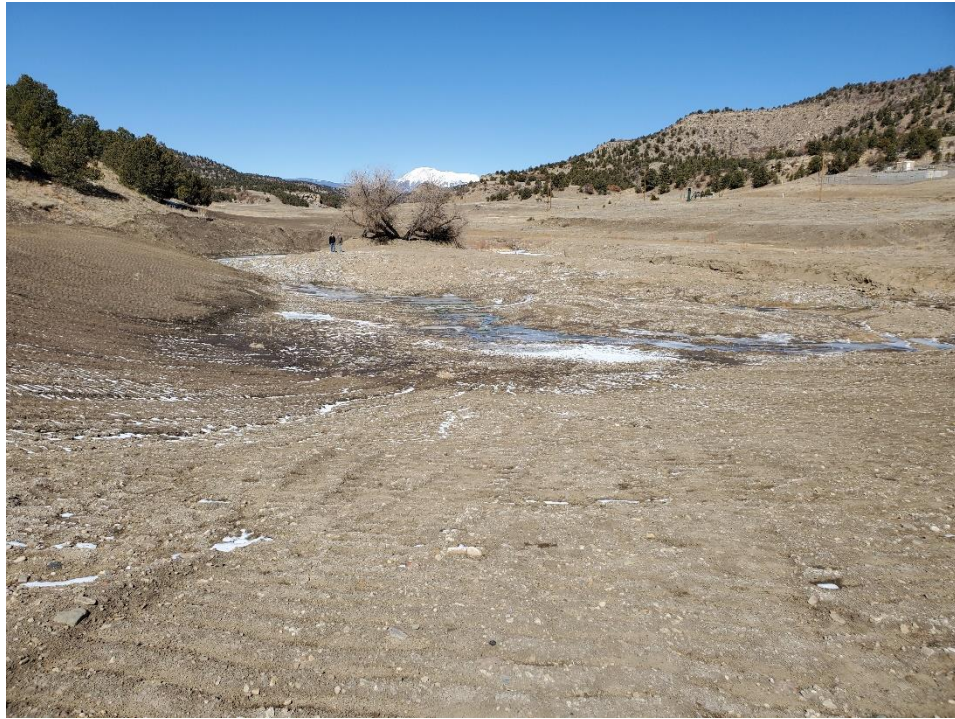
The area currently in reclamation, consisting of the eastern section of the permit and located along the Wet Canyon creek near the mine sites entrance, has been completely backfilled and graded. However, two small basins have been created on the north and south side of the access road. Mr. Robinson stated, that he had been in contact with the Division of Water Resources to obtain any augmentation for the water rights.

Photo 3: Reclamation Area

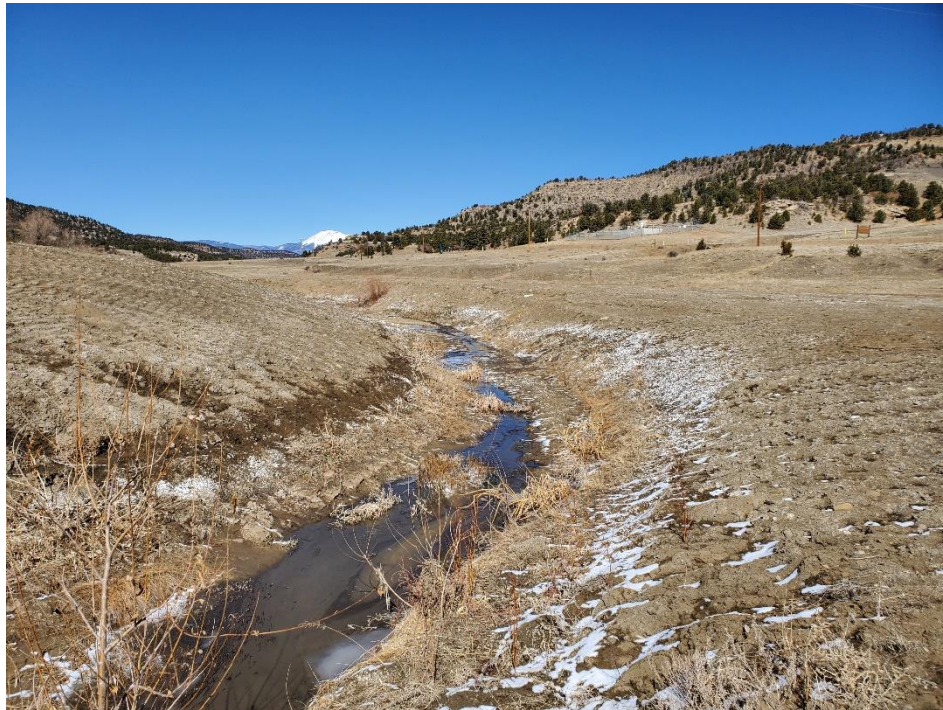
Photo 4: Creek Bed

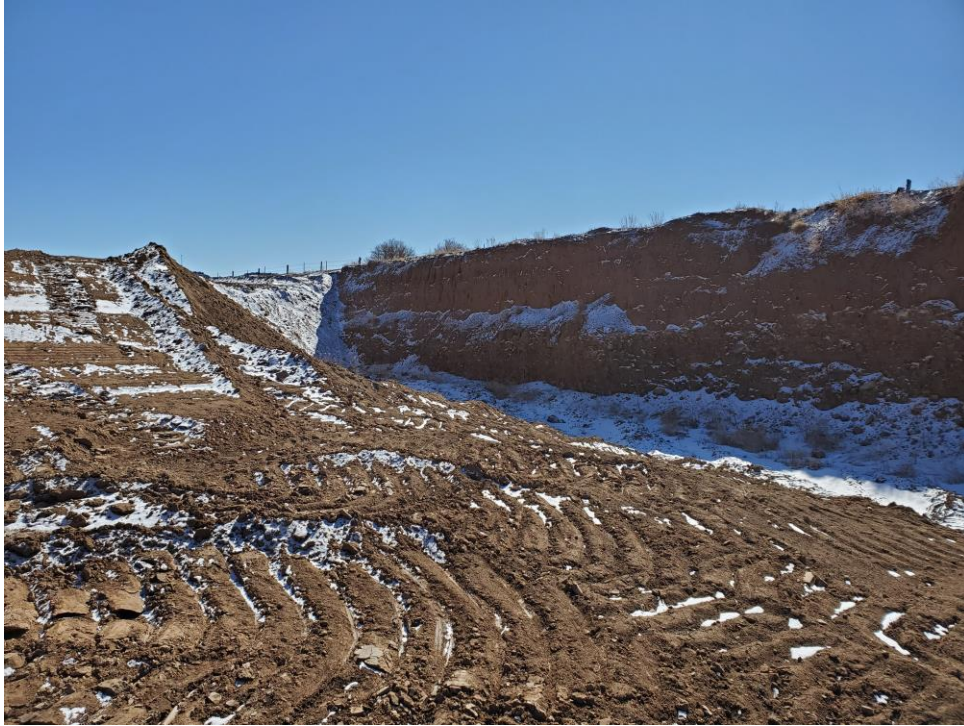
Photo 5: High wall

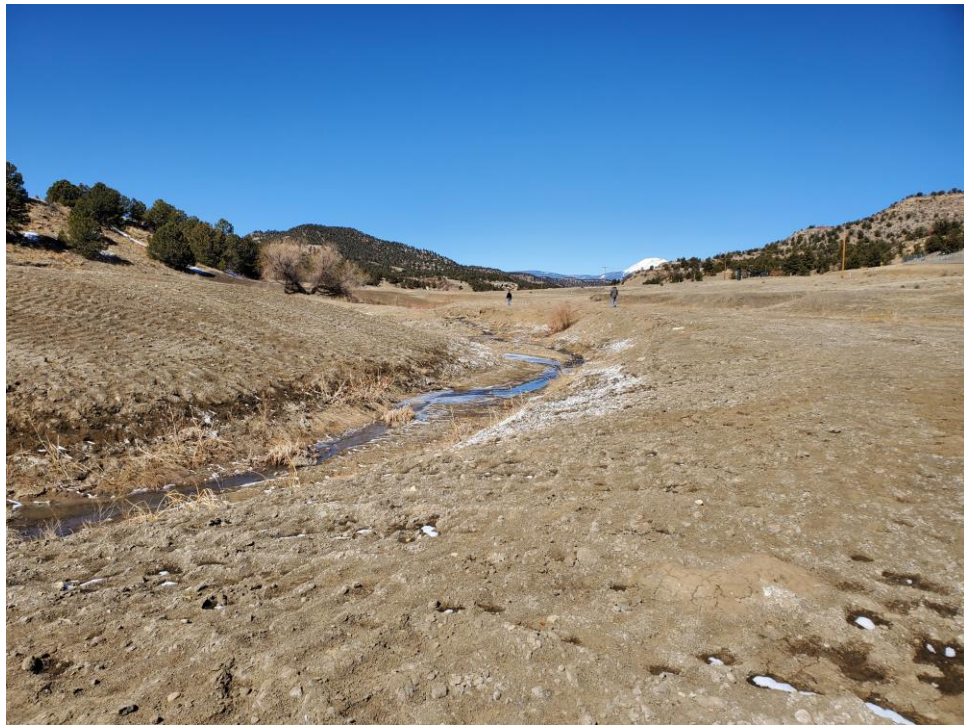
Photo 6: Reclaimed area
