**MINERALS PROGRAM INSPECTION REPORT**  
**PHONE: (303) 866-3567**

<b>MINE NAME:</b> Verhoeff Pit No 2	<b>MINE/PROSPECTING ID#:</b> M-1992-113	<b>MINERAL:</b> Sand and gravel	<b>COUNTY:</b> Bent
<b>INSPECTION TYPE:</b> Monitoring	<b>INSPECTOR(S):</b> Daniel Cunningham	<b>INSP. DATE:</b> March 10, 2020	<b>INSP. TIME:</b> 12:00
<b>OPERATOR:</b> Bent County	<b>OPERATOR REPRESENTATIVE:</b> Curtis Sniff	<b>TYPE OF OPERATION:</b> 112c - Construction Regular Operation

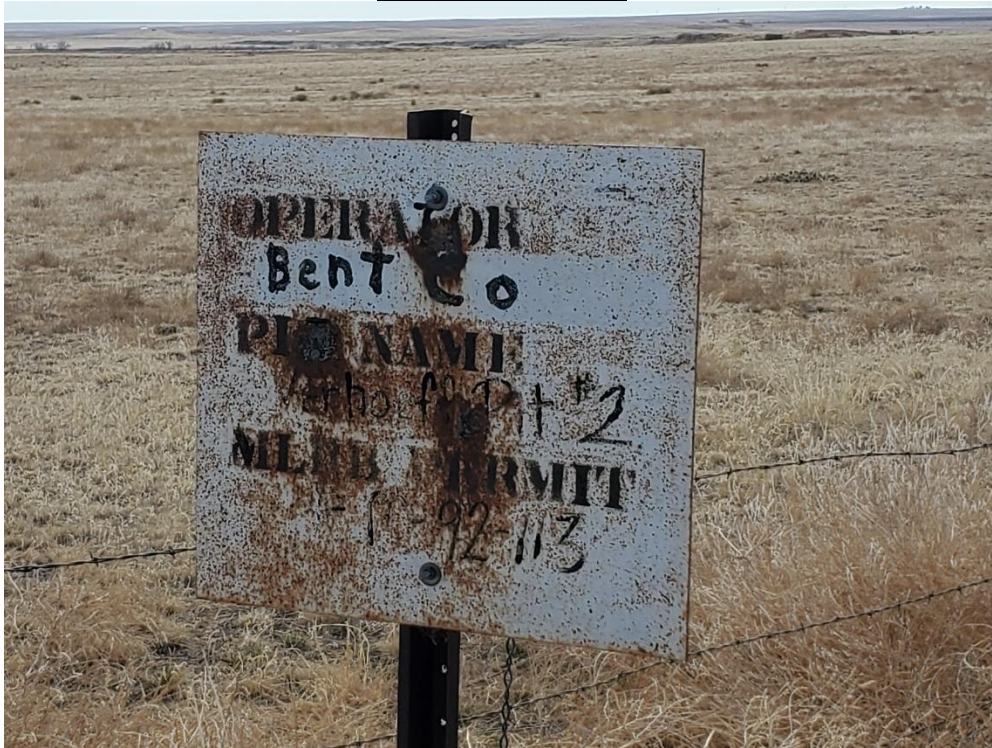
**Photo 1: Mine entrance sign**

**PROBLEM:** The site identification sign was unreadable. This is a problem for failure to maintain a clearly visible sign under rule 3.1.12(1).

The site identification sign was posted at the mine site entrance, however it was unreadable due to weathering. The Operator will need to replace the site identification sign. Boundary markers were seen around the permitted area.

**CORRECTIVE ACTIONS:** The Operator will replace the site identification sign with a readable one. The Operator will provide proof the sign has been replaced by the corrective action date.

**CORRECTIVE ACTION DUE DATE:** 5/15/20

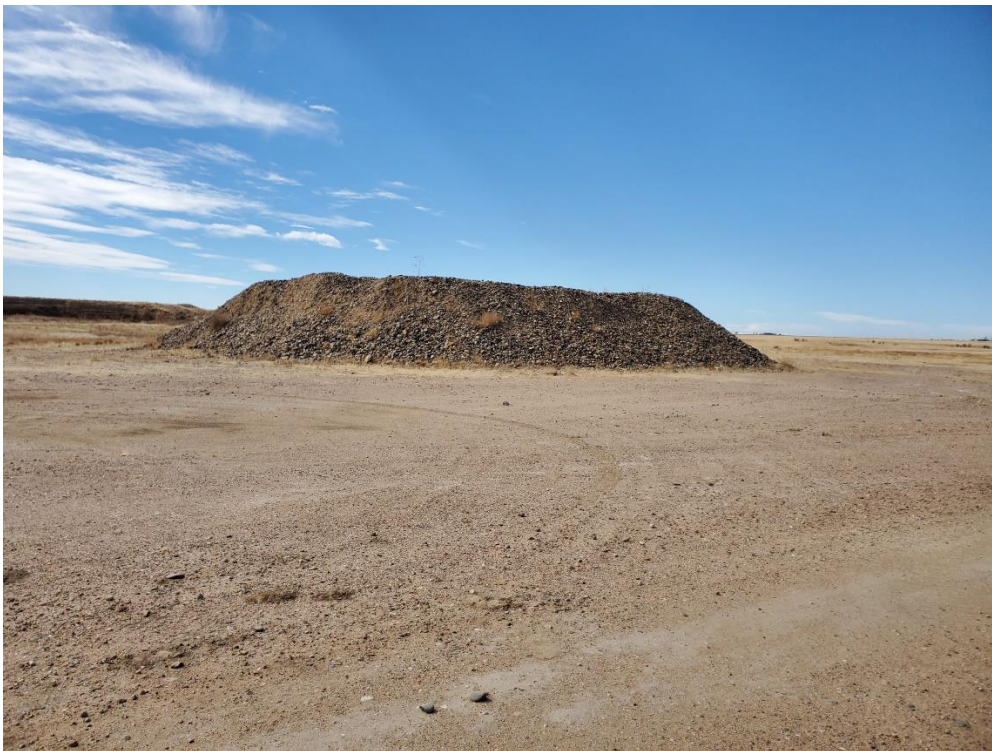
**Photo 2: Stockpile**

Several stockpiles were seen throughout the permitted area. Erosional issues were noted on the stockpiles. Mr. Sniff indicated that these stockpiles were left over from when the county purchased the pit. Topsoil and overburden were being stored near the western boundary of the permit. The topsoil was stable with good vegetation established.

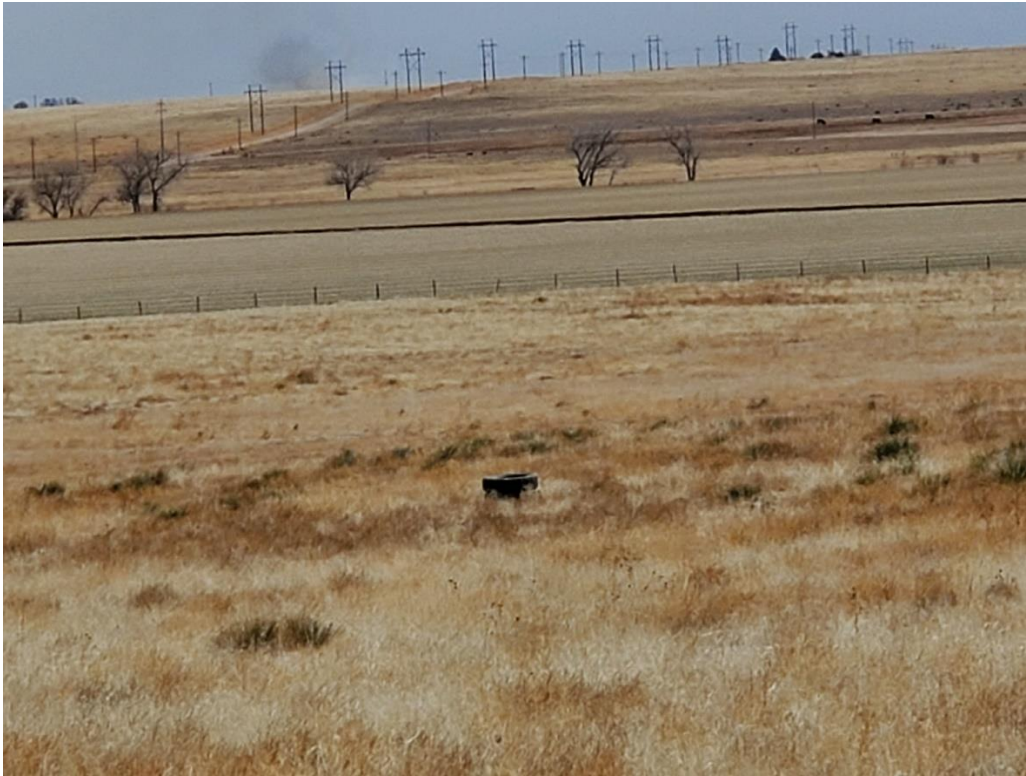
**Photo 3: Boundary marker and vegetation on eastern side of the permitted area.**

The eastern section of the permitted area was well vegetated with native species.
