RE: Preliminary Review of a 112 Construction Materials Reclamation Permit Amendment
Application Package AM03, Bestway Concrete Company, Permit M1998-013 -AM03;
Response

This letter is being generated to satisfy the preliminary review dated August 21, 2019 for the Bernhardt Gravel Mine. The italicized items are the current comment and the bold text are the responses:

This letter has been prepared to address the Mined Land Reclamation Board (MLRB) Construction Materials Rule 6, Section 4, Subsection 19, Exhibit S - Permanent Man-Made Structures (6.4.19, Exhibit S) for the proposed Vogl Amendment of the Shores Gravel Mine located in Weld County, Colorado. This letter describes the project and slope stability analyses utilized to evaluate the minimum distance between the edge of mining and adjacent structures to avoid damage to the structure.

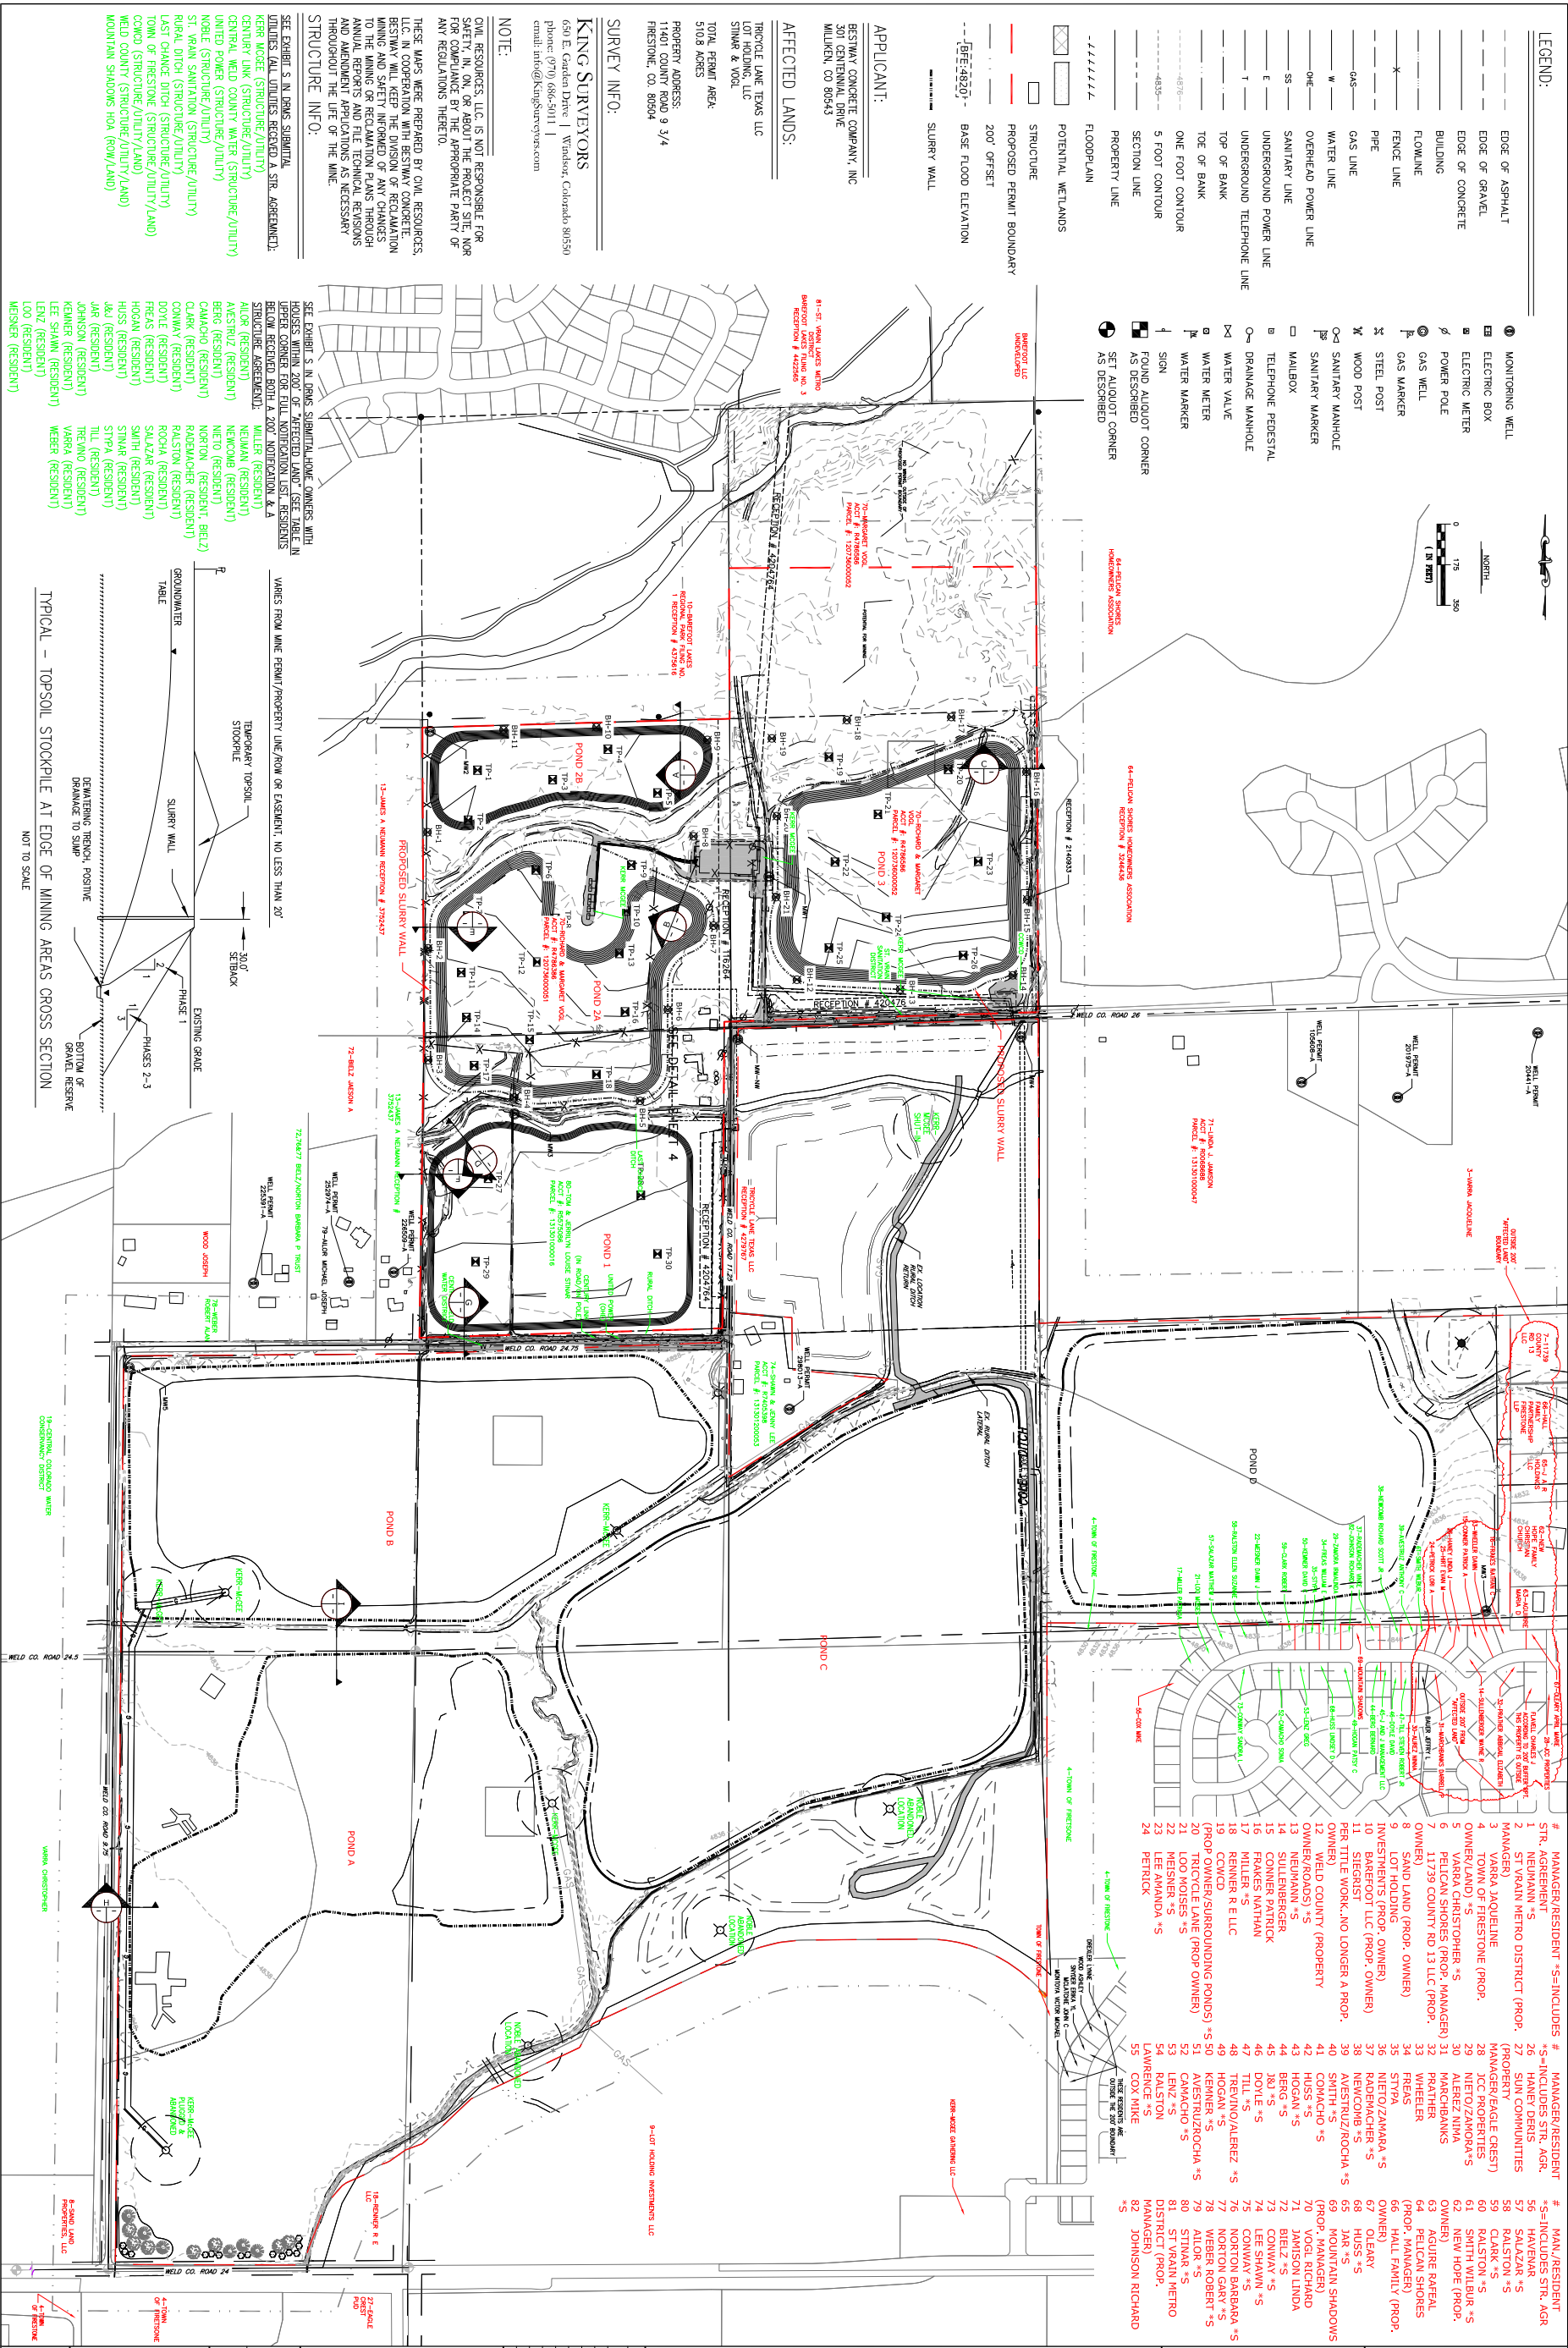
Attachments: Figure – Mine Plan showing boring locations and sections used.
 XSTABL Model Outputs: Sections 1, 2, and 3

The stability of structures within 200 feet of the proposed mining limits was evaluated at nine (9) sections. The sections evaluated either at the tallest high wall or in the area of the closest structure in each mine cell under anticipated loading conditions around the perimeter of the site as discussed below. The computer program XSTABL was used for the analysis. The method for selecting the critical failure surface for each analyzed loading condition is the following. The Modified Bishop's Method of Analysis is used to find the critical failure surface by randomly searching with 20 termination points and 20 initiation points (400 failure circles) with 7 foot line segments over the slope surface and at the structure in question to determine the lowest factor of safety. Both static stability under anticipated mining conditions and seismic stability under peak ground acceleration loads were performed. Seismic loading was obtained from the U.S.G.S. Unified Hazard Tool. Review of the Hazard Tool indicated a maximum horizontal acceleration of 0.096g with a return period of 2,475 years for the site.
