## Solid Minerals Inspection Report

<b>Type of Operation</b>	3809 Plan of Operations	<b>Project Name</b>	Sunday Mines Complex West Sunday
<b>Serial Number</b>	COC-53227, COC-52049	<b>Company/Org.</b>	PINON RIDGE MINING LLC PO BOX 825 NUCLA CO 81424- 0825
<b>Inspection Date</b>	04/29/2020	<b>Others Present</b>	None
<b>Inspection Time</b>	12:50	<b>Inspected By</b>	James Blair
<b>Report Date</b>	05/11/2020	<b>Legal</b>	T44N, R18W, multiple sections

The purpose of this inspection was to verify the construction of ore pads at the Sunday and Saint Jude mines (COC-53227), and at the West Sunday Mine (COC-52049). I arrived on site at approximately 12:50 AM. It was about 70 degrees out, with blue skies. Spring vegetation was just beginning to poke up, but it was drier than, while there was some green, it was browner than it might normally have been this time of year. I did not observe any other people during the inspection. The ore pads appeared to be of quality construction from what I was able to observe. A map of the site is followed by captioned photographs showing the ore pads that were visited. The photos are in the order they were taken.

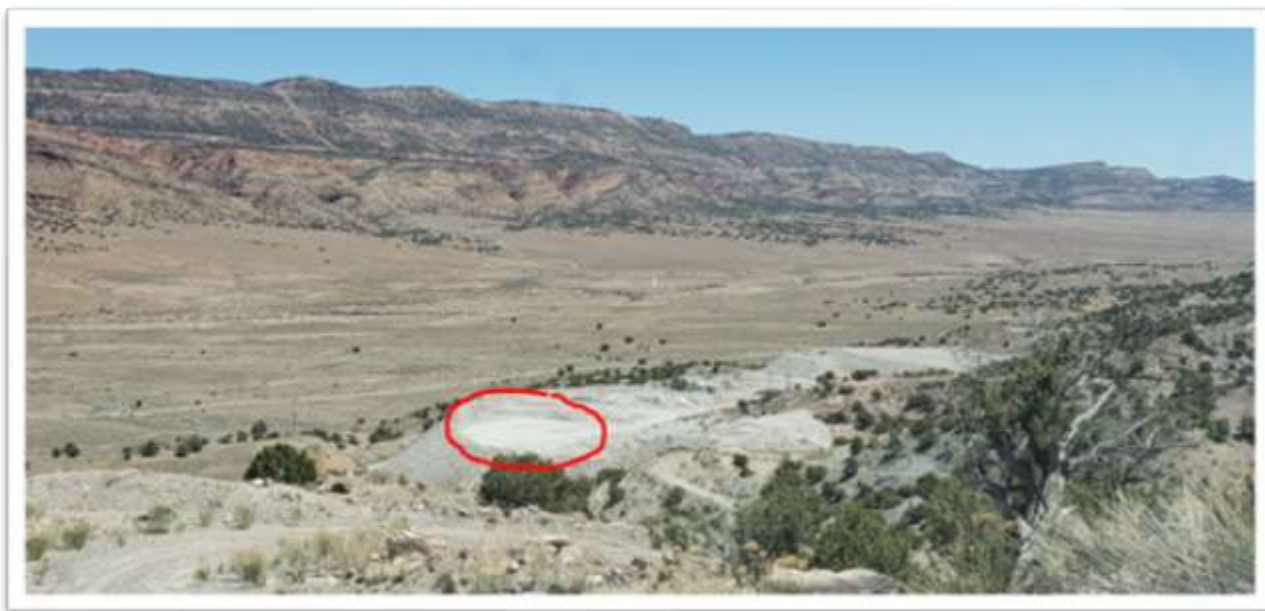
*Figure 2: View from approximately ¼ mile away, looking east towards the Sunday Mine from above on a bend in the 14 R road as it descends into Big Gypsum Valley. The ore pad is inside the red circle.*

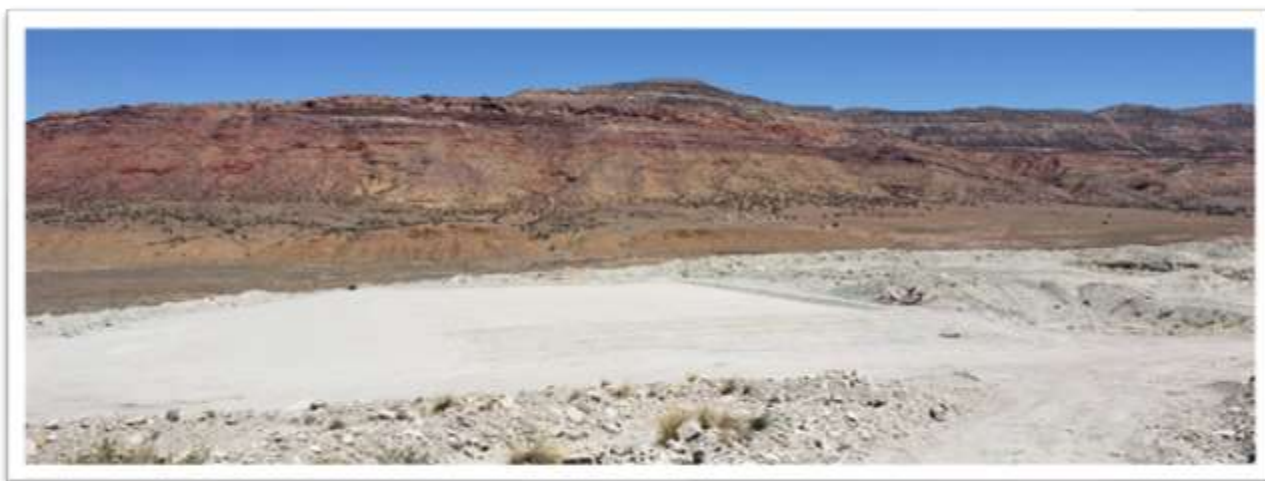
*Figure 3: View from approximately 100 feet away, looking northeast across the Sunday Ore pad. Note the raised rim on the upper right side is easy to see because of the angle.*

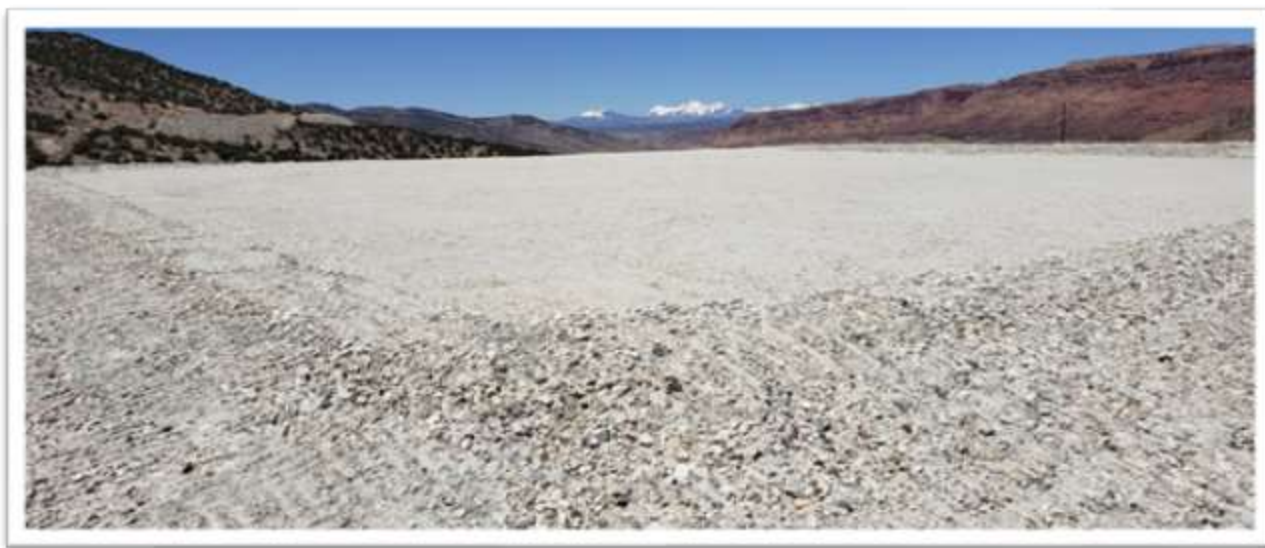
*Figure 4: View looking across the Sunday ore pad to the northwest, along the axis of Big Gypsum Valley. The La Sal Mountains, Utah are the snow capped peaks. Note that the working surface of the pad is a finer grain size and is more compacted than the sides (and presumably beneath). I did not observe any liner sticking out the sides or through the top.*

All three ore pads were constructed in the same fashion and appeared of the same quality. I did not see any liner protruding from either the sides or the top of any of the ore pads. Without destructive testing it would not be possible to determine that they were constructed to spec. The pads did appear to be neat with what appears to be quality, workmanlike construction. Combined with the affidavit submitted to DRMS, I think it can be verified that the pads were constructed to spec.

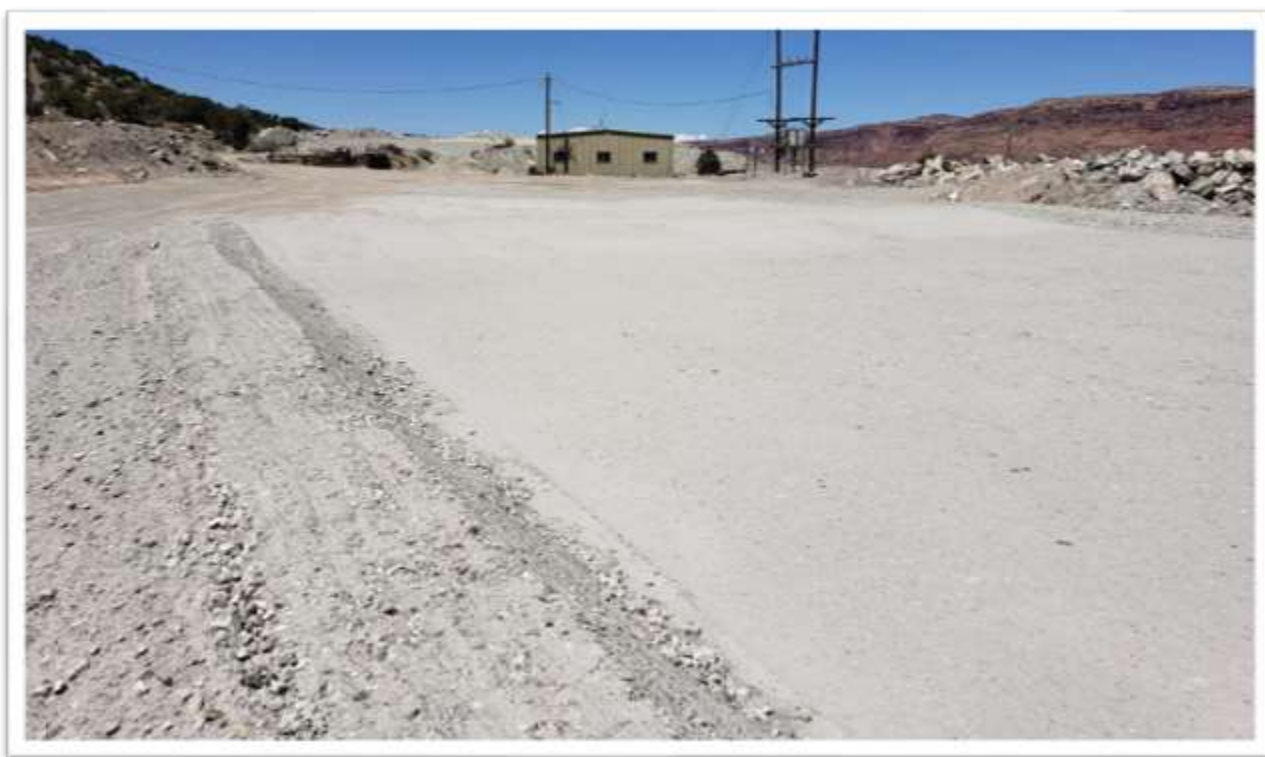
*Figure 5: A photo looking northwest across the ore pad at the St. Jude Mine towards the shop building. The drivable berm is along the opposite edge of the photo between the lens and the shop.*

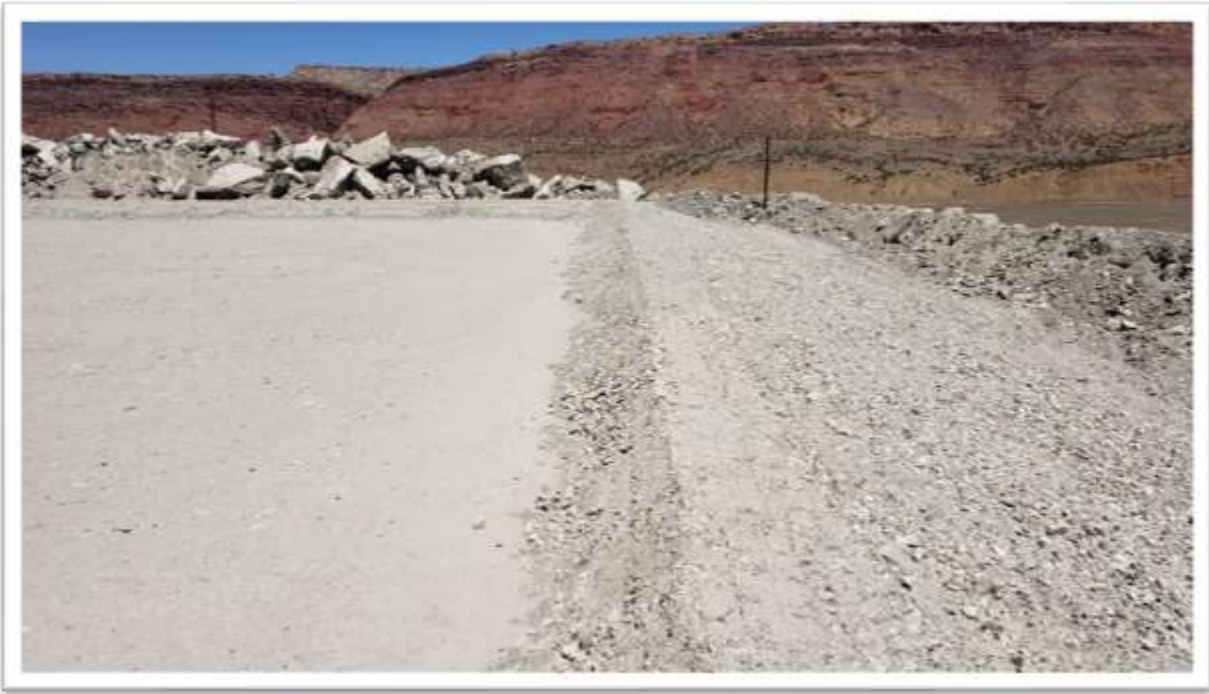
*Figure 6: Photo looking due north along the east edge of the St. Jude ore pad towards Hamm Canyon.*

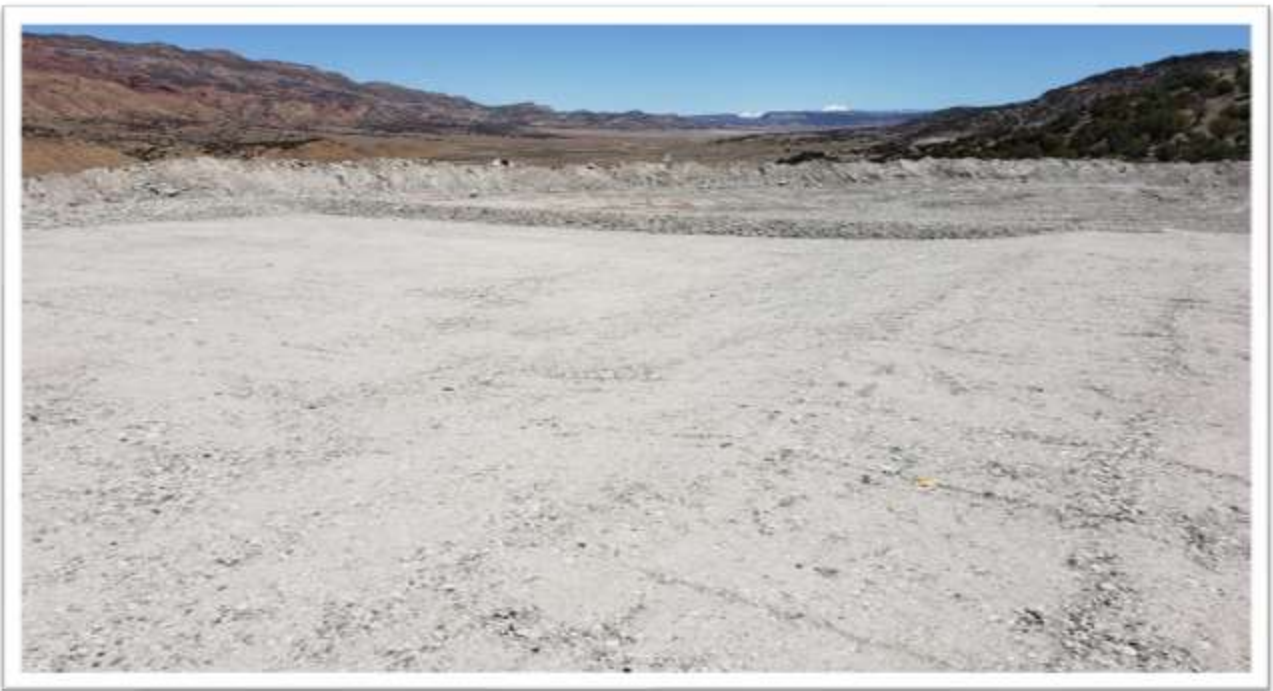
*Figure 7: A view looking east-northeast across the ore pad at the West Sunday Mine. The San Miguel mountains are in the distance. This pad was constructed the same as the other pads. This photo does a good job of showing the how the drivable berms were constructed along one edge of the ore pad (the south edge, in this case). These berms are where equipment would access and leave to ore pad to load and unload. The other three sides have steeper, non-drivable berms. Construction and workmanship at this pad were similar to that at the St. Jude and the Sunday Mines.*
