COLORADO
Division of Reclamation,
Mining and Safety
Department of Natural Resources

Permit Number: C-1981-028 Mine Name: Keenesburg Strip Mine Operator: Coors Energy Company Operator Address: Mr. Danny Kipp 1801 California Street Suite 4600 Denver, CO 80202	County: Weld Operation Type: Surface Permit Status: Active Ownership: Private
	Operator Representative Present: Danny Kipp
Operator Representative Signature: (Field Issuance Only)

Inspection Start Date: May 19, 2020 Inspection Start Time: 07:25 Inspection End Date: May 19, 2020 Inspection End Time: 10:30		Inspection Type: Coal Complete Inspection Inspection Reason: Normal I&E Program Weather: Clear	
Joint Inspection Agency: None		Joint Inspection Contacts:	
Post Inspection Agency: None		Post Inspection Contacts:	
Inspector(s): Robert Zuber, P.E.	Inspector's Signature: <i>Robert D. Zuber</i>		Signature Date: 5/19/2020

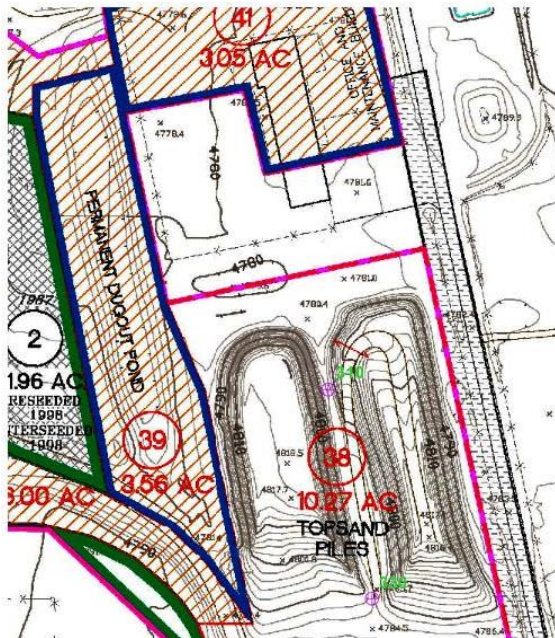
- The topsand depths at four locations within the Long Term Spoil Area were all found to be greater than 15 inches.
- The topsand depths at two locations within the B Pit were both found to be greater than 24 inches.
- The topsand depths at four locations within the topsand pile areas were all found to be greater than 6 inches.

**East Map – Locations of holes for checking topsand depths
(two in topsand pile area)**

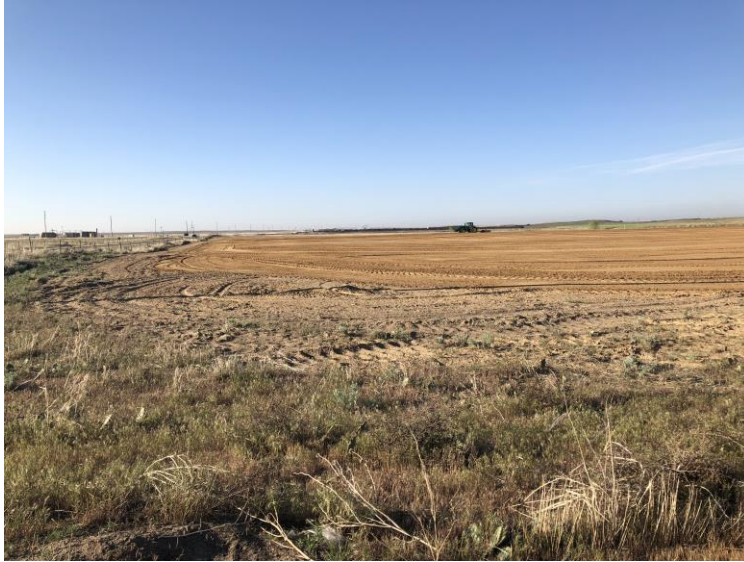
A complete inspection was conducted by Rob Zuber of DRMS. Danny Kipp and Mark Quimby of Coors Energy Company (CEC) were on site, but did not accompany Rob on the inspection. They were performing final grading of the area south of the facilities area (A-1 and B-1 Topsand Piles) and cutting weeds along the edge of the recent reclamation (areas not yet seeded).

Final grading at area where topsand was stockpiled (pile A-1)

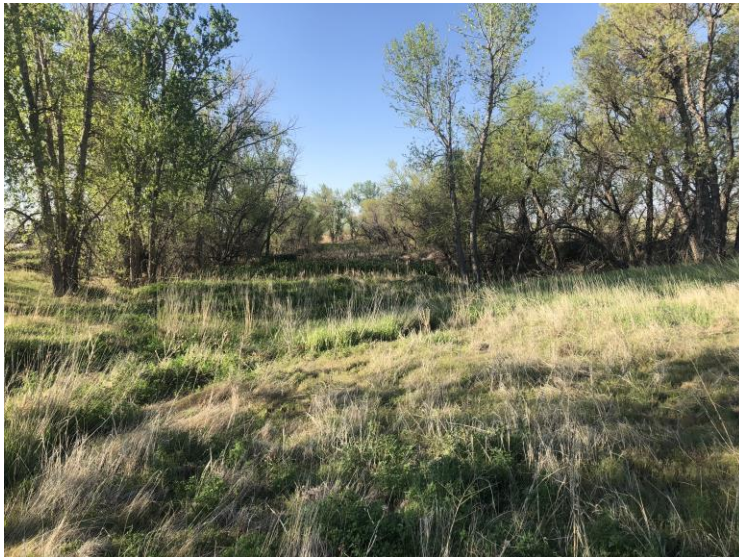
Significant volumes of water were observed in the two ponds, but levels were well below spillways, and neither pond was discharging during the inspection. There were no signs that they had discharged recently. As usual, they both contained large amounts of riparian vegetation. No problems were observed with the two ponds.

Dugout Pond

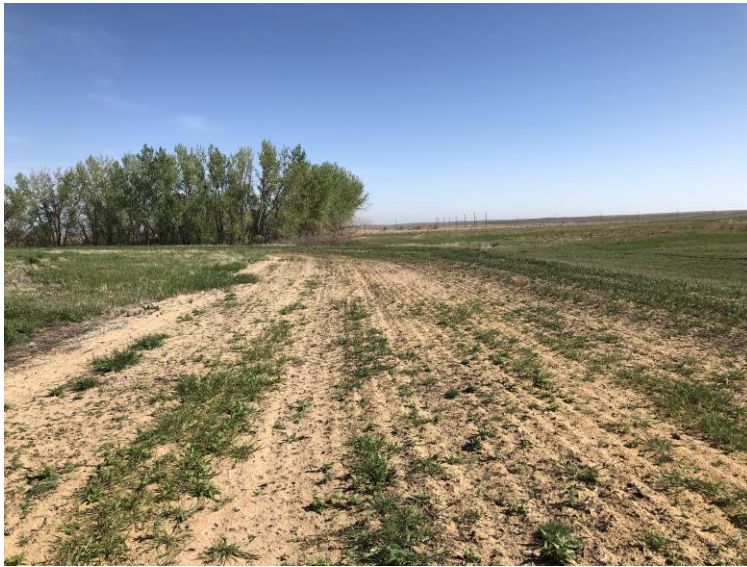
Reclaimed road south of Sediment Pond #2

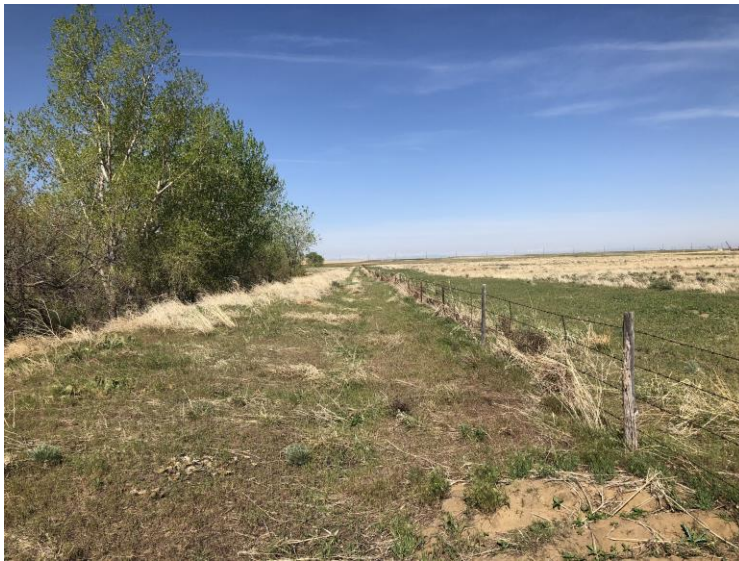
Much of the northern boundary of the site (down gradient) was observed, and no signs of pollutant loading from the mine site were seen.

Northeast corner of permit boundary, with Sediment Pond #2 on left
