## Seneca II-W (C-1982-057) and Yoast Mine (C-1994-082) Inspection Reports

# **PERMIT INFORMATION**

Permit Number: C-1982-057 Mine Name: Seneca II-W Mine Operator: Seneca Property LLC Operator Address: Ms. Miranda Kawcak	County: Routt Operation Type: Surface Permit Status: Permanent Cessation Ownership: Private	
29515 Routt County Road 27	Operator Representative Present:	
Oak Creek, CO 80467	T and the second	
	None	
Operator Representative Signature: (Field Issuance Only)

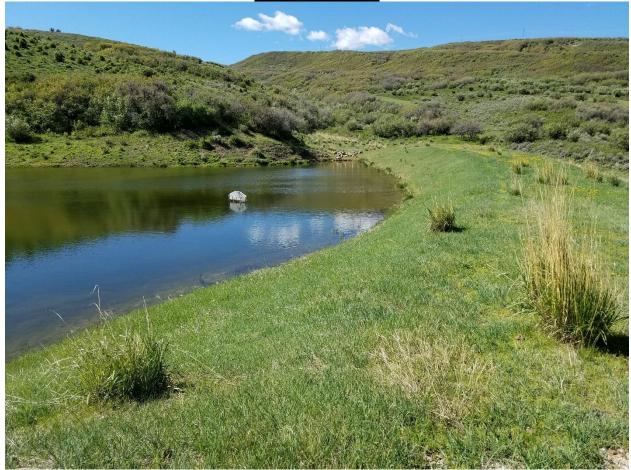
Pond 005 was holding water and discharging. The embankment was stable and the primary and emergency spillway was clear and functional.

Figure 1. Pond 005

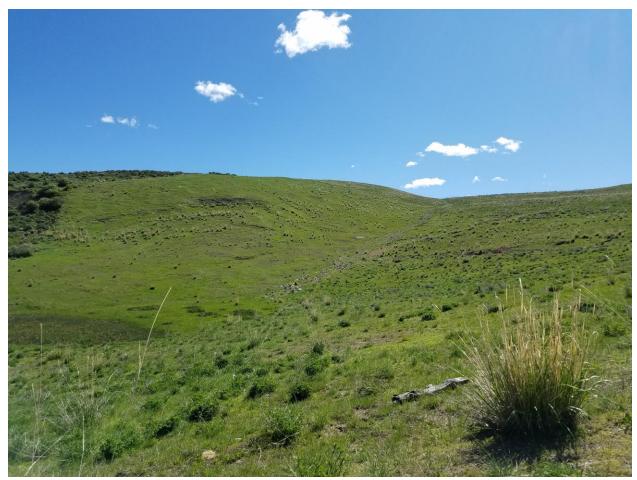
Stock pond T-20 was holding water and appeared stable. Drainage 005-E1 was rock-lined and appeared stable.

The drainage basins surrounding drainages 005-E1 and 005-GULCH was observed. Dense native grasses, forbs and shrubs were observed throughout the reclaimed area.

Figure 2. 005-E1 Drainage Basin

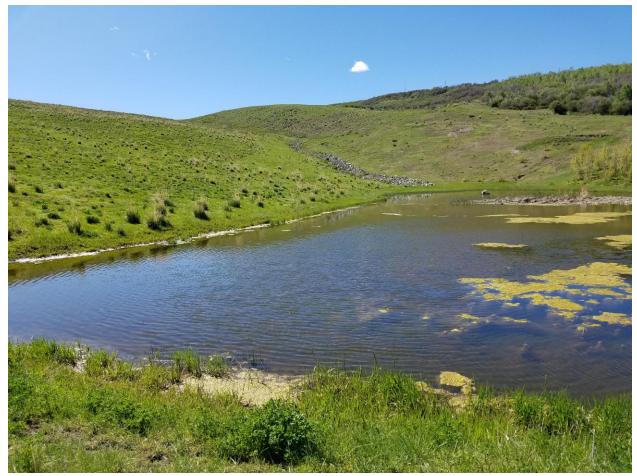
Stock pond T-18 was holding water and appeared stable. Drainage 005-GULCH was stable and functional.

Figure 3. Stock pond T-18 and 005-GULCH drainage basin.

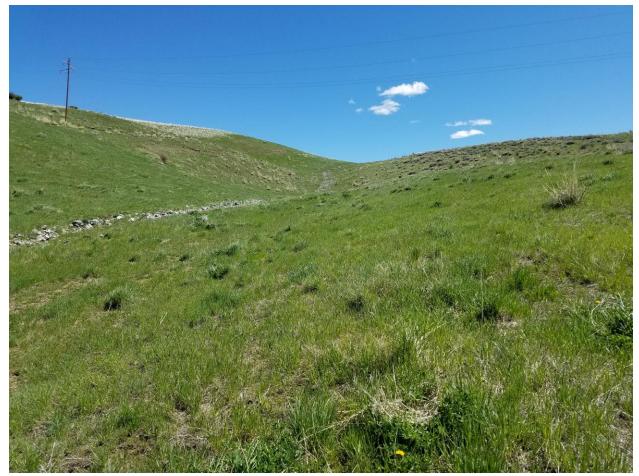
Drainages 006-NE4, 006-NE3, 006-GULCH and 006-E1 were walked and observed. These channels are rocklined and appeared stable and functional. Grasses, forbs and shrubs were observed growing in and around the rock lined channels.

The drainage basins surrounding drainages 006-NE4, 006-NE3, 006-GULCH and 006-E1 was observed. Dense native grasses, forbs and shrubs were observed throughout the reclaimed area.

Figure 4. 006-NE4 drainage basin.

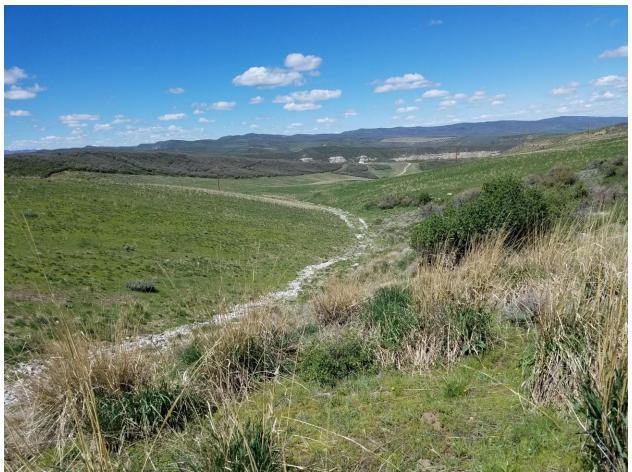
Figure 5. 006-E1 drainage basin.

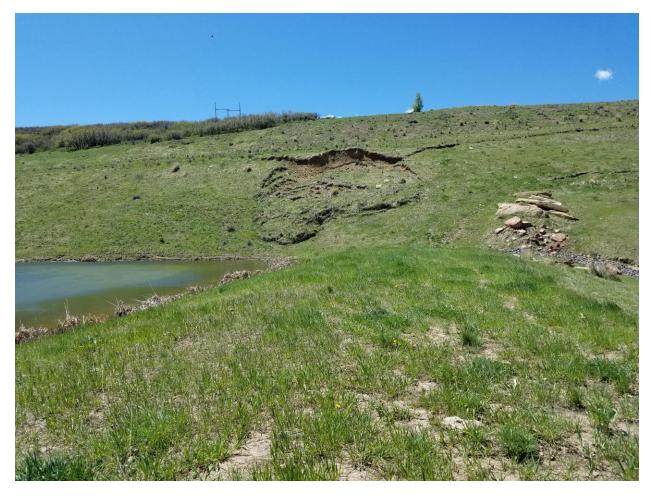
Figure 6. Slump above Pond 006.
