COLORADO
Division of Reclamation,
Mining and Safety
Department of Natural Resources

Permit Number: C-1981-028 Mine Name: Keenesburg Strip Mine Operator: Coors Energy Company Operator Address: Mr. Danny Kipp 1801 California Street Suite 4600 Denver, CO 80202	County: Weld Operation Type: Surface Permit Status: Active Ownership: Private
	Operator Representative Present: Danny Kipp
Operator Representative Signature: (Field Issuance Only)

Inspection Start Date: May 27, 2020 Inspection Start Time: 07:50 Inspection End Date: May 27, 2020 Inspection End Time: 09:35		Inspection Type: Coal Partial Inspection Inspection Reason: Normal I&E Program Weather: Clear	
Joint Inspection Agency: None		Joint Inspection Contacts: 	
Post Inspection Agency: None		Post Inspection Contacts: 	
Inspector(s): Robert Zuber, P.E.	Inspector's Signature: <i>Robert D. Zuber</i>		Signature Date: 5/27/2020

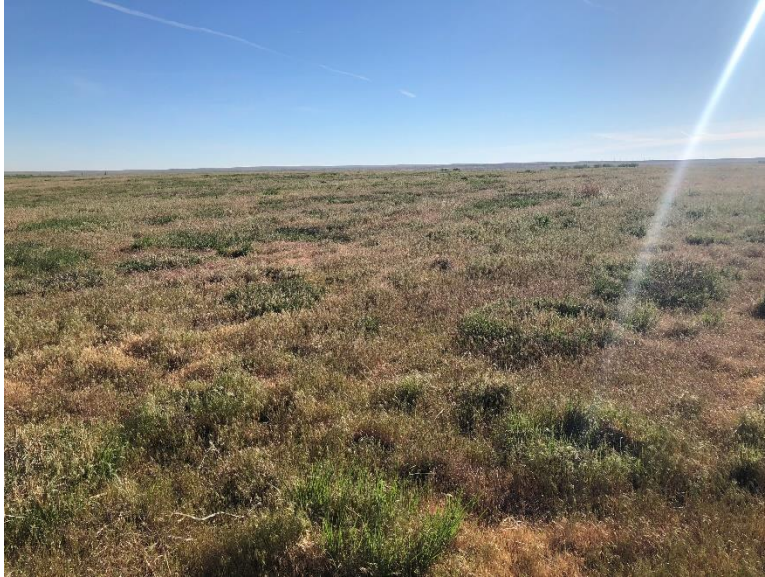
No problems were observed at the reclaimed areas, other than the usual issues with cheat grass. As noted before, this is a prevalent species on the adjacent lands around the permit area. The areas that were walked during the inspection include Areas 29, 30, 31, 32, and 33. The cheat grass appeared to be most prevalent in Areas 29 and 30, compared to the other areas.

Several Prickly Poppy (*Argemone polyanthemus*) plants were seen in the western portion of Area 30. These are not noxious and do not need to be eradicated.

Southwest corner of Area 30, looking northeast

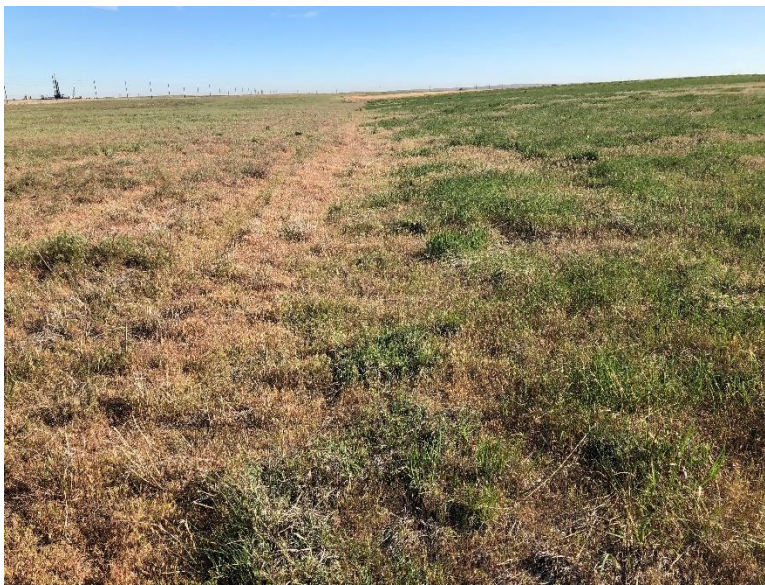
Undisturbed area on left and Area 31 on right

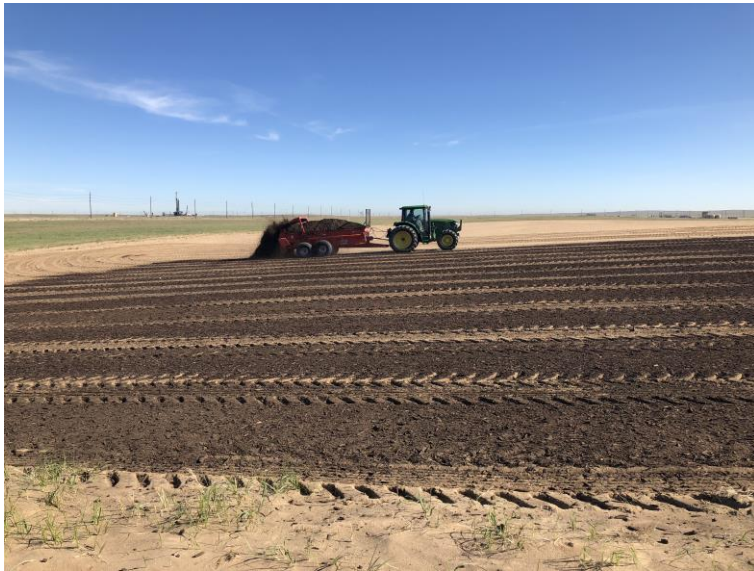
A partial inspection was conducted by Rob Zuber of DRMS. Danny Kipp and Mark Quimby of Coors Energy Company (CEC) were on site, but did not accompany Rob on the inspection. They were spreading a mulch/compost mixture on the south side of the B Pit reclamation area (portion that is not yet vegetated). The material is stockpiled at the south end of the Long Term Spoil Area.

Application of the mulch at B Pit was creating a flume above the equipment, but it did not travel far from the work site, and it was not transported off site.

Application of compost/mulch on B Pit reclamation area

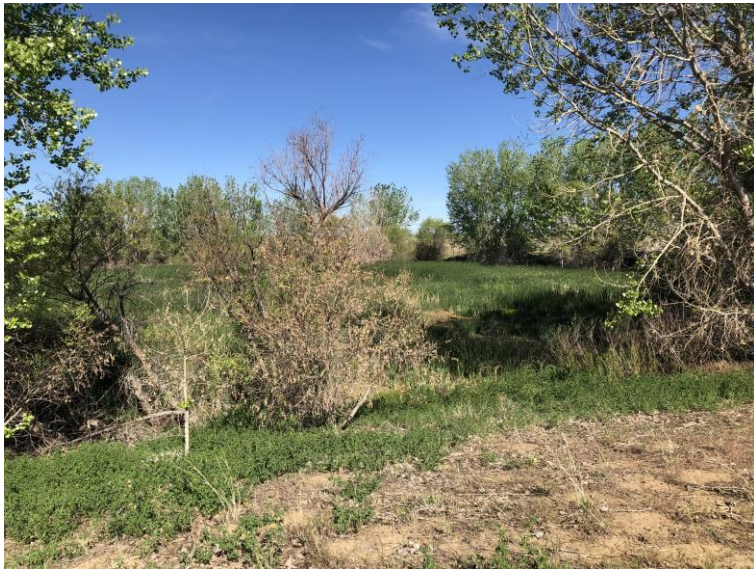
Small volumes of water were observed in the two ponds, levels were well below spillways, and neither pond was discharging during the inspection. There were no signs that they had discharged recently. As usual, they both contained large amounts of riparian vegetation, providing excellent habitat for birds and small animals. No problems were observed with the two ponds.

Sediment Pond 2
