MINERALS PROGRAM INSPECTION REPORT
PHONE: (303) 866-3567

MINE NAME: J & P Trucking Pit # 1	MINE/PROSPECTING ID#: M-2011-021	MINERAL: Borrow material for and sand and gravel	COUNTY: Baca
INSPECTION TYPE: Monitoring	INSPECTOR(S): Daniel Cunningham	INSP. DATE: June 1, 2020	INSP. TIME: 16:00
OPERATOR: J & P Trucking	OPERATOR REPRESENTATIVE: Jeff Chenoweth	TYPE OF OPERATION: 112c - Construction Regular Operation	
REASON FOR INSPECTION: Normal I&E Program	BOND CALCULATION TYPE: Complete Bond	BOND AMOUNT: \$24,347.61	
DATE OF COMPLAINT: NA	POST INSP. CONTACTS: None	JOINT INSP. AGENCY: None	
WEATHER: Clear	INSPECTOR'S SIGNATURE:

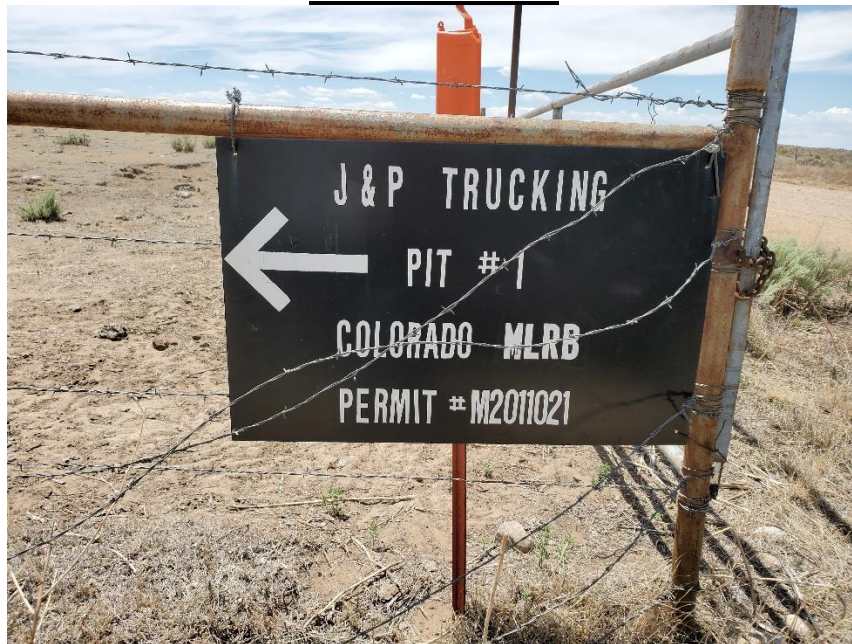
The site identification sign was posted at the mine site entrance and the permit boundary were marked. All mined slopes were at a 3H:1V or greater, no erosional issues were noted during the inspection. Topsoil was being stored on site, and was stable with good vegetation. Areas that have already been mined and are in reclamation show promising results with vegetation being established.

Photo 1: Entrance Sign

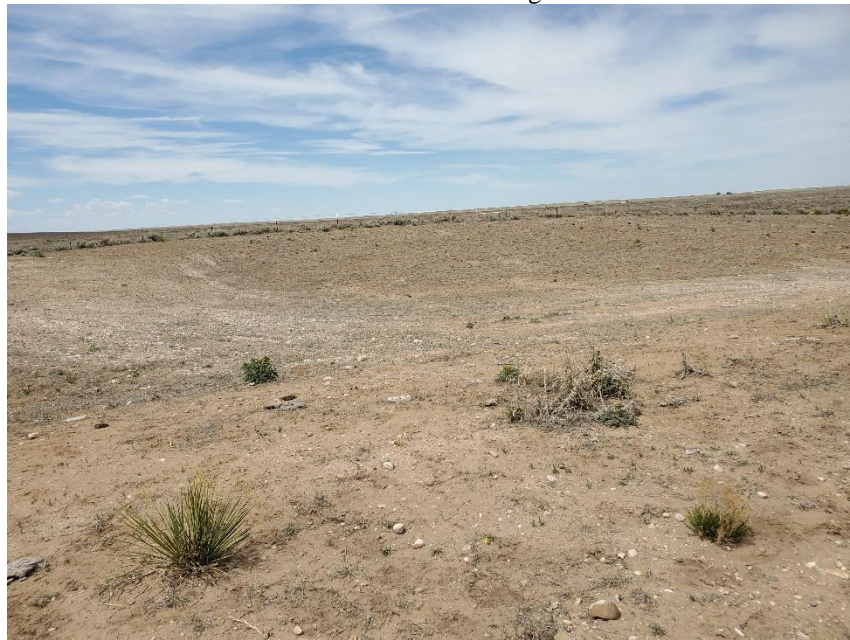
Photo 2: Mined slopes at 3H:1V

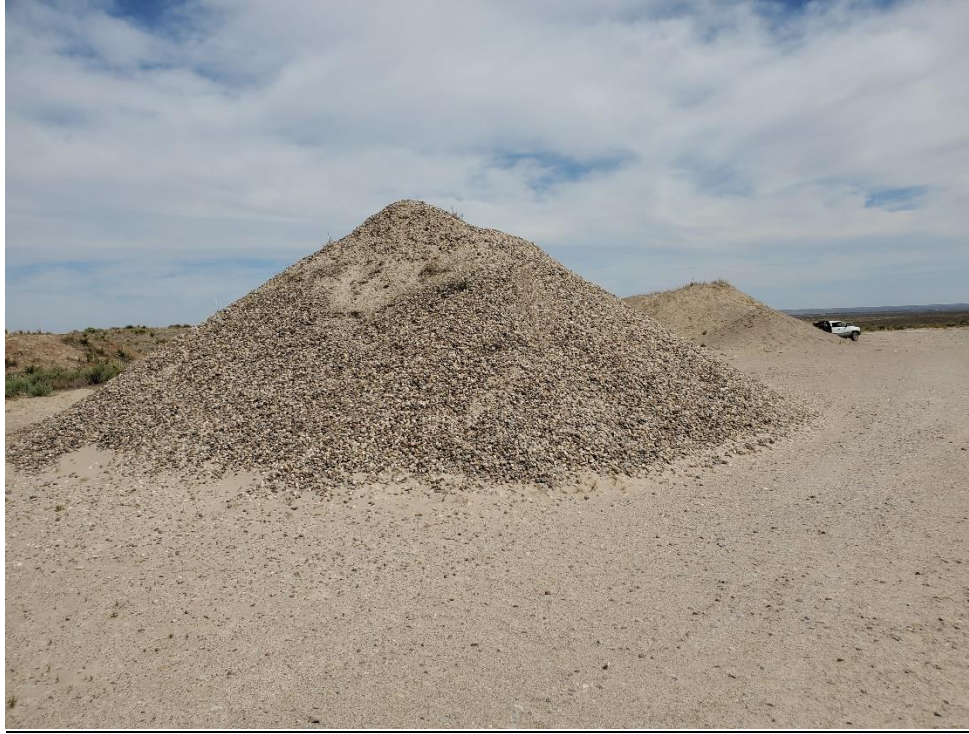
Photo 3: Stockpiles

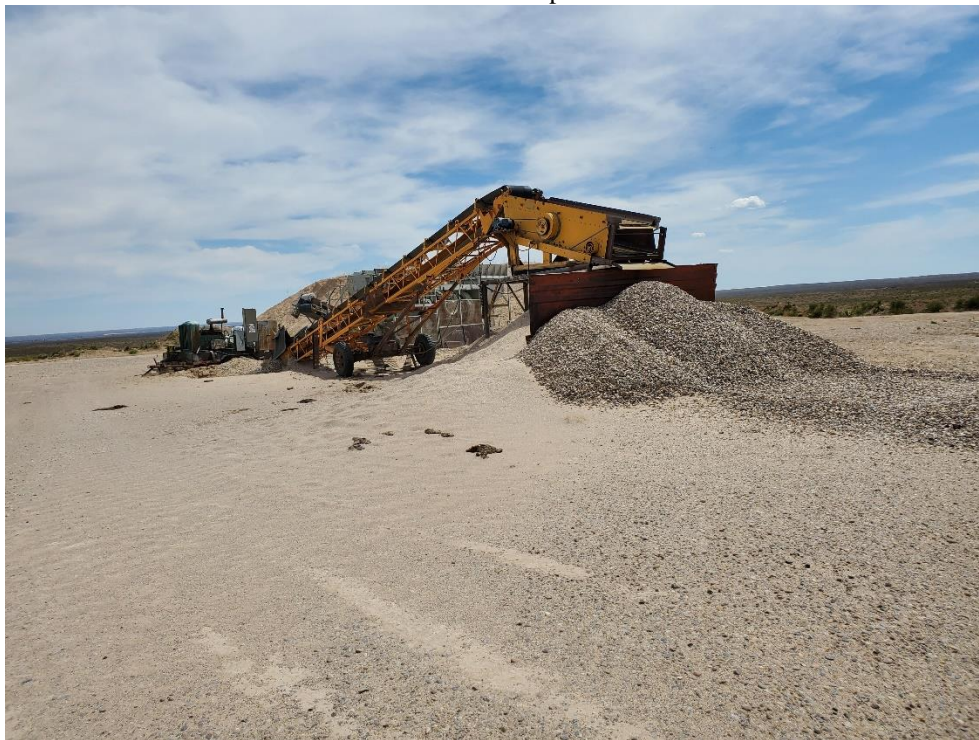
This was a routine monitoring inspection conducted at the J & P Trucking Pit #1 by DRMS representative DJ Cunningham. Jeff Chenoweth represented J & P Trucking during the inspection. This site is an active, 155.2 acre, 112c permit, where 15 acres are allowed to be disturbed at a time. The site was not active at the time of the inspection, however a crusher and conveyor were on site.

Photo 4: Machines on site
