MINERALS PROGRAM INSPECTION REPORT
PHONE: (303) 866-3567

MINE NAME: Walstrum Mine	MINE/PROSPECTING ID#: M-1983-033	MINERAL: Granite, granite gneiss	COUNTY: Clear Creek
INSPECTION TYPE: Monitoring	INSPECTOR(S): Peter Hays	INSP. DATE: June 5, 2020	INSP. TIME: 09:30
OPERATOR: Albert Frei & Sons Inc.	OPERATOR REPRESENTATIVE: Al Frei Jr, Steve O'Brian, Joel Bolduc	TYPE OF OPERATION: 112c - Construction Regular Operation	
REASON FOR INSPECTION: Surety Release Requested	BOND CALCULATION TYPE: None	BOND AMOUNT: \$742,000.00	
DATE OF COMPLAINT: NA	POST INSP. CONTACTS: None	JOINT INSP. AGENCY: None	
WEATHER: Clear	INSPECTOR'S SIGNATURE:

OBSERVATIONS

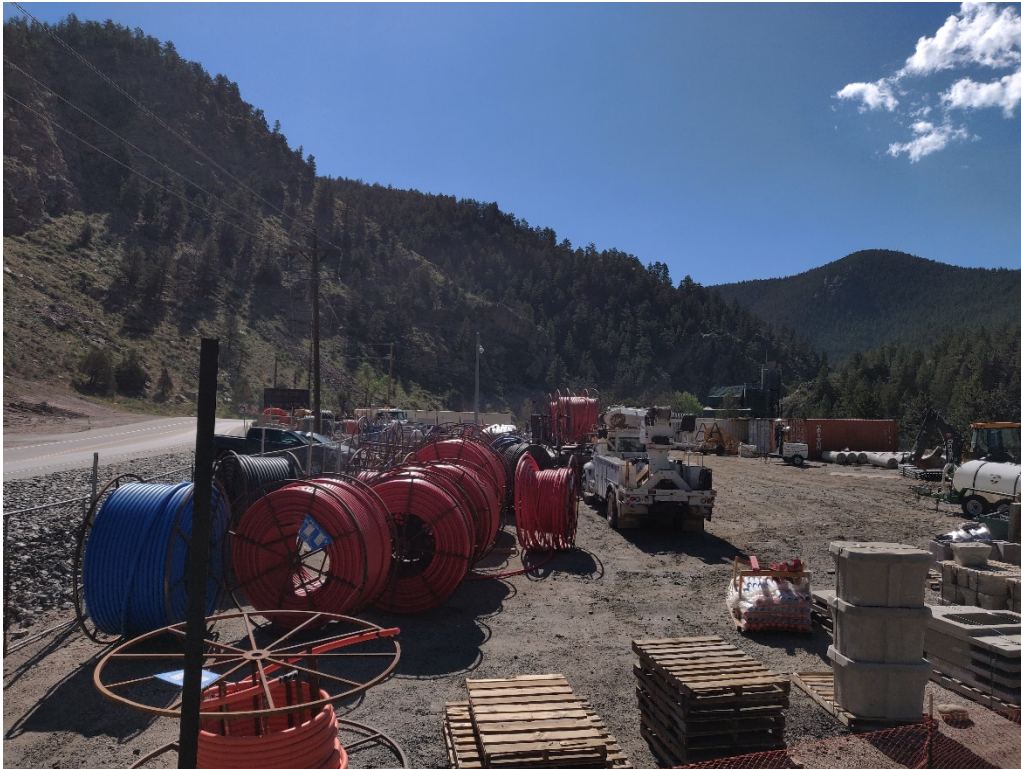
View of Stage X from the northwest corner looking east

Stage X is being used as a storage area by CDOT. The flat (northern portion) of the stage is surrounded by a chain-link fence and orange safety fence with t-posts. The floor of the area was a gravel surface. The area contained various construction materials, equipment and stockpiles of materials. The area was stable and is being utilized as the intended post-mining land use of industrial/commercial.

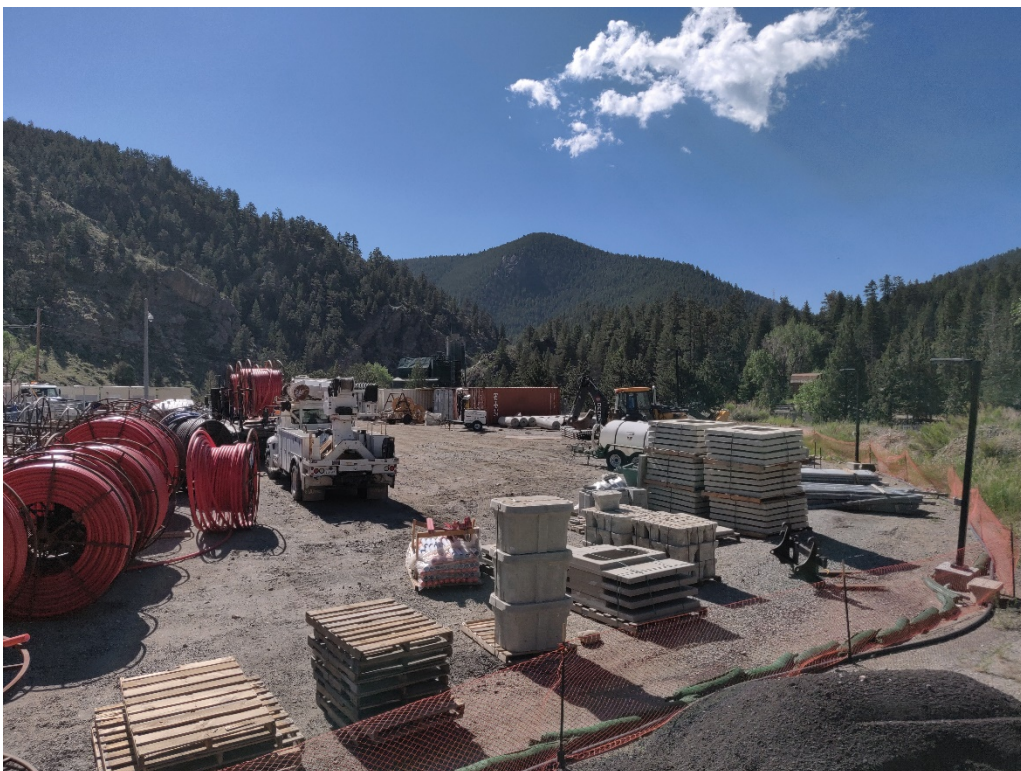
View of Stage X from the northwest corner looking southeast

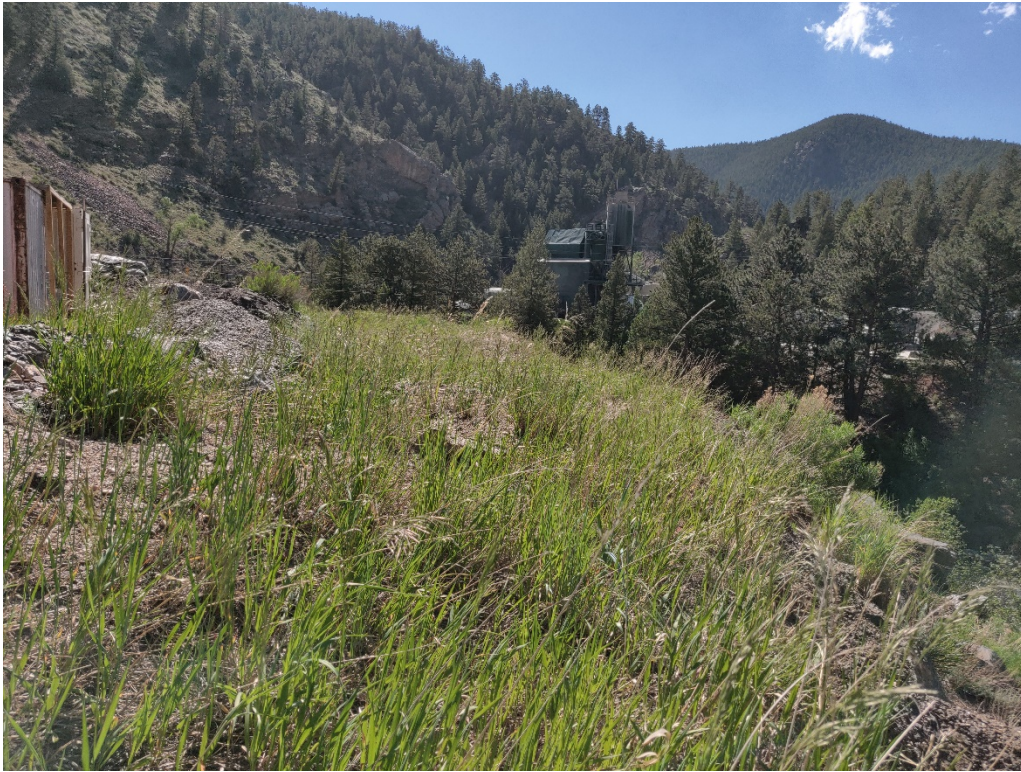
View of vegetation in Stage X looking east

The slope from the storage area to Clear Creek consists of rip-rap bank reinforcement and well-establish wheatgrasses and trees. An earthen berm is constructed between the storage area and the slope to prevent stormwater from leaving the storage area. The slope was stable and no erosion features were observed during the inspection.

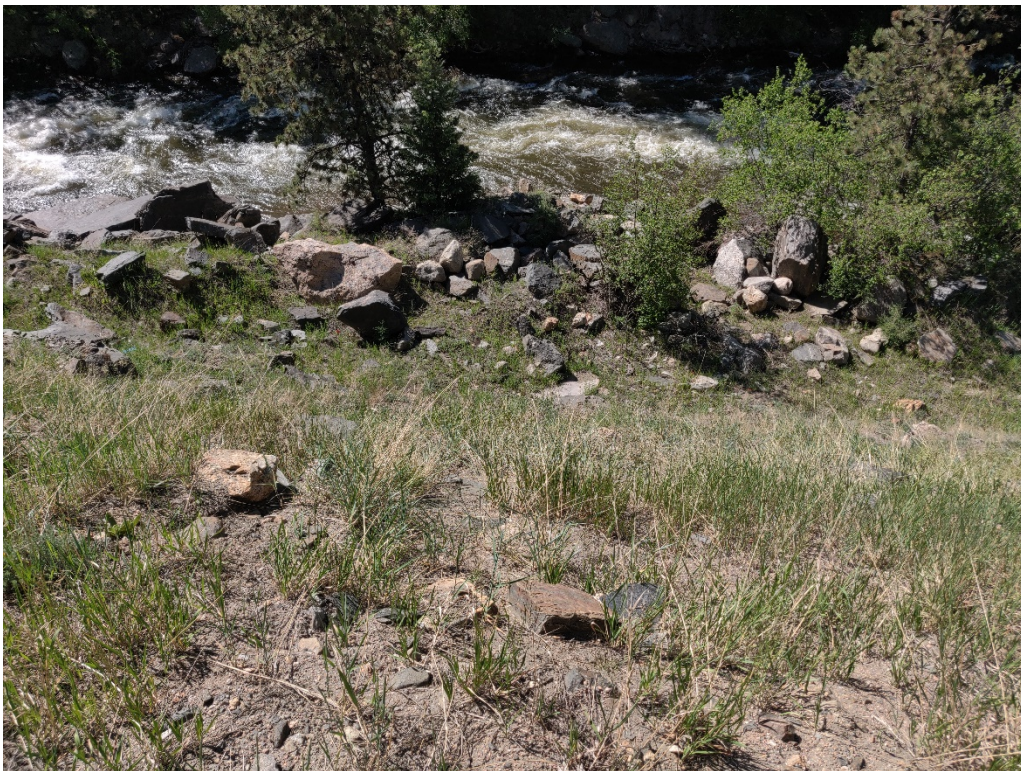
View of vegetation in Stage X looking south down the slope

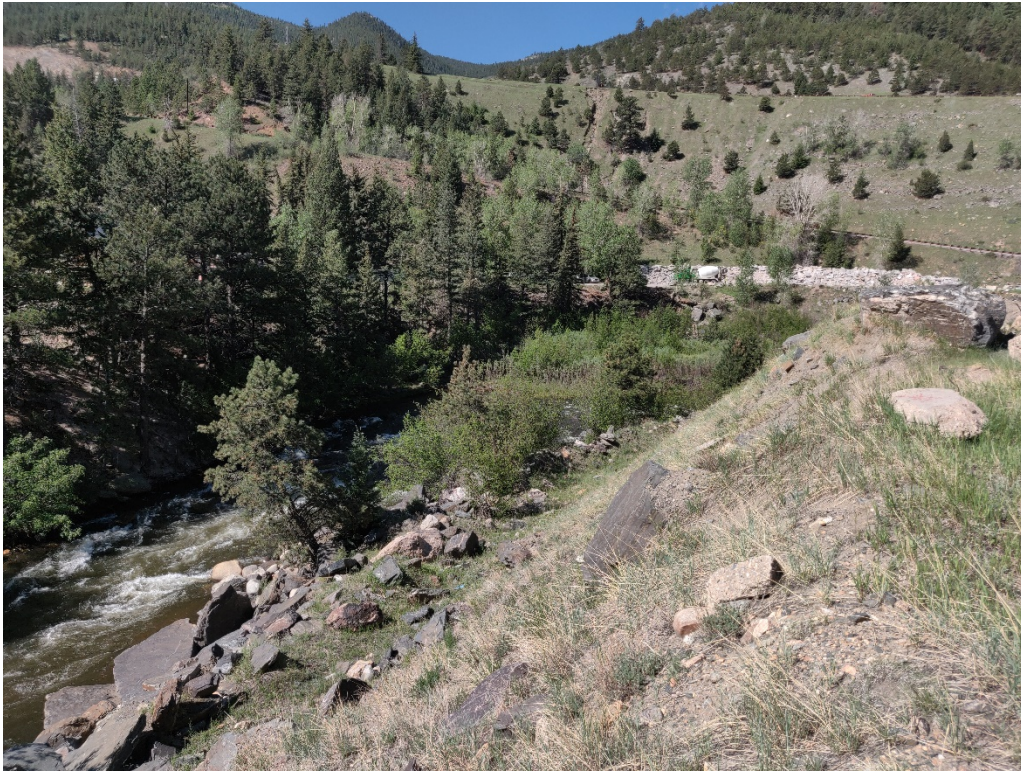
View of vegetation in Stage X looking southwest from east side of the stage

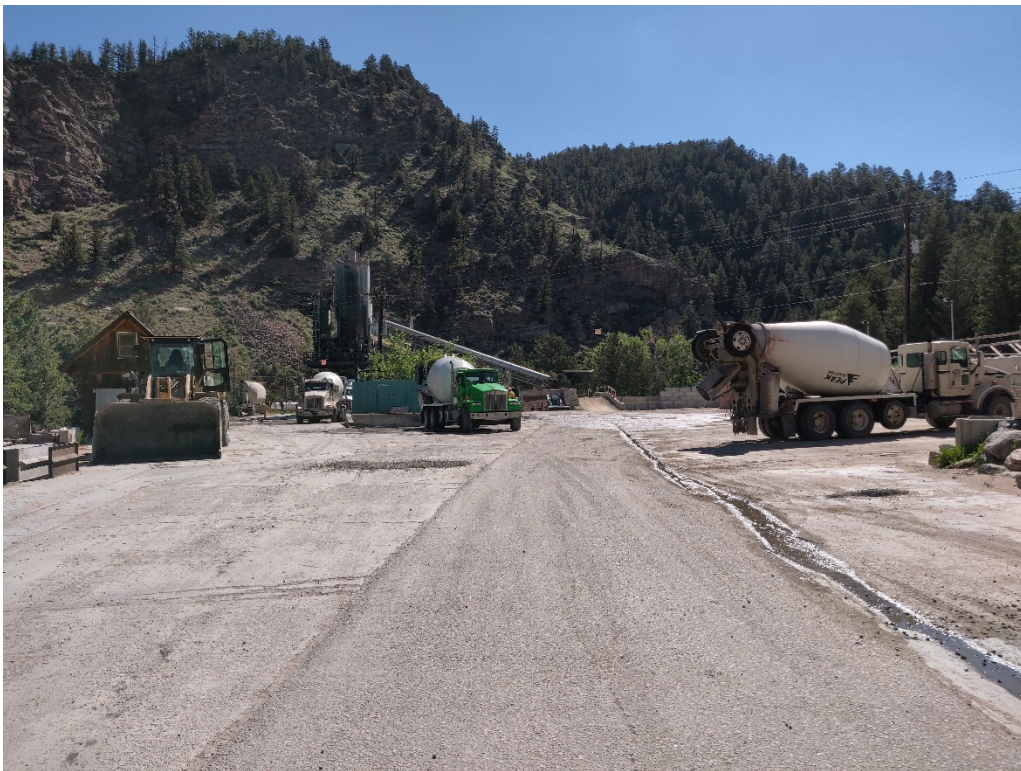
View of Stage Z from the west side looking east

Stage Z is leased by Albert Frei & Sons, Inc. to a concrete company, Peak Materials. The site contains a concrete batch plant, concrete truck parking and other facilities and structures associated with the concrete production operation. The area was stable and is being utilized as the intended post-mining land use of industrial/commercial.

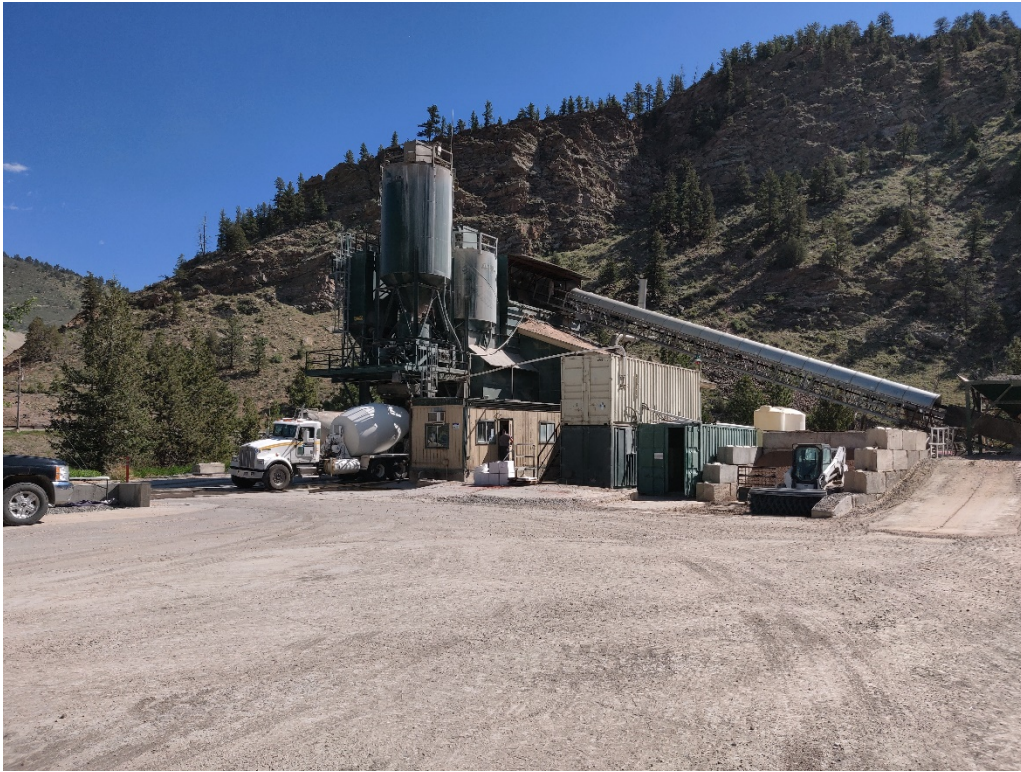
View of concrete batch plant in Stage Z

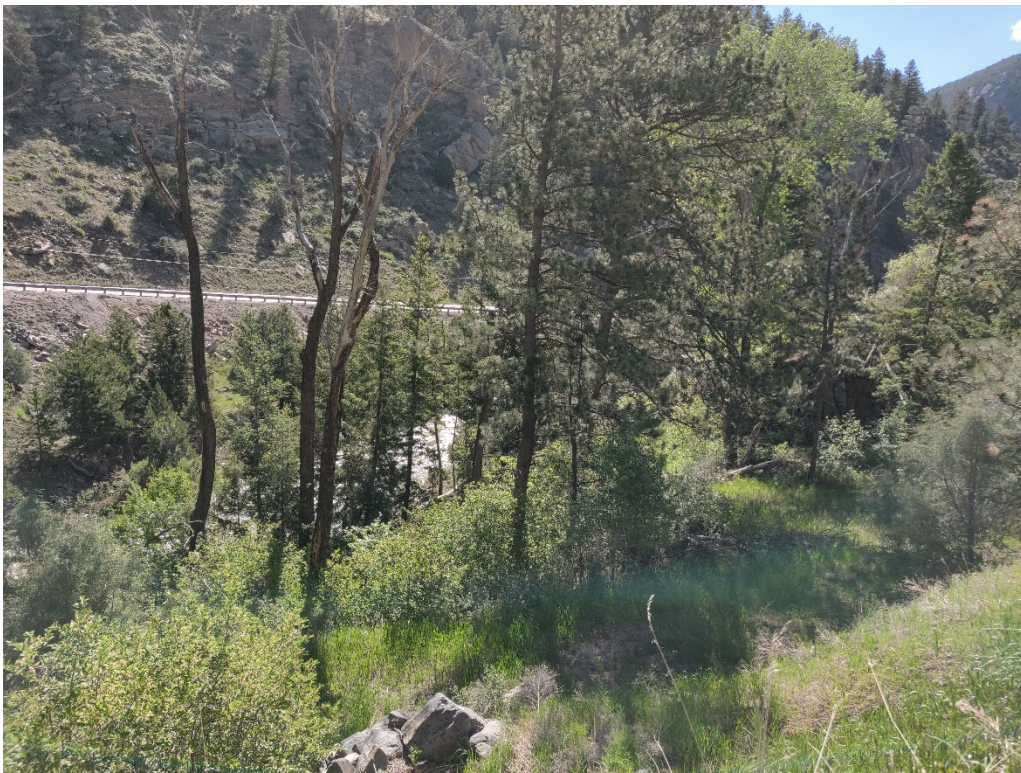
View of existing vegetation east of the batch plant in Stage Z looking northeast

The slope from the concrete facilities to Clear Creek consists of well-establish wheatgrasses and trees. The slope was stable and no erosion features were observed during the inspection.
