Tom Zimmerman EA Complete - El Rancho Bondo Plan of Operations Modification (Dredging)

Minerals Plan of Operations Inspection
U.S. Department of the Interior
Bureau of Land Management
Royal Gorge Field Office

Date: Nov 15, 2019 Time: 12:38 Weather: Sunny	Operation Name: Zimmerman-El Rancho Bondo Case Number: COC75265 CDRMS Number: M-2018-028
<u>Attendees</u> BLM: A. Sanderson, C. Duval, Z. Dilles, & A. Parker Operator(s): Not present Other(s): None	<u>General</u> Operation(s) are in compliance with documentation on file <input checked="" type="checkbox"/> Yes <input type="checkbox"/> No <input type="checkbox"/> N/A Operation(s) and disturbance on-site coincide with the operations and access on file <input checked="" type="checkbox"/> Yes <input type="checkbox"/> No <input type="checkbox"/> N/A

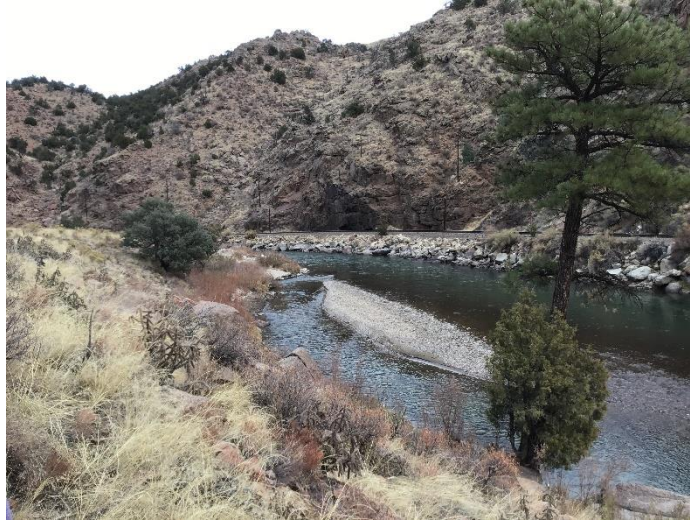
Image 1: (Images taken by Charles Duval, 11/15/19)

Comment: View looking north of operational area; dredging operations (EA) between the west bank of the river and sandbar are pending until State compliance is met

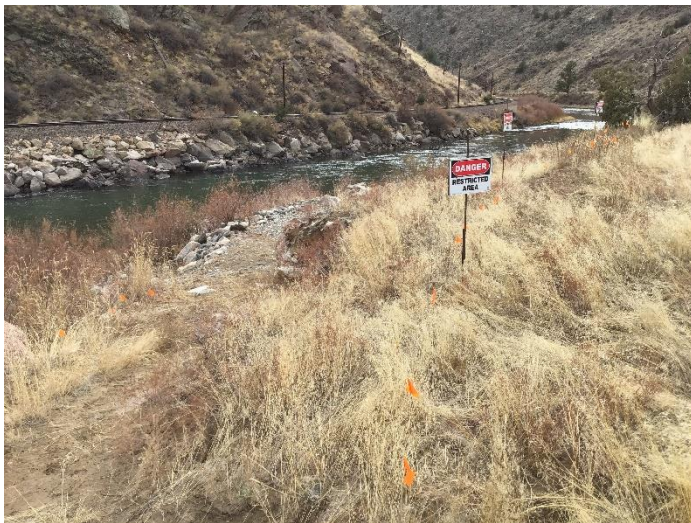
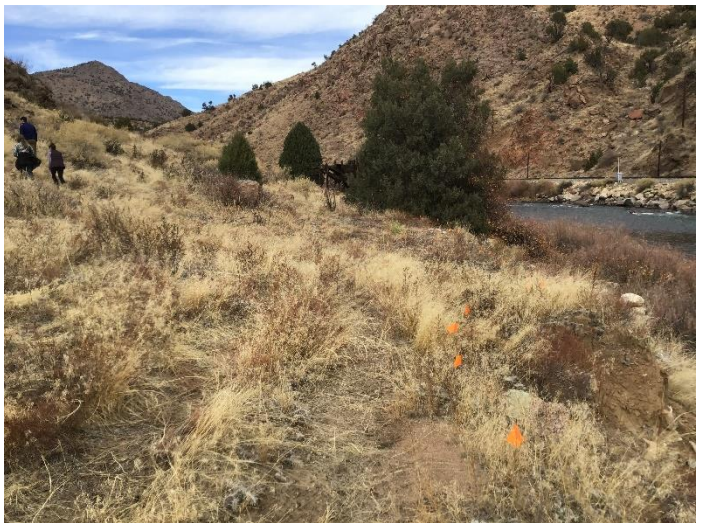
Images 2-3: (Images taken by Charles Duval, 11/15/19)

Comment: Pin flags and signs are in-place to provide the general public a visual safety precaution to the edge of the active working face.

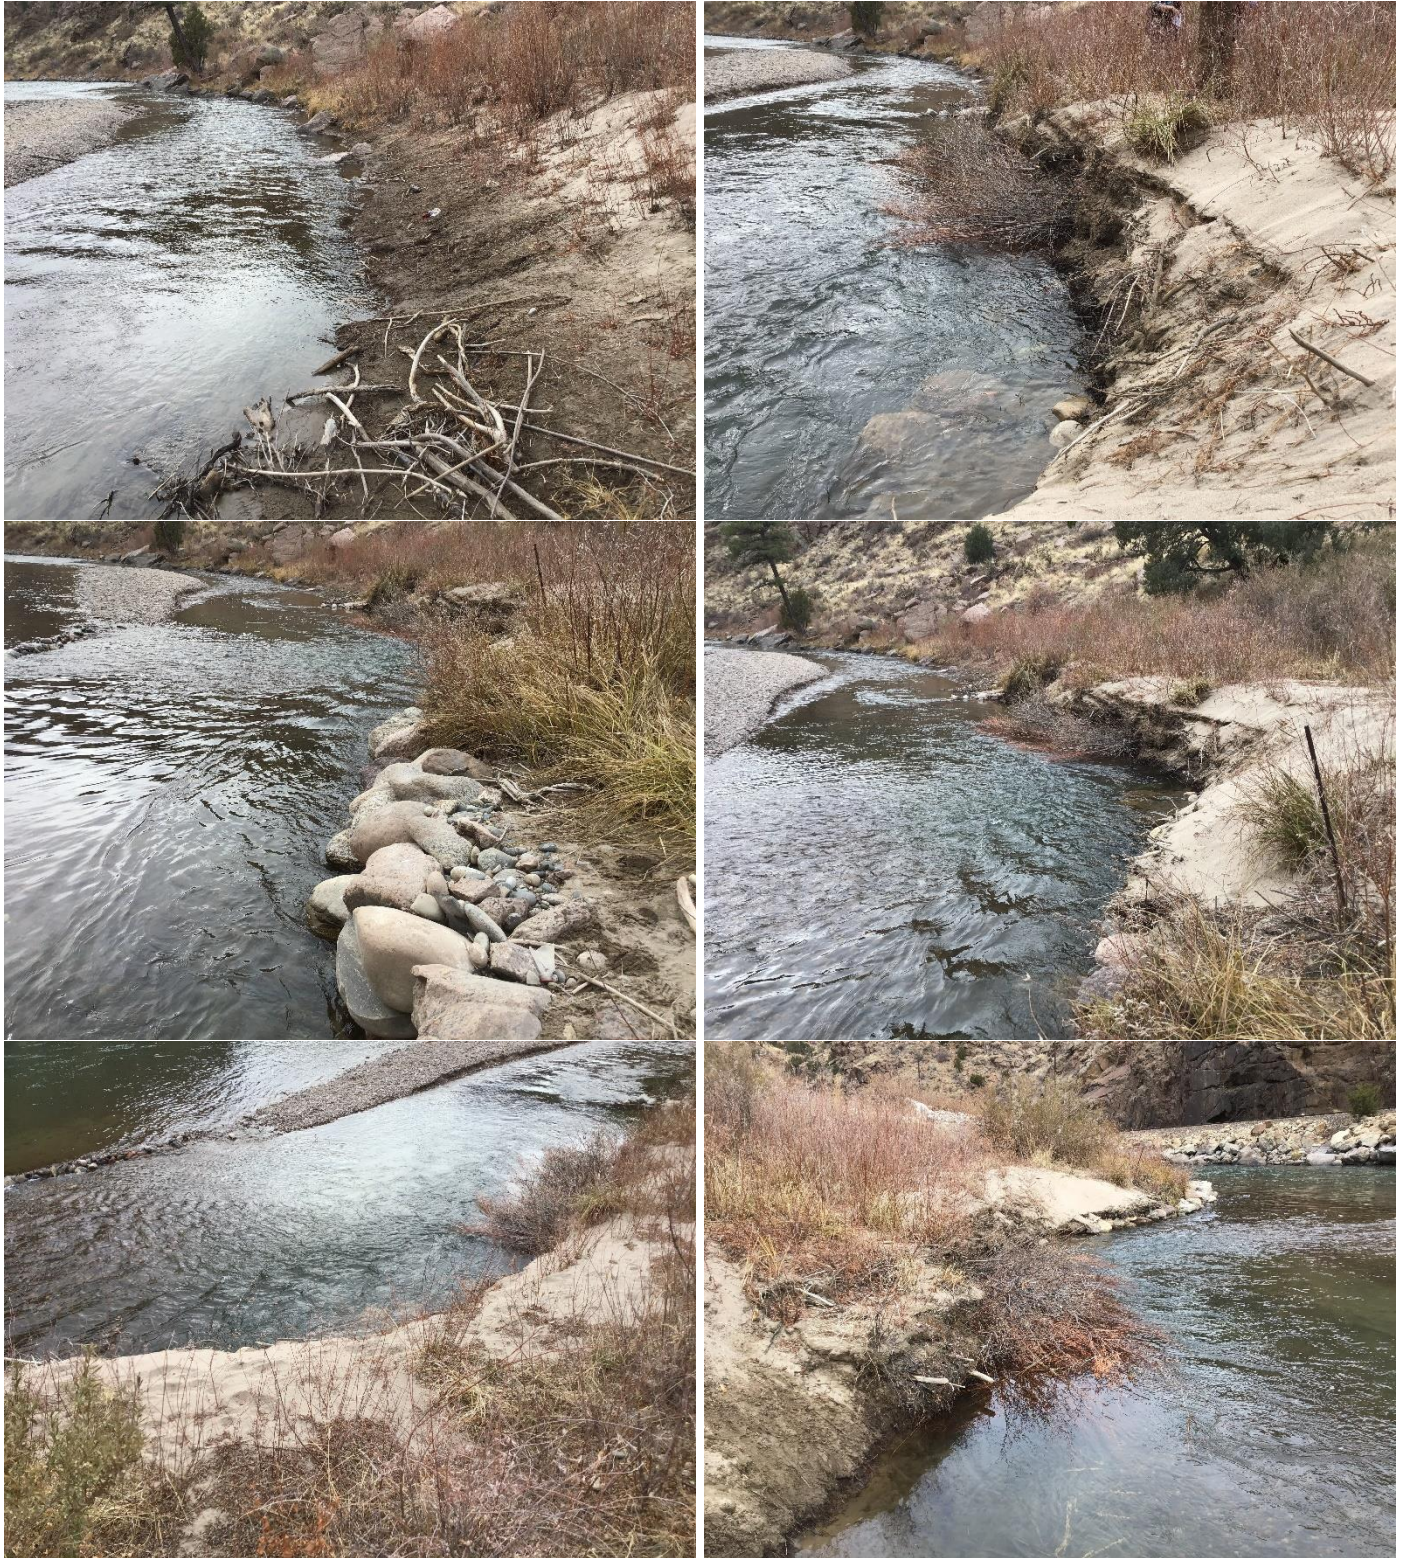
Images 4-9: (Images taken by Charles Duval, 11/15/19)

Comment: Southern (4-8) and eastern (9) views of the river bank and bank stabilization work that the operator emplaced to decrease natural erosion and undercutting by beavers; New beaver activity is undercutting the bank and may cause a potential issue by decreasing the distance between the bank and the waste stockpiles.

Additional Actions Necessary	
Non-Compliance Issues to be addressed by Operator	
<ul style="list-style-type: none"> None 	
Final Notes	
General Comments: <ul style="list-style-type: none"> No evidence of recent mining activity Bank stabilization may need to be updated due recent beaver activity (ref. 5, 7 & 8 images) Environmental Assessment (EA) was recently completed and the Plan of Operations authorized. Operations remain pending until the bond is reviewed and subsequently posted by the operator. CDRMS permit remains pending until other state permits are obtained by the operator. 	
Proprietary Information: N/A	
Date inspection shared with CDRMS:	
Date inspection shared with Operator:

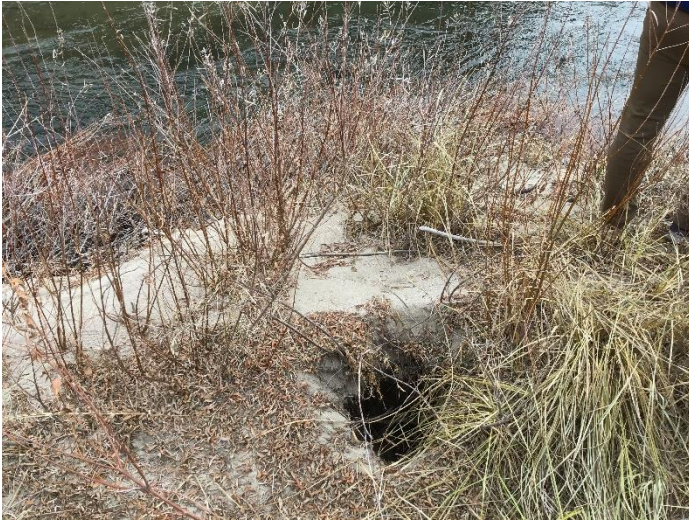
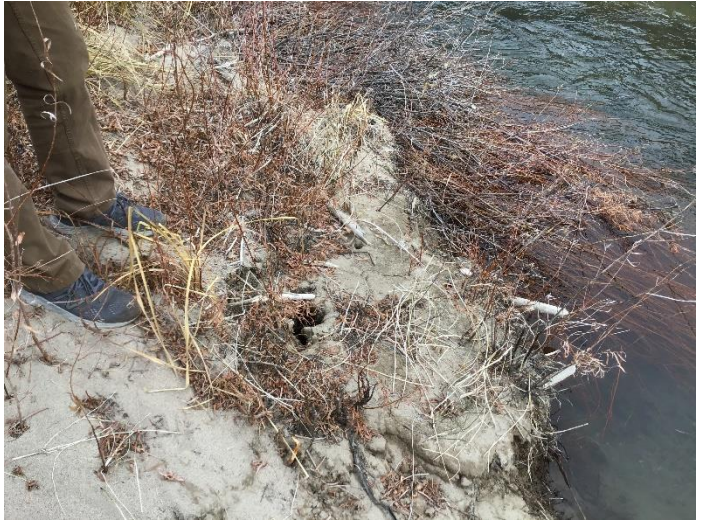
Images 10-11: (Images taken by Charles Duval, 11/15/19)

Comment: Beaver holes located on the bank stabilization bank; bank is starting to slough and become unstable; operator will likely need to add more material to build up the support of the bank if the beaver activity becomes inactive.

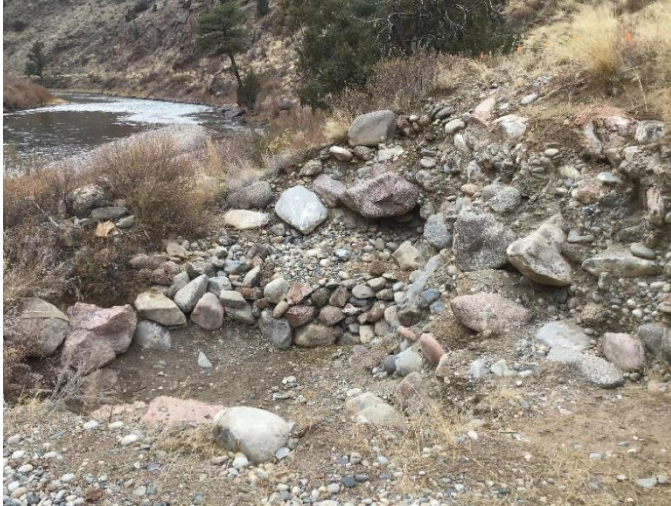
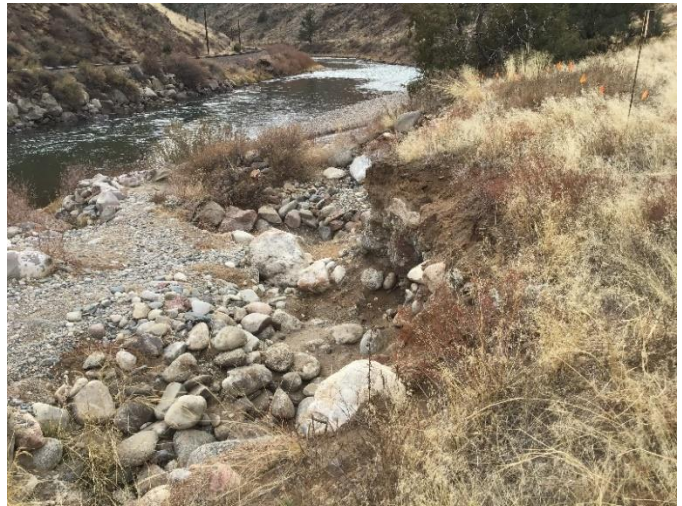
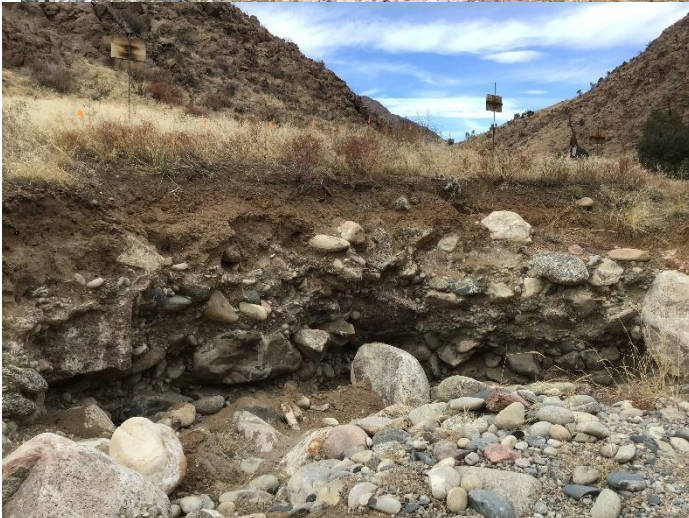
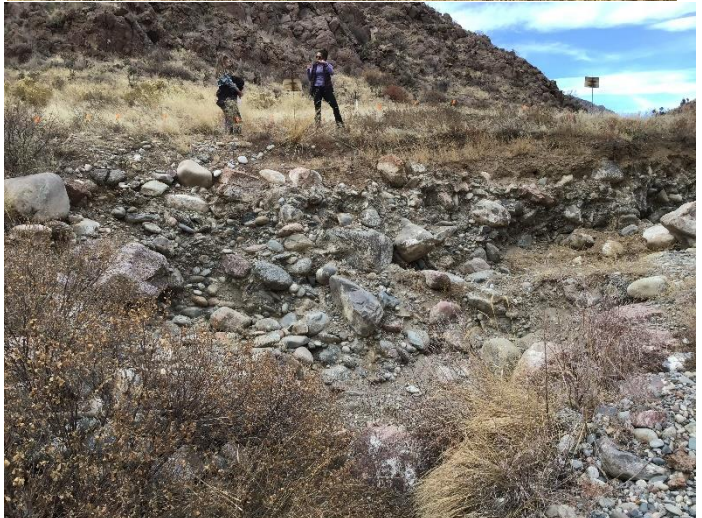
Images 12-15: (Images taken by Charles Duval, 11/15/19)

Comment: Southern (12-13) and western (14-15) views of the active working face

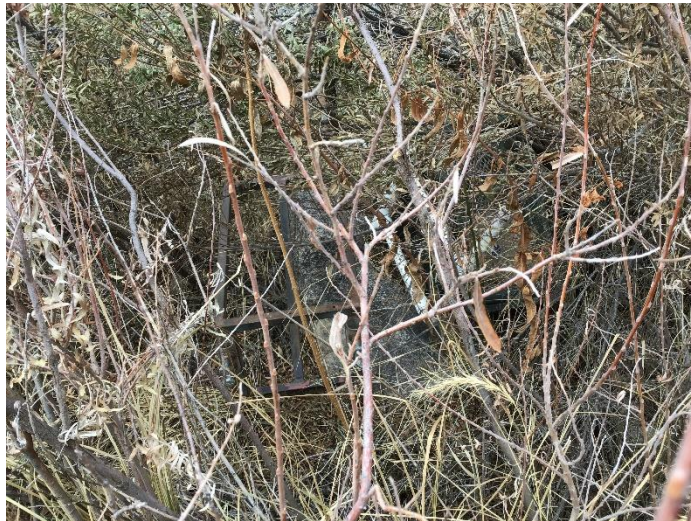
Image 16: (Images taken by Charles Duval, 11/15/19)

Comment: Mining related equipment stored among the vegetation west of the river bank

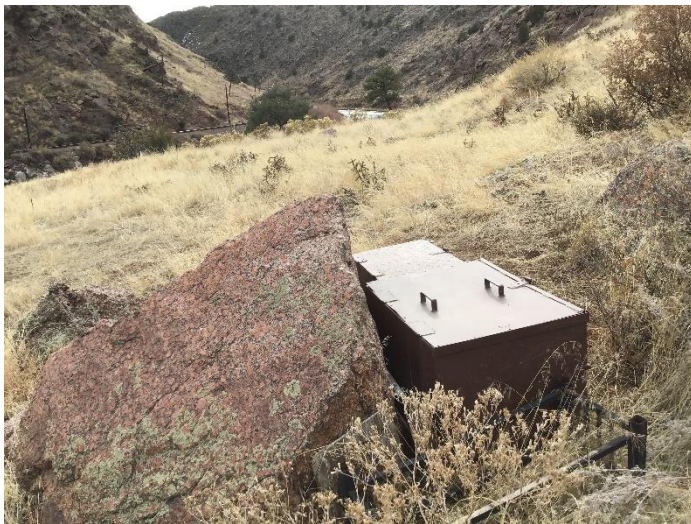
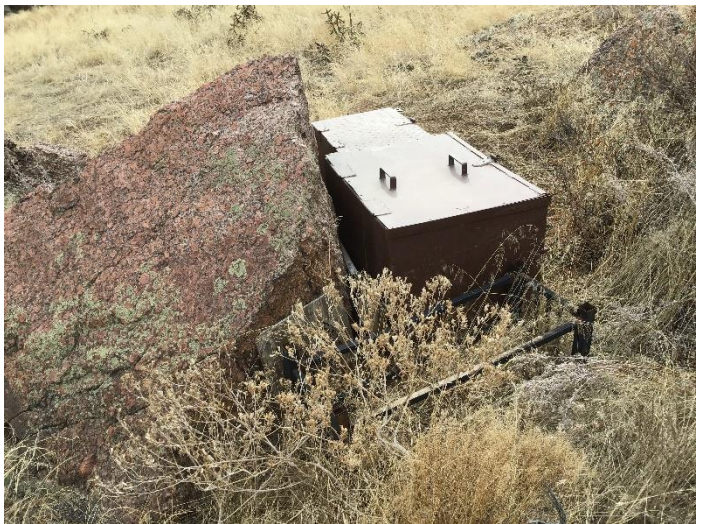
Images 17-18: (Images taken by Charles Duval, 11/15/19)

Comment: Storage steel locker (occupancy) used to store mining related equipment located a couple hundred feet from the western river bank

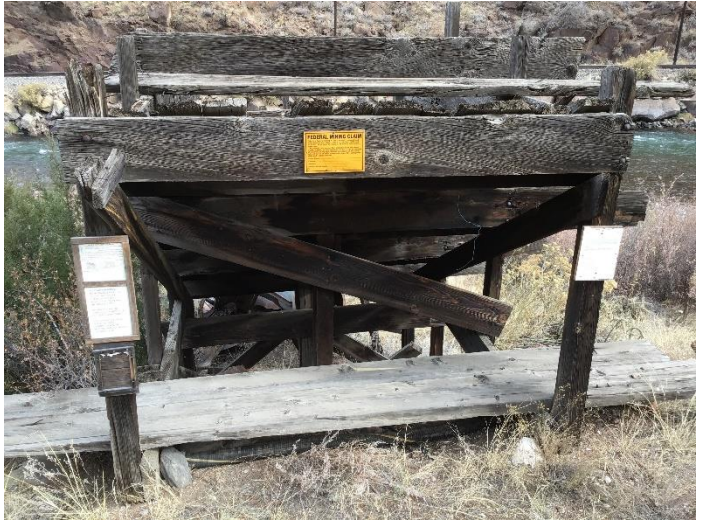
Images 19-20: (Images taken by Charles Duval, 11/15/19)

Comment: Claim and operation signs located north of the active working face

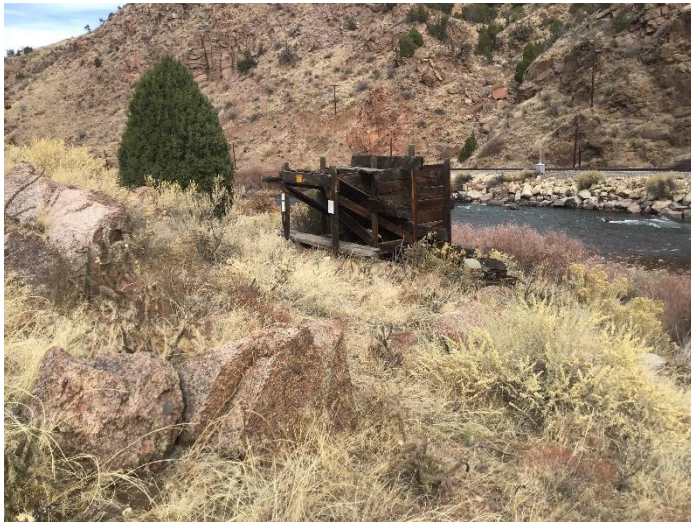
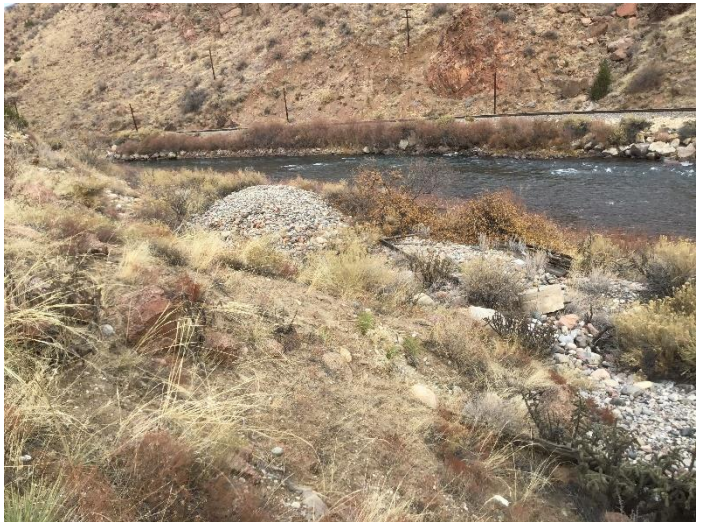
Images 21-22: (Images taken by Charles Duval, 11/15/19)

Comment: Historic mining structure and waste rock pile located north of the active operational area; not used in active mining operations.
