MINERALS PROGRAM INSPECTION REPORT
PHONE: (303) 866-3567

MINE NAME: Ackerman Pit	MINE/PROSPECTING ID#: M-2019-037	MINERAL: Sand and gravel	COUNTY: Cheyenne
INSPECTION TYPE: Monitoring	INSPECTOR(S): Timothy Cazier	INSP. DATE: June 11, 2020	INSP. TIME: 11:55
OPERATOR: Cheyenne County	OPERATOR REPRESENTATIVE: Jim Brown	TYPE OF OPERATION: 110c - Construction Limited Impact	
REASON FOR INSPECTION: Normal I&E Program	BOND CALCULATION TYPE: None	BOND AMOUNT: \$0.00	
DATE OF COMPLAINT: NA	POST INSP. CONTACTS: None	JOINT INSP. AGENCY: None	
WEATHER: Clear	INSPECTOR'S SIGNATURE:

M-2019-037 2020 Post-Inspection Map

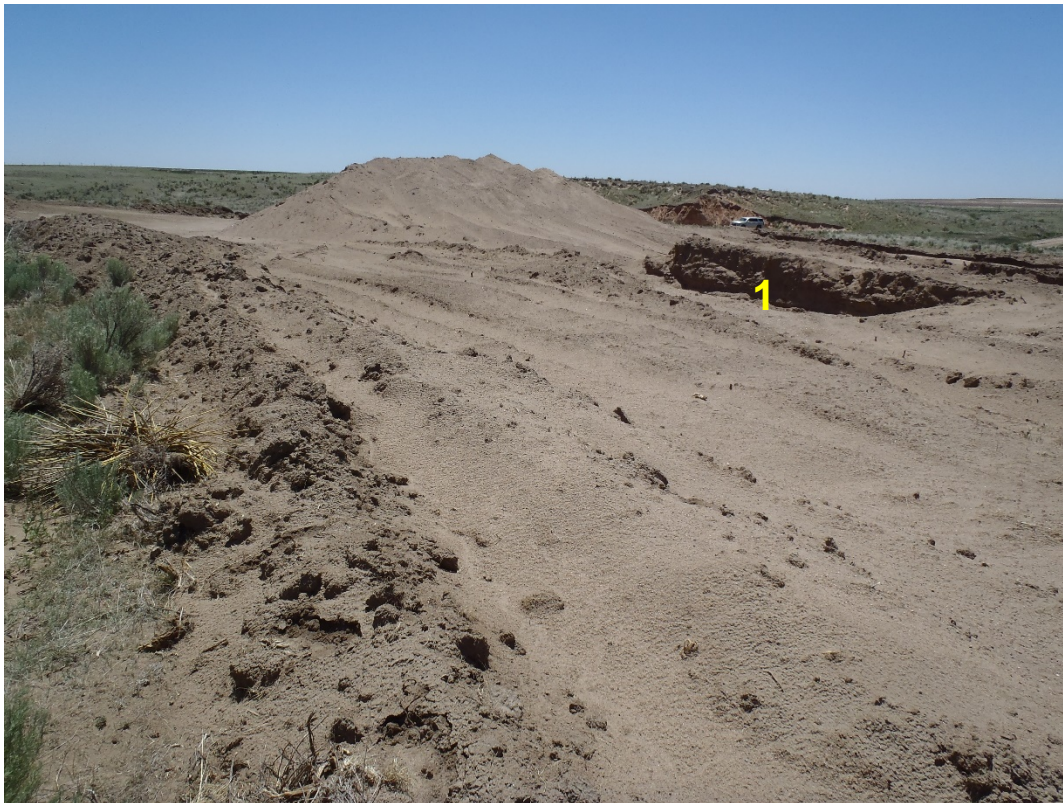
Photo 1. North trench (1) and product stockpile (looking SE from NW corner).

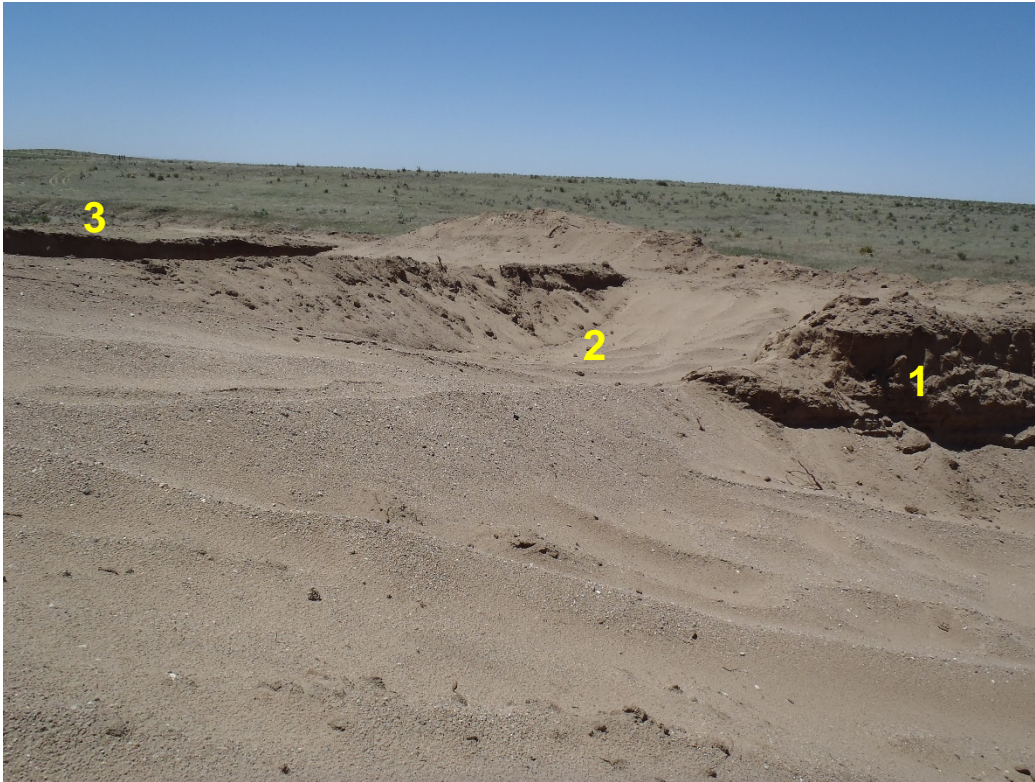
Photo 2. Three trenches (1, 2 and 3 – looking SW).

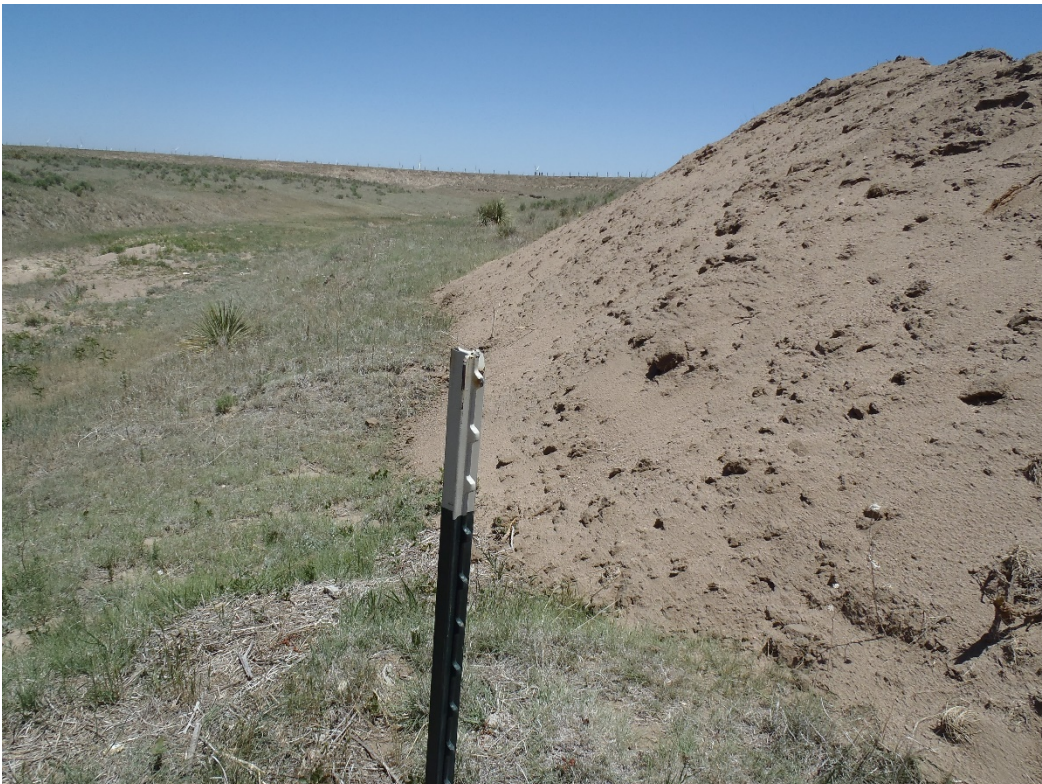
Off-site Damage: The operation appeared to be confined to the permit boundary, based on site observations. However, the topsoil stockpiled on the west side is on, or possibly slightly over the line-of-sight permit boundary (see **Photo 3**). This inspector informed Mr. Brown of the proximity issue.

Topsoil: Topsoil was stockpiled on the west side of the pit (see **Photo 3**).

Photo 3. Typical permit boundary marker and topsoil stockpile (west side, looking north).

Signs and Markers: The permit sign was properly posted (see **Photo 8**) and T-post boundary markers were observed to delineate the permit boundary (see **Photo 3**). This inspector recommended additional boundary markers be placed on the north side to maintain the offset from the fence.

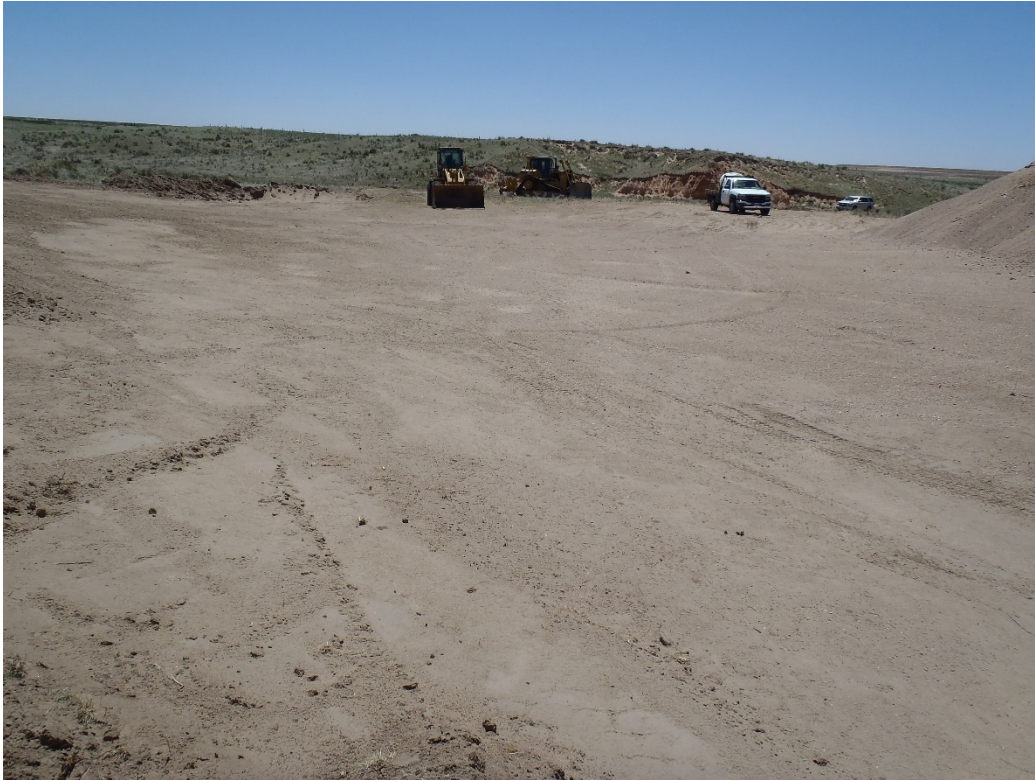
Support Facilities On-site: A loader and dozer were observed on site (see **Photo 4**).

Photo 4. Staging area, loader, and dozer (looking south).

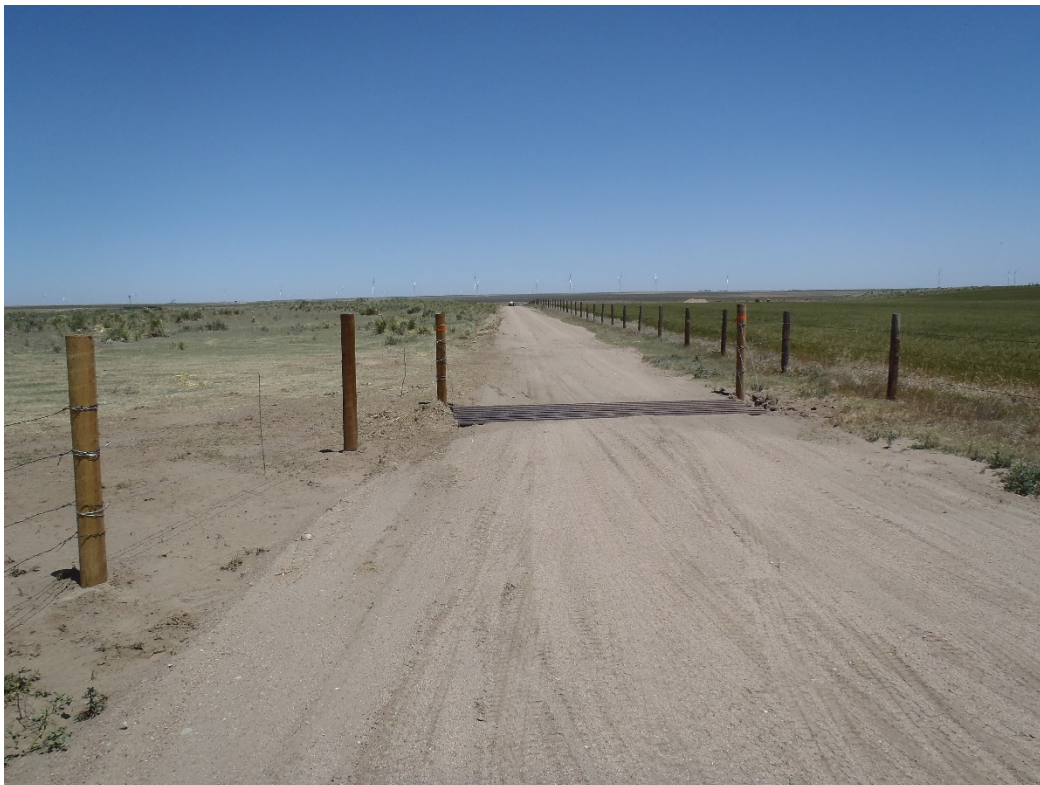
Roads: The roughly 1,700 foot long access road did not appear to be a source of sediment that could be tracked offsite. Road side ditches were clean (see **Photos 5** and **6**).

Photo 5. Access road from Co Rd U (looking north).

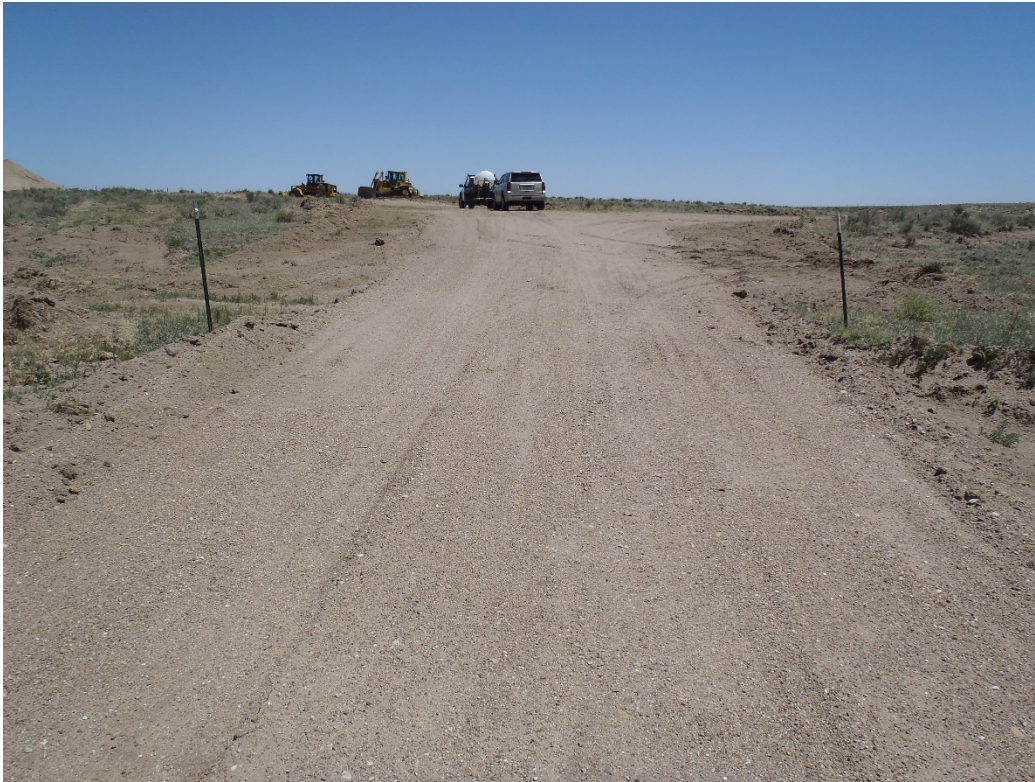
Photo 6. Access road from Smokey Hill River (looking NE).

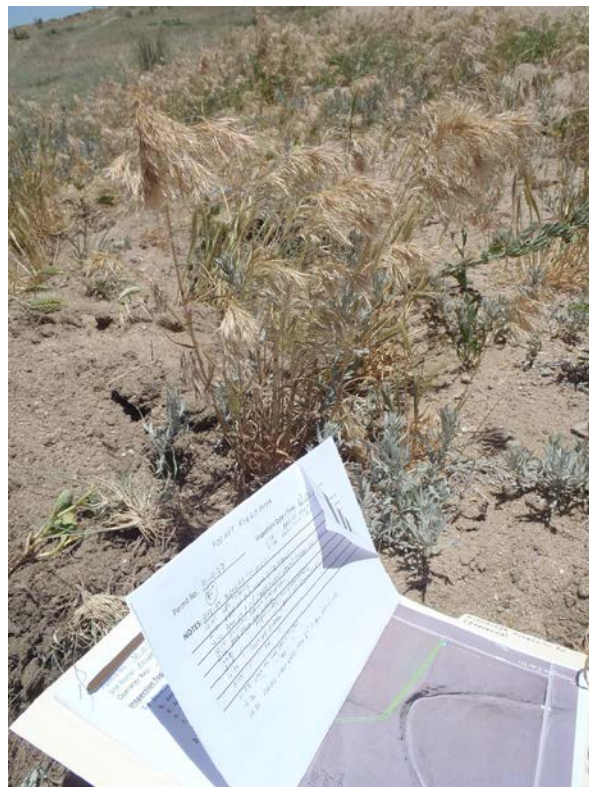
Revegetation: No revegetation had been initiated. Some downy brome (cheat grass, see **Photo 7**) was observed on the south side near the edge of the Smokey Hill River. This is a noxious weed List C species, so it was not

Photo 7. Downy brome near Smokey Hill River (file folder for scale).

cited as a problem. However, the Operator should implement a weed control program to reduce the cheat grass on site.

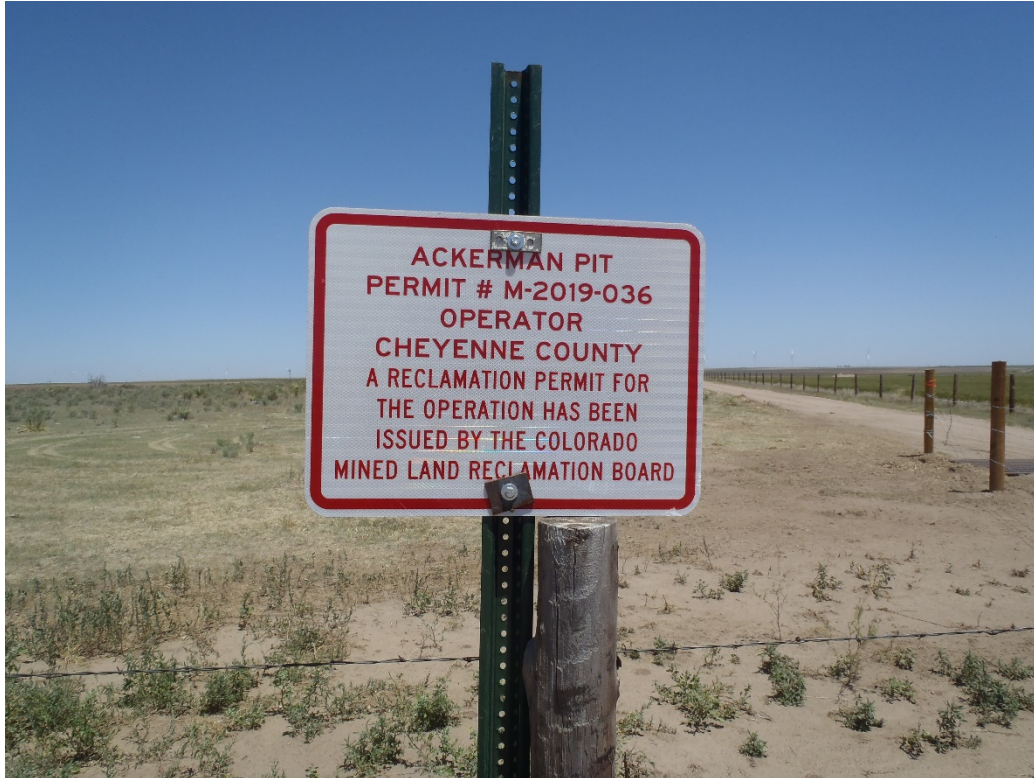
Photo 8. Permit sign at entrance off Co Rd U.

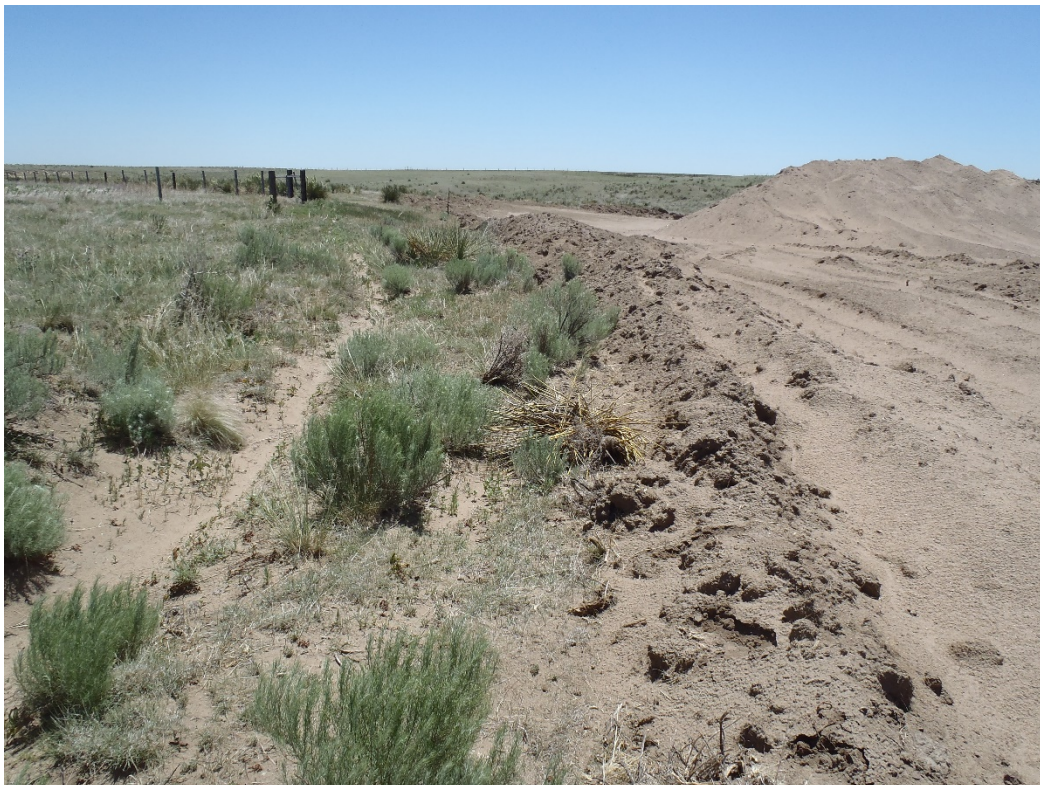
Structures: The only structure observed within 200 feet of the affected area was the fence (see **Photo 9**) identified in Exhibit E of the application, on the north side of the site.

Photo 9. Fence on north side (looking SE).
