**MINERALS PROGRAM INSPECTION REPORT**  
**PHONE: (303) 866-3567**

| <b>MINE NAME:</b><br>Ted Franciscotti Pit #1 | <b>MINE/PROSPECTING ID#:</b><br>M-2007-006 | <b>MINERAL:</b><br>Sand and gravel | <b>COUNTY:</b><br>Huerfano |
| <b>INSPECTION TYPE:</b><br>Monitoring | <b>INSPECTOR(S):</b><br>Patrick Lennberg | <b>INSP. DATE:</b><br>June 24, 2020 | <b>INSP. TIME:</b><br>09:10 |

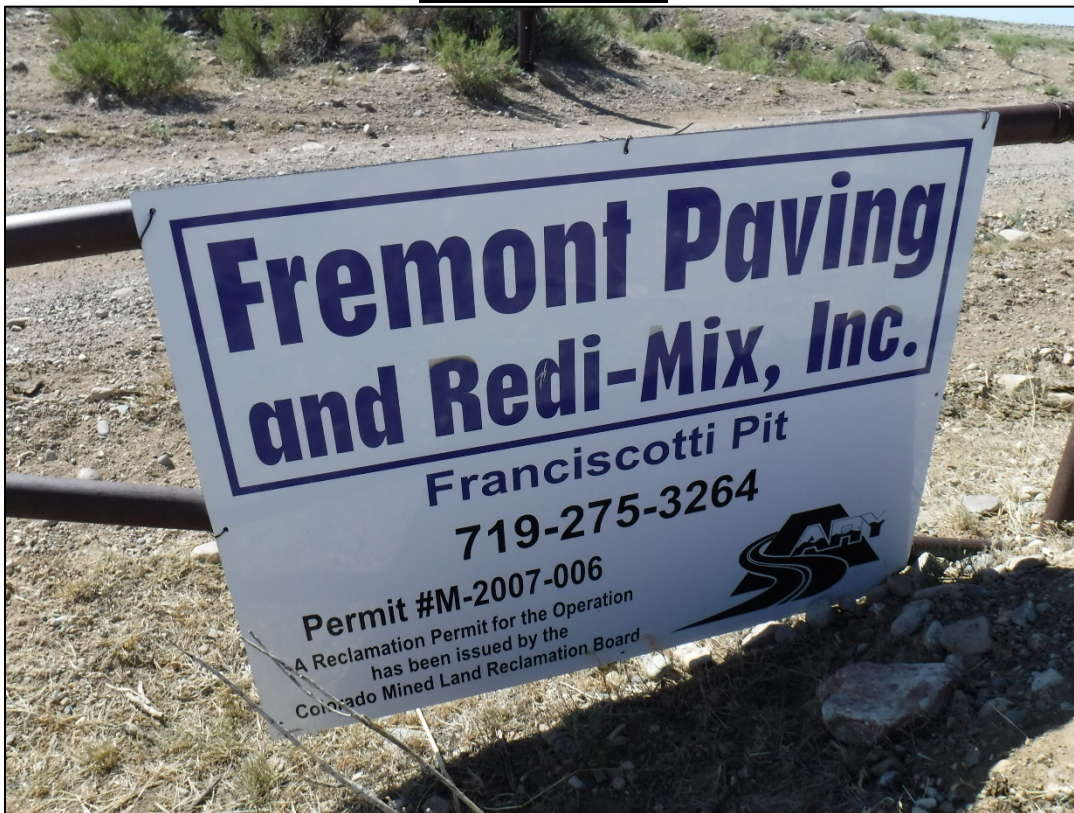
The Ted Franciscotti Pit #1 is adjacent to County Road (CR) 640 approximately 1.75 miles west from the junction of the frontage road along Interstate 25. The site itself is approximately 9.5 miles north of Walsenburg, CO. The site is surrounded by rangeland and farmland with the post-mining land use is rangeland. The pit is a 282-acre 112c Construction Materials Reclamation Permit with a maximum allowed disturbance of 25 acres and mined in 7 phases. The primary commodity being mined at the site is sand and gravel. The approved post-mining land use is rangeland. The mine site was surrounded by the following land uses: rural residential, agricultural, and rangeland. A mine sign was observed as required by Rule 3.1.12.

**Photo 1:** Mine sign posted at mine entrance

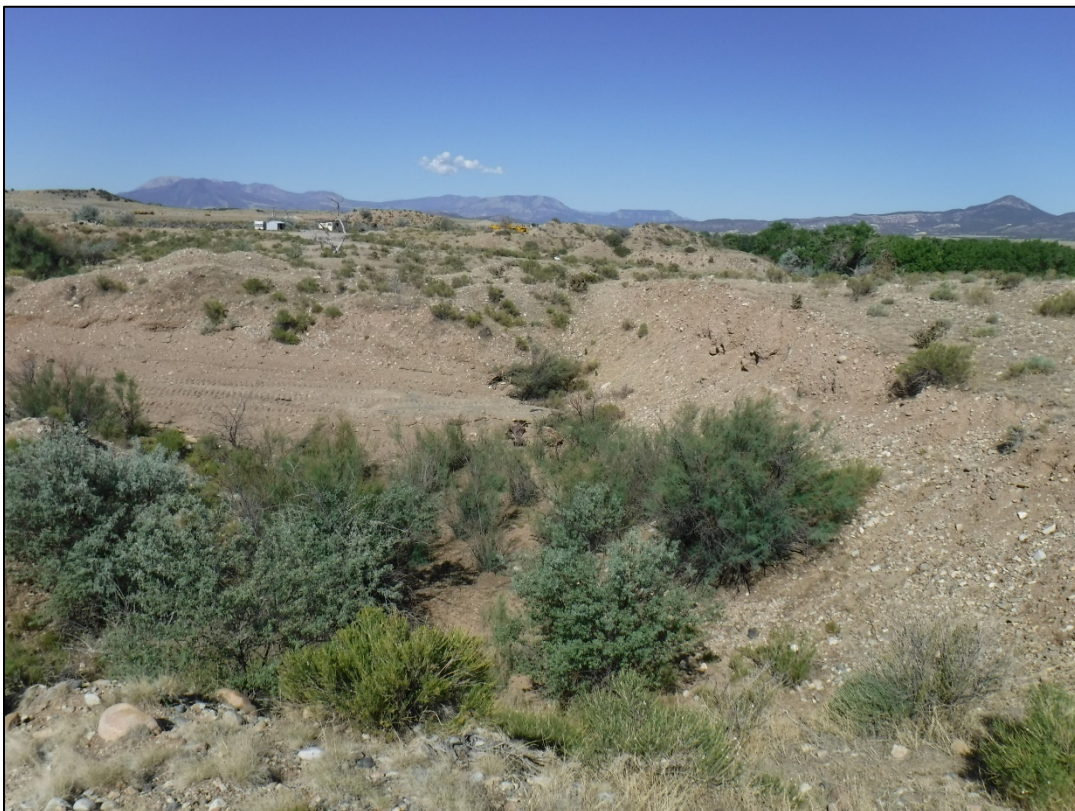
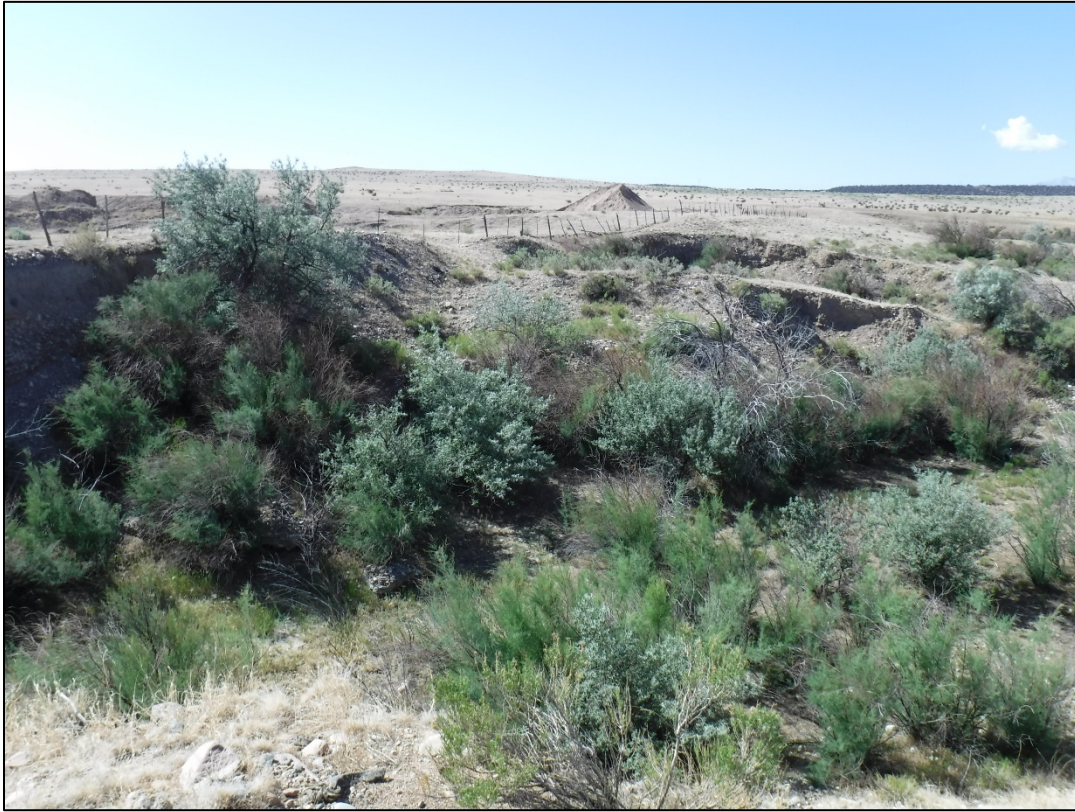
**PROBLEM:** Tamarisk (salt cedar) and Russian Olive trees are present within or have volunteered into the permit area and are becoming established. This is a problem for failure to employ weed control methods for a state listed noxious weed species within the permitted area, and to reduce the spread of weeds to nearby areas as required by Section 3.1.10 (6) of the rule.

The site was not active at the time of the inspection. It was noted that it appears that the land owner has been using various areas of the permit area to store materials. These materials are not part of the reclamation plan and will have to be removed prior to bond release. Activity has not progressed very much beyond the last inspection and the annual reports state that the material was last removed from the site in 2009. The Operator is strongly encouraged to either resume mining operations or enter into final reclamation. During the inspection it was observed that Tamarisk and Russian-olive trees were common throughout the permit area. These trees are a list B noxious weeds, fact sheets for Tamarisk and Russian-olive has been included with this report. The number trees at the site is being cited as a problem within this report and will have to be mitigated.

**Photo 2:** Tamarisk and Russian-olive trees in historic mining feature

**Photo 3:** Tamarisk and Russian-olive trees in historic mining feature

**CORRECTIVE ACTIONS:** The operator shall either implement the existing weed control plan, or develop a weed control and management plan in accordance with Section 3.1.10 (6) of the Rule. This plan should be developed in consultation with the county extension agency, or weed control district office and should include specific control measures to be applied, a schedule for when control measures will be applied and a post-treatment monitoring plan. This weed control plan shall be submitted to the Division as a Technical Revision to the approved plan with the appropriate Technical Revision fee of \$216.00 by the corrective action date.

**CORRECTIVE ACTION DUE DATE:** 8/31/20

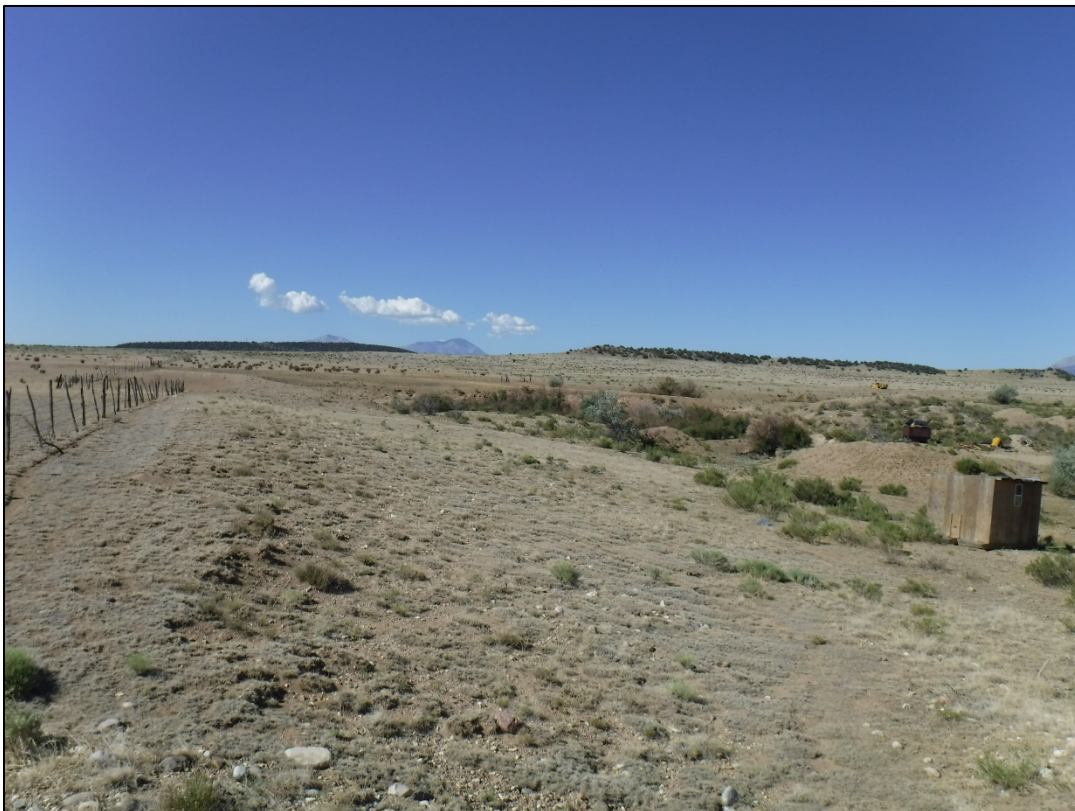
**Photo 4:** Mining area last disturbed in ~2009

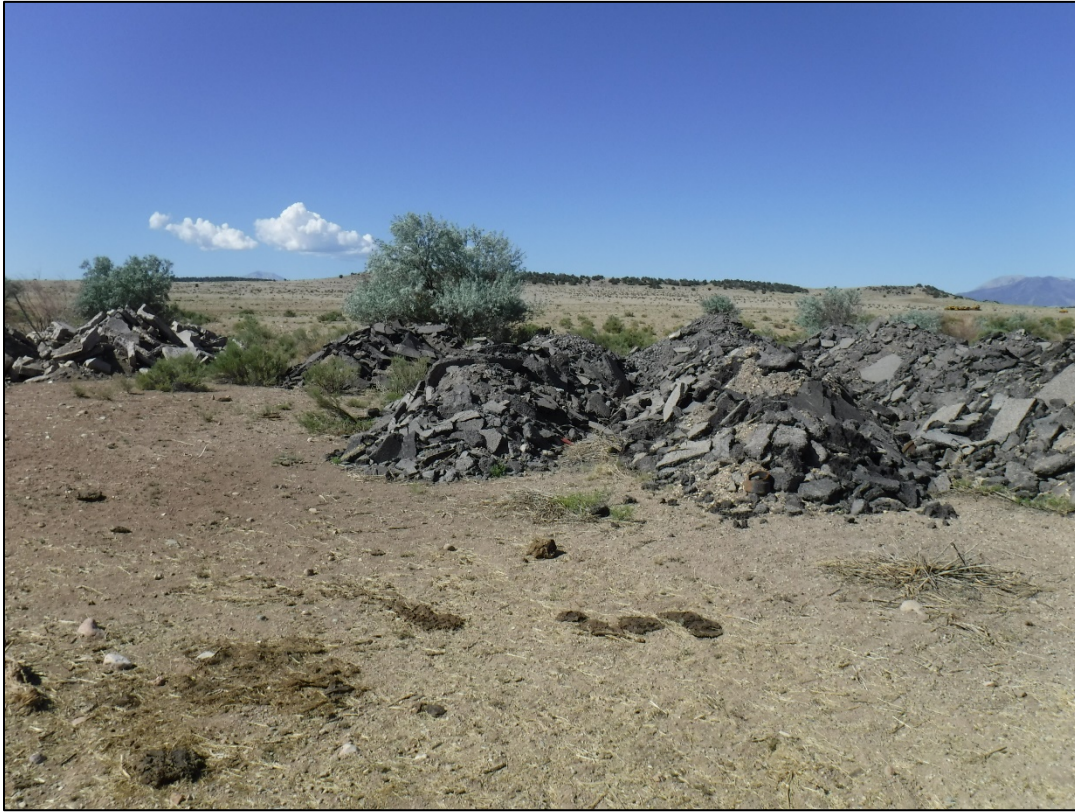
It appears that asphalt and concrete debris has been stored at the site. The Division was unable to find within the approved permit that inert fill was allowed to be used as backfill material. The Operator will have to file a technical revision to allow the material to be used as backfill or the debris will have to be removed from the site. On the western side of Phase 1 where there is a reject stockpile of material, volume estimated to be 9,500 to 10,000 cubic yards, from the previous permits it appears that the landowner is removing this material. According to the approved reclamation plan this material was to be used for filling the central depression area at the request of the landowner. It appears that there is approximately 20 acres of disturbance that needs to be reclaimed at this time. There are 7.75 acres in the eastern area encompassing the pre-law mining disturbances, 9.1 acres of the central depressed area that needs re-contouring, and 3 acres

**Photo 5:** Concrete and asphaltic debris at the site

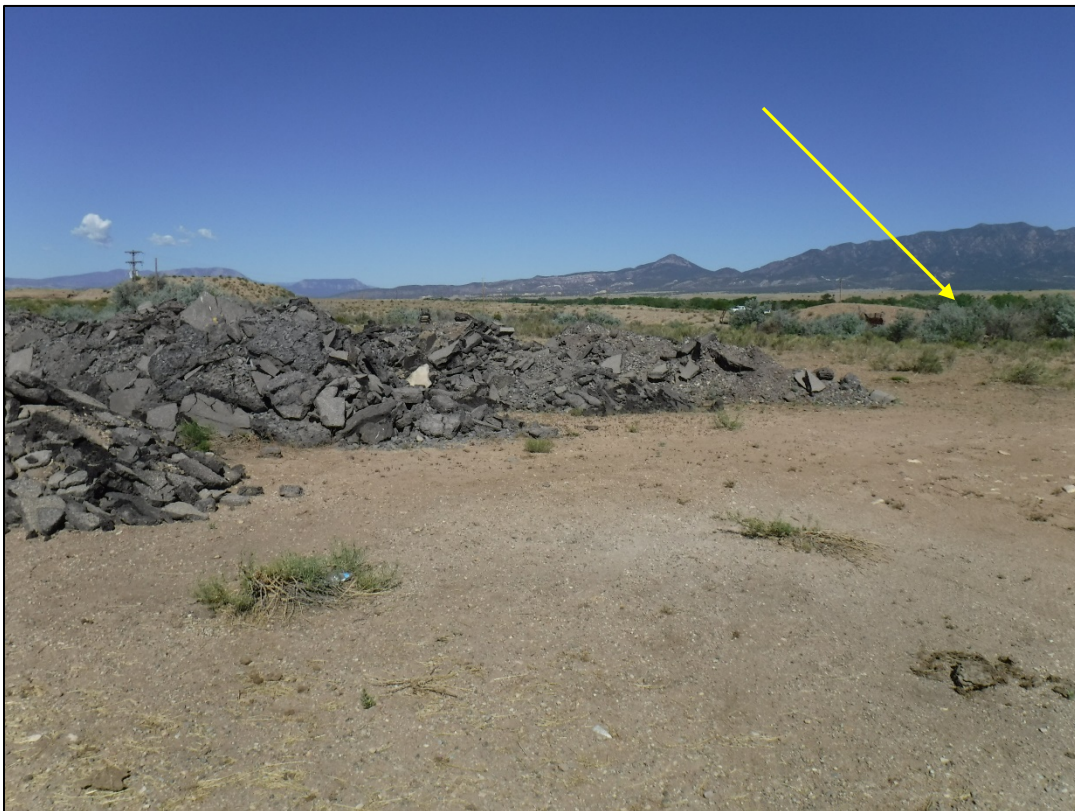
near the reject stockpile. All roads onsite are approved to remain after mining. Outside of these disturbance areas the permit area appears to be in stable with diverse vegetation becoming established.

**Photo 6:** Asphalt debris in the foreground and the depressed area requiring re-contouring yellow arrow
