**MINERALS PROGRAM INSPECTION REPORT**  
**PHONE: (303) 866-3567**

<b>MINE NAME:</b> Glacier Rock	<b>MINE/PROSPECTING ID#:</b> M-1994-096	<b>MINERAL:</b> Gravel	<b>COUNTY:</b> Larimer
<b>INSPECTION TYPE:</b> Monitoring	<b>INSPECTOR(S):</b> Amy Eschberger	<b>INSP. DATE:</b> July 10, 2020	<b>INSP. TIME:</b> 10:00
<b>OPERATOR:</b> Glacier Rock Company	<b>OPERATOR REPRESENTATIVE:</b> Roger Hageman	<b>TYPE OF OPERATION:</b> 112c - Construction Regular Operation

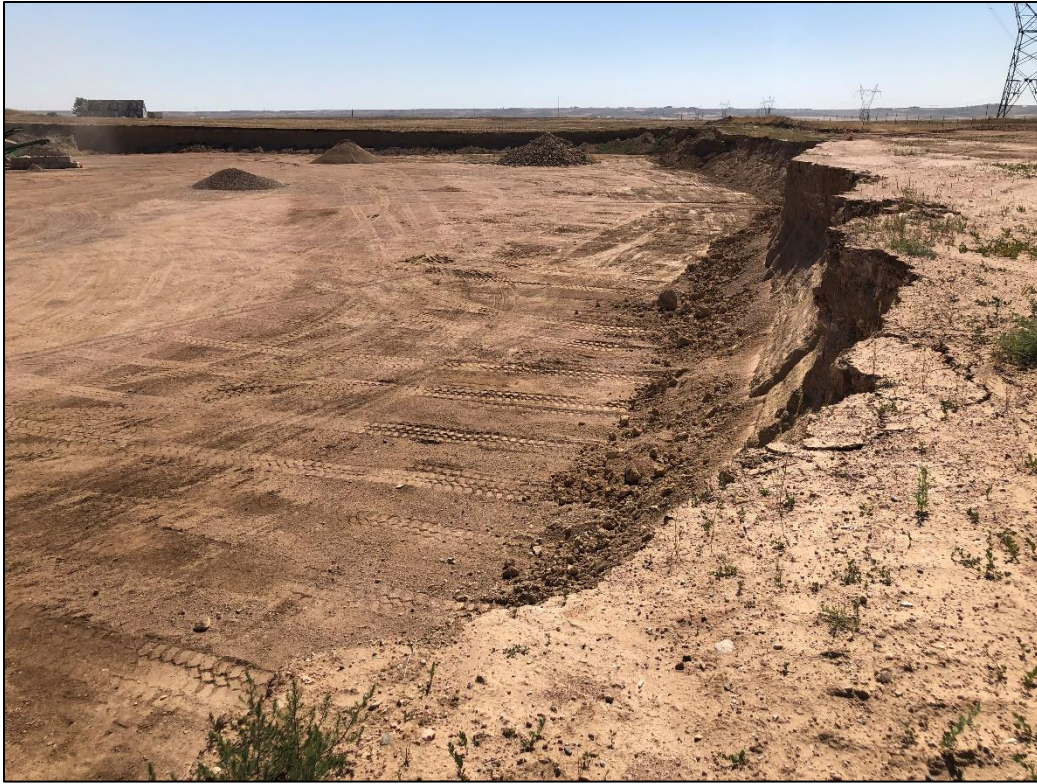
**Photo 1.** View looking east across southeastern pit wall approximately 15-18 feet in height with near vertical slopes.

**CORRECTIVE ACTIONS:** By the corrective action date, the operator shall submit a Technical Revision, with the required \$216 revision fee, to update and clarify the current approved mining plan to reflect existing and proposed activities. Specifically, the revision shall propose an increase in the maximum allowed disturbance at any time from 10 acres to at least the current disturbance amount (estimated to be approximately 12.35 acres).

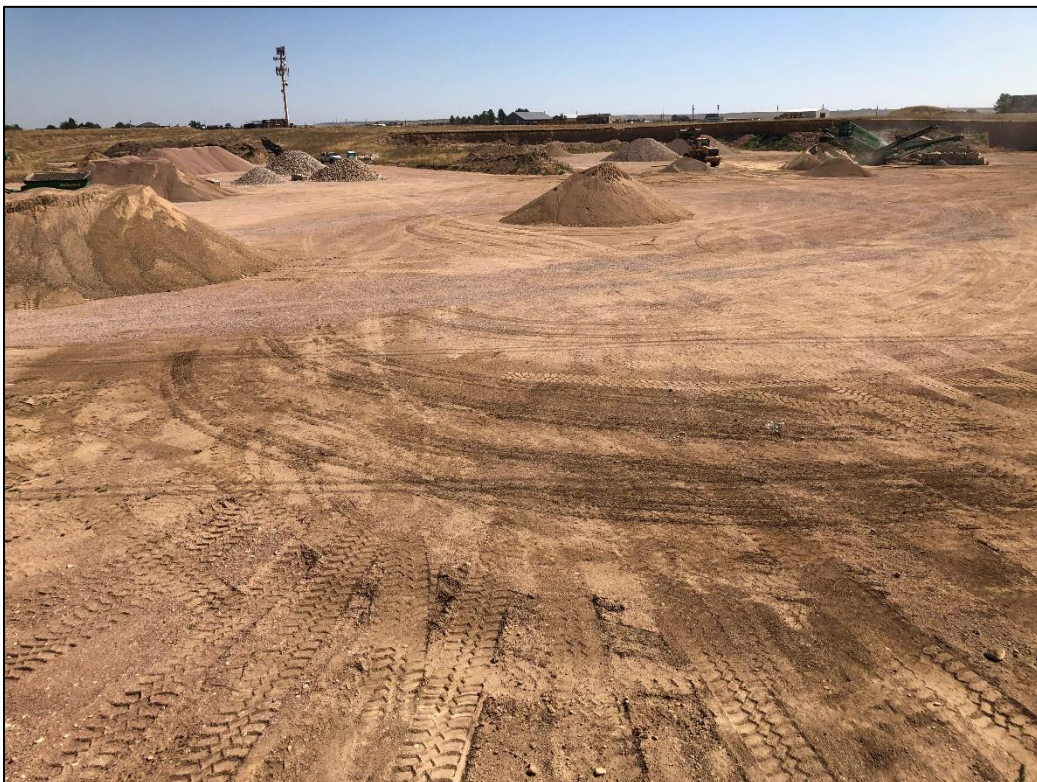
**Photo 2.** View looking northeast across pit from its southern edge. Note several material stockpiles and portable processing equipment stored on pit floor (in background).

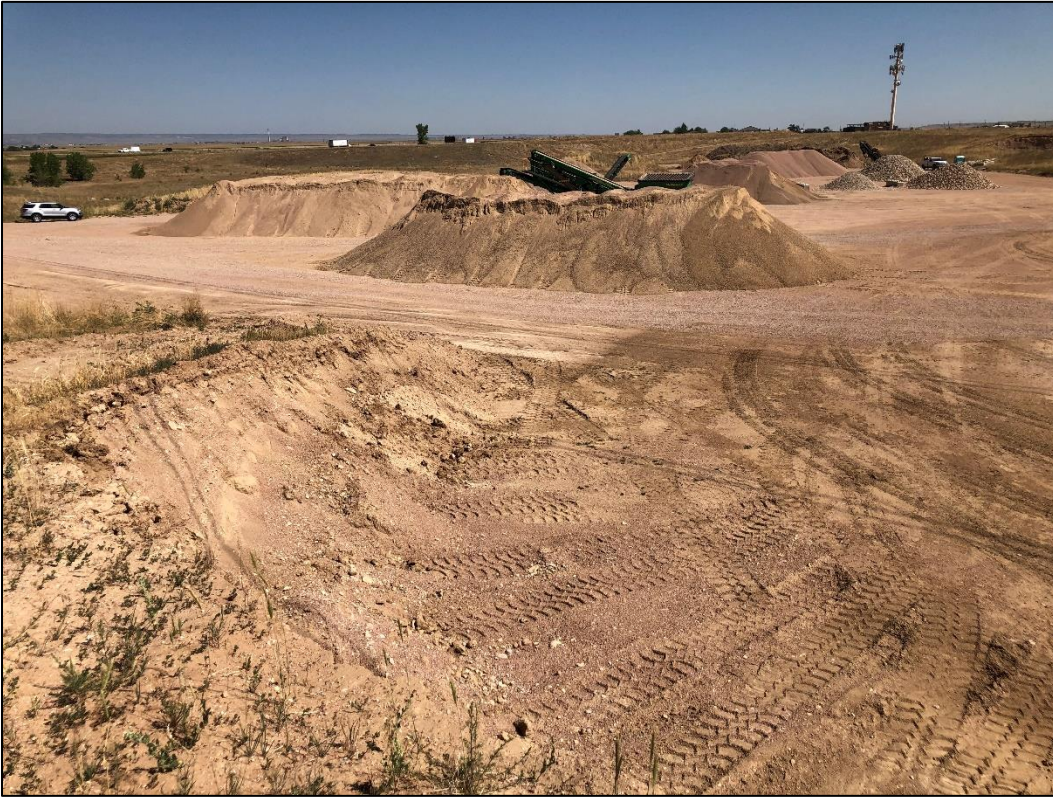
**Photo 3.** View looking north across pit from its southern edge. Note several material stockpiles and processing equipment stored on pit floor (in background).

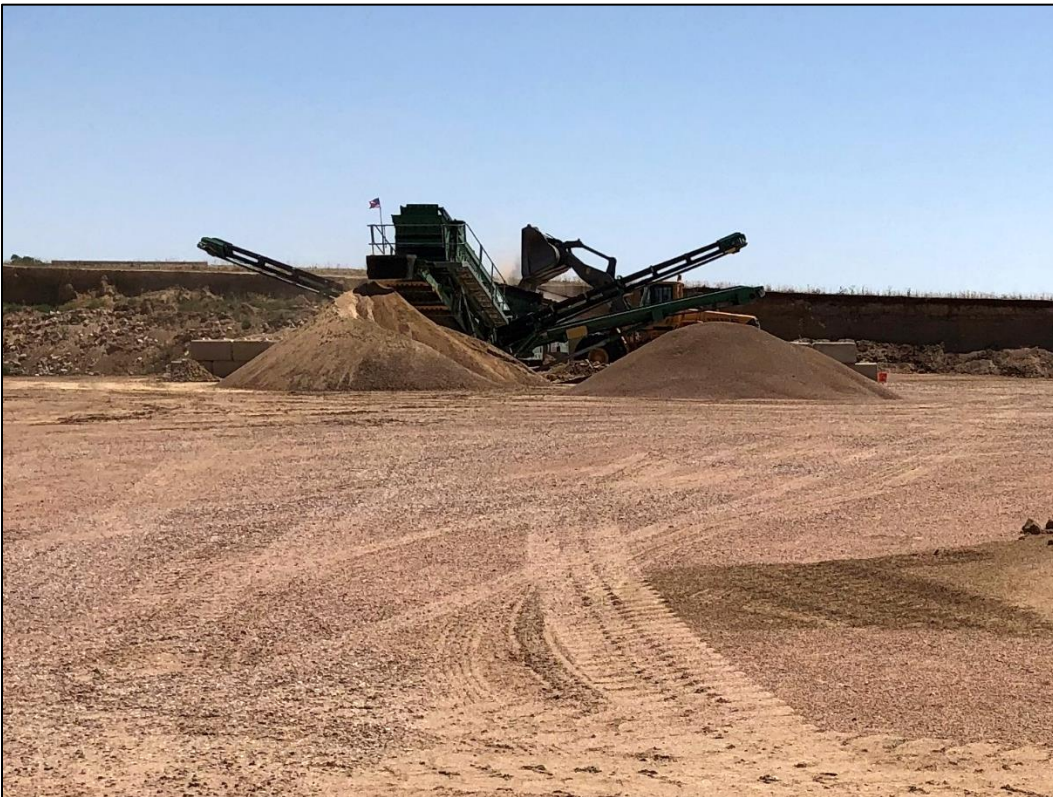
**Photo 4.** View looking east across central portion of pit, showing portable processing plant active on pit floor during inspection.

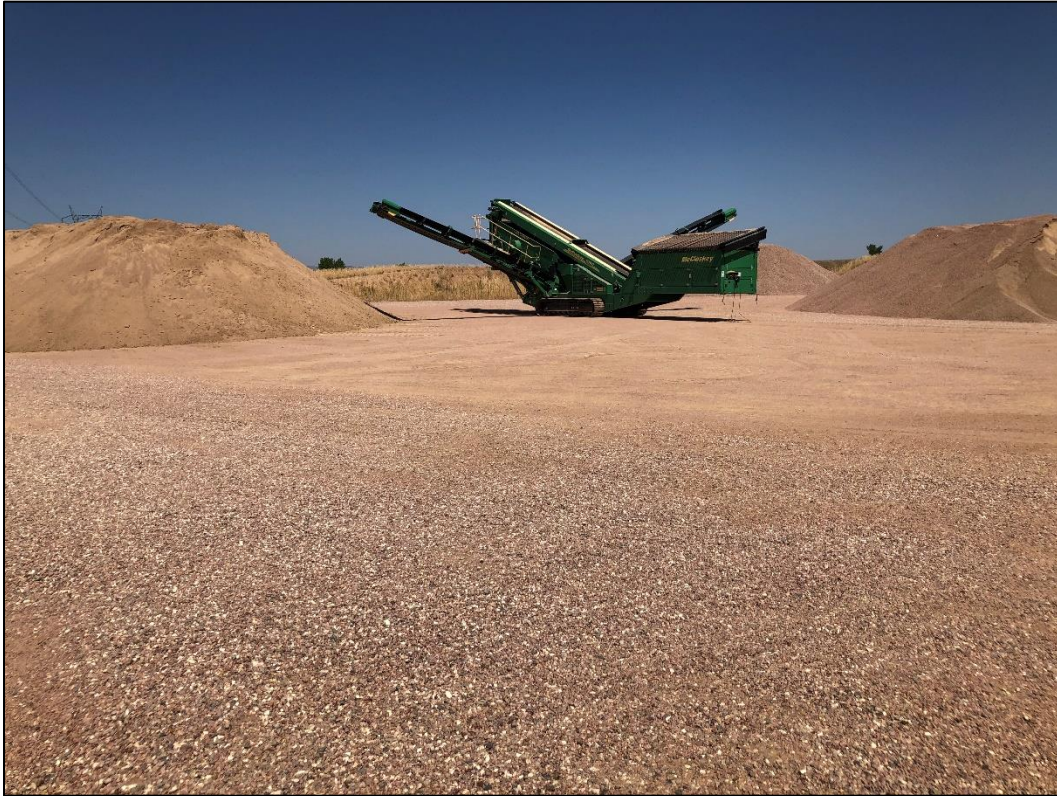
**Photo 5.** View looking west across southwestern portion of pit, showing material stockpiles and processing equipment stored on pit floor.

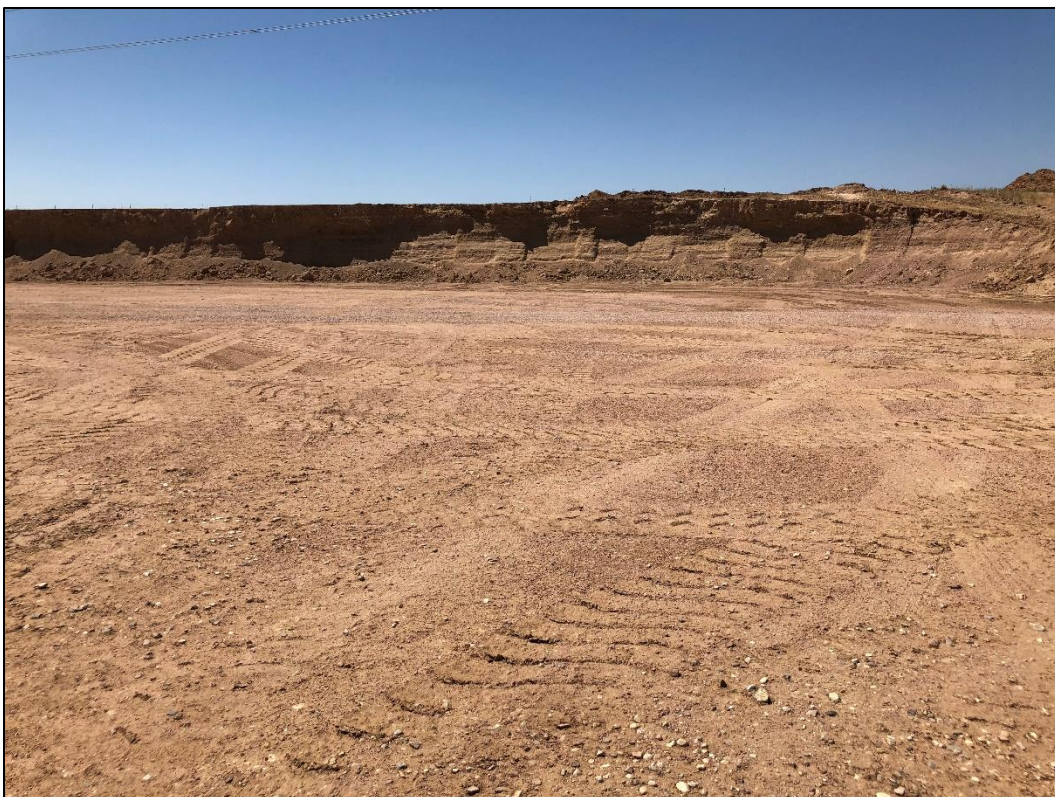
**Photo 6.** View looking south at southeastern pit wall approximately 15-18 feet in height with near vertical slopes.

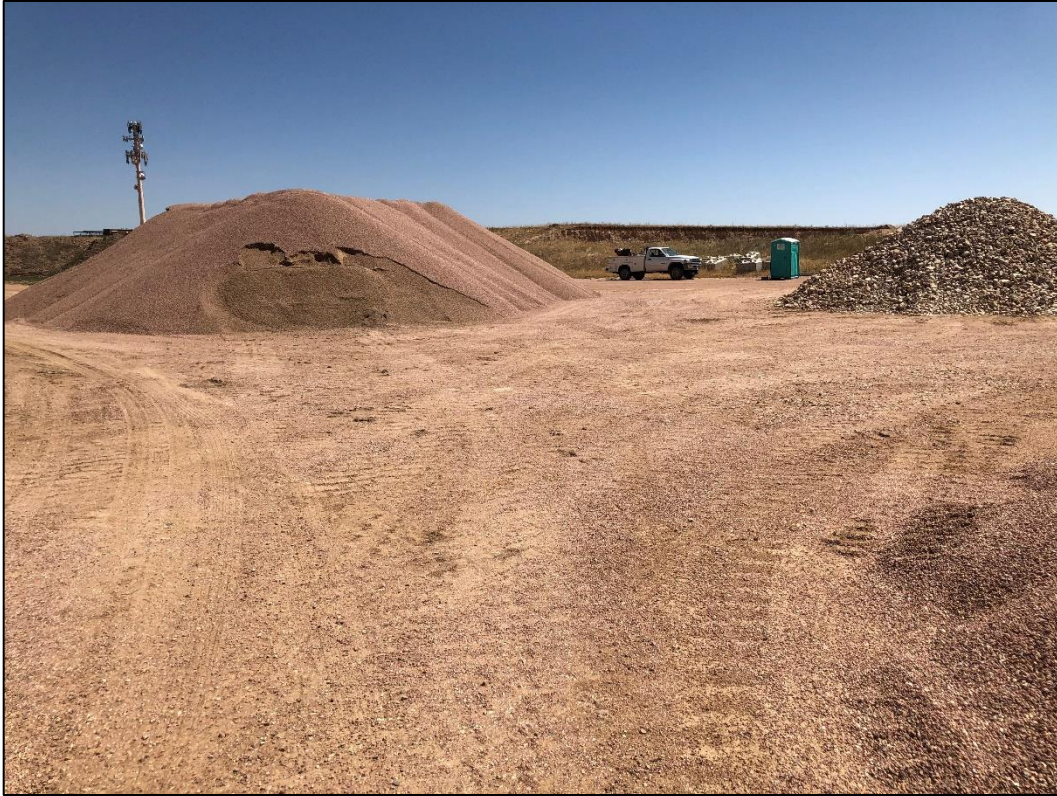
**Photo 7.** View looking east across northeastern portion of pit, showing material stockpiles stored on pit floor.

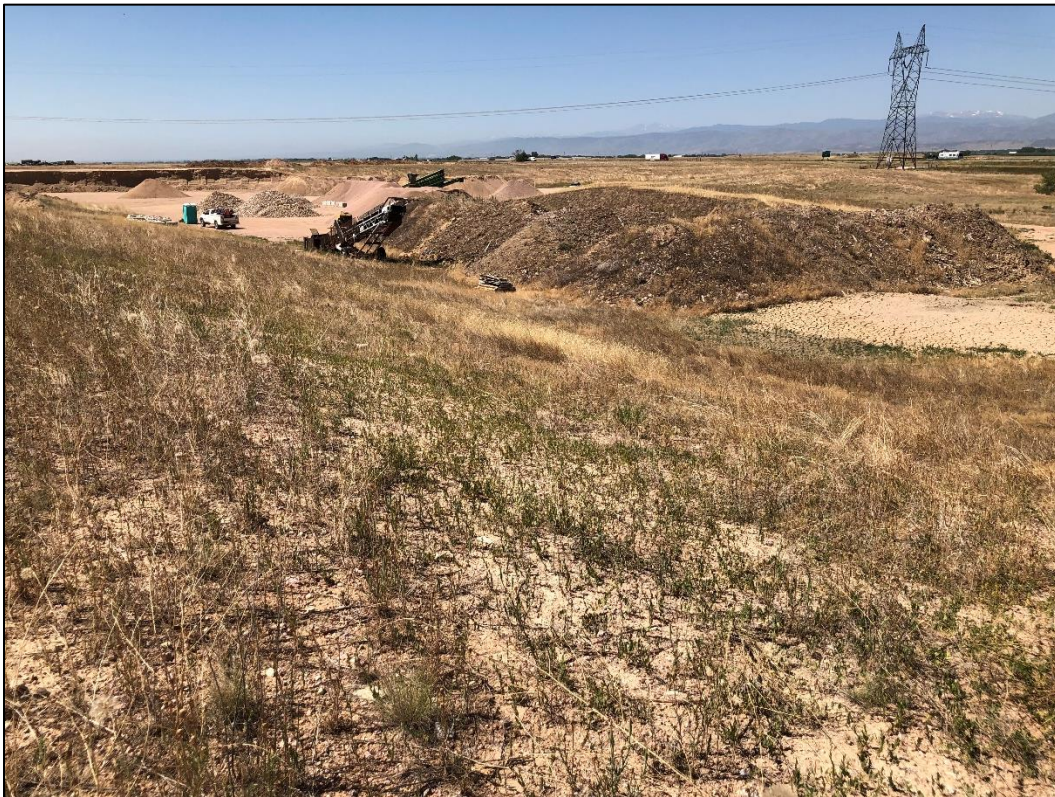
**Photo 8.** View looking southeast across northern portion of pit, showing material stockpiles stored on pit floor.

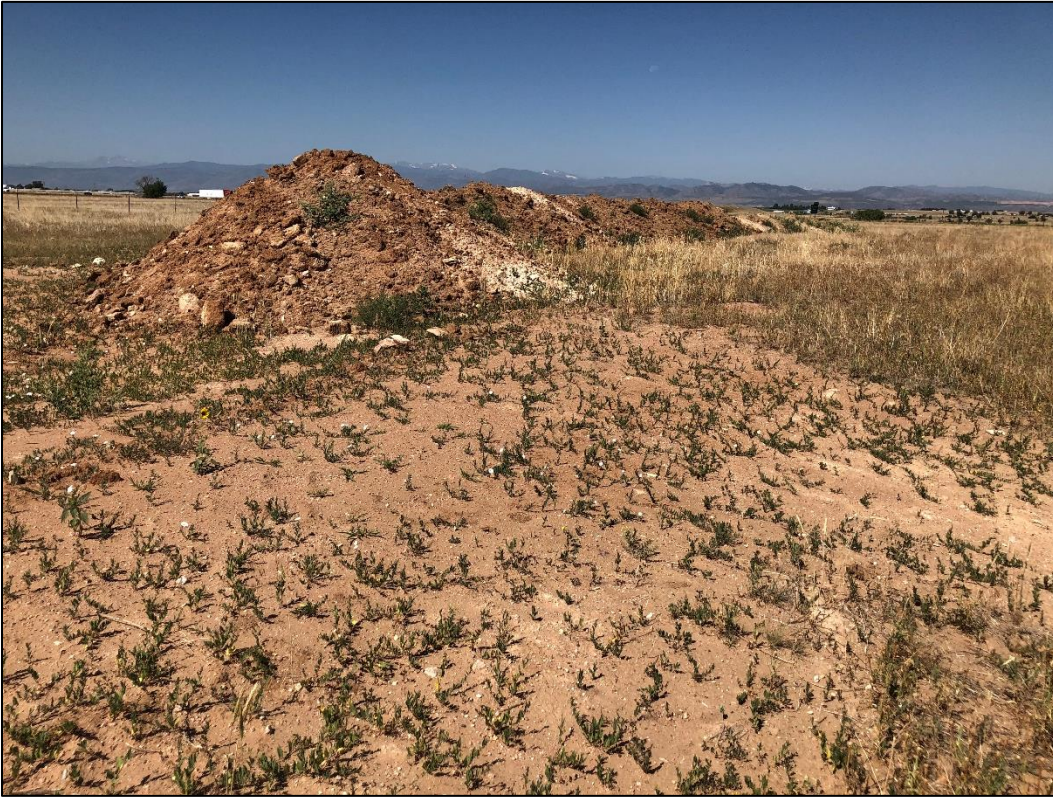
**Photo 9.** View looking west at topsoil stockpile stored along top of reclaimed southwestern pit wall.

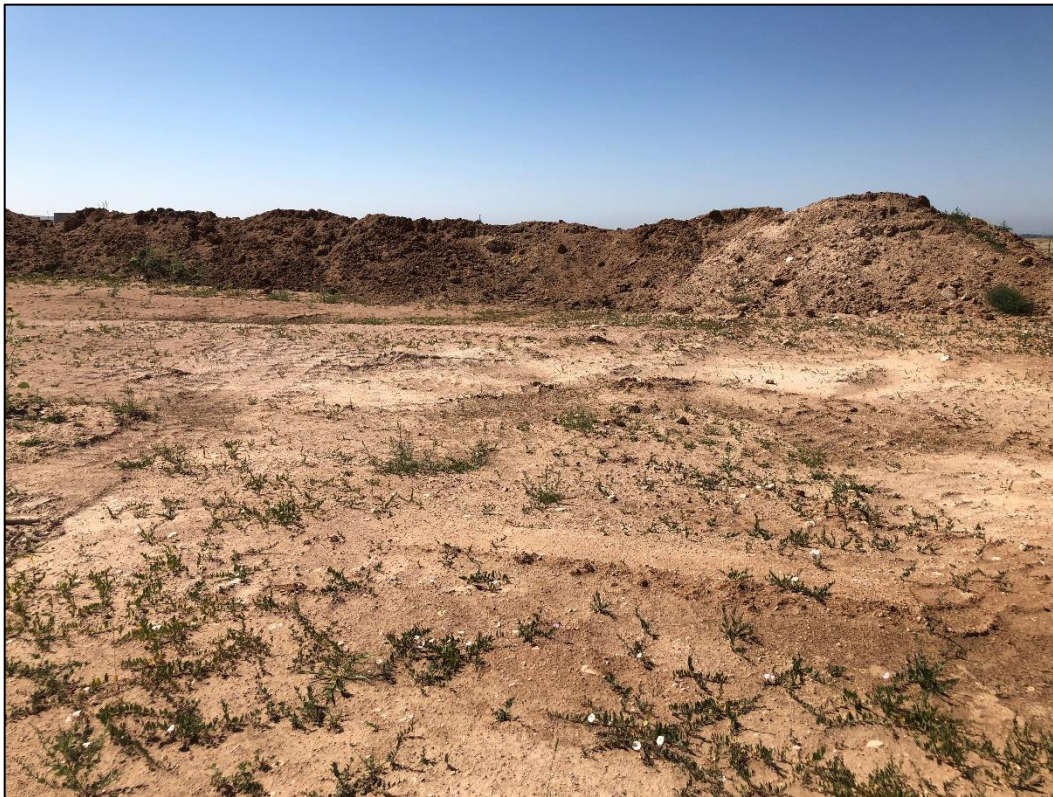
**Photo 10.** View looking southeast at topsoil stockpile stored along top of southeastern pit wall.

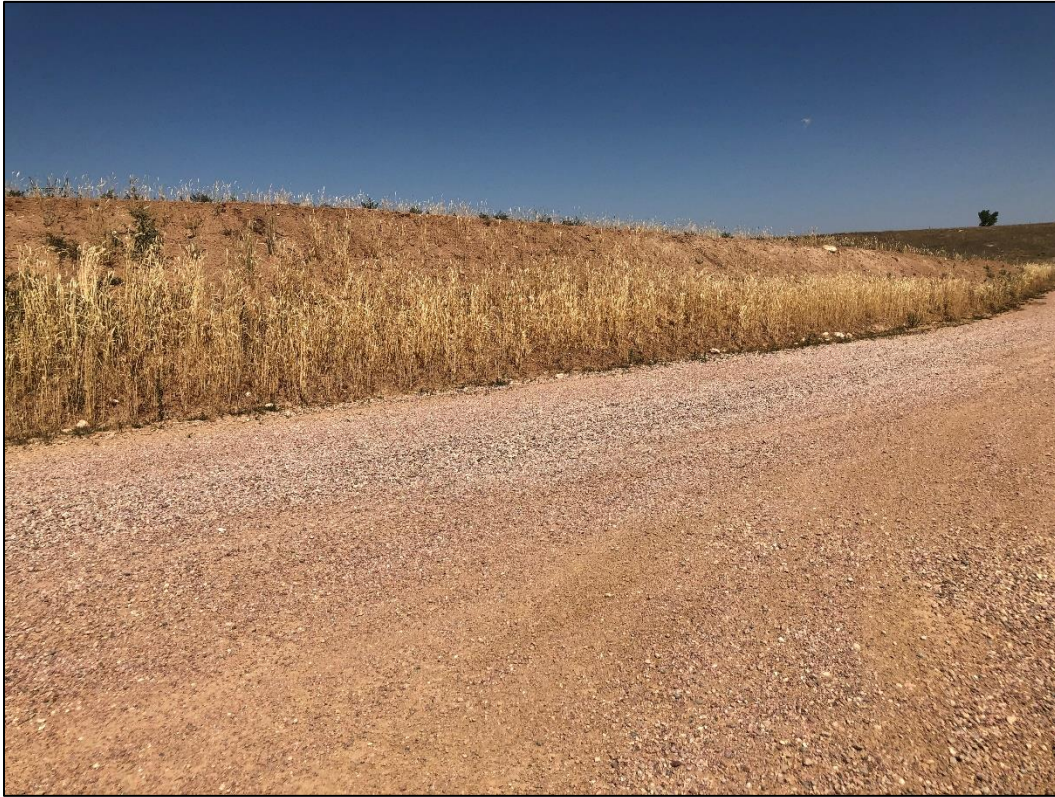
**Photo 11.** View looking northwest at topsoil stockpile stored on pit floor at western edge of pit.

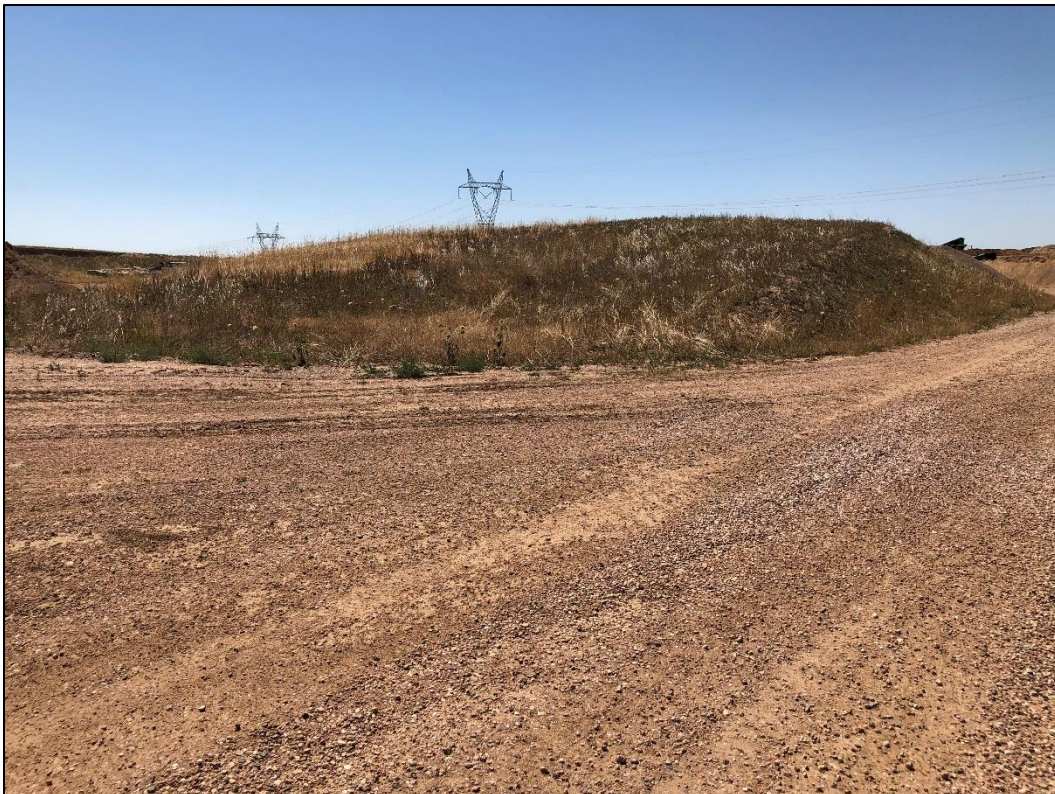
**Photo 12.** View looking southeast at topsoil stockpile stored on pit floor at northwestern edge of pit.

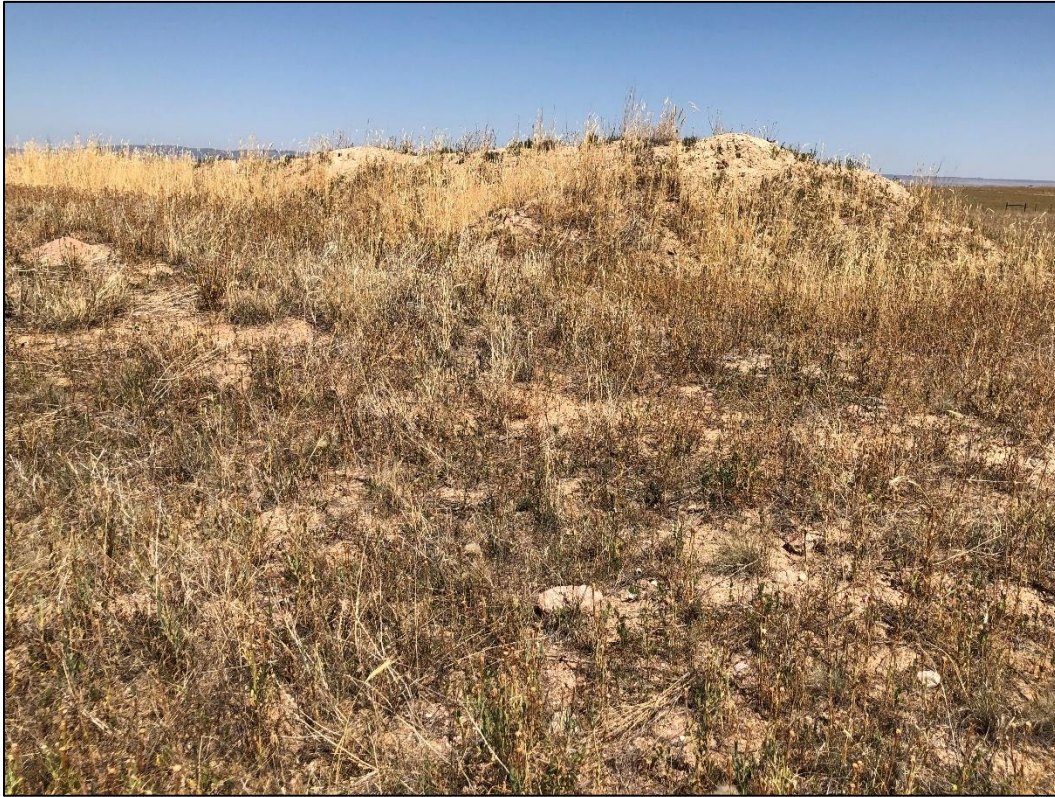
**Photo 13.** View looking northwest at topsoil stockpile stored along top of reclaimed northern pit wall.

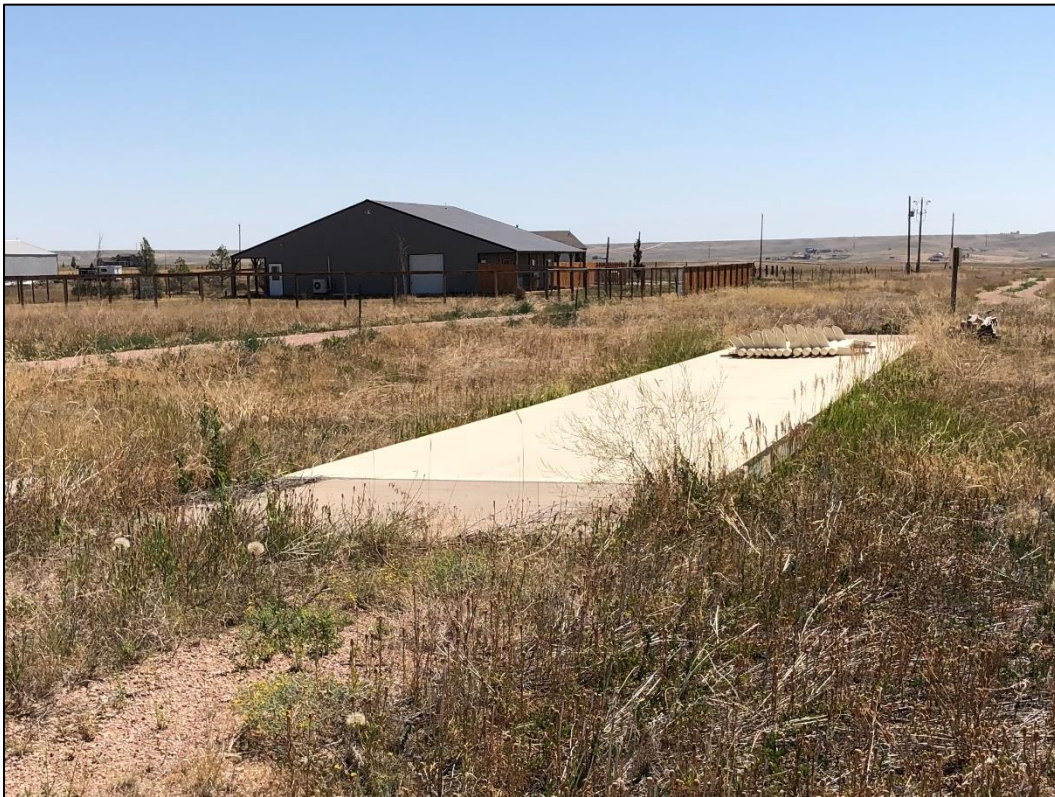
**Photo 14.** View looking northeast at portable above-ground truck scale present on old haul road at northern edge of permit area.

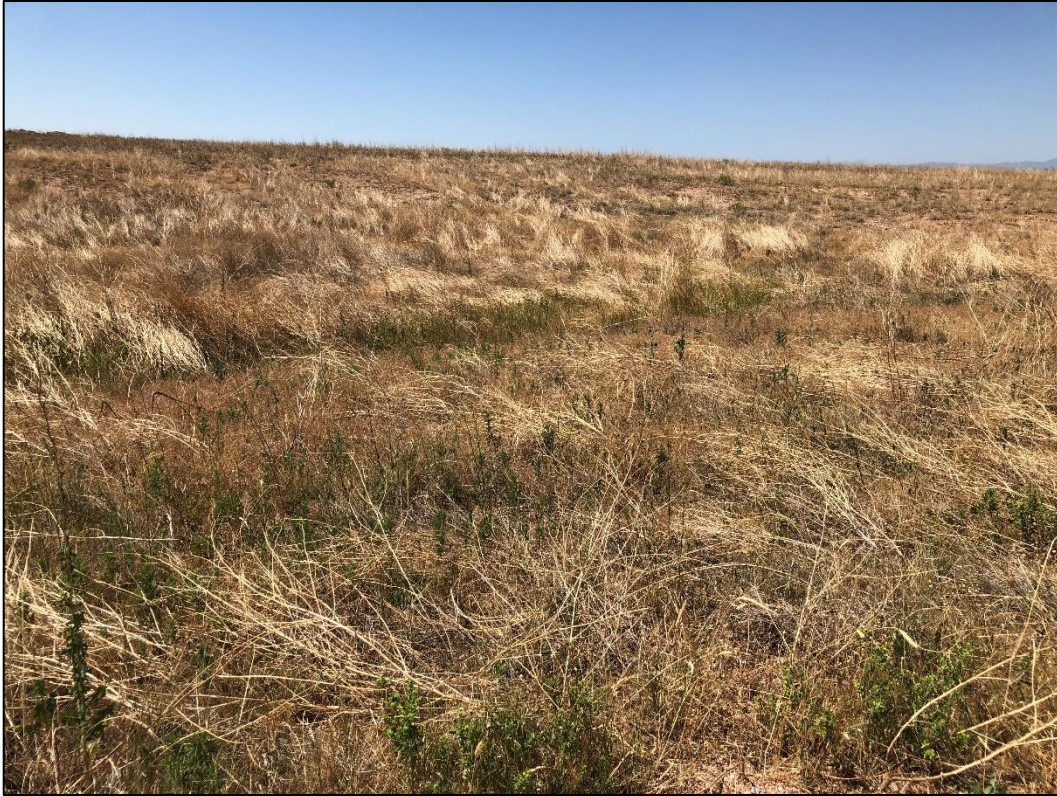
**Photo 15.** View looking southwest across reclaimed southwestern portion of pit with slopes of 3H:1V or flatter and established grass cover.

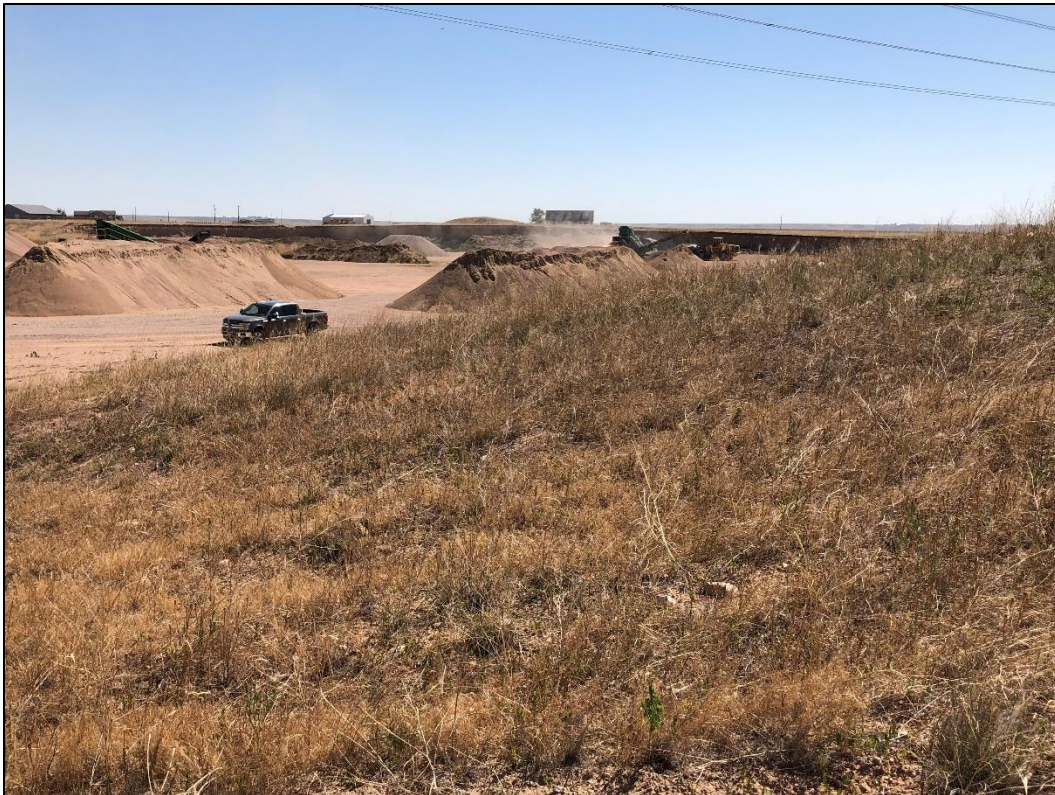
**Photo 16.** View looking east across reclaimed southwestern pit wall with slopes of 3H:1V or flatter and established grass cover.

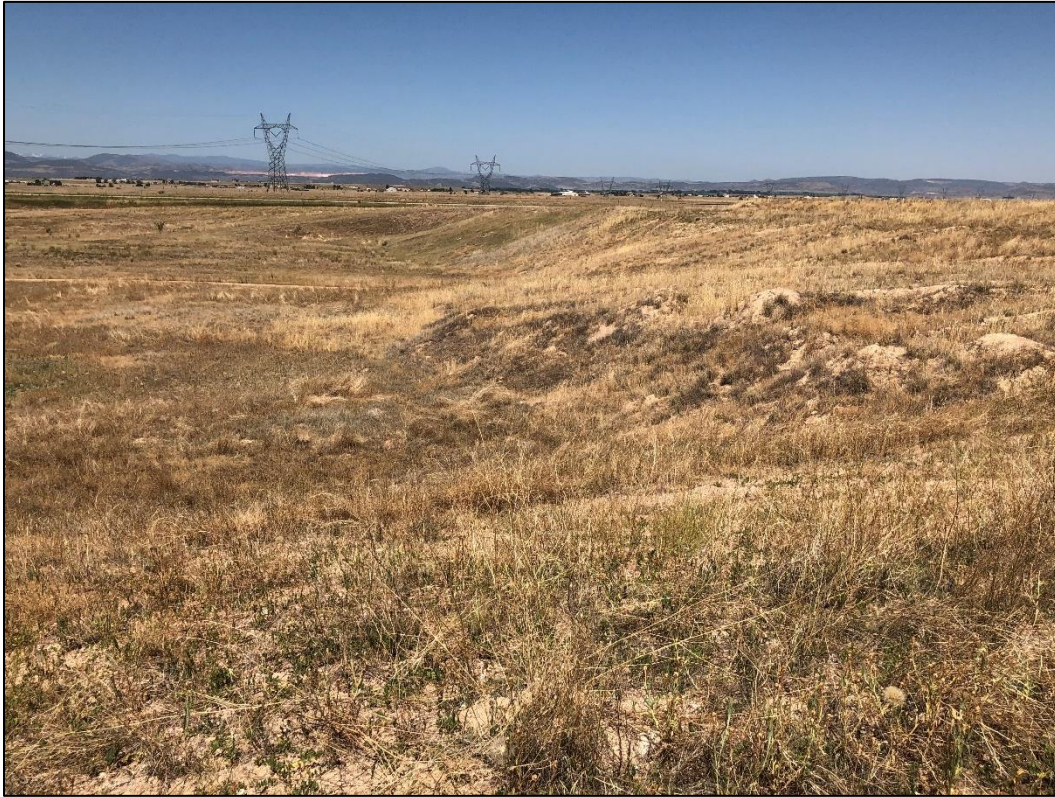
**Photo 17.** View looking west across reclaimed northern portion of pit with slopes of 3H:1V or flatter and established grass cover.

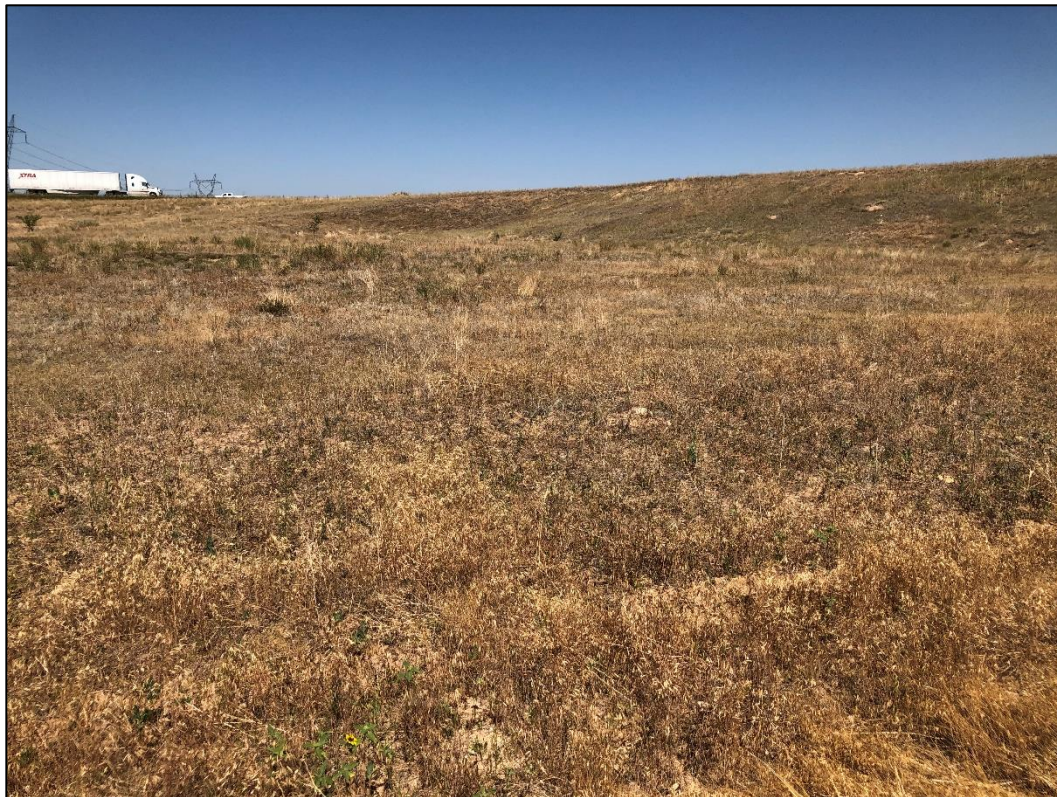
**Photo 18.** View looking northwest across reclaimed northwestern portion of pit with slopes of 3H:1V or flatter and established grass cover.

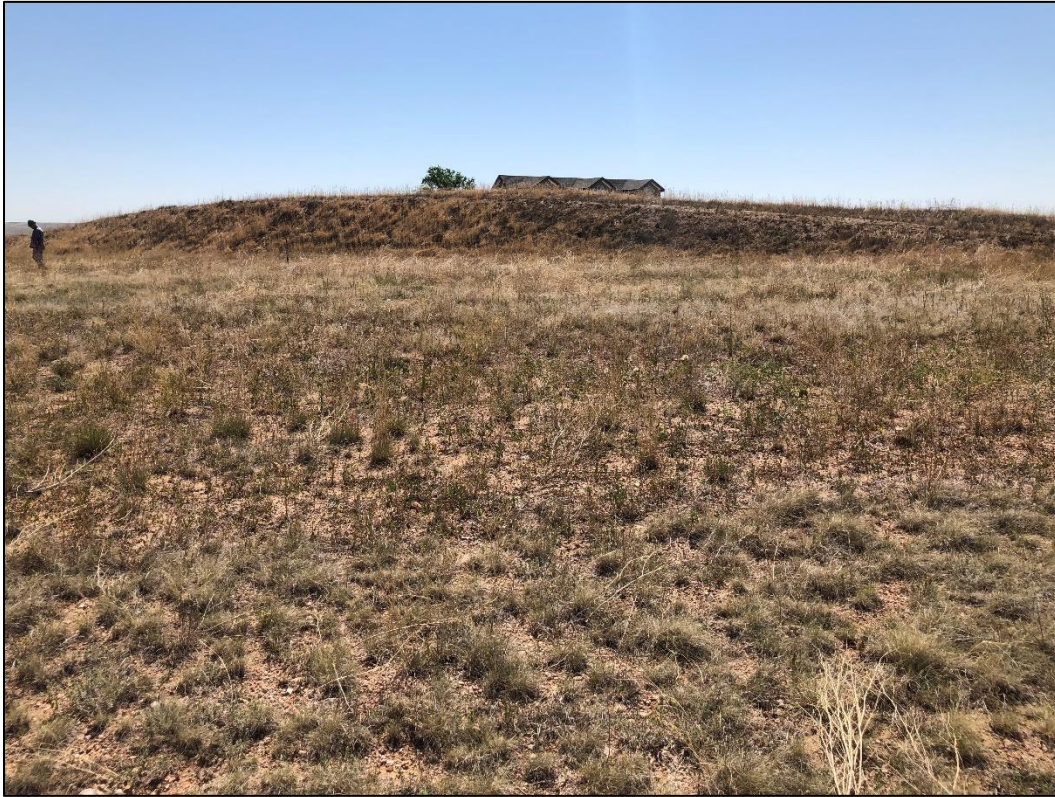
**Photo 19.** View looking southeast at large topsoil stockpile stored at eastern edge of site. Areas north of this stockpile which were disturbed by previous stockpiling activities are reclaimed with established grass cover.

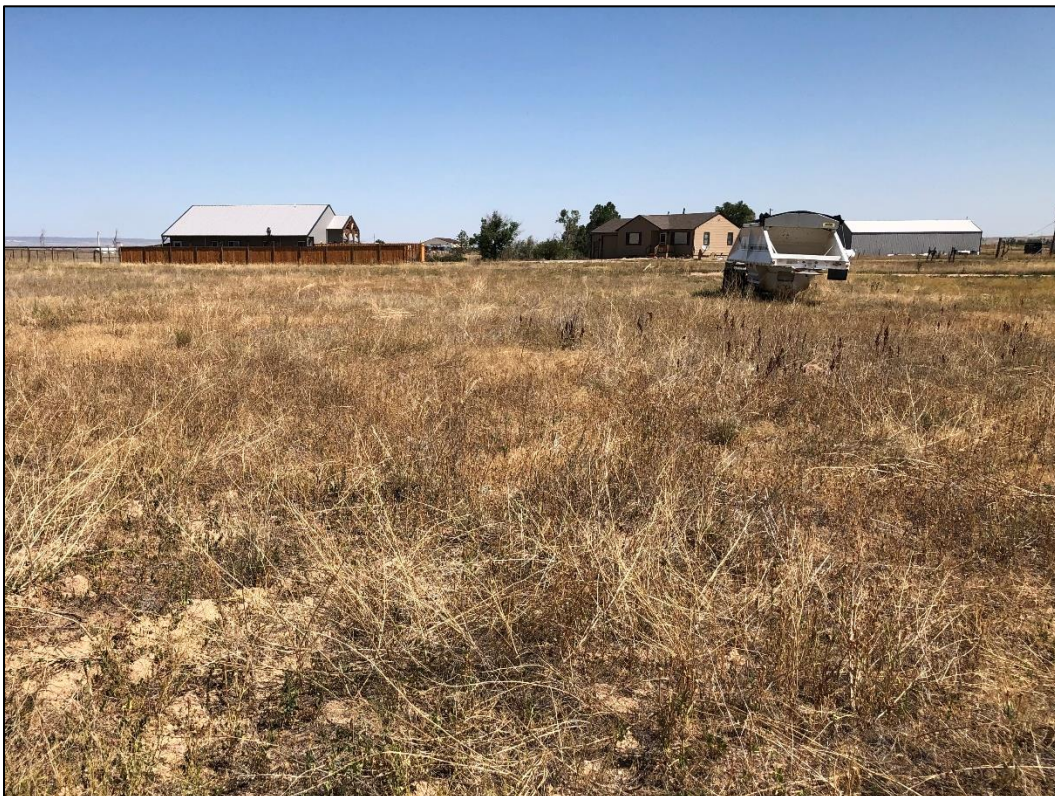
**Photo 20.** View looking north at area north of large topsoil stockpile stored at eastern edge of site. This area was disturbed by previous stockpiling activities and is now reclaimed with established grass cover.

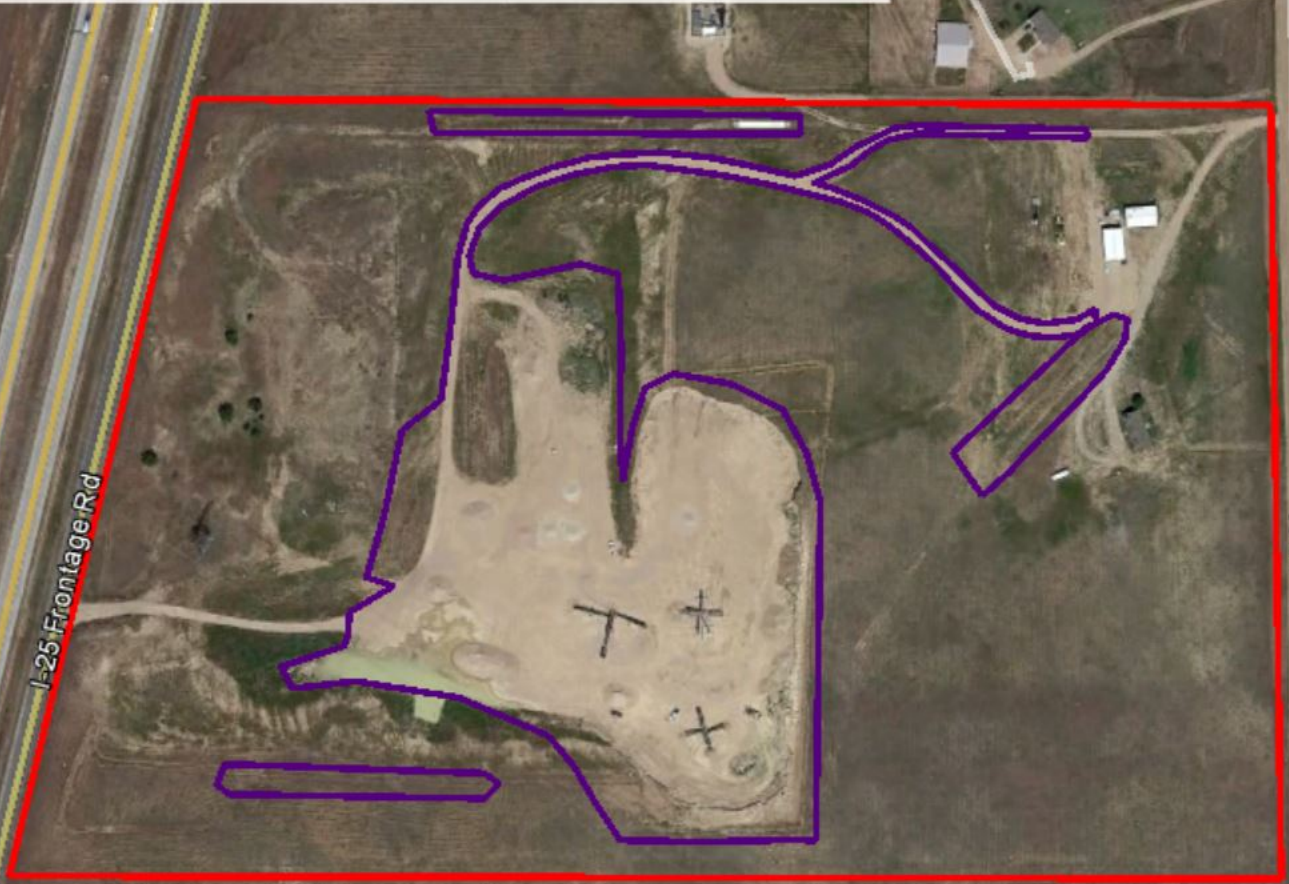
**M-1994-096 / Glacier Rock / Glacier Rock Company (112c)**

Red outline = 49 acres = Approved permit area (location approximated based on approved maps)  
Purple outline = 12.35 acres = Disturbed area requiring reclamation (based on 7/10/20 inspection)  
(Image data from 7/17/2019)
