July 9, 2020  
Project#01349-0001

Subject: Summary of Instrumentation Monitoring  
2<sup>nd</sup> Quarter 2020  
Bowie Coal Waste Disposal Area No. 2  
Paonia, Colorado

**SUBJECT: Summary Report, 2<sup>nd</sup> Quarter 2020, Inclinator and Active Vibrating Wire Piezometer Data April – June 2020, Bowie Mine #2 Coal Waste Disposal Area (CWDA) #2**

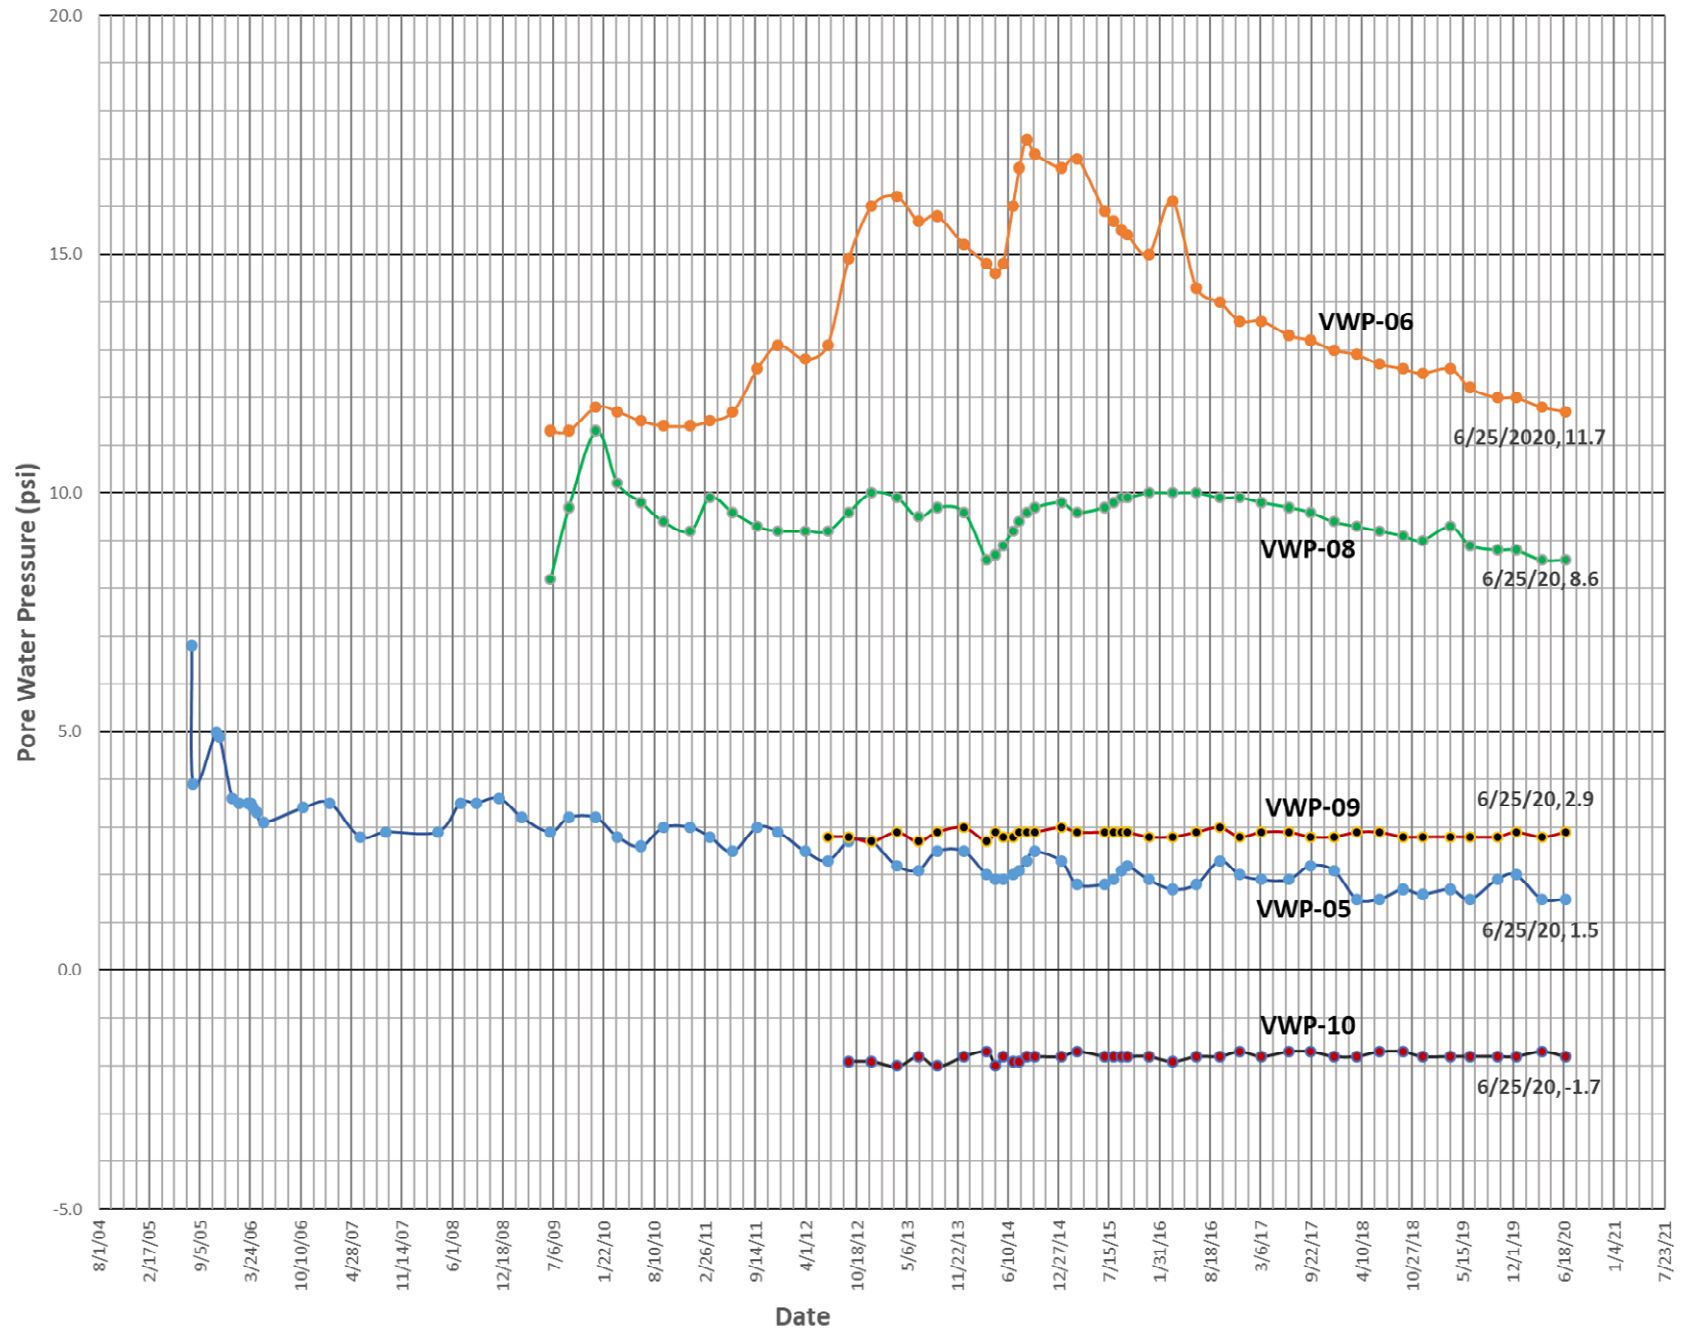
**Figure 2 - Bowie Mine #2 - CWDA #2**  
**Active Vibrating Wire Piezometer Data**

As seen on Figure 2, the VWP readings and trends are consistent with recent and historic readings. Pore pressure readings varied very little (by 0 to  $\pm 0.1$  psi) since the first quarter readings. When compared with a year ago (Q2 2019), pore pressures varied from 0 to 0.1 psi for three of the piezometers and by -0.5 psi for VWP-06 and by -0.3 psi for VWP-08. Since installation, four of the piezometers experienced 0.4 psi or less, while VWP-05 had a pore pressure that decreased by 5.3 psi.

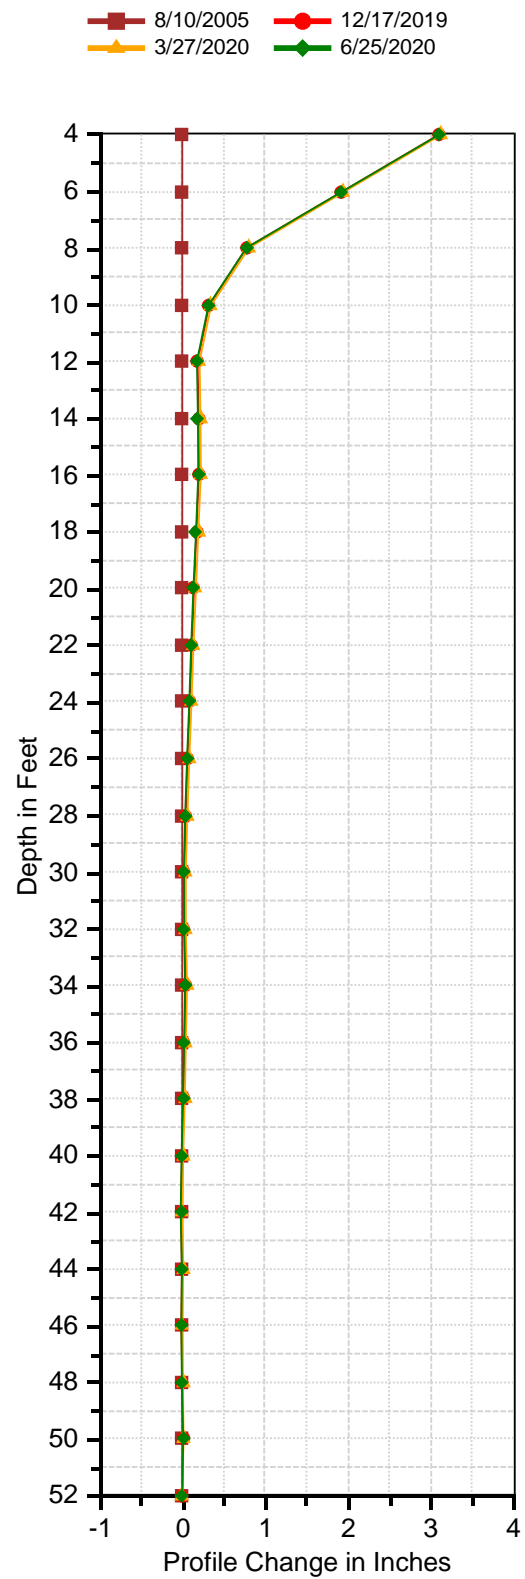
BOWIE BG05\_4 A

As described in previous reports, historic displacements indicated on the plots for the approximate upper ten feet of the inclinometers since installation in 2005 are due to placement of cover soil on the face of the waste pile during revegetation operations in late 2006/early 2007. This man-caused displacement is documented in a report by Buckhorn Geotech dated September 22, 2008 to Bowie Resources called *Revised Stability Evaluations for Coal Mine Waste Disposal Area No. 2, Bowie No. 2 Mine*.

Based on the current inclinometer readings, there hasn't been downslope movement (Axis A) in any of the inclinometers since 2007 and they are generally consistent with previous readings. As we mentioned in our October 2019 (Q3) report, there appeared to have been some displacement in the orthogonal direction (Axis B) for inclinometer BG05-5B in the 3<sup>rd</sup> quarter of 2019. However, in June 2020 (Q2) the displacement graph appeared to be very similar to the March 2020 (Q1), March 2019 (Q1), June 2019 (Q2), and December 2019 (Q4) readings. Based on the three consistent readings listed above, we conclude that the displacement calculated in October 2019 (Q3) reading was due to a recording error near 42 feet and should be disregarded. We will continue to track this to confirm whether there is additional movement.

It should be noted that water was standing in the BGI05-04 inclinometer pipe at a depth of about 1 foot below grade (while it was at 5 feet during our Q1 site visit). Based on our observations there has always been water in the pipe. We measured water around 10 feet in inclinometer BGI05-07 during our June Q2 2020 readings and there was no water in the BGI05-05 pipe.
