MINERALS PROGRAM INSPECTION REPORT

MINE NAME: Revenue Mine 2015 NOI	MINE/PROSPECTING ID#: P-2015-003	MINERAL: Silver, gold, copper,	COUNTY: Ouray
INSPECTION TYPE: Surety Release Inspection	INSPECTOR(S): Lucas West	INSP. DATE: August 6, 2020	INSP. TIME: 09:53
OPERATOR: Ouray Silver Mines Inc.	OPERATOR REPRESENTATIVE: Kyle Erdmann	TYPE OF OPERATION: MP - Mineral Prospecting

This inspection was conducted in response to the Prospector's request for Final Release of the Notice of Intent to Conduct Prospecting Operations, SL-02. The Revenue Mine 2015 NOI is a Notice of Intent to Conduct Prospecting Operations located at various locations in Silver and Governor's Basins in Ouray County. All sites associated with the NOI are located on Private Patented Claims owned by Ouray Silver Mines, Inc. the sites total .1 Acres of disturbance at varying elevations. The Division currently holds \$7,826.61 in Financial Warranty for the NOI. Four Photos accompany this report to illustrate the current site conditions.

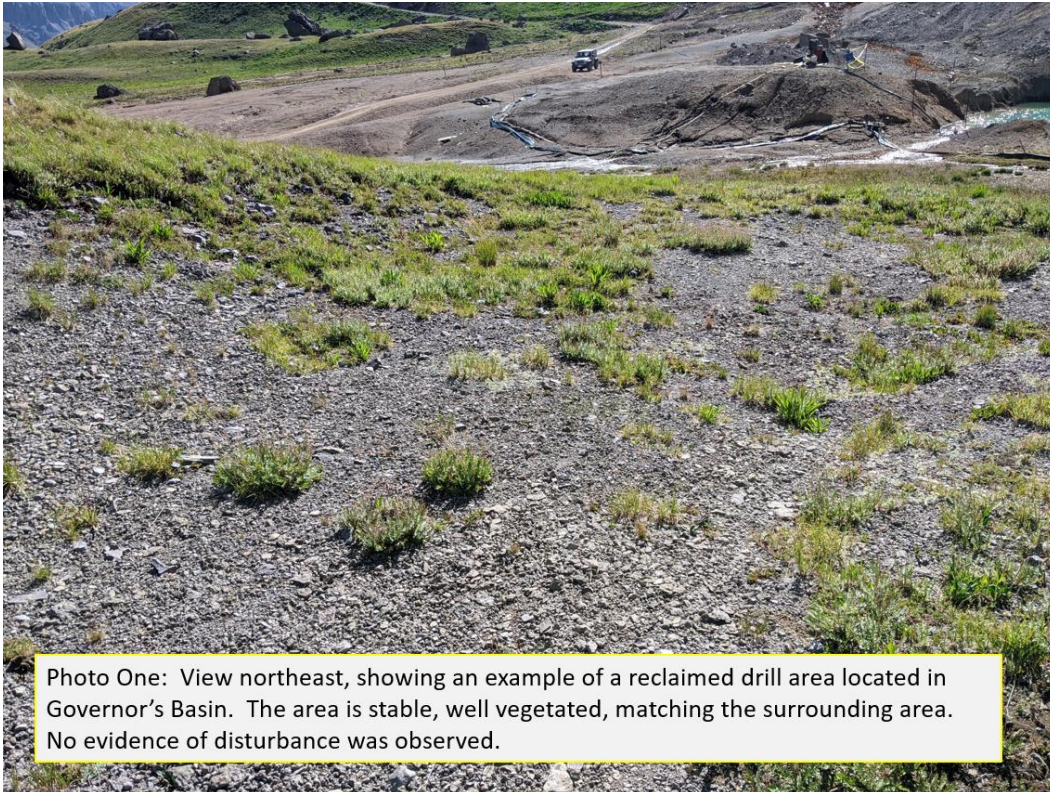
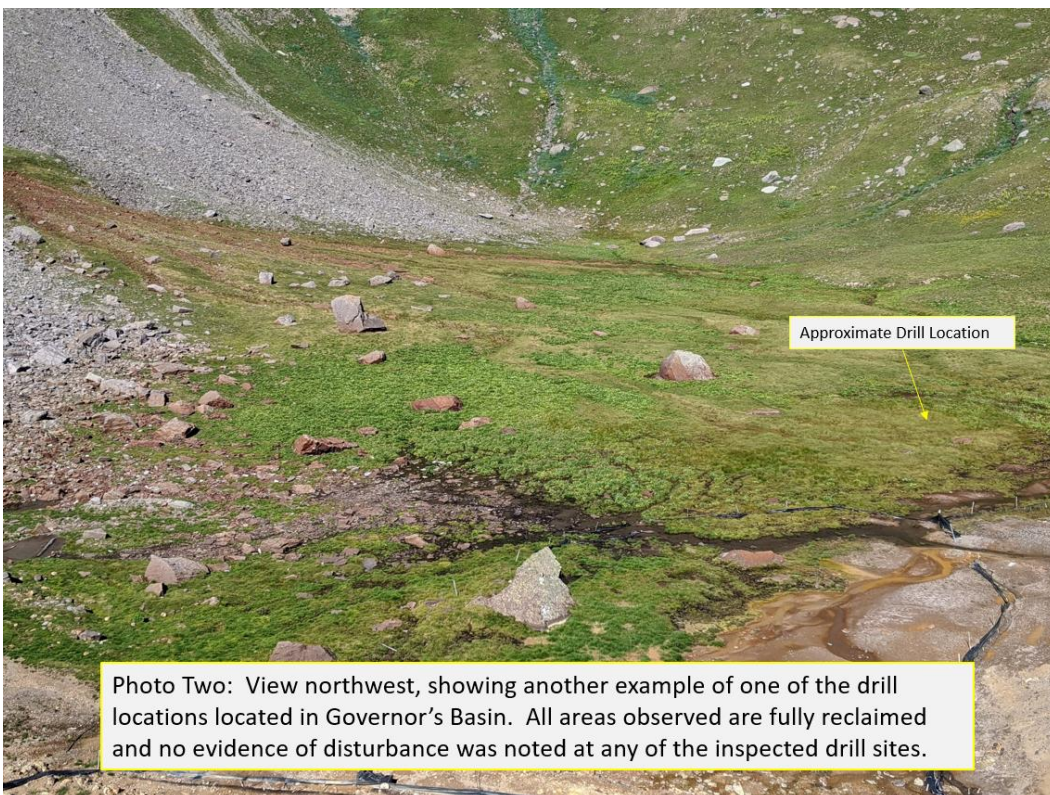
The various sites were not active at the time of the inspection. Full and final reclamation has been completed and no prospecting equipment was observed at any of the drill locations during the inspection. The drill locations range from being located near roadways, above tree line in the tundra vegetation in Governors Basin to densely wooded areas in Silver Basin. In Governor's Basin, a total of 4 drill locations were utilized with several drill holes each. All drill locations that were observed were stable at the time of the inspection. No evidence of surface disturbance or drilling was discernable. In areas where vegetative cover was applicable, the vegetation was dense, diverse and no evidence of activity was observed. Photos One and Two show a representation of the drill locations observed in Governors basin. Three drill locations are located up gradient of the Monongahela Raise Bore and Secondary Escapeway associated with the Revenue Mine Permit Number M-2012-032. These locations were not inspected at this time as they were covered by recent rock slides covering the drill locations making them inaccessible. Discussions with the Operator indicate that all drill holes were properly reclaimed prior to the rock slide events.

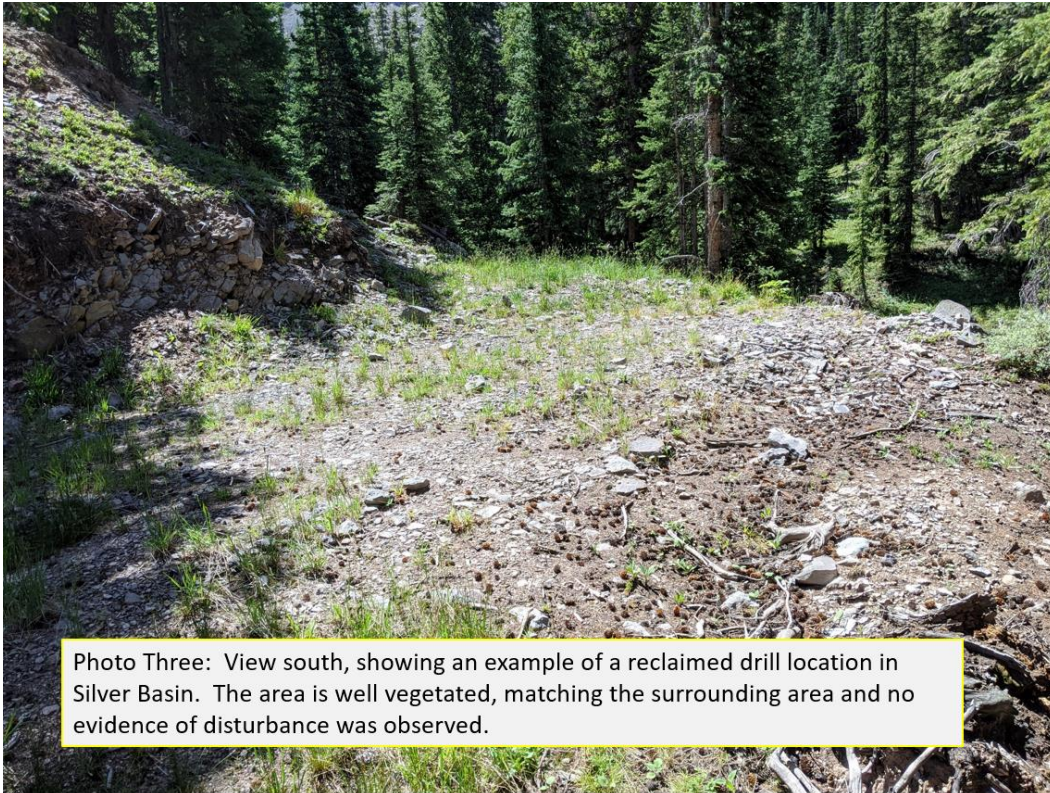
The Silver Basin sites that were observed were in a similar condition of those located in Governor's Basin. All drill locations and holes have been properly reclaimed including the drill holes being plugged and abandoned. The reclamation was conducted in a manner that no evidence of prospecting activities or drill holes was observed in the drill locations. In areas where a vegetative cover was applicable the vegetation was dense, diverse and showed signs of self-regeneration. All drill locations were stable and well vegetated at the time of the inspection. Photos Three and Four show a representation of the observed reclaimed drill areas located in Silver Basin.

Photo Three: View south, showing an example of a reclaimed drill location in Silver Basin. The area is well vegetated, matching the surrounding area and no evidence of disturbance was observed.

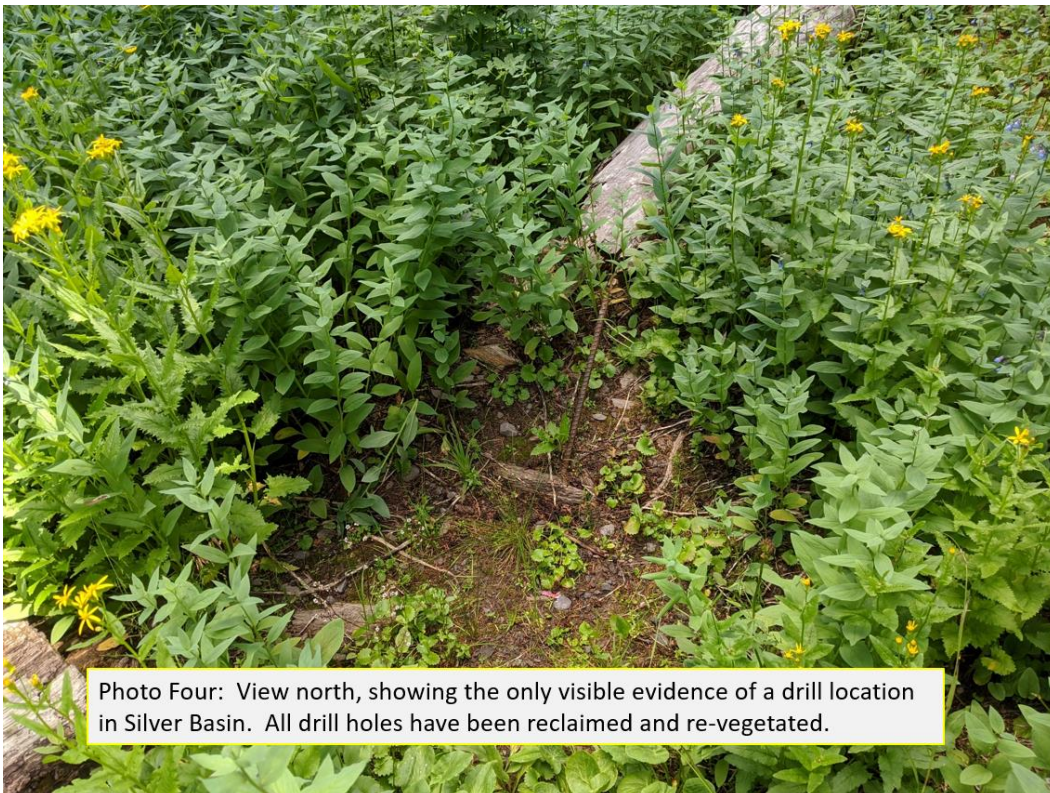
Photo Four: View north, showing the only visible evidence of a drill location in Silver Basin. All drill holes have been reclaimed and re-vegetated.
