**MINERALS PROGRAM INSPECTION REPORT**  
**PHONE: (303) 866-3567**

<b>MINE NAME:</b> Gladstone	<b>MINE/PROSPECTING ID#:</b> M-2020-030	<b>MINERAL:</b> Silver and gold	<b>COUNTY:</b> Clear Creek
<b>INSPECTION TYPE:</b> Monitoring	<b>INSPECTOR(S):</b> Peter Hays	<b>INSP. DATE:</b> August 4, 2020	<b>INSP. TIME:</b> 13:30
<b>OPERATOR:</b> Salisbury Gladstone LLC	<b>OPERATOR REPRESENTATIVE:</b> Jeff Carter	<b>TYPE OF OPERATION:</b> 110(1) - Hard Rock Limited Impact	
<b>REASON FOR INSPECTION:</b> Citizen Complaint	<b>BOND CALCULATION TYPE:</b> None	<b>BOND AMOUNT:</b> No Bond Held	
<b>DATE OF COMPLAINT:</b> NA	<b>POST INSP. CONTACTS:</b> None	<b>JOINT INSP. AGENCY:</b> None	
<b>WEATHER:</b> Clear	<b>INSPECTOR'S SIGNATURE:</b>

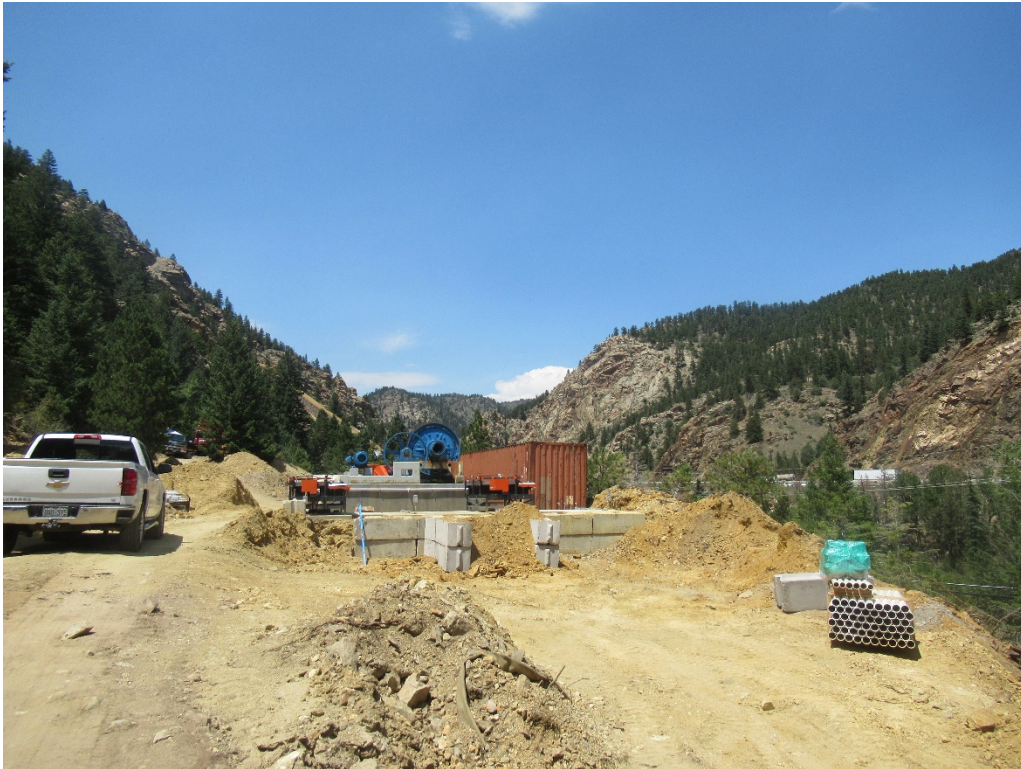
View of the ball mill construction from the east side of the facility looking west

**The Division believes a possible violation pursuant to C.R.S. 34-32-109(2) for failure to first obtain from the Board or Office a reclamation permit prior to engaging in a new operation occurred at the Gladstone site based on the inspection observations. The Division will schedule this matter for a hearing before the Colorado Mined Land Reclamation Board. The notice of possible violation and information regarding the Board hearing will be sent under separate cover.**

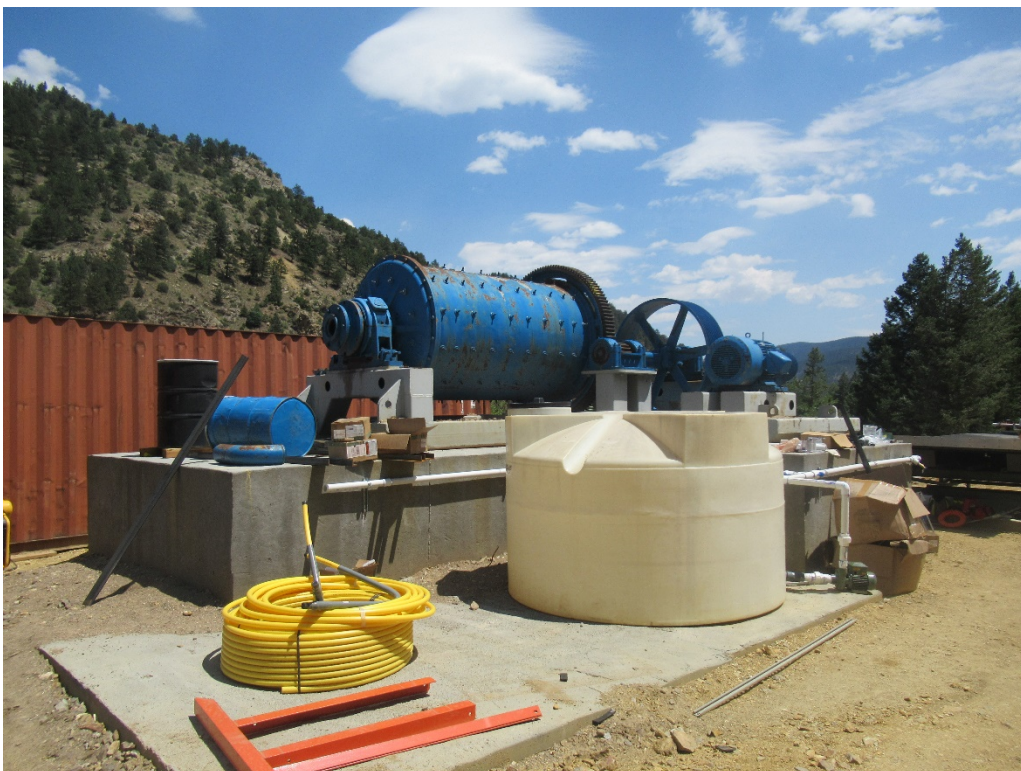
View of the ball mill construction from the southwest side of the facility looking northeast

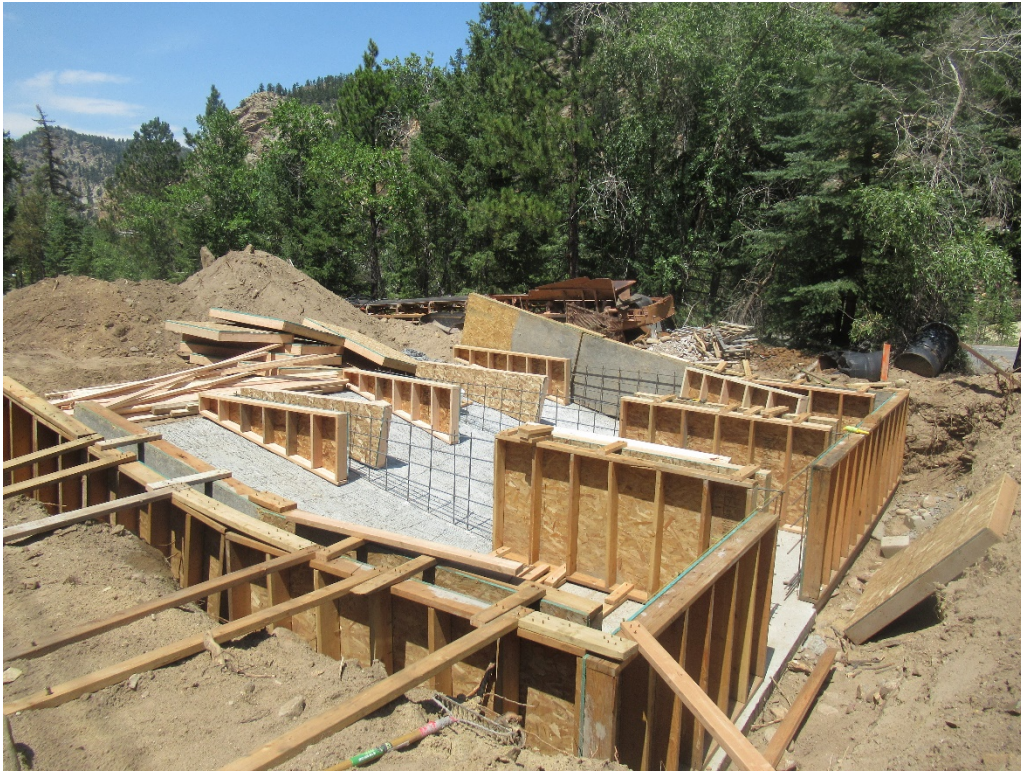
The complaint reported the Operator was pouring a foundation for a ball mill and the foundation may or may not be located on their property. Since the previous inspection, the Applicant has begun construction of the ball mill and sediment containment structure prior to the Division issuing the Reclamation Permit for the site. The mill facility and sediment containment structure appeared to be located within the propose boundary of the site based on lath with flagging indicated by the Applicant during the inspection, however the back wall of the sediment containment structure was close to the marked boundary.

View of the sediment containment structure construction from the southeast corner looking northwest
