**MINERALS PROGRAM INSPECTION REPORT**  
**PHONE: (303) 866-3567**

<b>MINE NAME:</b> Kiewit Carr Sand & Gravel	<b>MINE/PROSPECTING ID#:</b> M-2020-029	<b>MINERAL:</b> Sand and gravel	<b>COUNTY:</b> Weld
<b>INSPECTION TYPE:</b> Preoperation Inspection	<b>INSPECTOR(S):</b> Daniel Cunningham	<b>INSP. DATE:</b> August 12, 2020	<b>INSP. TIME:</b> 10:00
<b>OPERATOR:</b> Kiewit Infrastructure Co.	<b>OPERATOR REPRESENTATIVE:</b> Jared Dains	<b>TYPE OF OPERATION:</b> 112c - Construction Regular Operation	
<b>REASON FOR INSPECTION:</b> Preoperation Inspection	<b>BOND CALCULATION TYPE:</b> Complete Bond	<b>BOND AMOUNT:</b> No Bond Held	
<b>DATE OF COMPLAINT:</b> NA	<b>POST INSP. CONTACTS:</b> None	<b>JOINT INSP. AGENCY:</b> None	
<b>WEATHER:</b> Clear	<b>INSPECTOR'S SIGNATURE:</b>

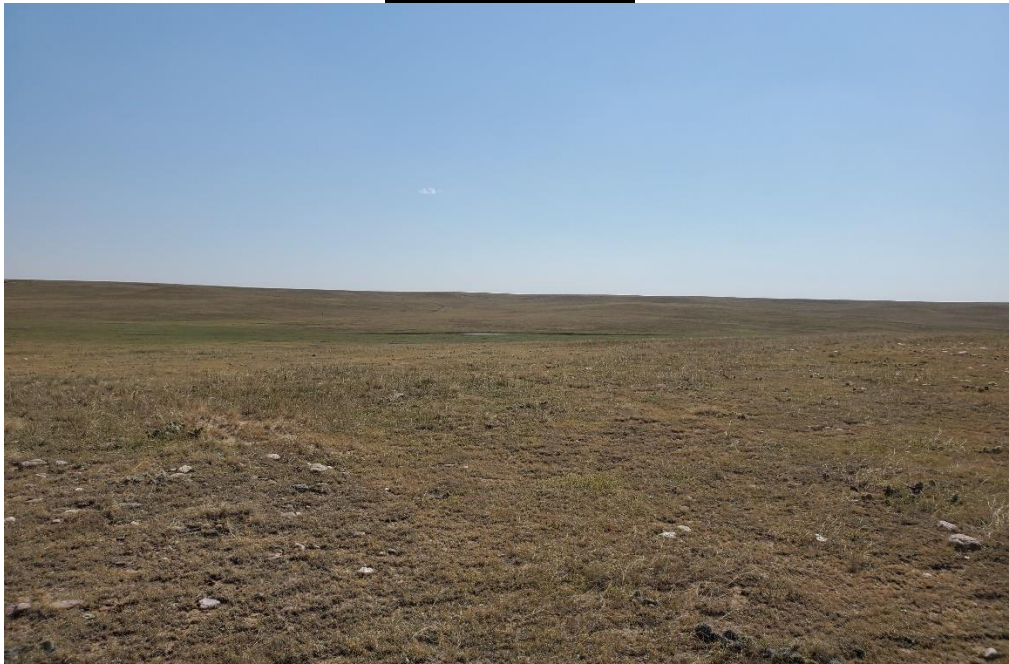
During the inspection, two small ponds were noted on the site that are not featured in the permit. The Operator will need to update the permit application with all required information for the two ponds. If the Operator intends to drain the pond, permission from the land owner will first need to be obtained and an explanation of how the Operator will follow Rule 3.1.6.

Pond found on the permit site

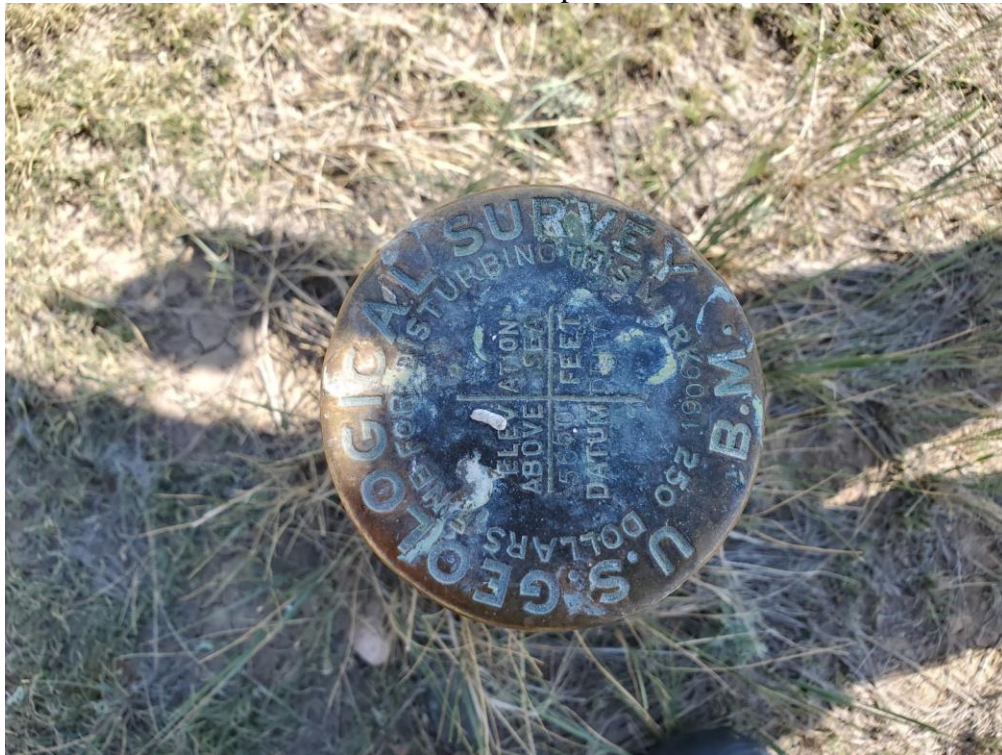
USGS Marker

A USGS marker was found during the inspection. The Operator will need to contact the USGS for further instructions on whether or not the marker can be removed. This information will need to be added to the permit application as well.

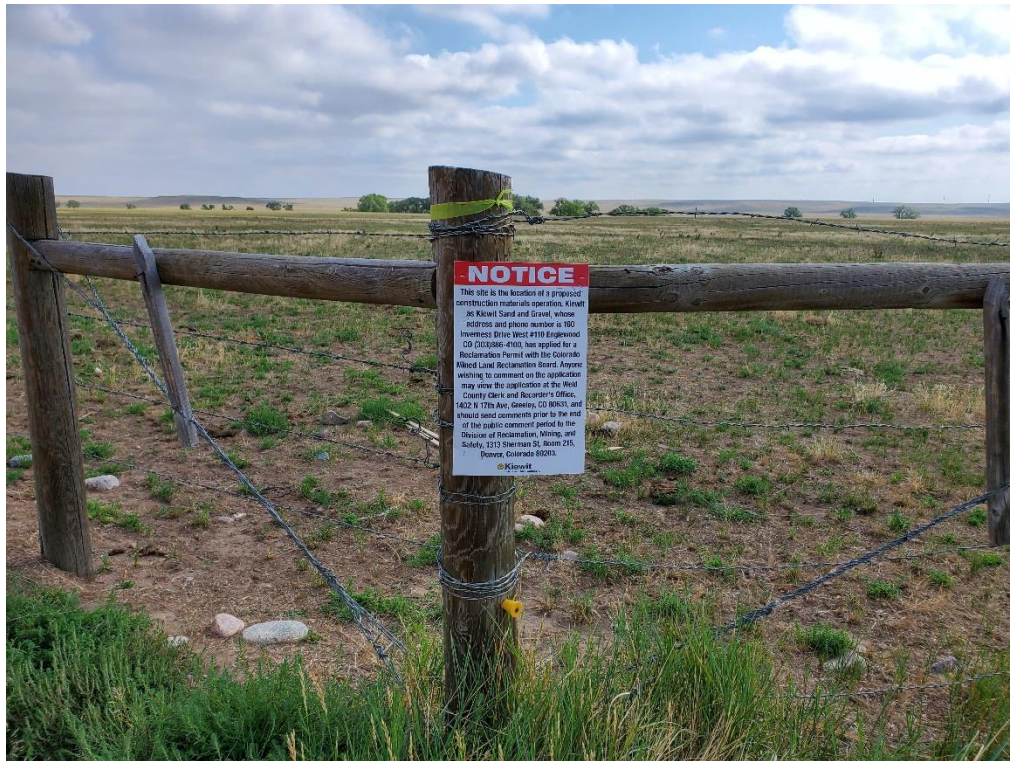
Public Notice

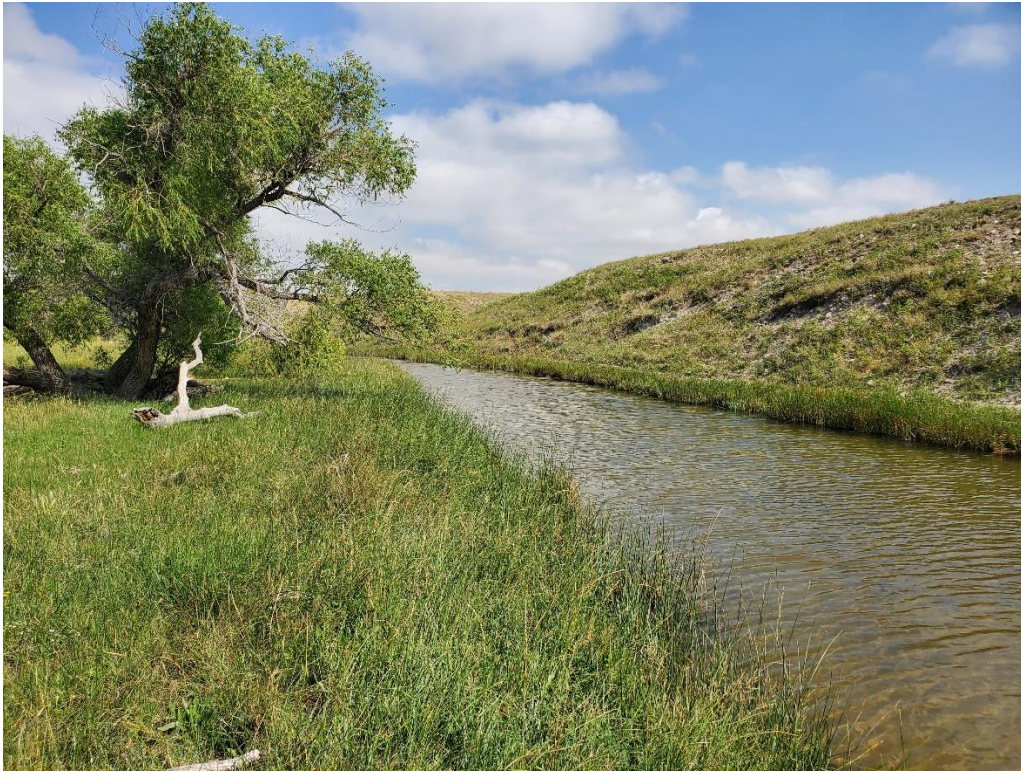
River on the permit
