Site Name:	REDCONE Drilling Pad	Client:	Sierta Redcone
Location, API:	Park County, CO, near Bailey	Date:	August 19, 2020
AFE Number:	NA	Weather:	Overcast / Cloudy, 70 °F
RPG Consultant:	Joe Schultz	Arrival Time:	7:00 AM
		Departure Time:	3:00 PM

Project Progress	Description	% Complete
Phase 1	Regrading & Contouring	100%
Phase 2	Reseeding	100%
Phase 3	Removal of Contaminated Soil	100%
Project Completion	Start Date 8/20/20 // End Date 8/20/20	100%

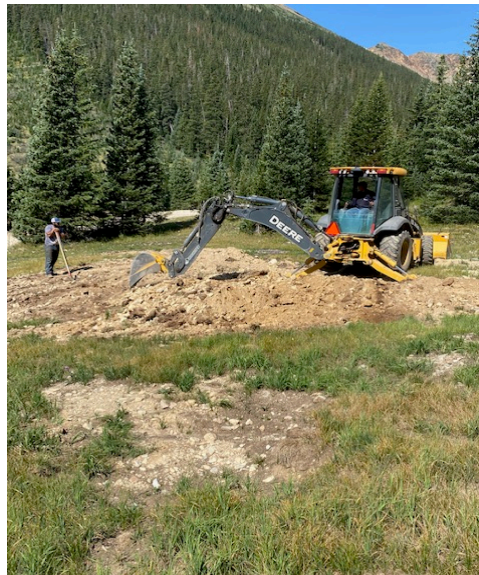
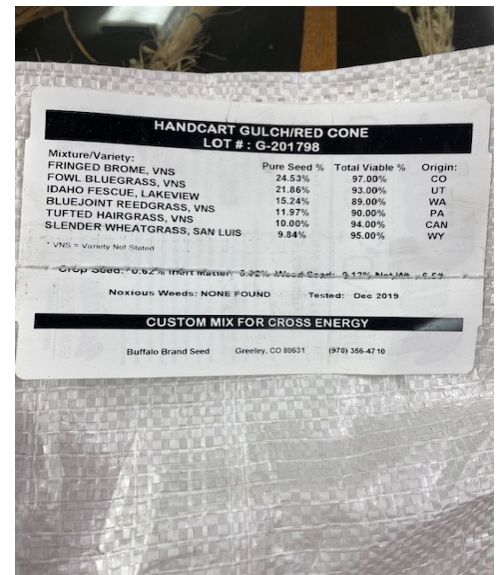
Photo 1

Left: View of soil recontouring on northern drill site.
Right: View of weed free seed certificate

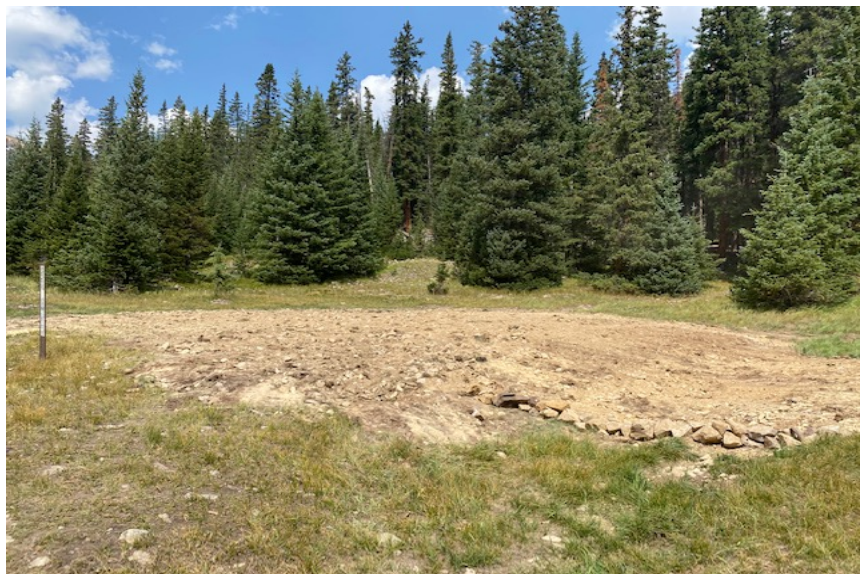
Photo 2

View of finished north drill site reclaim with rock check dam to manage upgradient drainage and mitigate sediment migration.

1. Cross Energy used the backhoe to relevel disturbed area, compact and bring back to pre-existing grade
2. Northern reclaim area consisted of a natural drainage swale; to avoid sediment migration, Cross used existing rocks to establish rock check dam/berm to contain sediment runoff in major rain event
3. Cross collected all trash, debris and foreign object and disposed of off-site
4. Available topsoil was spread across reclaim areas; Seed was spread and raked into soil to lay dormant over winter months for spring germination.
5. All contaminated soils were excavated and removed from site.

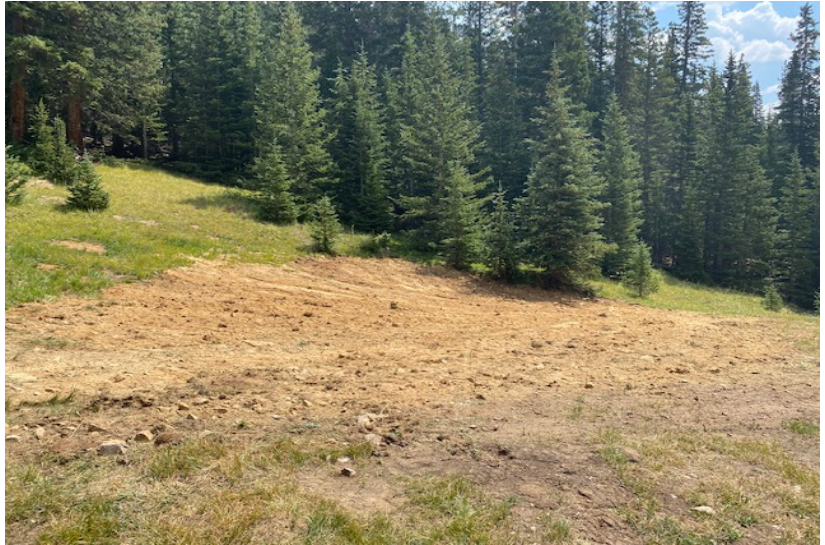
Photo 3

View of south drilling site brought back to pre-existing conditions with available topsoil laid across area

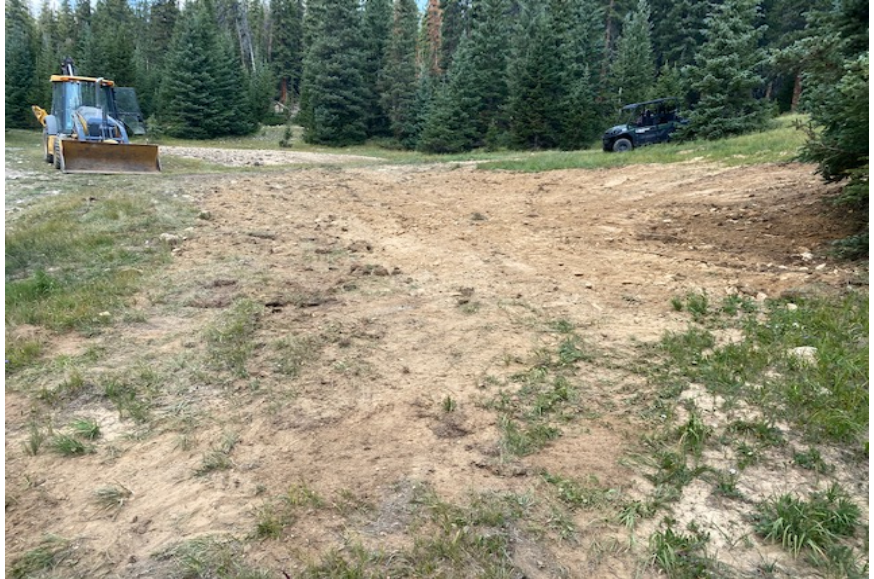
Photo 4

View of south drilling site brought back to pre-existing contours and seed spread evenly and raked across area.

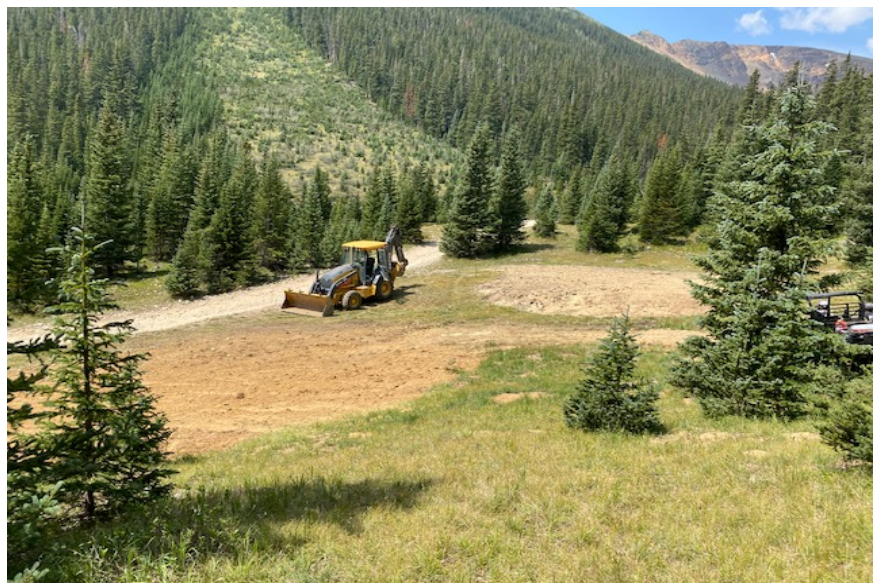
Photo 5

Overall view of both reclaim sites
