MINERALS PROGRAM INSPECTION REPORT
PHONE: (303) 866-3567

MINE NAME: Red Wolf Quarry	MINE/PROSPECTING ID#: M-1999-063	MINERAL: Sandstone (silica, st quartzite)	COUNTY: Larimer
INSPECTION TYPE: Monitoring	INSPECTOR(S): Robert Zuber, P.E.	INSP. DATE: September 22, 2020	INSP. TIME: 10:05
OPERATOR: Luis M. Vasquez	OPERATOR REPRESENTATIVE: Raul Vasquez	TYPE OF OPERATION: 110c - Construction Limited Impact

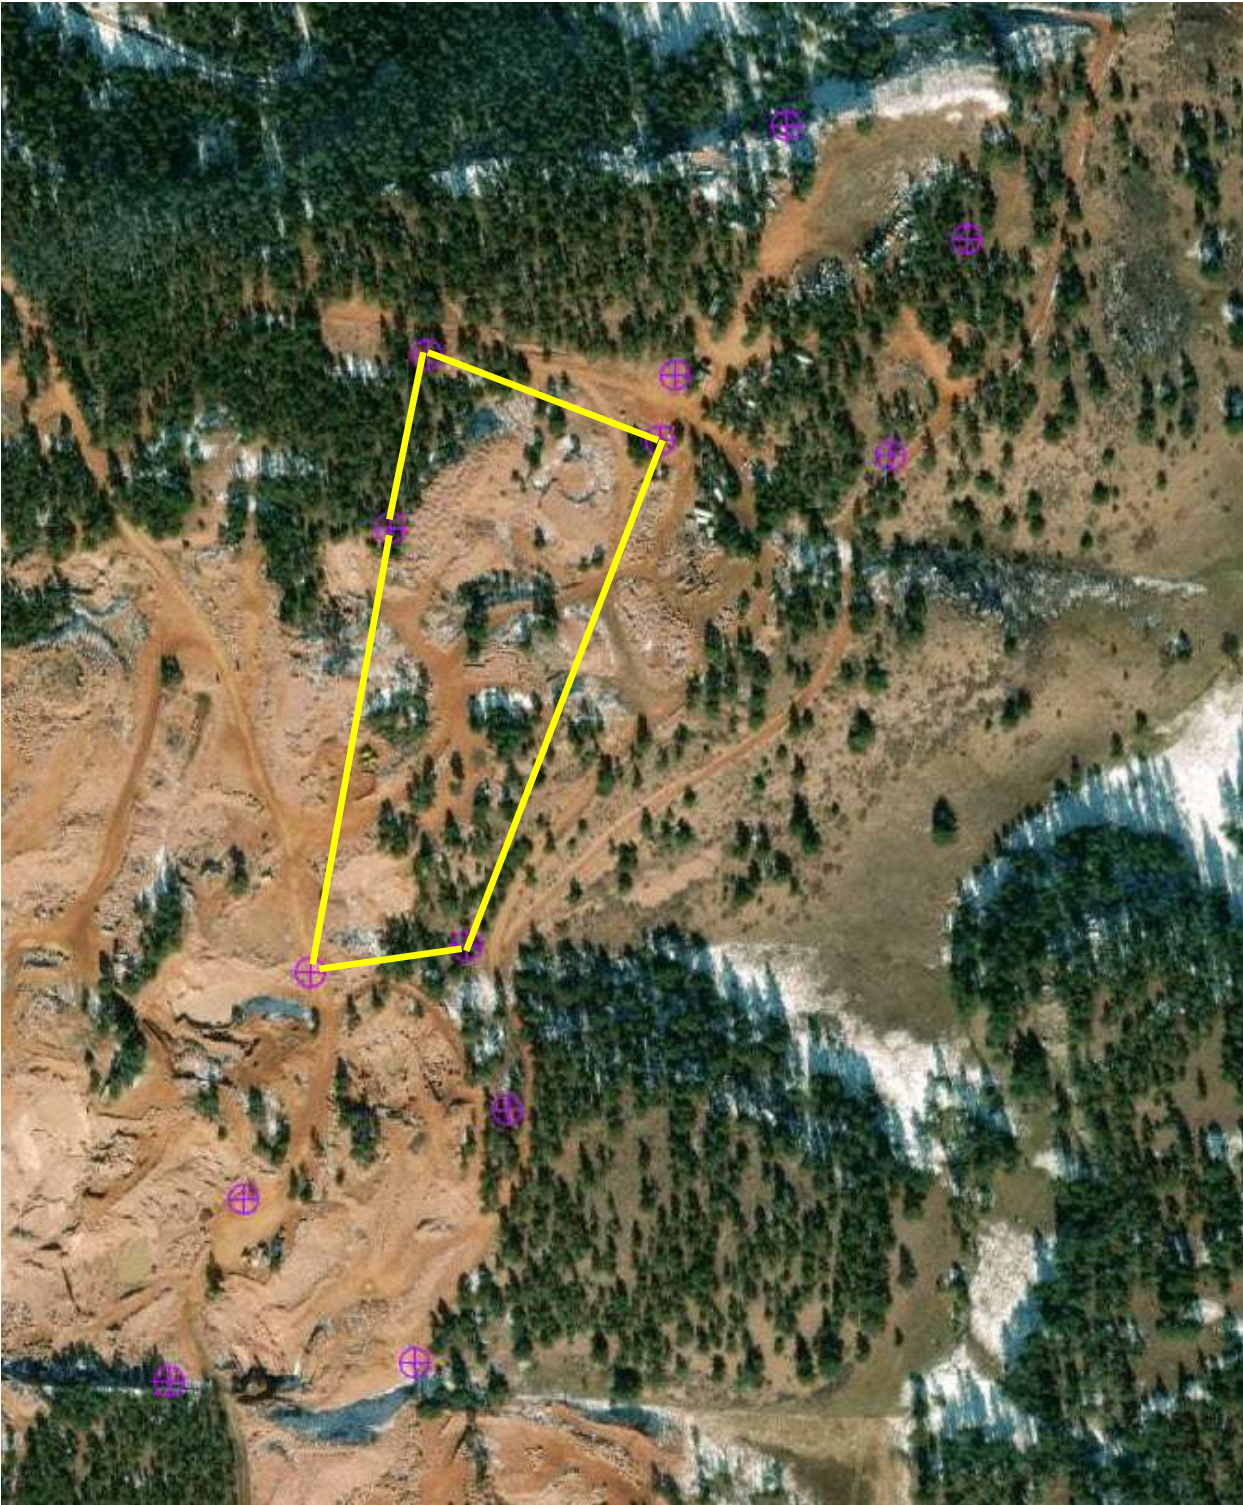
Figure 1. Boundary of Red Wolf Quarry per Markers on the Ground

Permit boundary markers were found at the corners of the site, and these were checked using GPS and by comparing to the boundary outline in the permit maps. There appears to be one or more issues with the marking of the boundary. See the figures below. It appears that the markers on the ground indicate a narrow permit area in the east/west direction compared to the site plan. In particular, the corners at the south end are less than 300 feet apart (using Google Earth), but the site plan indicates that they should be 620 feet apart. The markers are important in determining where the Red Wolf Quarry permit ends and where other permits begin (Beech Hill, for example).

Purple crosshair symbols are from DRMS GPS data collection at on-the-ground markers

(Indio Red Quarry Number 1 & 2 are also shown to the south and to the north)

Yellow lines are an estimate of the boundary from connecting the GPS points

CORRECTIVE ACTIONS: The operator shall conduct a survey and replace the boundary markers in the correct location(s). The operator shall provide proof to the Division that this has been done by the corrective action date.

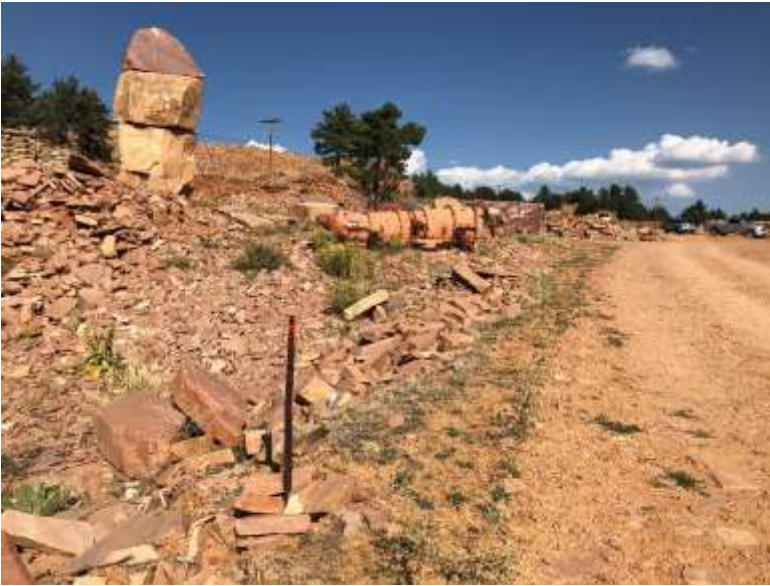
Southwest corner of site (looking north) with boundary marker

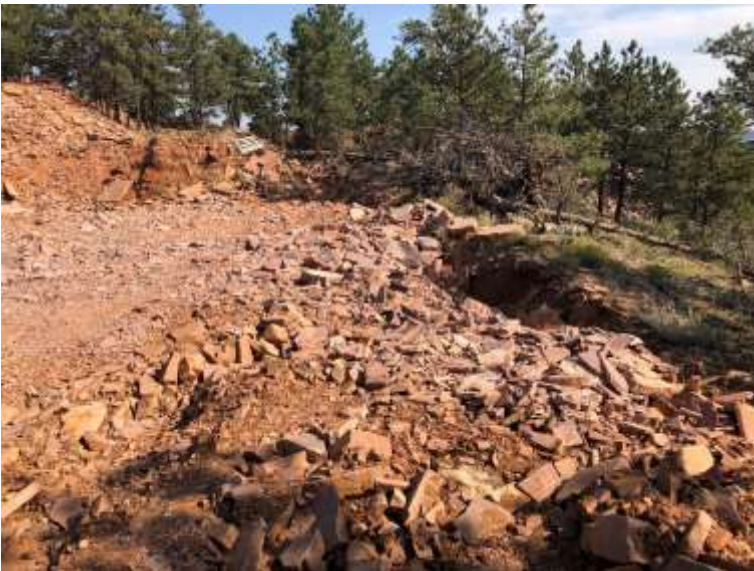
Eastern edge of large quarry

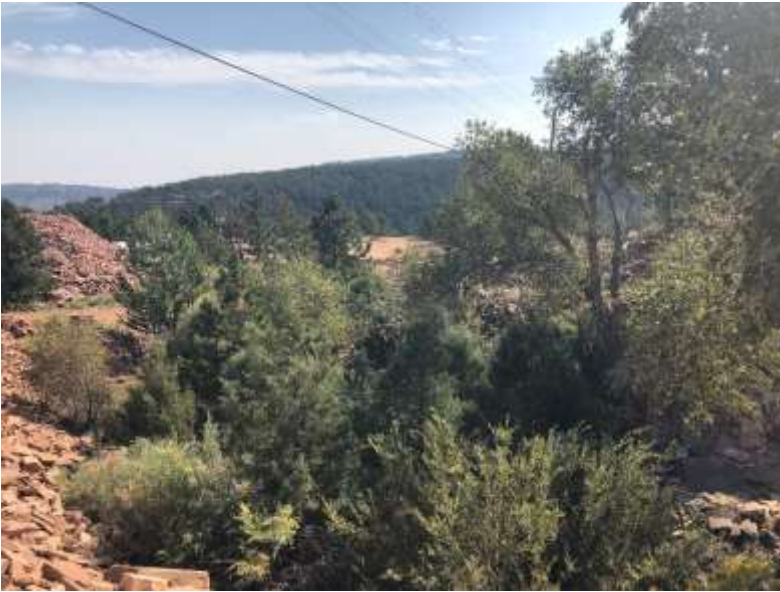
Undisturbed area near north end of permit area

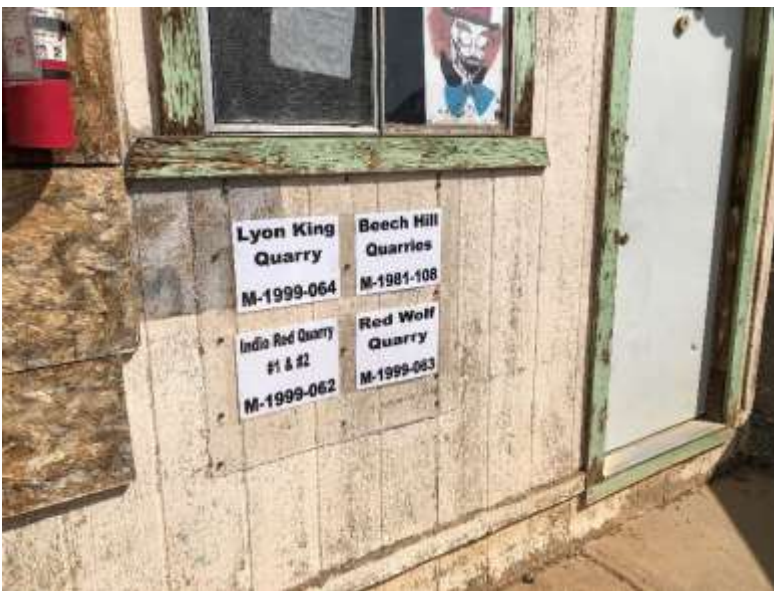
The mine entrance sign was seen at the scale house, near the south end of the permit boundary. It contained the quarry name and DRMS permit number. It did not list the name of the operator or mention the permit with DRMS. This information should be added to the sign.

Entrance signs for Red Wolf Quarry and other mines

CORRECTIVE ACTIONS: The operator shall, at the entrance of the mine site, post a sign which shall be clearly visible from the access road with the following: the name of the operator, a statement that a reclamation permit for the operation has been issued by the Colorado DRMS; and the permit number. The operator shall submit photo documentation that a proper sign has been posted by the corrective action date.
